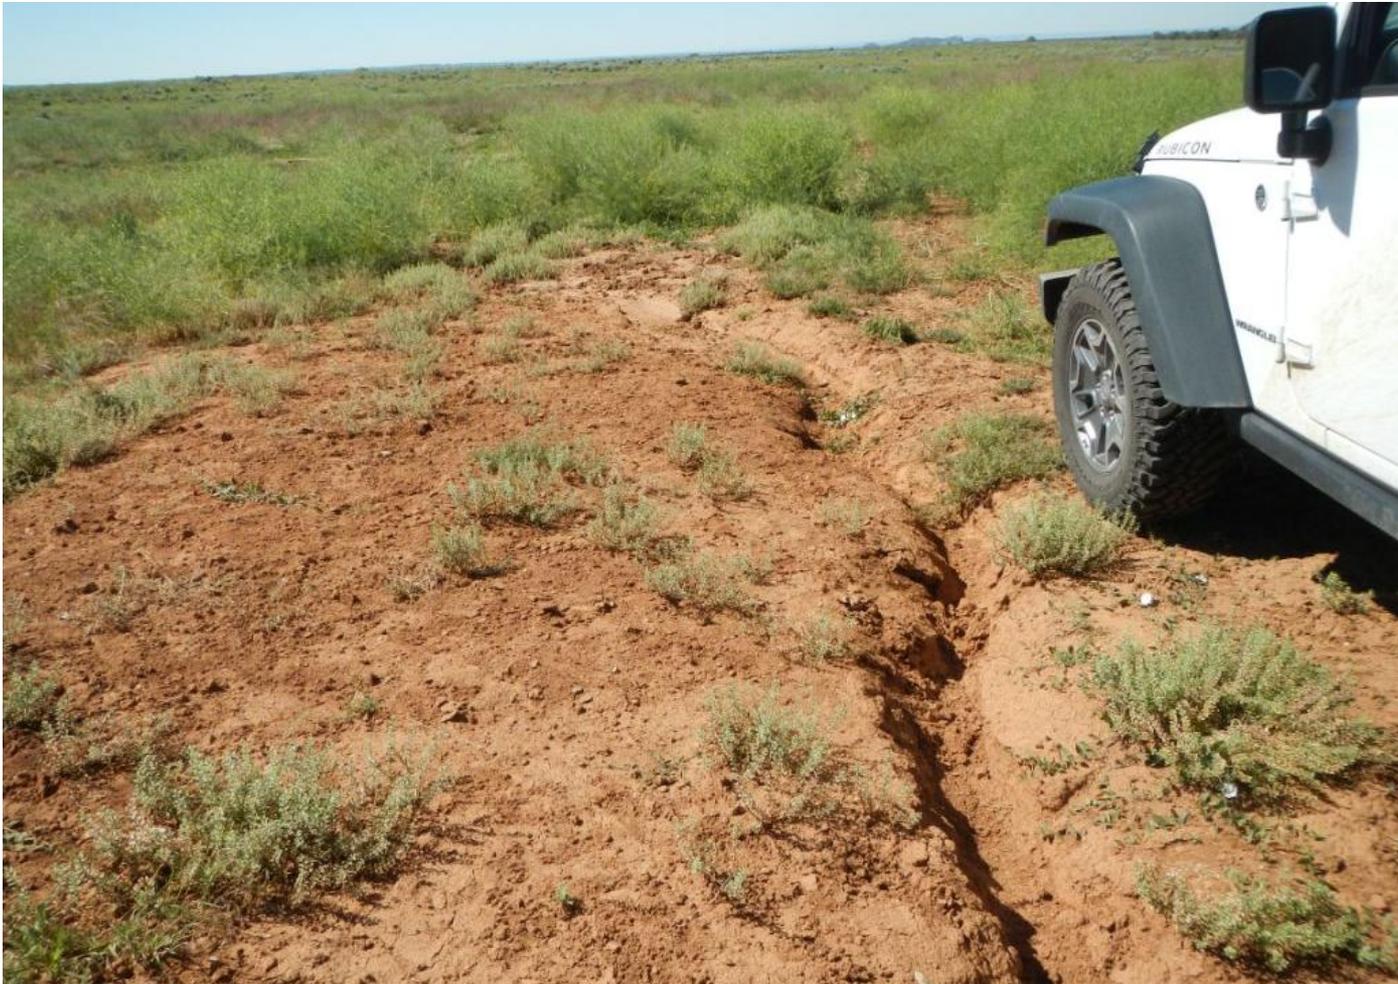
Photo 1. View of rill erosion (approximately 6 inches wide and 6 inches deep) at the entrance to the well pad.

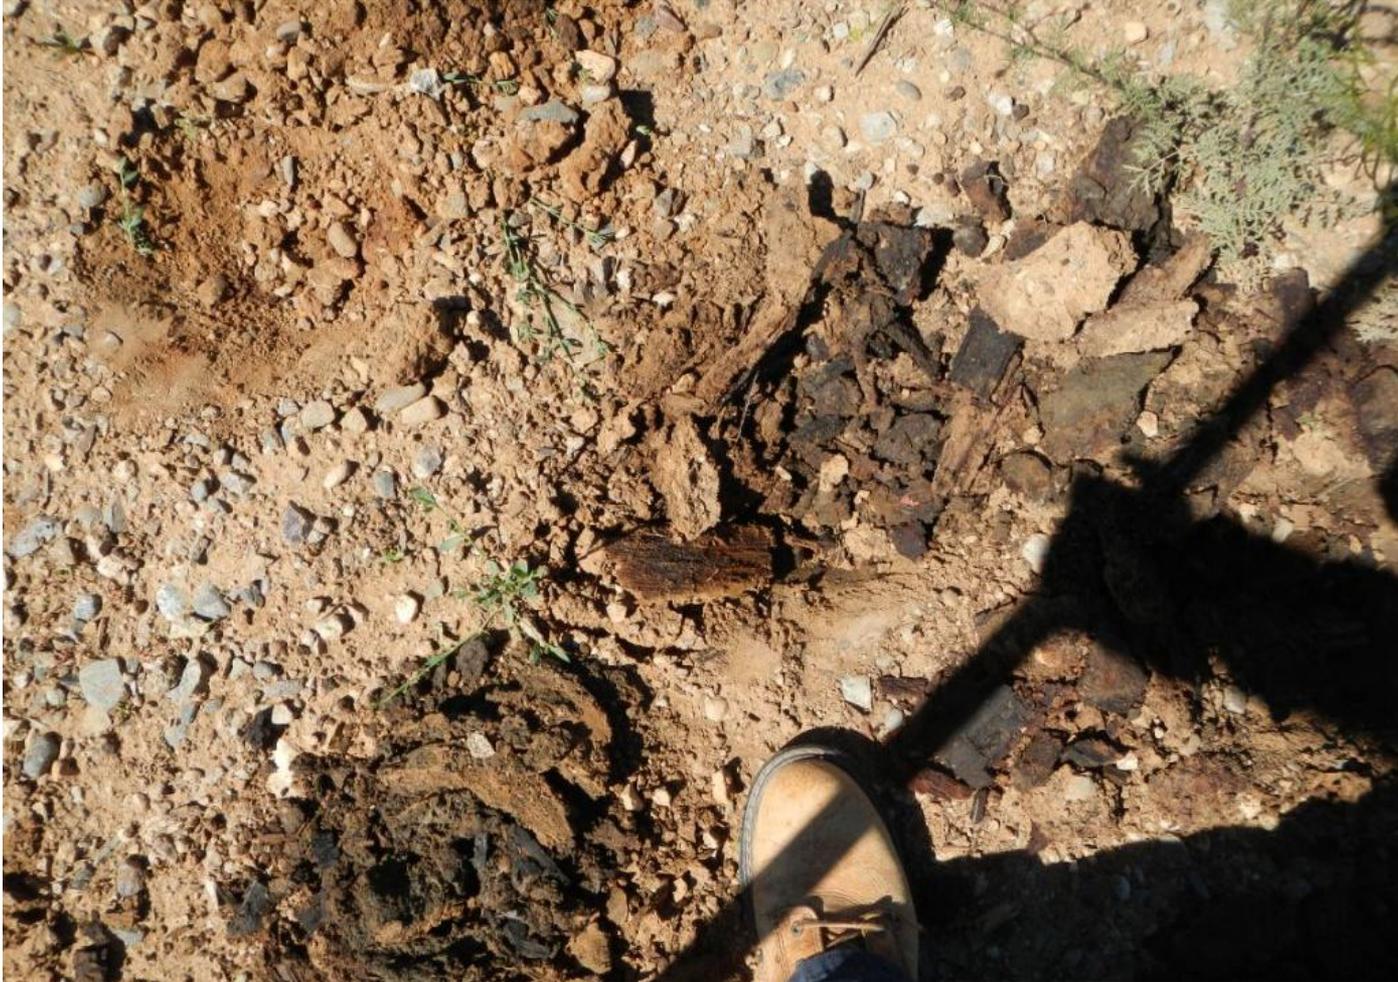
Photo 2. View of what appears to be oil stained soils and gravel around what was likely the well head area.

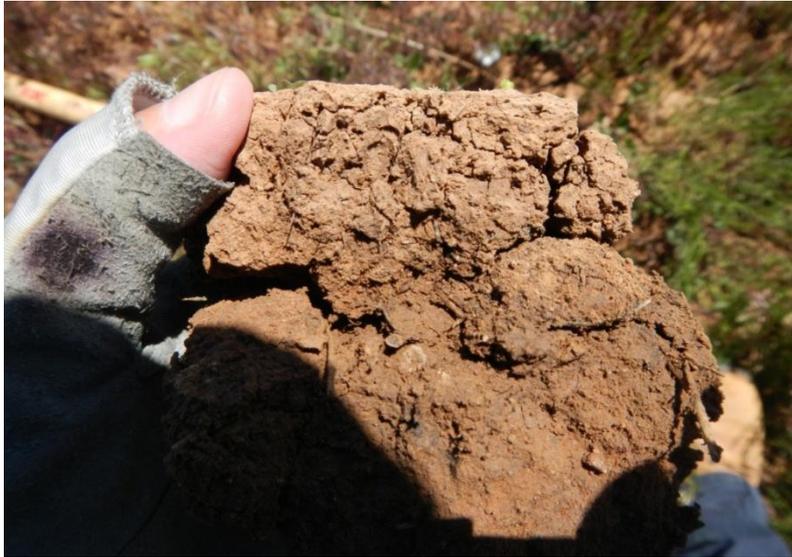
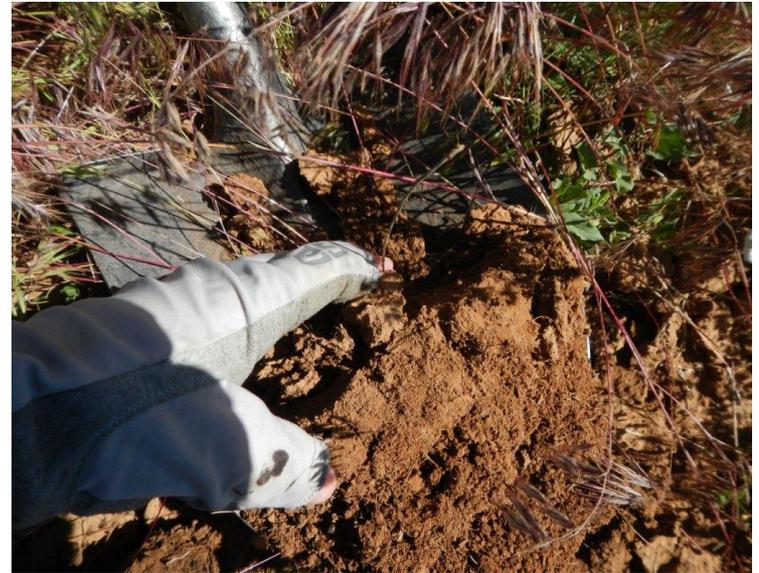
Photos 3 and 4. Close-up view of soil from well pad that is compacted (on left) and close-up of soil outside of the project area that is loose and not compacted ( on right).

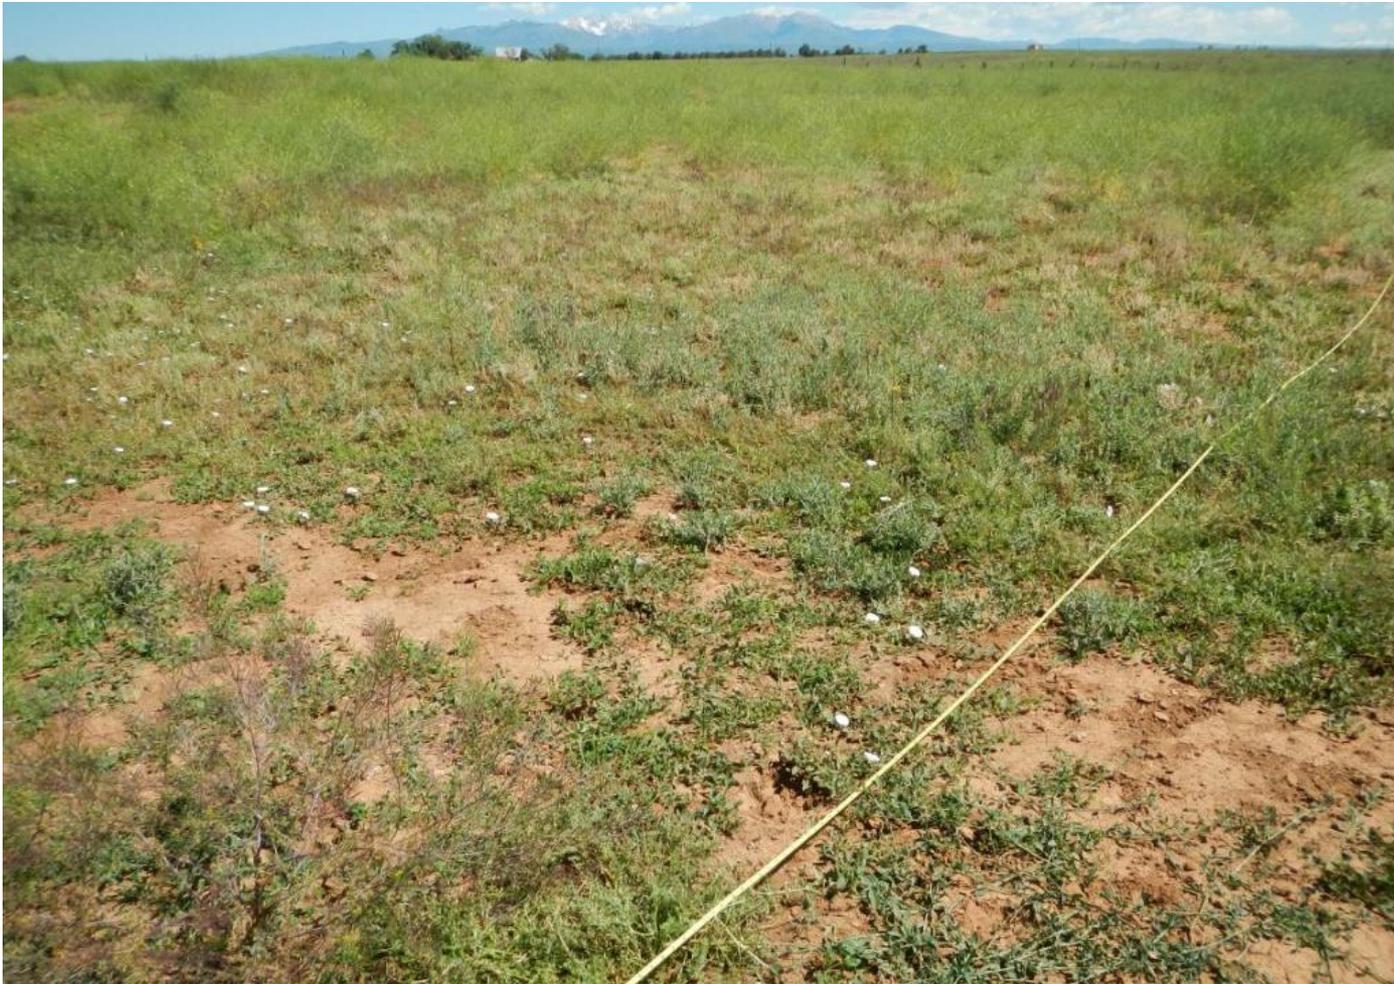
Photo 5. View from midpoint along vegetation transect within the project disturbance. Greenish-gray plants in mid-ground are Russian knapweed (*Acroptilon repens*). Additionally, weedy vegetation such as flixweed (*Descurainia sophia*) and field bindweed (*Convolvulus arvensis*) are readily observable.

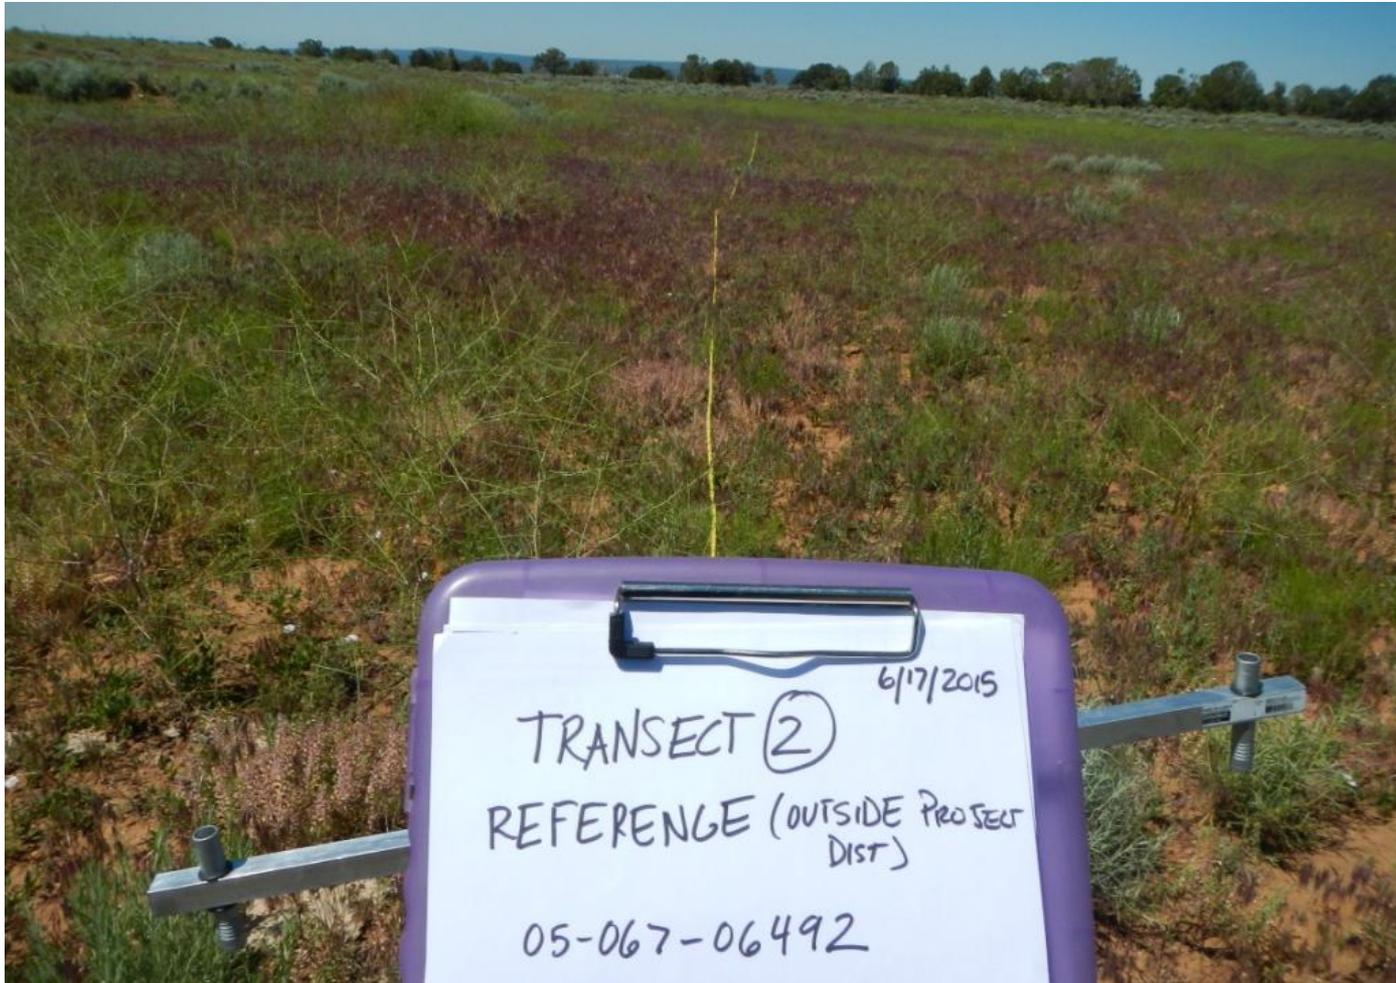
Photo 6. View of reference transect outside of project disturbance facing south-southwestward. Vegetation such as flixweed, rubber rabbitbrush (*Ericameria nauseosa*), and cheatgrass (*Bromus tectorum*) are readily observable.
