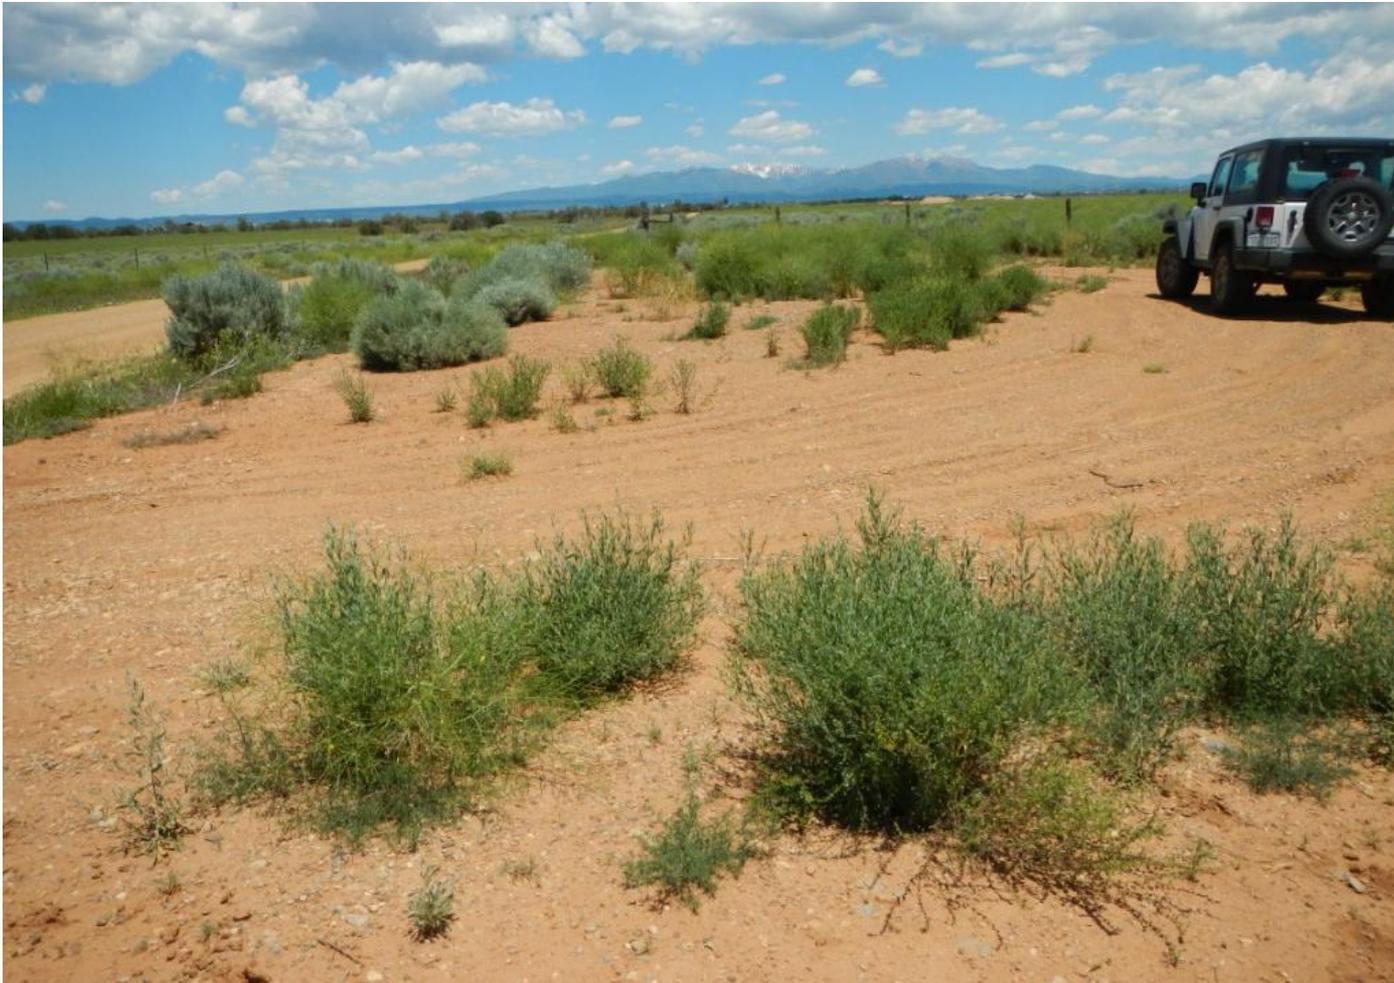
Photo 1. View of tank battery from southern edge facing northward. Russian knapweed (*Acroptilon repens*) plants are visible in the foreground and rubber rabbitbrush (*Ericameria nauseosa*) and tumble mustard (*Sysimbrium altissimum*) in the background. Tank battery area does not appear to have been de-compacted and reclaimed.

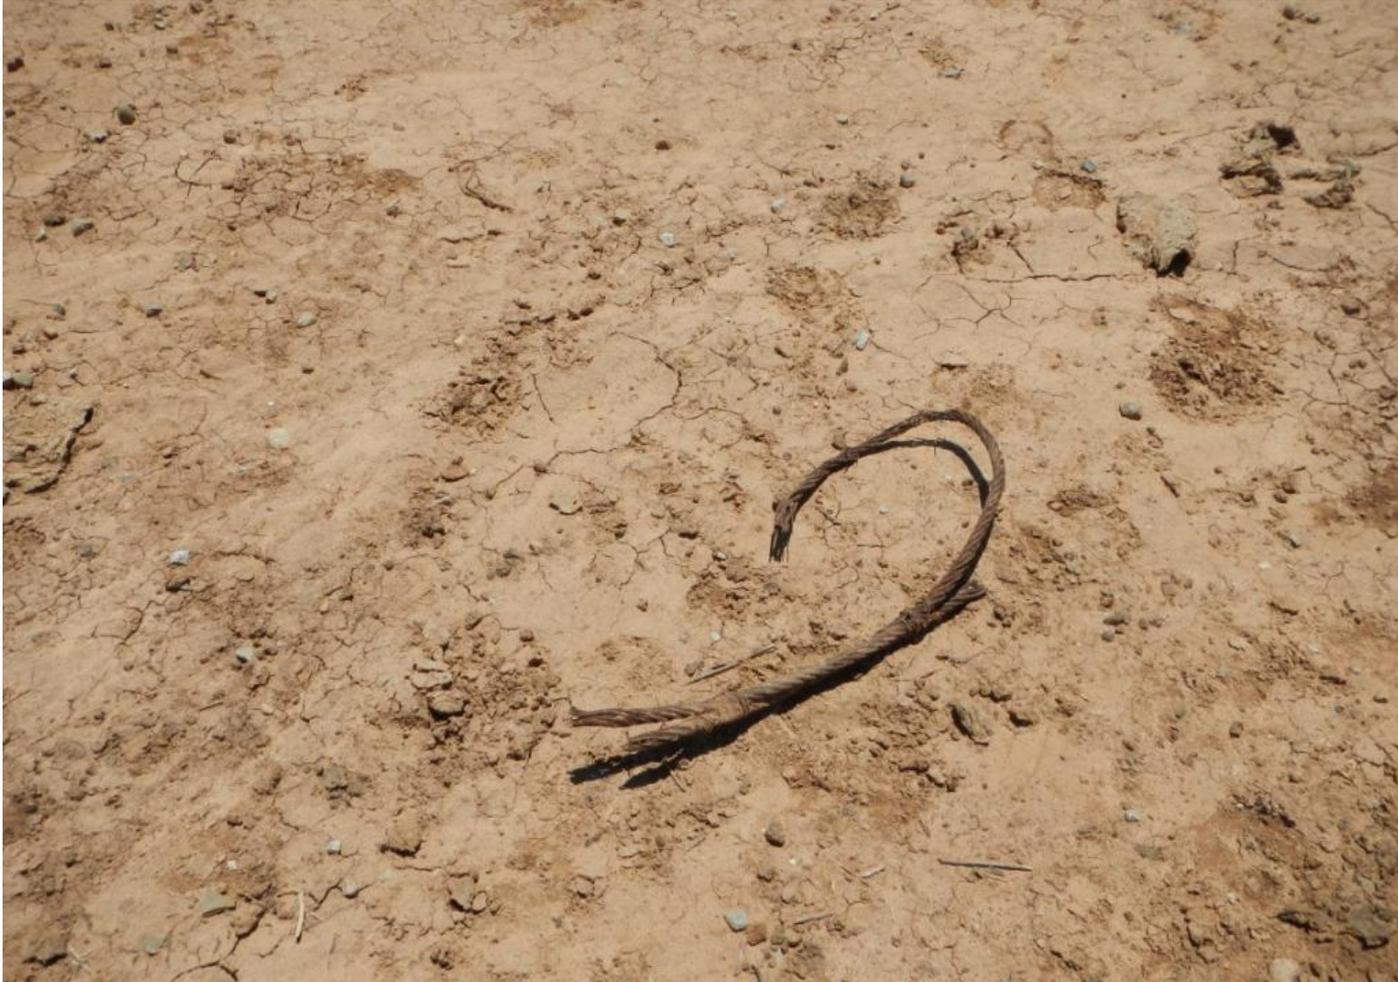
Photo 2. View of rig anchor cable within well pad area.

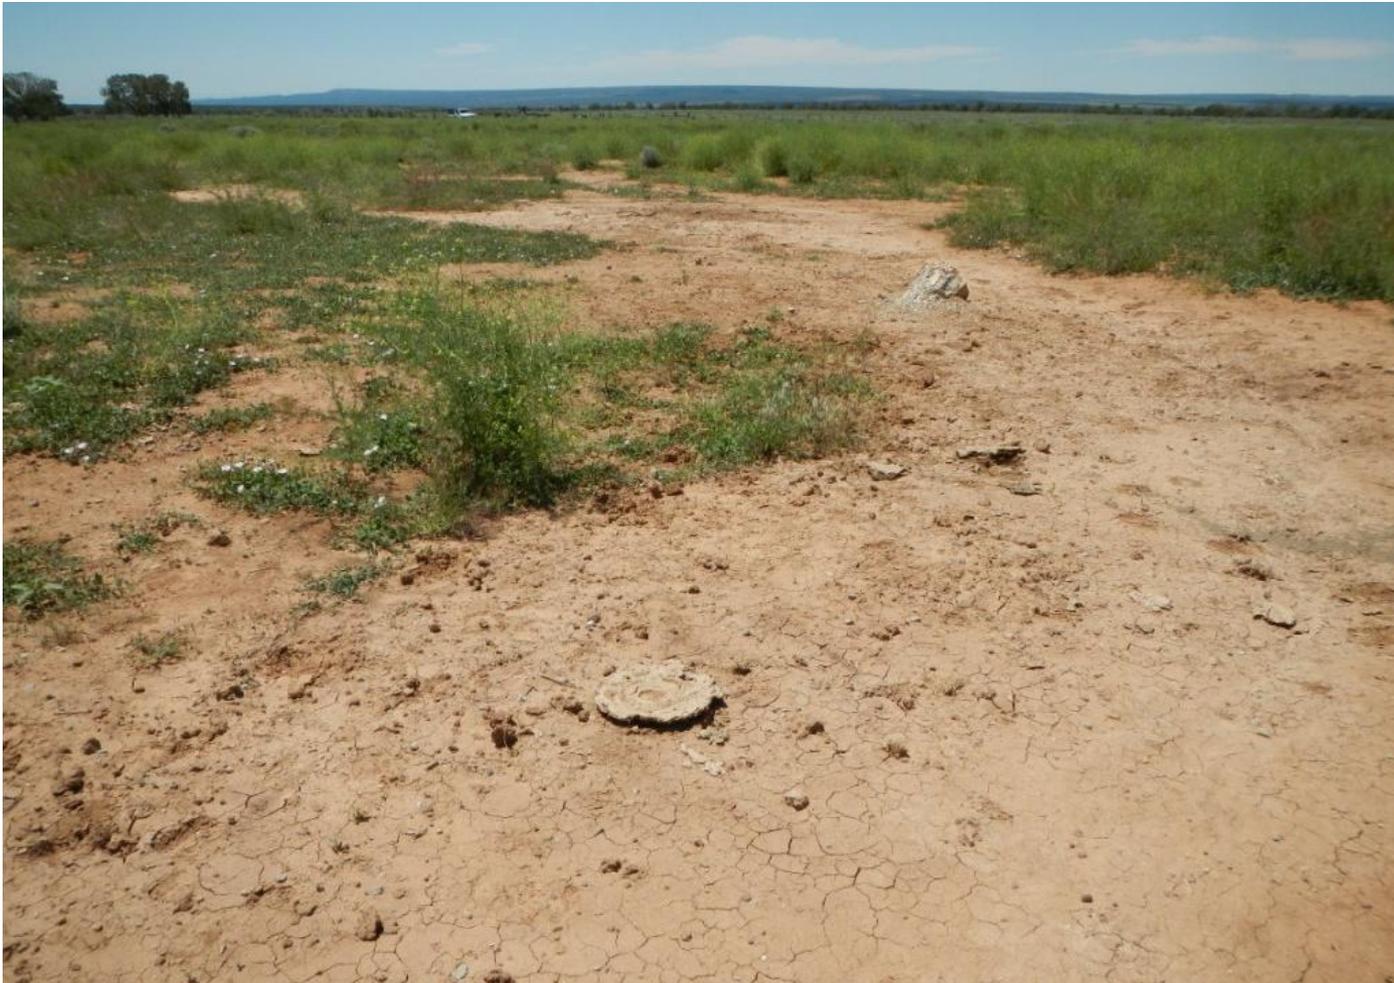
Photo 3. View from northern edge of well pad facing southwestward. What appears to be cement debris is present in the mid-ground of photo. An area approximately 90 feet long and 15 feet wide that is largely devoid of vegetation is present on the well pad.

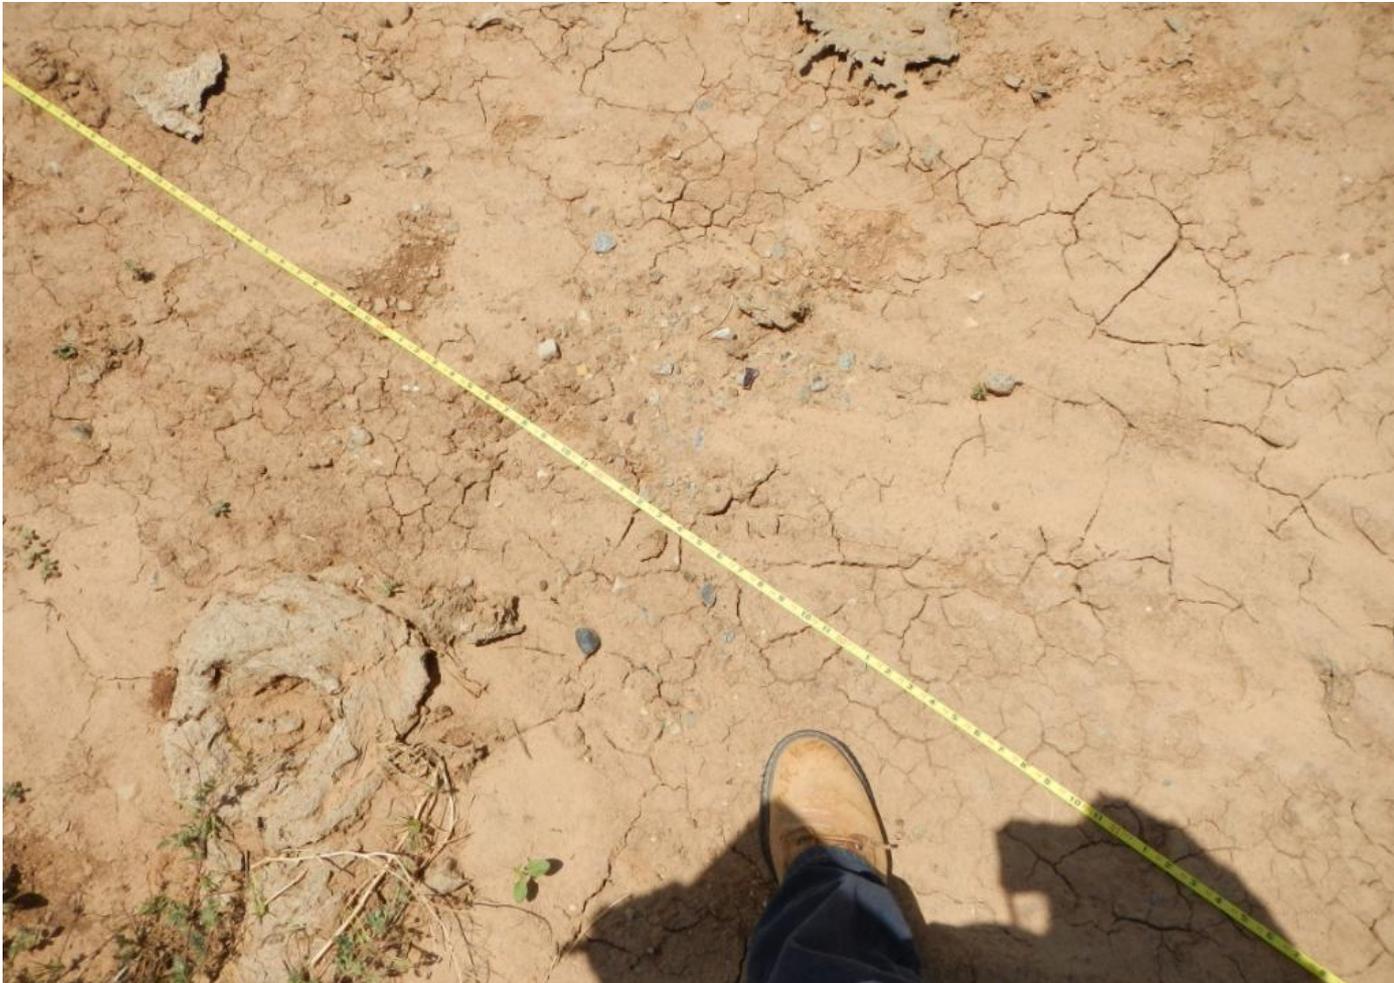
Photo 5. Birdseye view of the midpoint along Transect 1, within the project disturbance. Vegetation left of foot is field bindweed (*Convolvulus arvensis*).

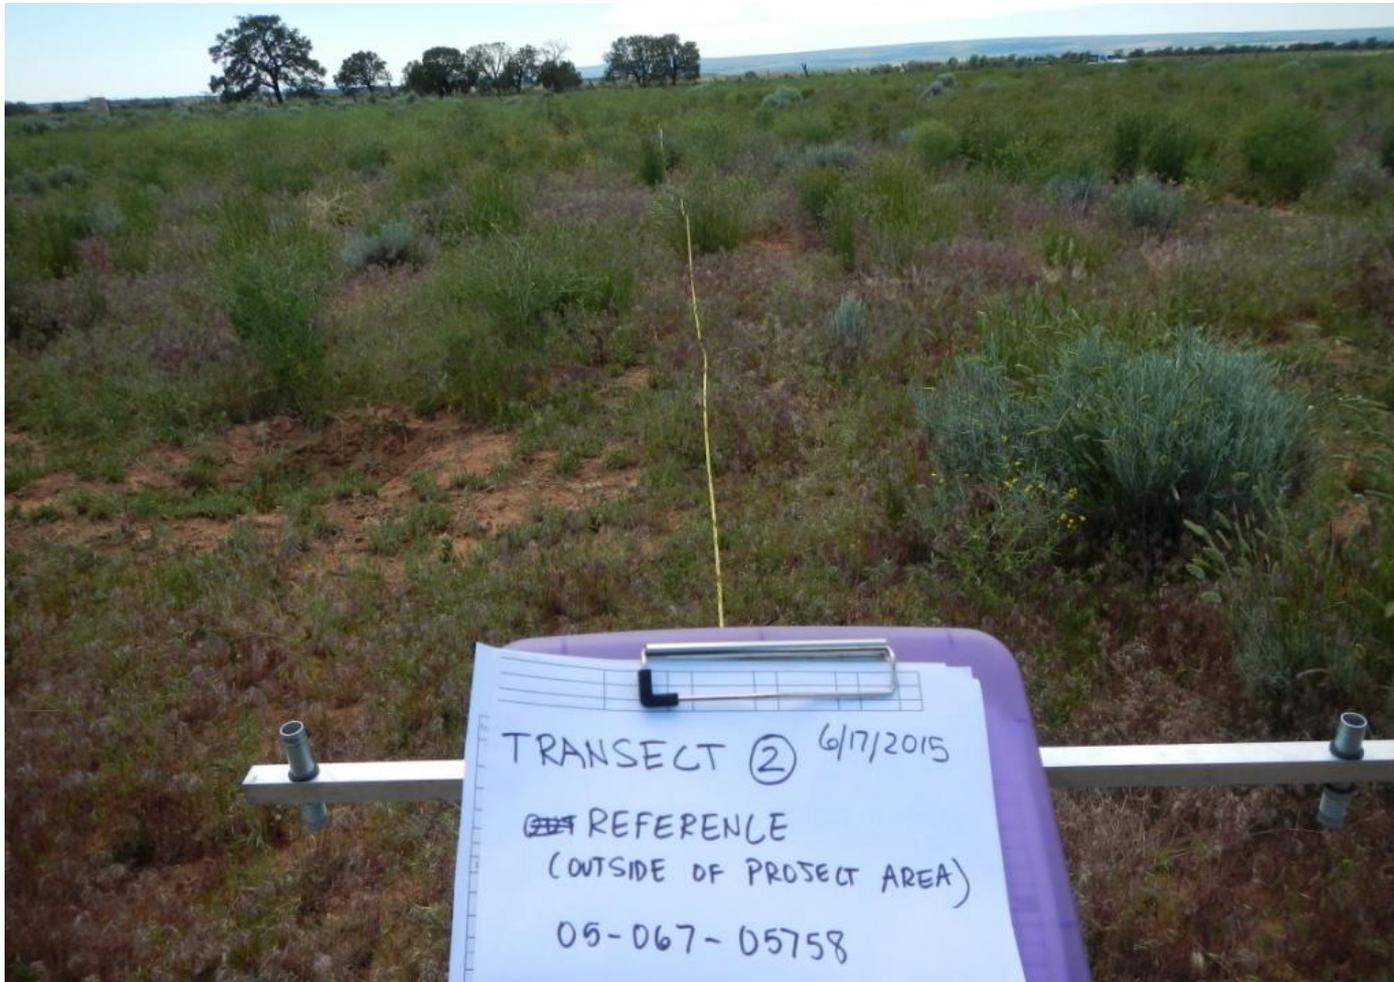
Photo 6. View of the beginning of Transect 2, reference transect that is outside of project disturbance, facing southwestward. Vegetation is comprised of native and non-native species such as crested wheatgrass (*Agropyron cristatum*), cheatgrass (*Bromus tectorum*), rubber rabbitbrush (*Ericameria nauseosa*) and tumble mustard (*Sysimbrium altissimum*).

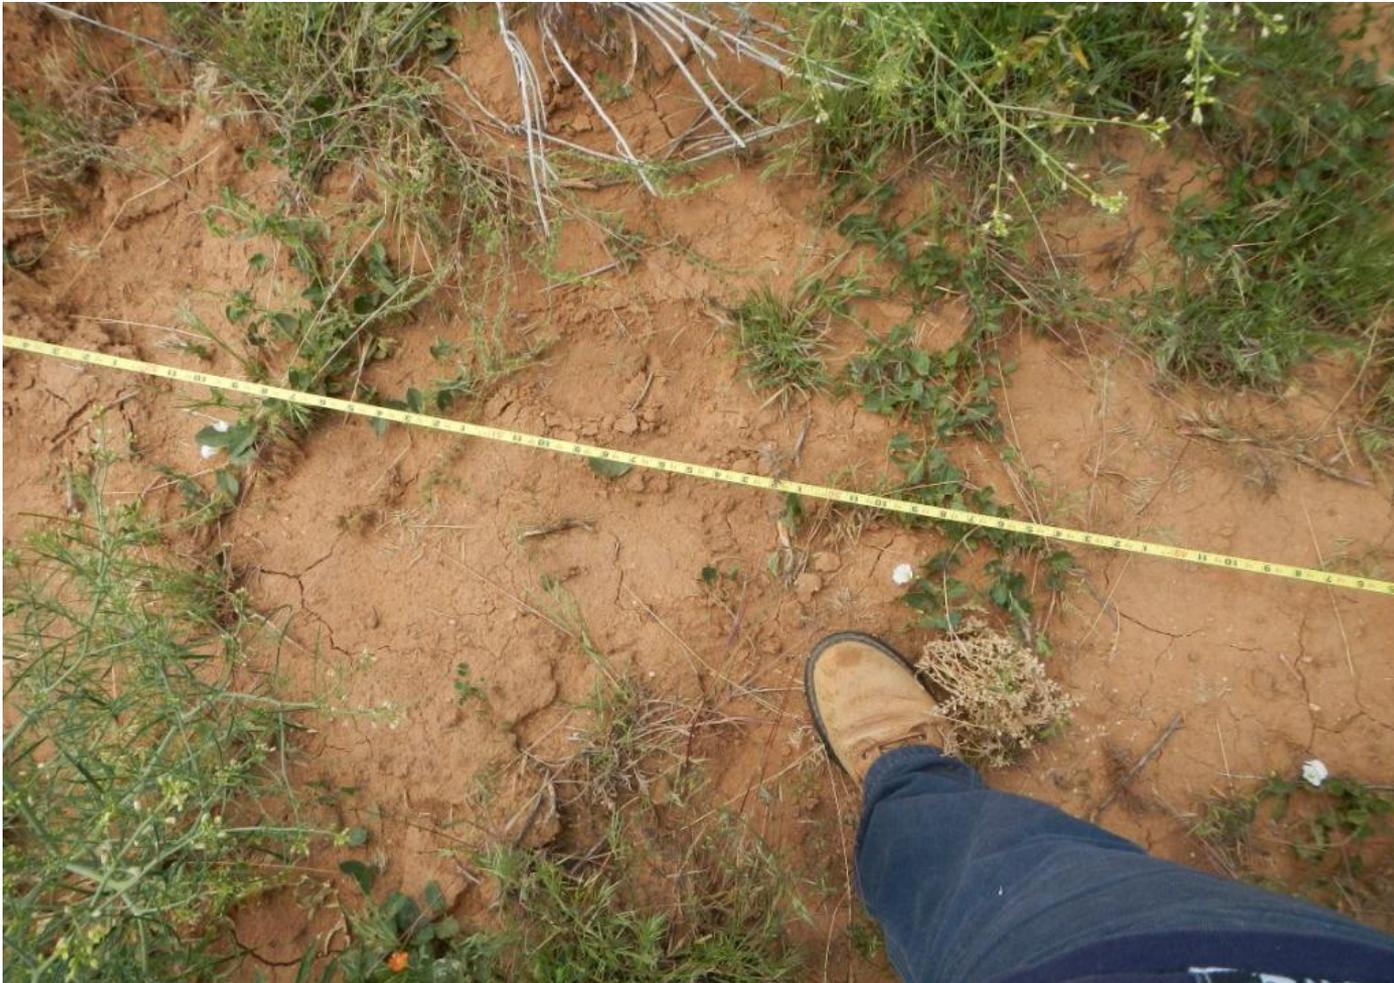
Photo 7. Birdseye view of midpoint along Transect 2, reference transect that is outside of project disturbance. Vegetation here is comprised of tumbledustard, cheatgrass, field bindweed, and globemallow (*Sphaeralcea coccinea*).
