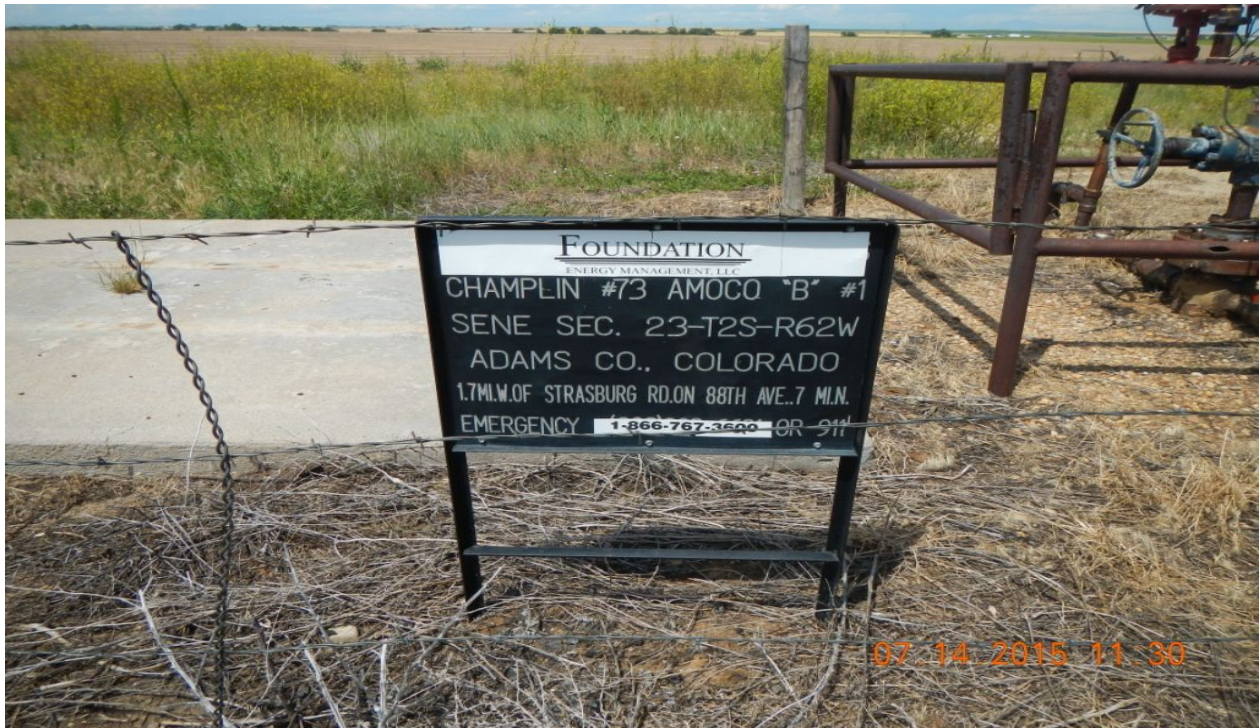
photo 1: Will sign

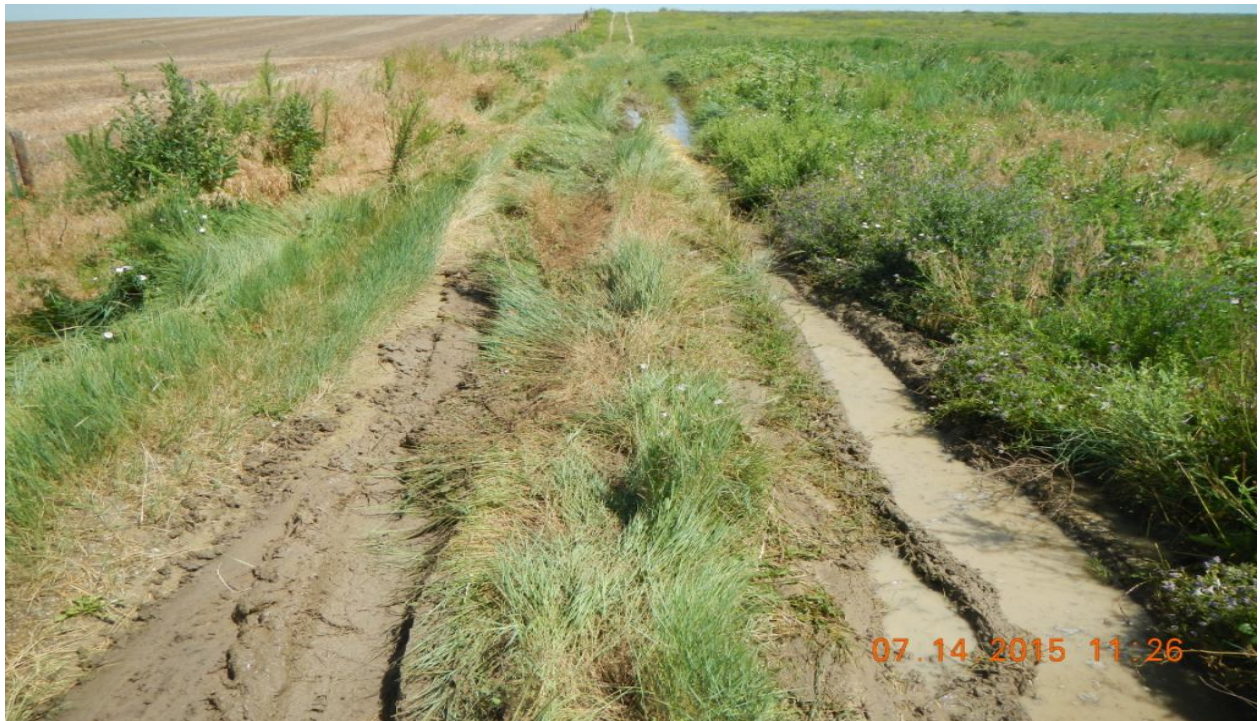
photo 2: Access road traveling north to the location may be inaccessible to emergency vehicles.

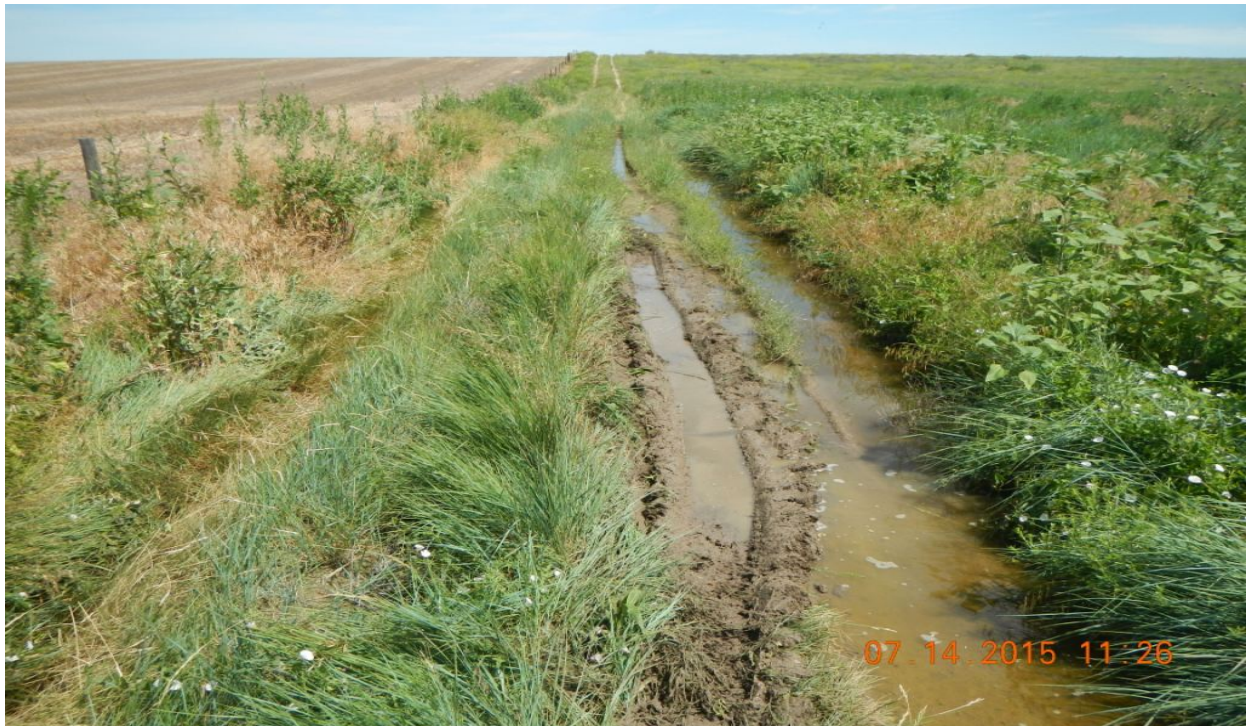
photo 3: Access road traveling north to the location may be inaccessible to emergency vehicles.

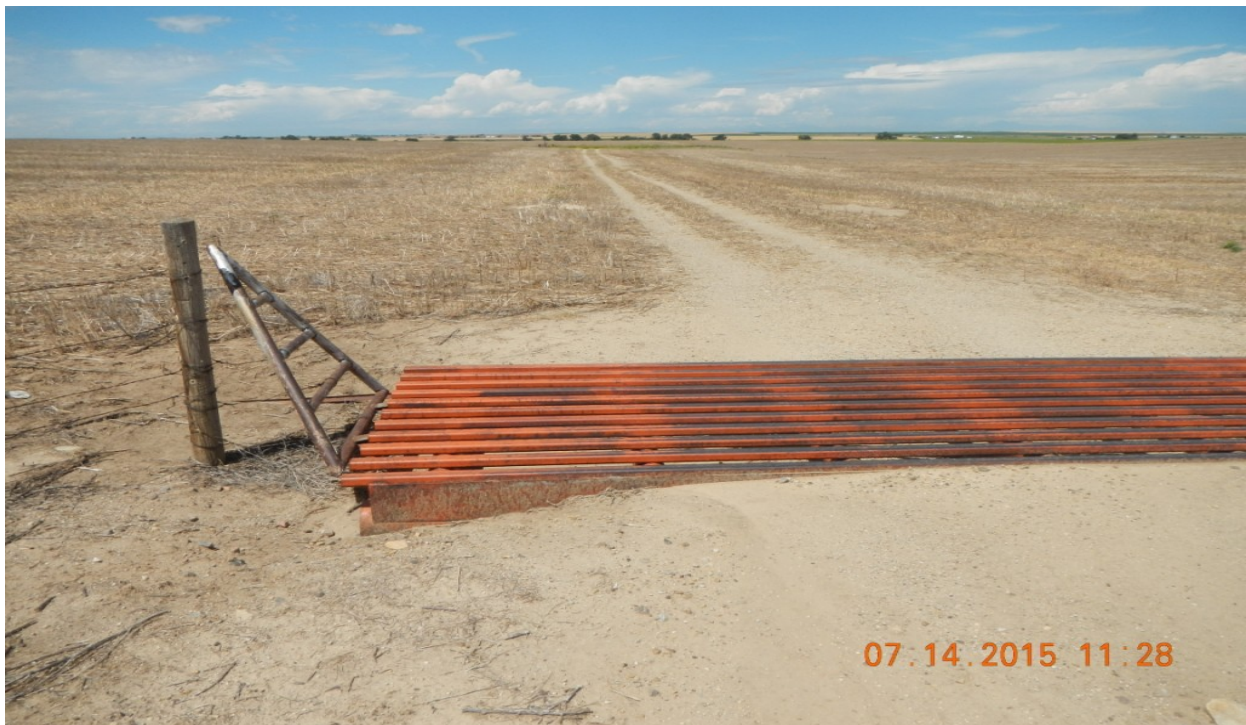
photo 4: Facing west towards the location at the cattle guard.

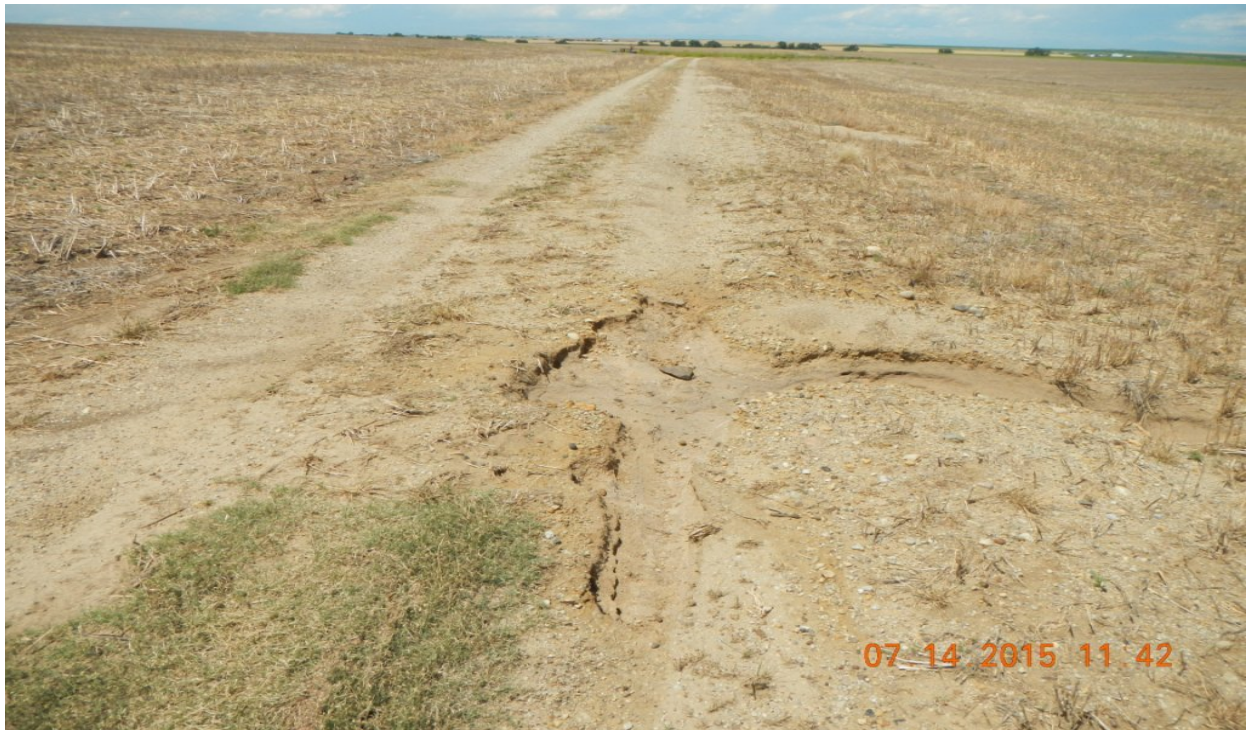
photo 5: Erosion is occurring along the access road traveling west towards the location.

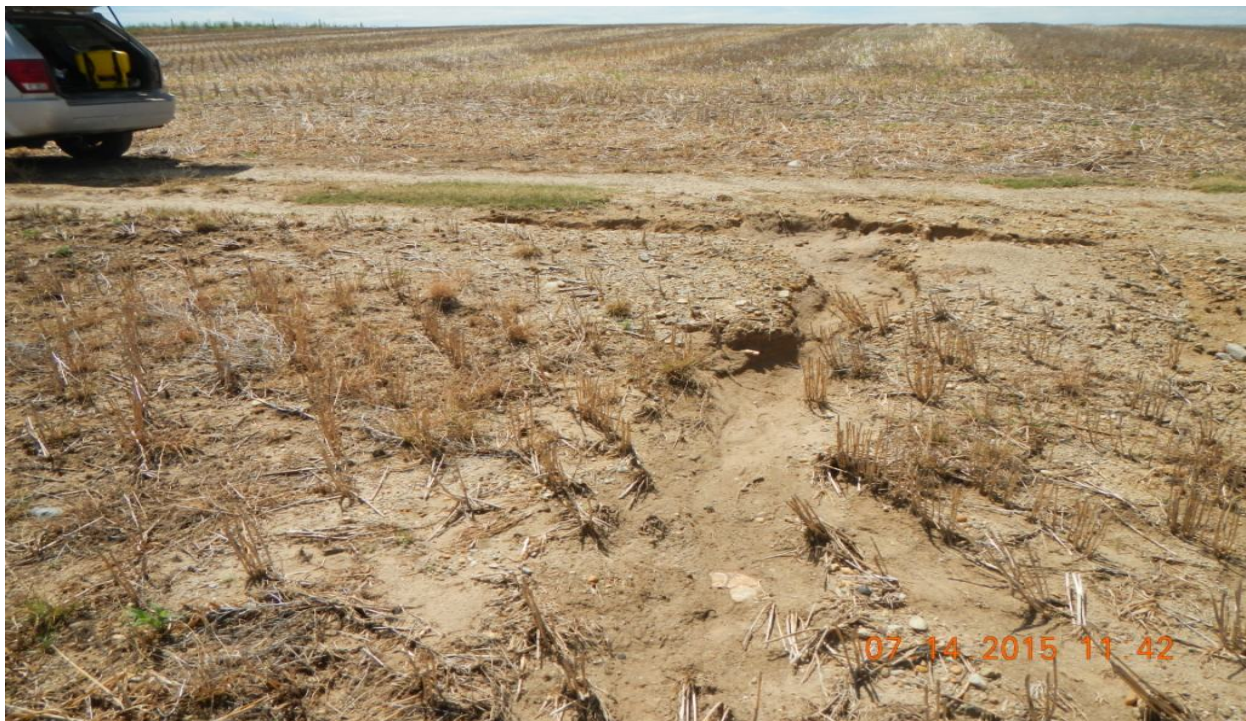
photo 6: Sediment is being transported off of the access road out into the surrounding cultivated field.

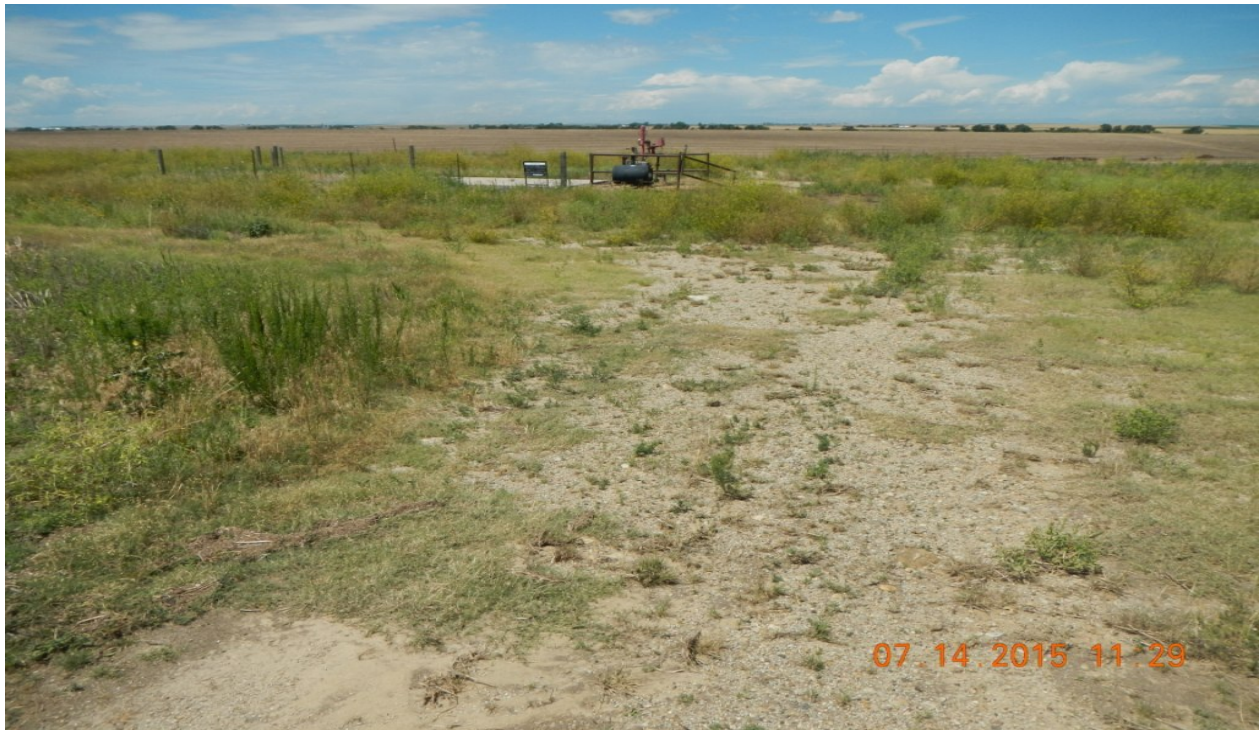
photo 7: Facing west towards the equipment on location.

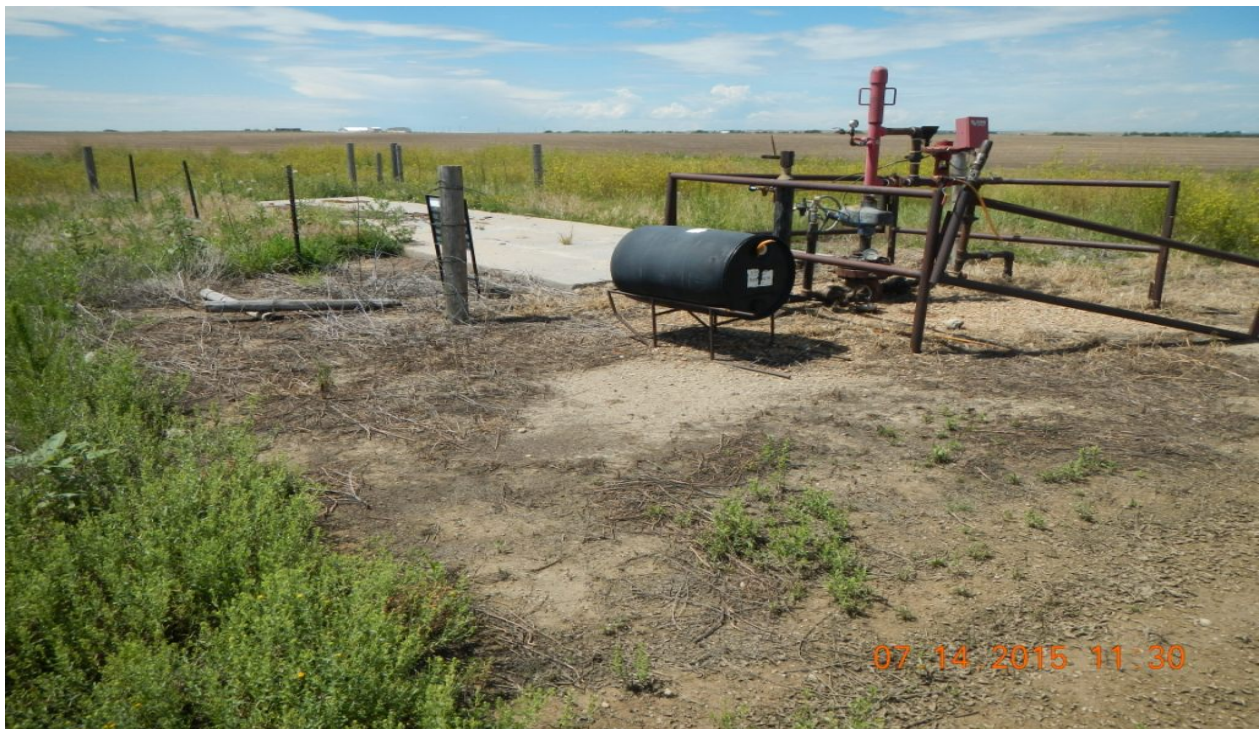
photo 8: Equipment at the location.

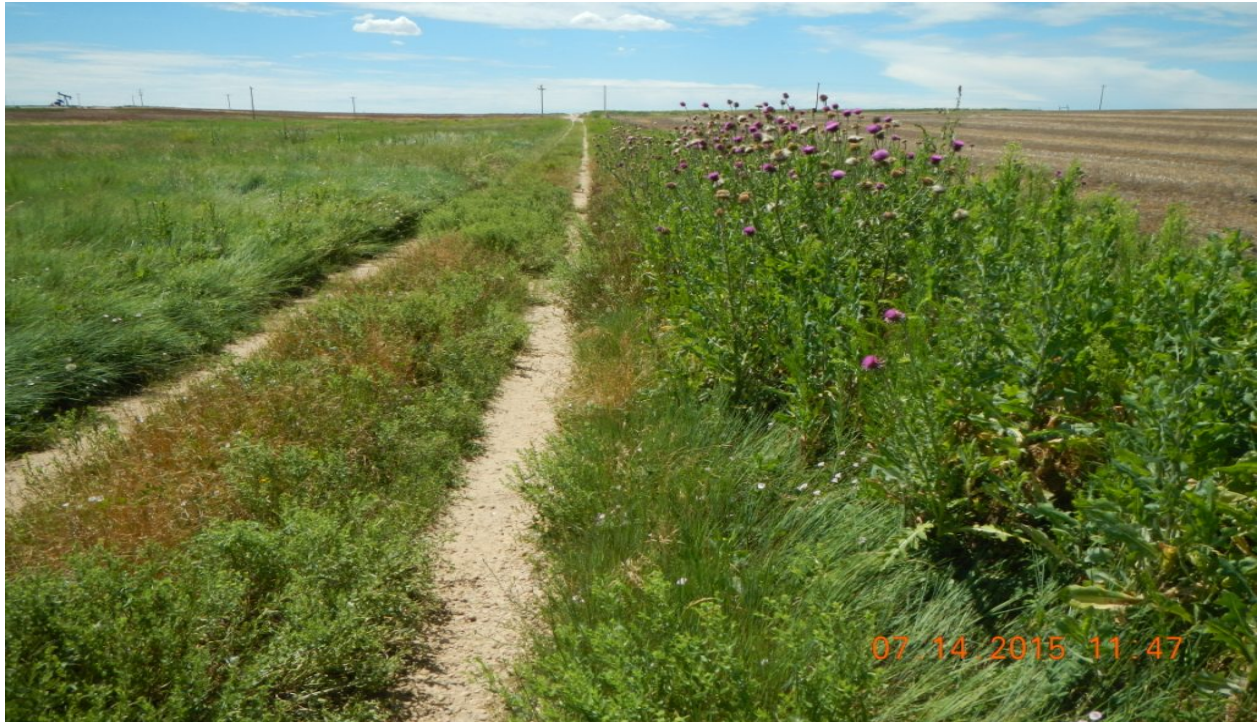
photo 9: Traveling south from the well site. Noxious weeds are growing along the roadside.

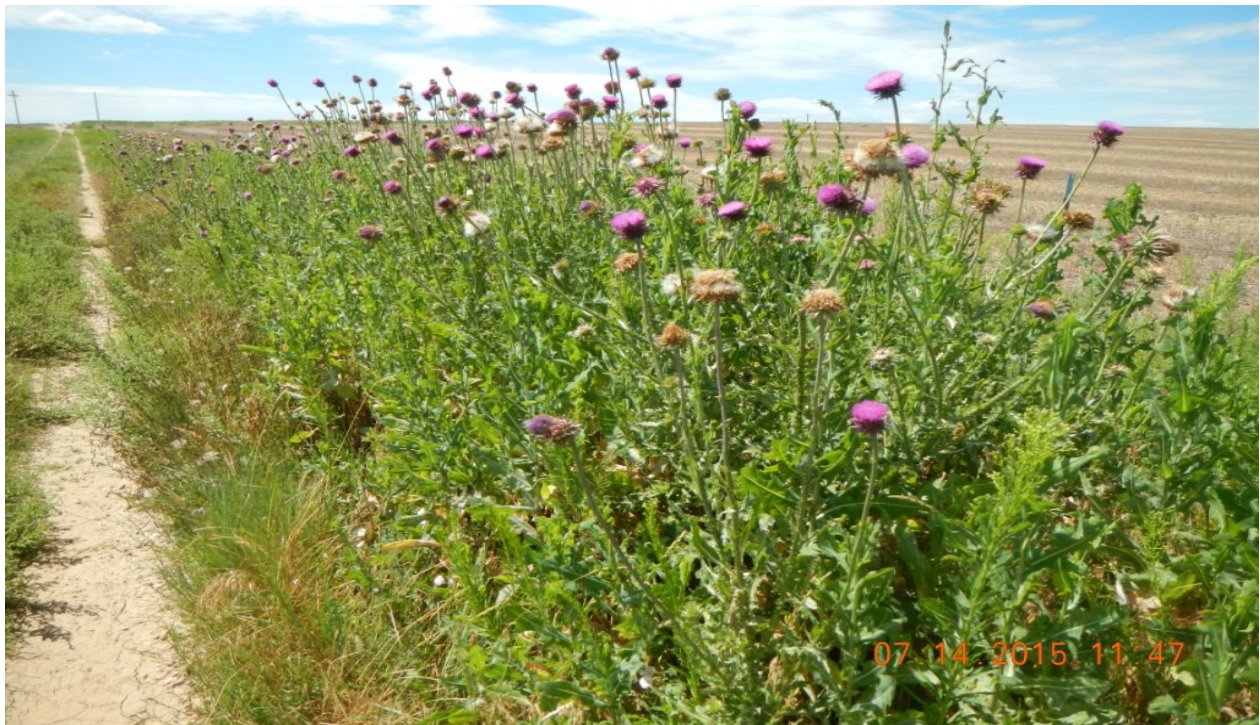
photo 10: Musk thistle (List B noxious weed) growing along the roadside.

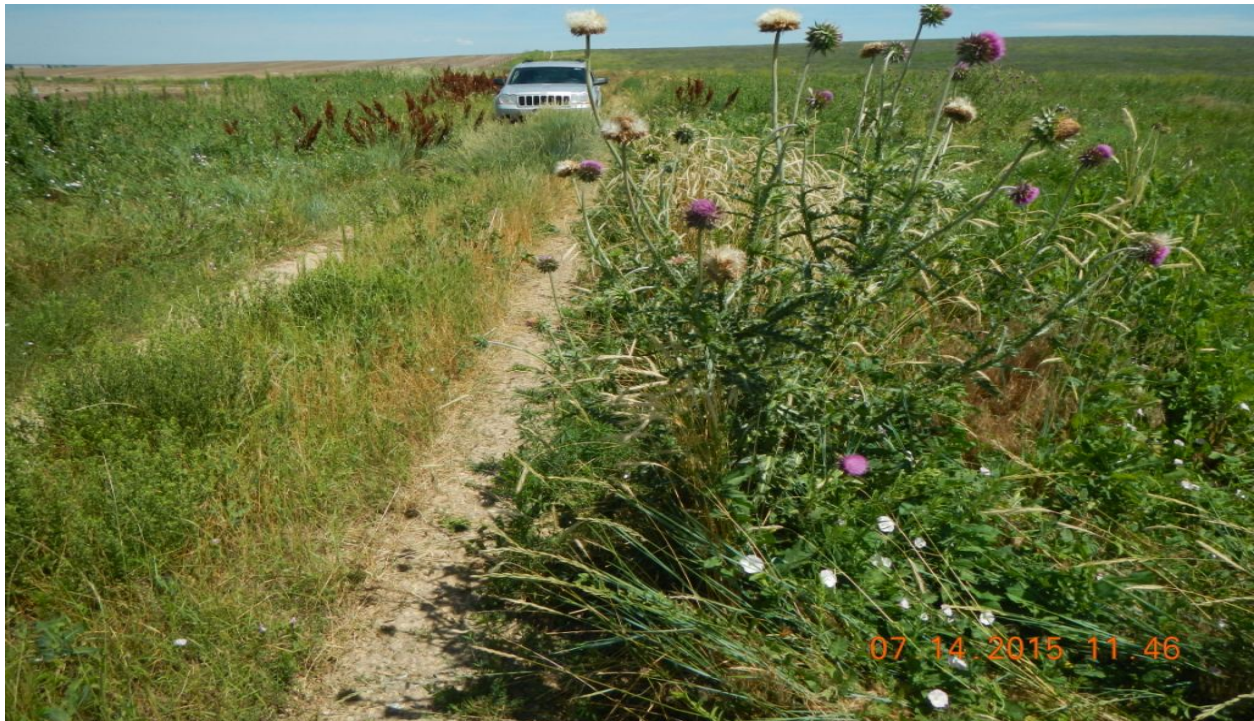
photo 11: Facing north along the access road.

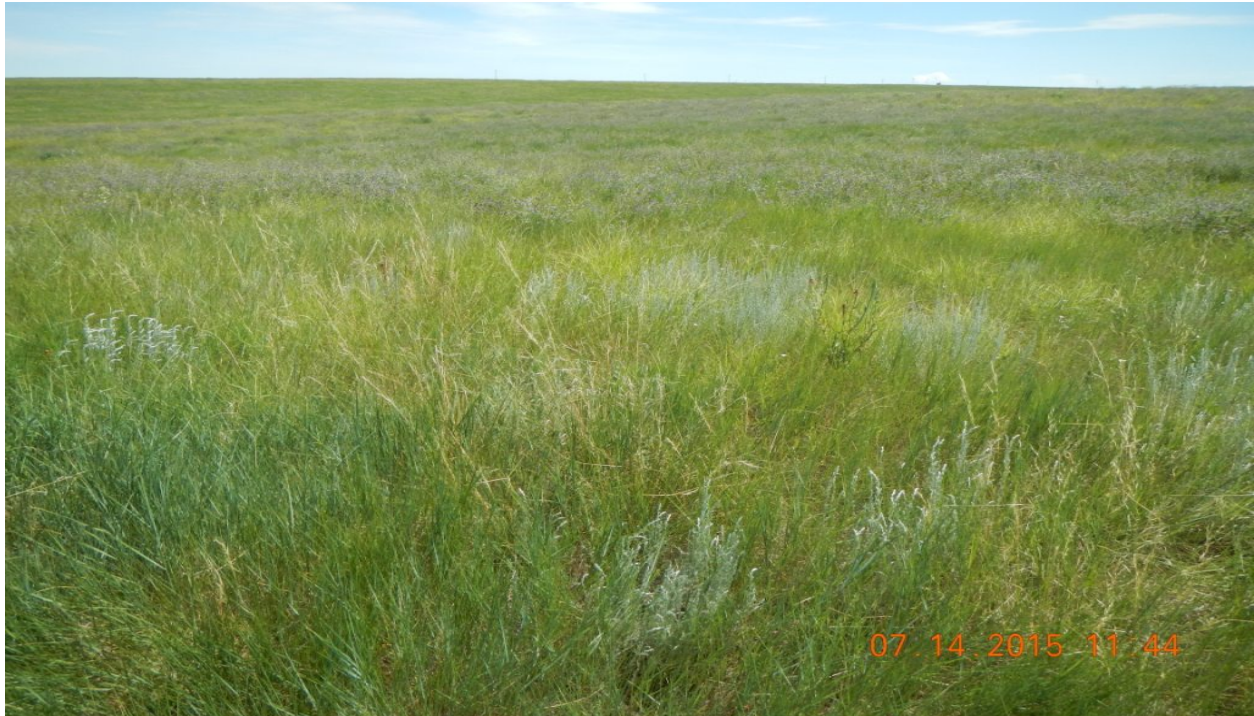
photo 12: Surrounding vegetation along the access road did not appear to have very many noxious weeds.
