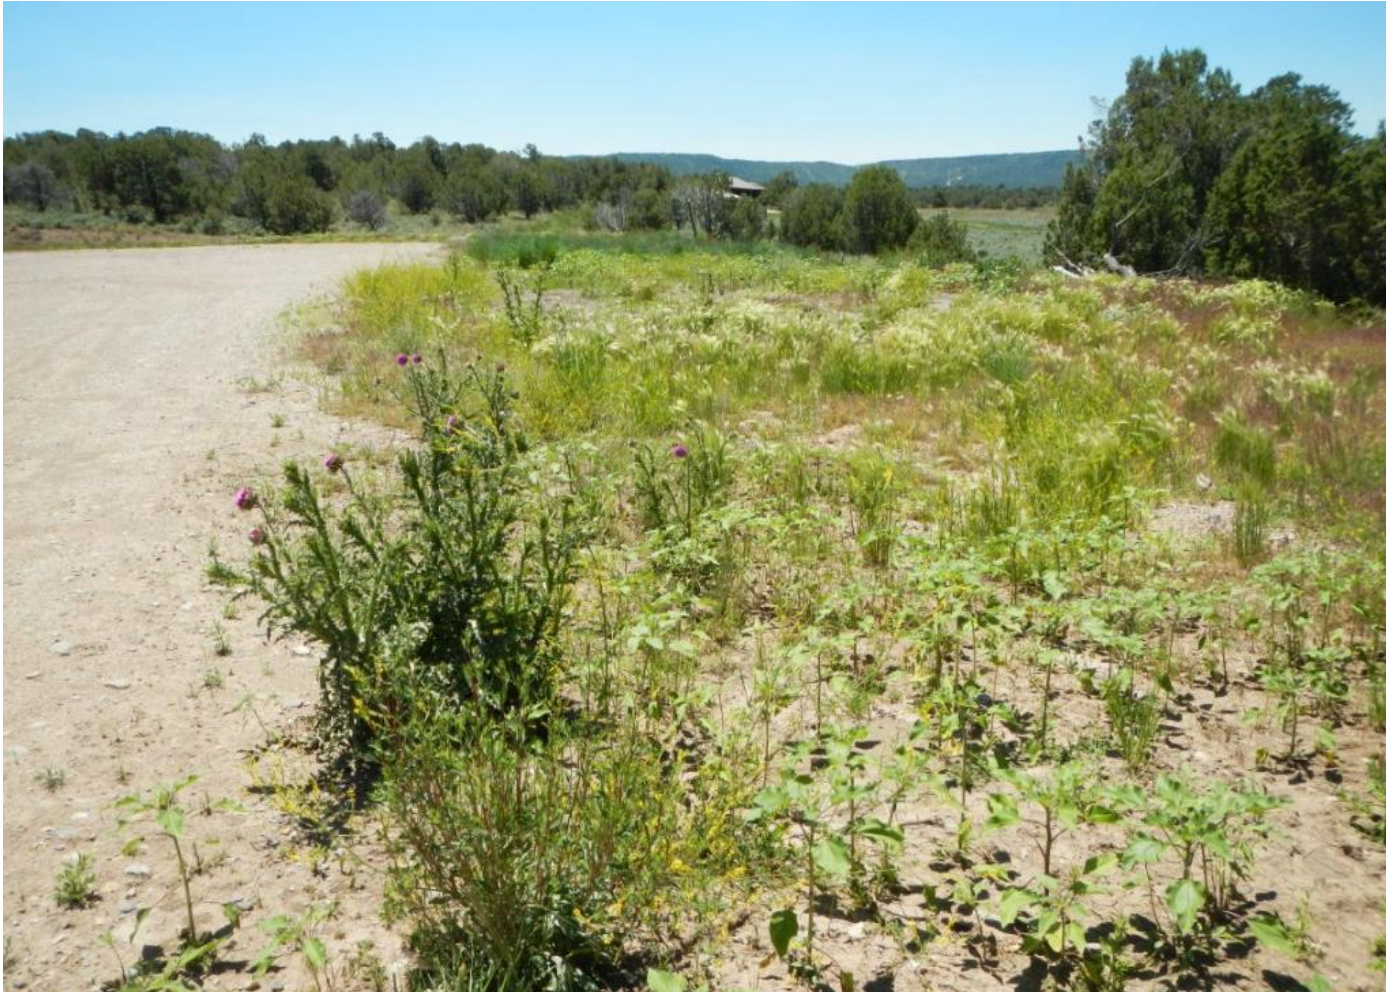
Photo 1. View of western portion of project area from northern edge facing southward. Ruderal vegetation such as Musk thistle (*Carduus nutans*), yellow sweetclover (*Melilotus officinalis*), annual sunflower (*Helianthus annuus*), foxtail barley (*Hordeum brachyantherum*), and cheatgrass (*Bromus tectorum*) are growing within this area.

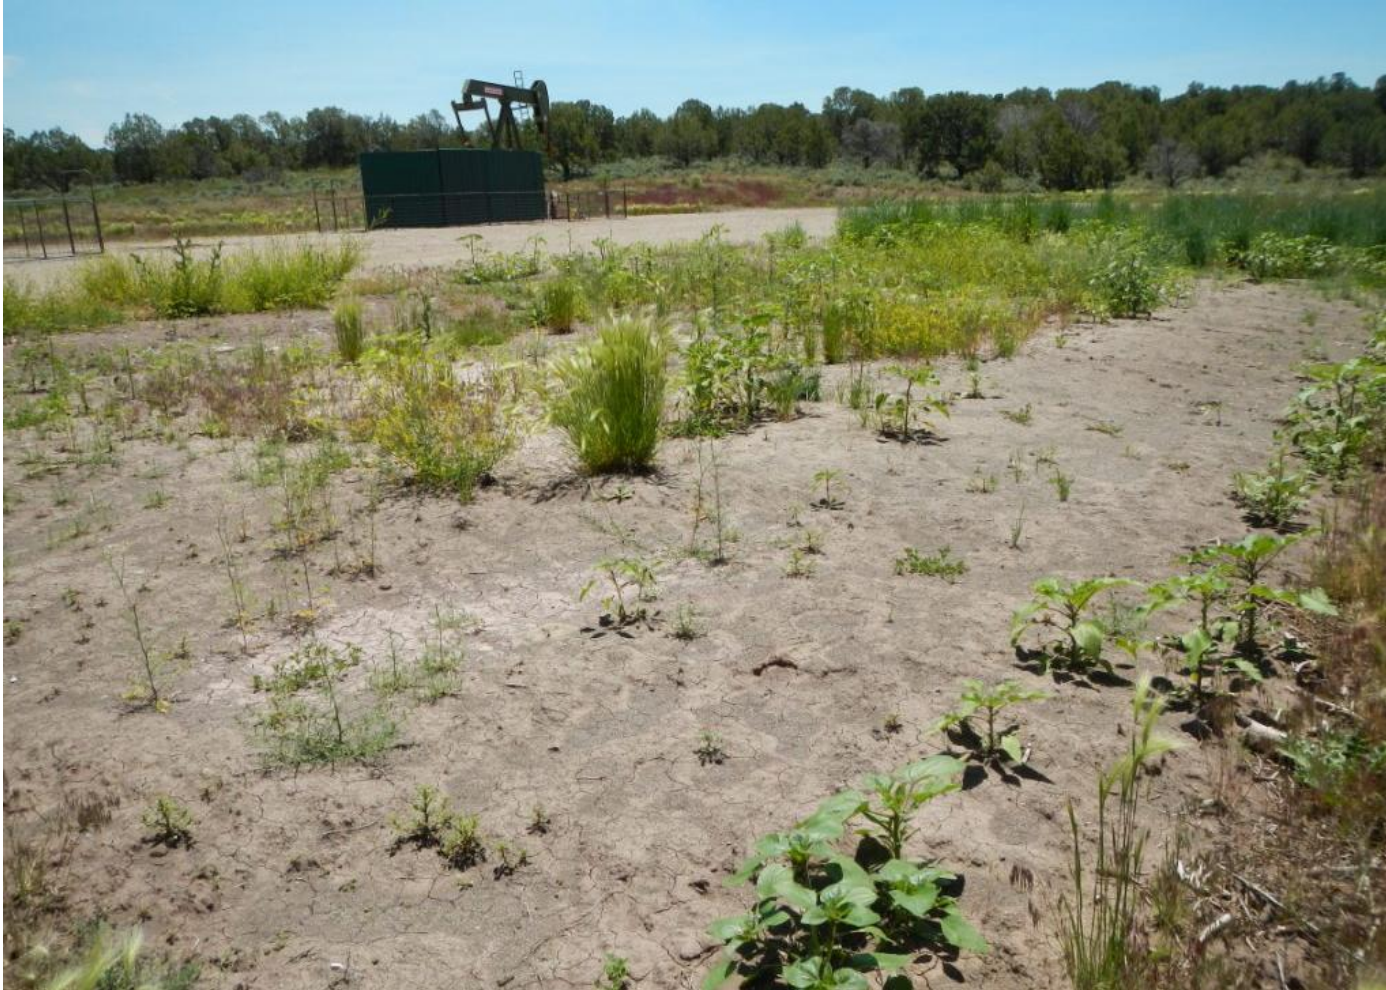
Photo 2. View of reclaimed pit area from western edge facing southeastward. This area does not appear to have been mulched and seeded as proposed in reclamation plan.

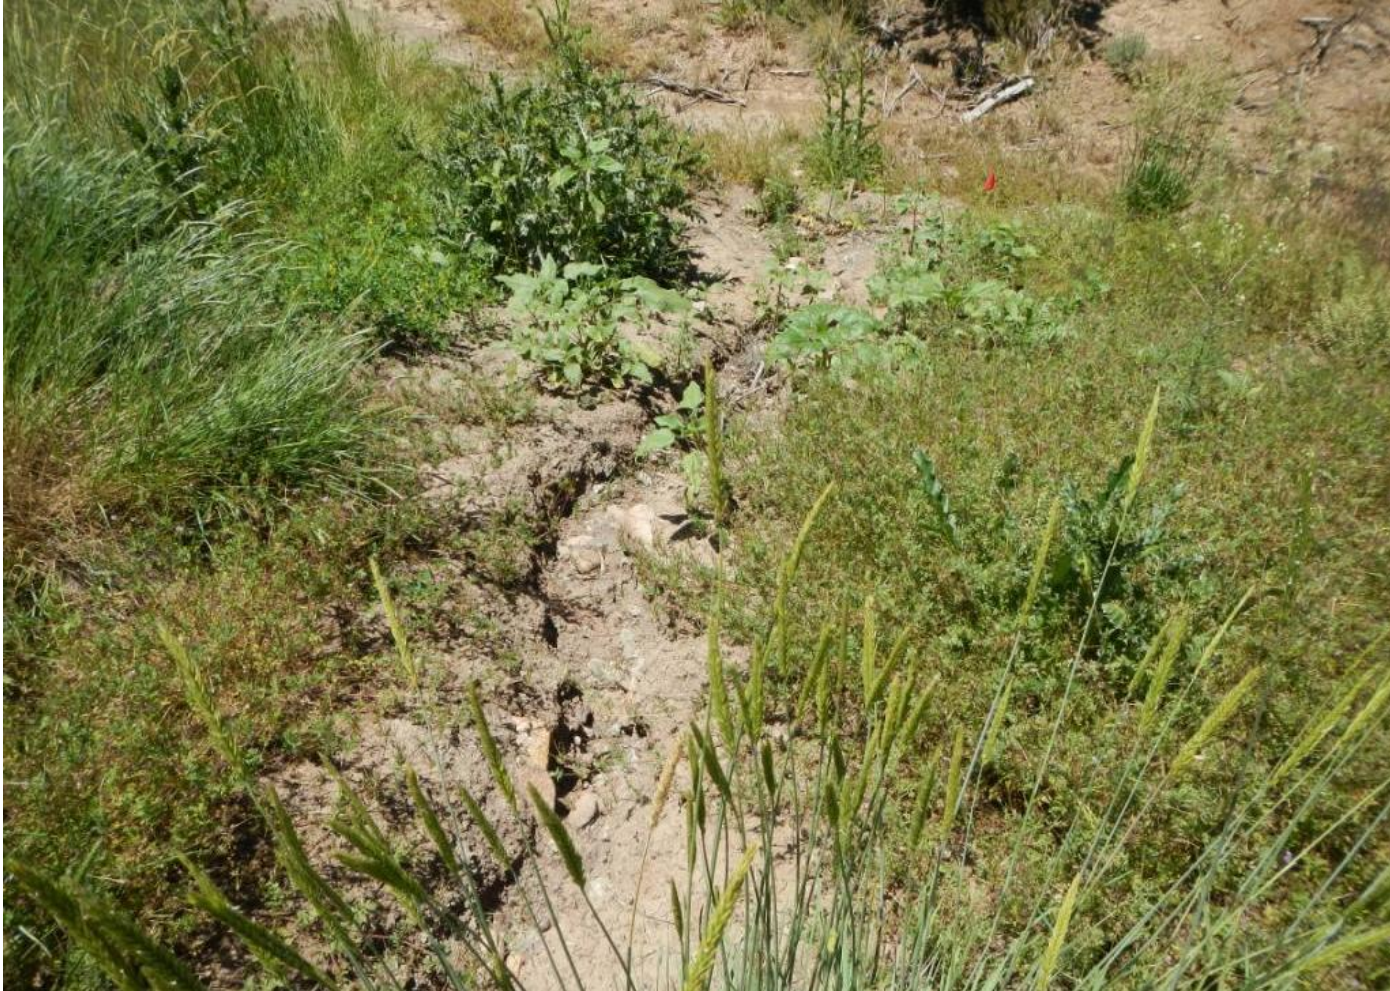
Photo 3. View of erosional channel within western portion of project area. This channel is approximately 8 inches deep and 6 inches wide.

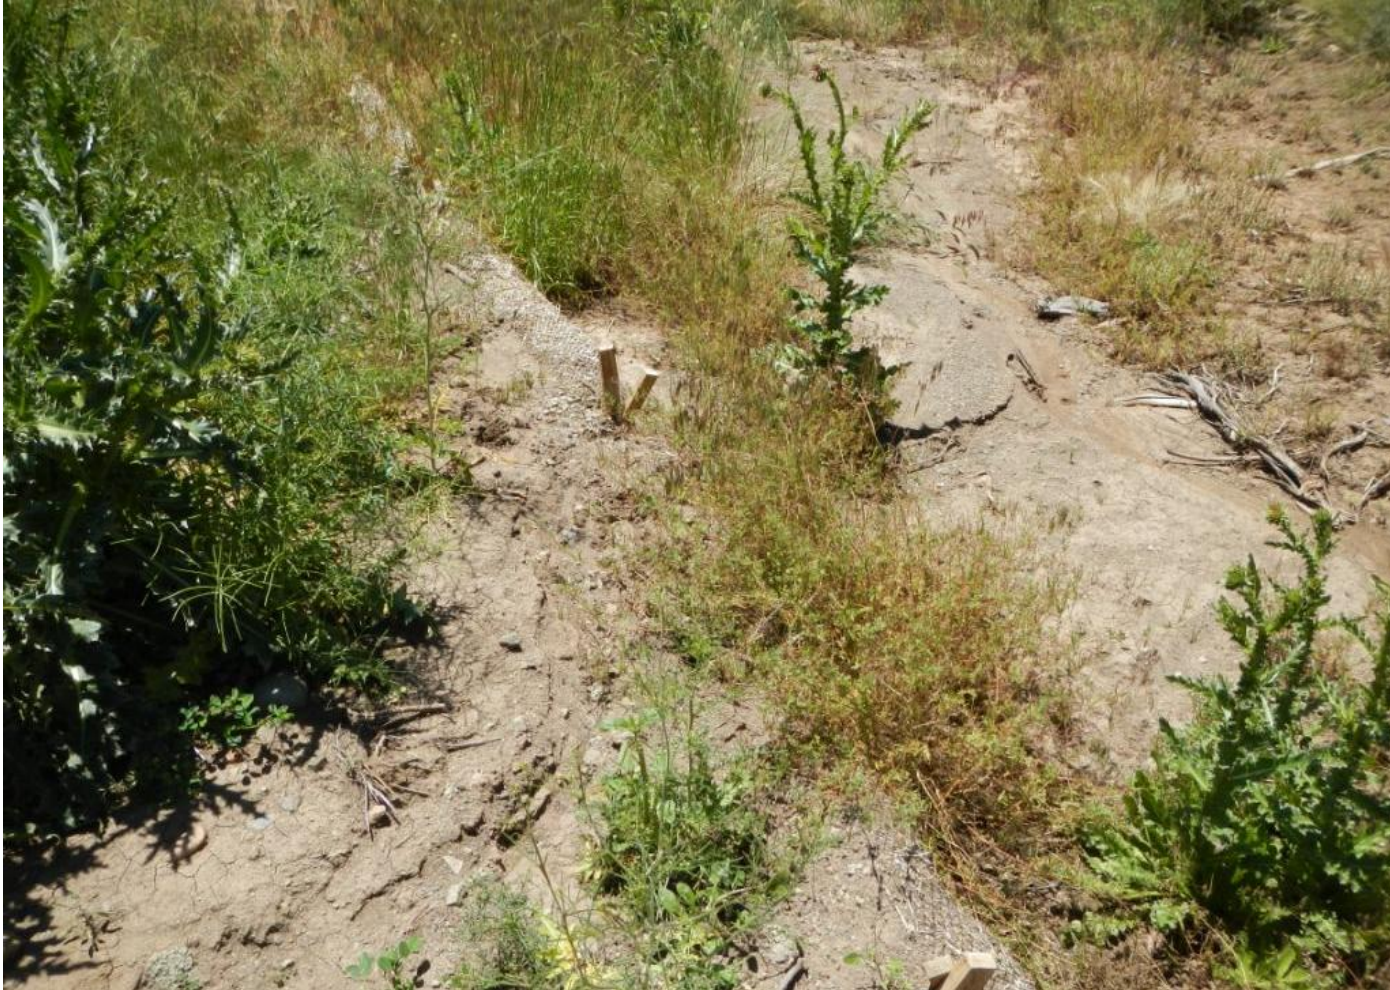
Photo 4. View of sediment deposition along western edge of project area showing where sediment appears to be discharging outside of the project area straw wattles.

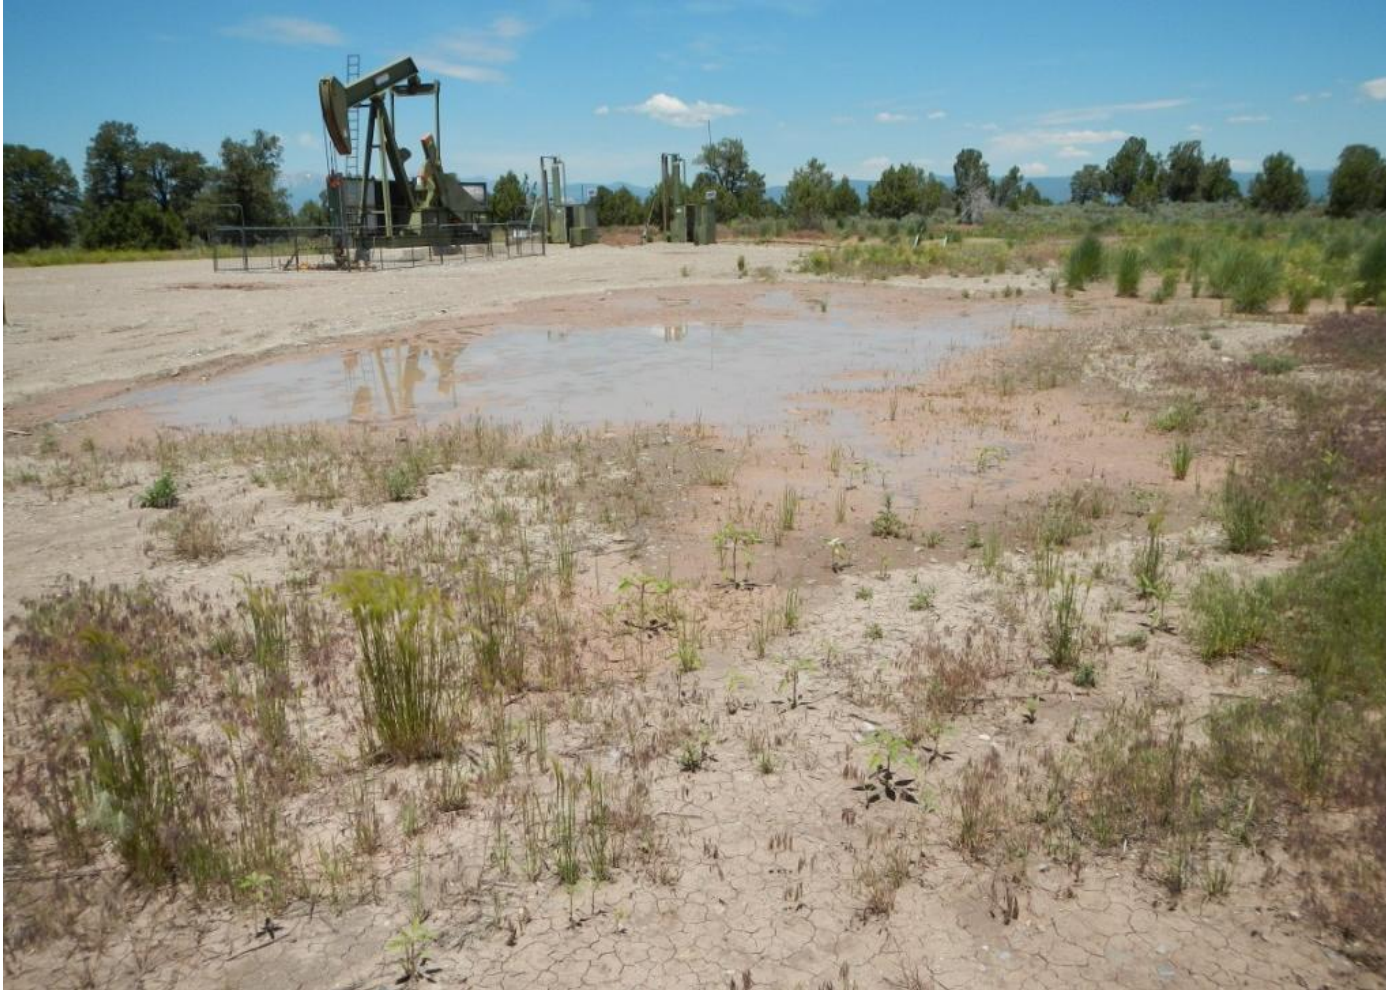
Photo 5. View of eastern project area from east facing northwestward. This area does not appear to have been mulched and re-seeded as proposed in the reclamation plan.

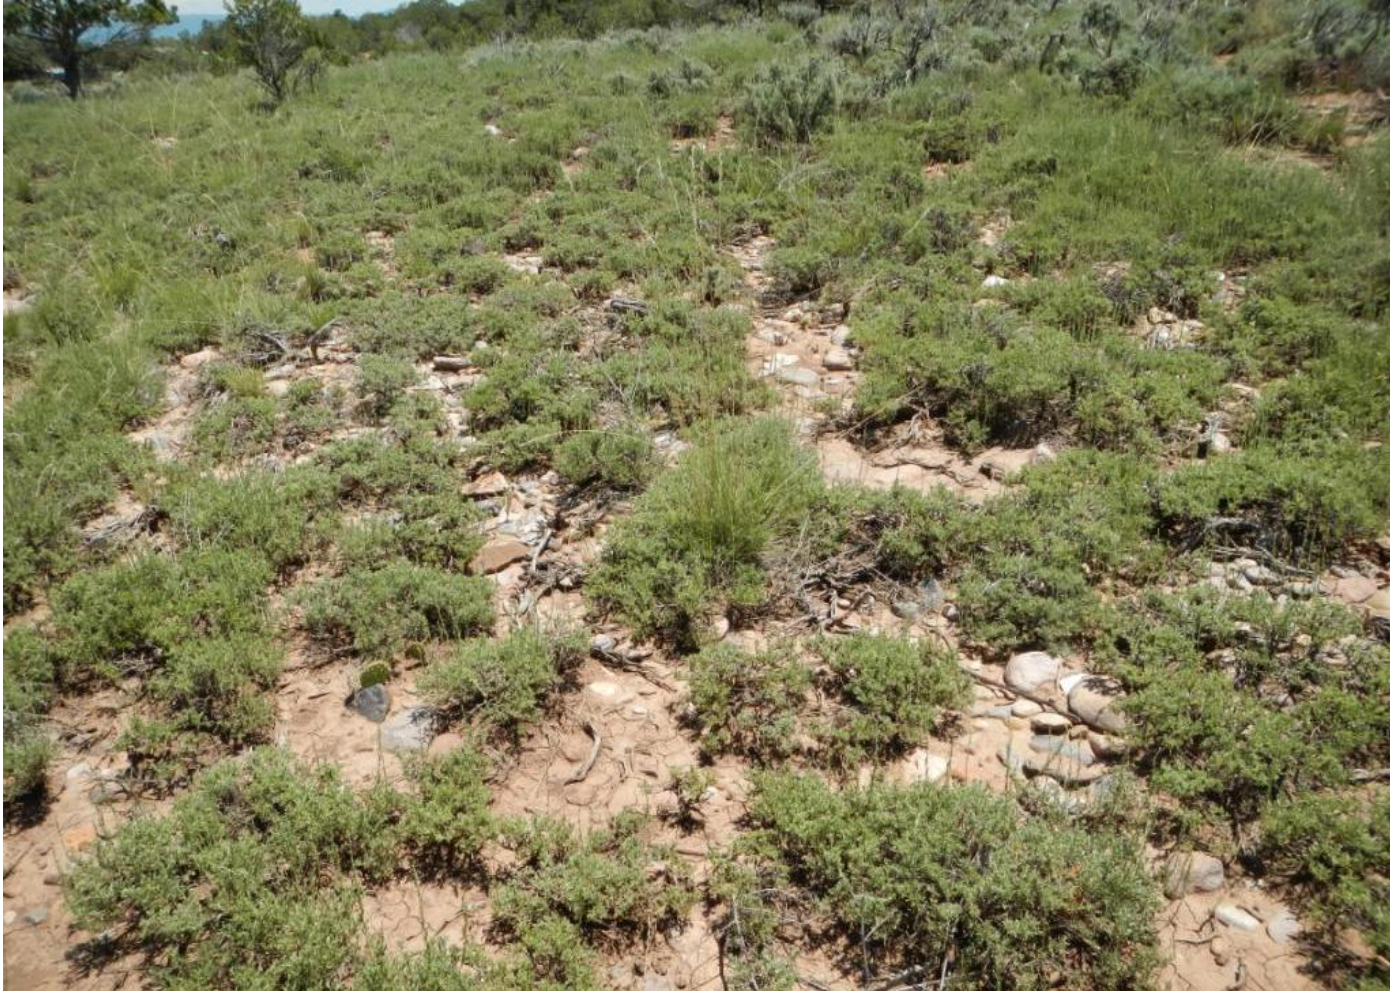
Photo 6. View of vegetation community adjacent to the project area from northeastern edge facing eastward. Vegetation here dominated by black sage (*Artemisia nova*), great basin sagebrush (*Artemisia tridentata*), and needle and thread grass (*Hesperostipa comata*).
