# ENCANA OIL & GAS (USA) INC

K10 pad

Location # 335676

# EnCana K10 location # 335676

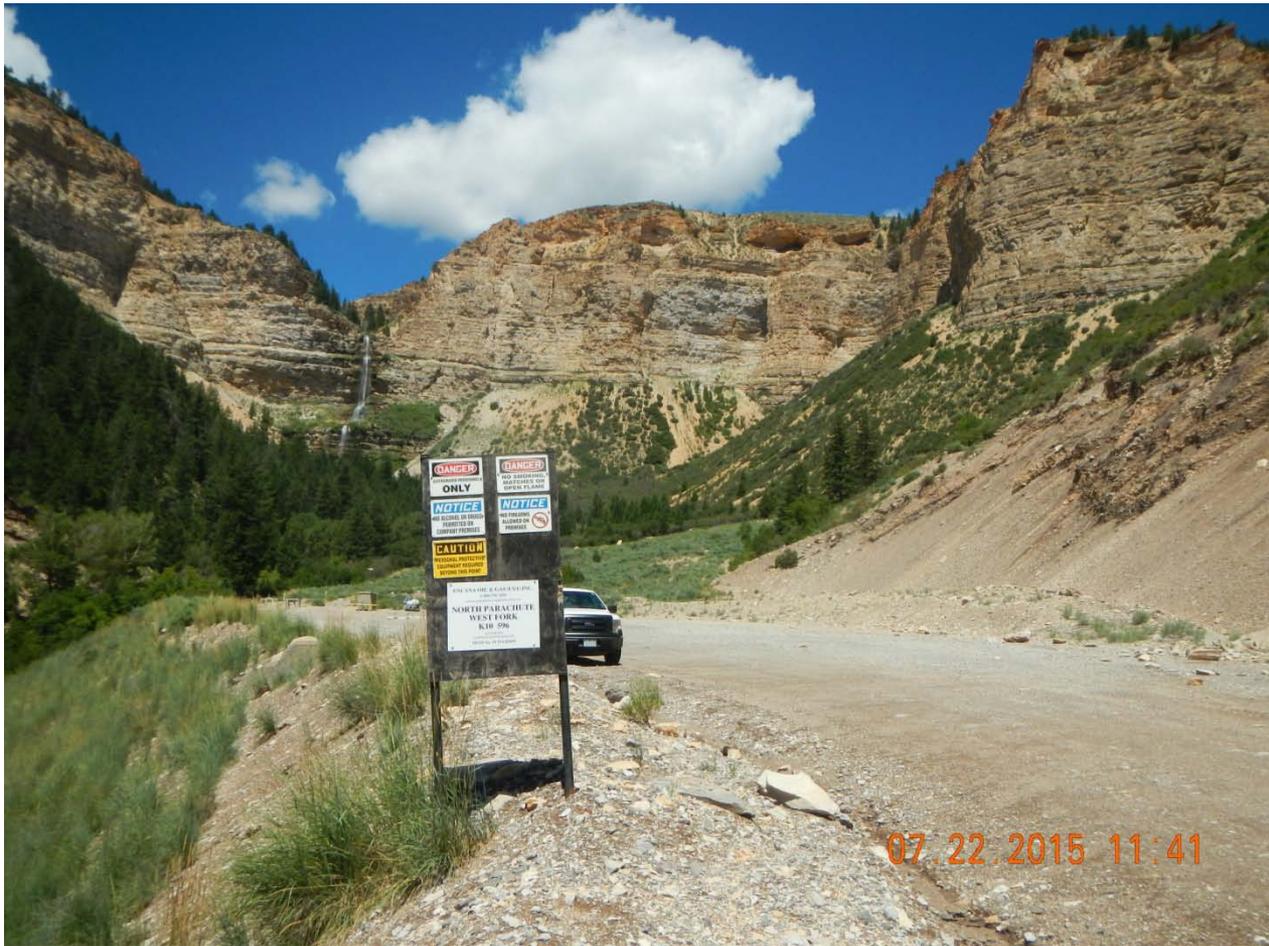
# Unstable cut slope

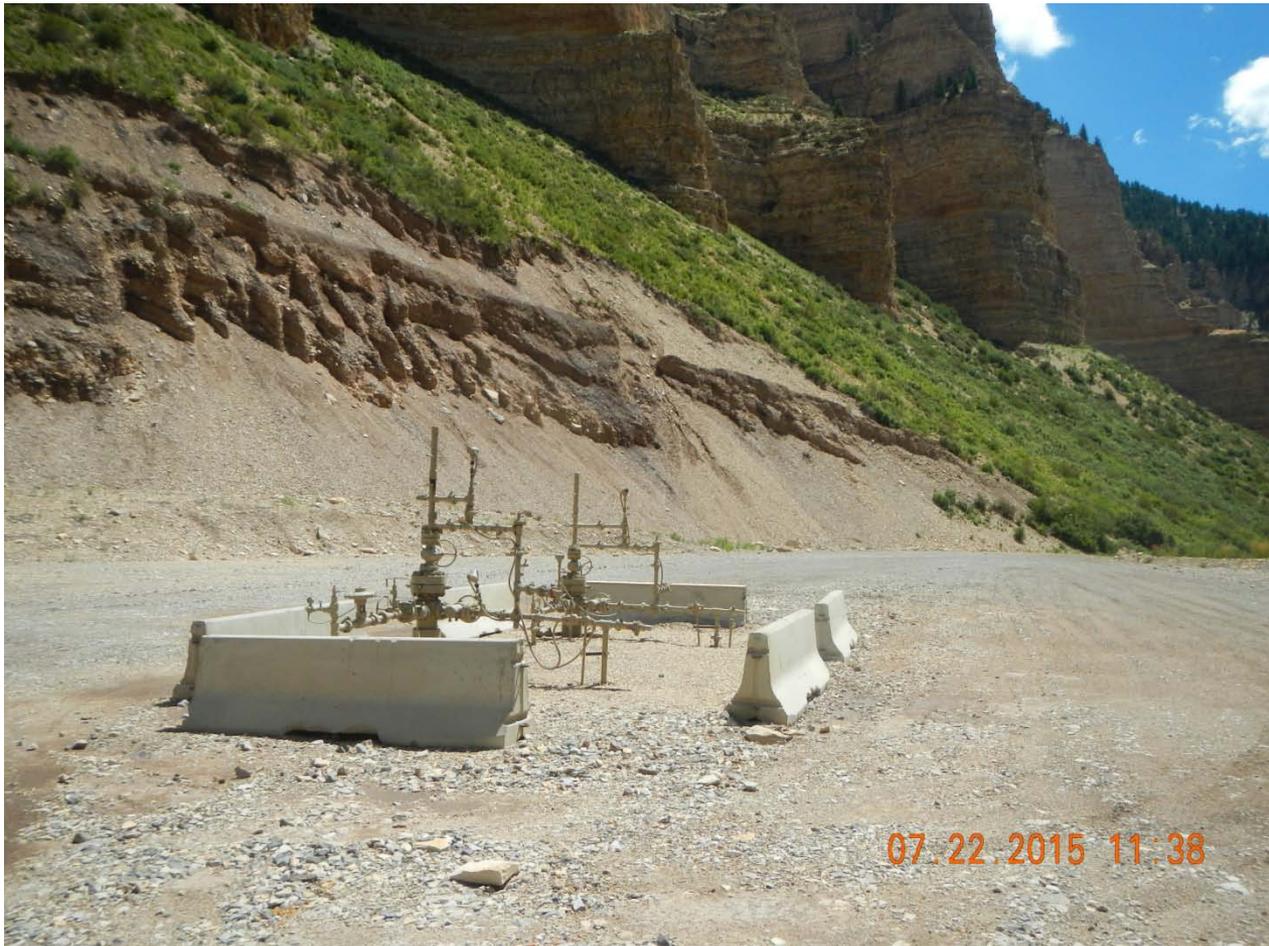
Water diversion ditch above cut slope has collapsed allowing rock and sediment migrate.
