Moffat County 1-8

Inspection# 673402235

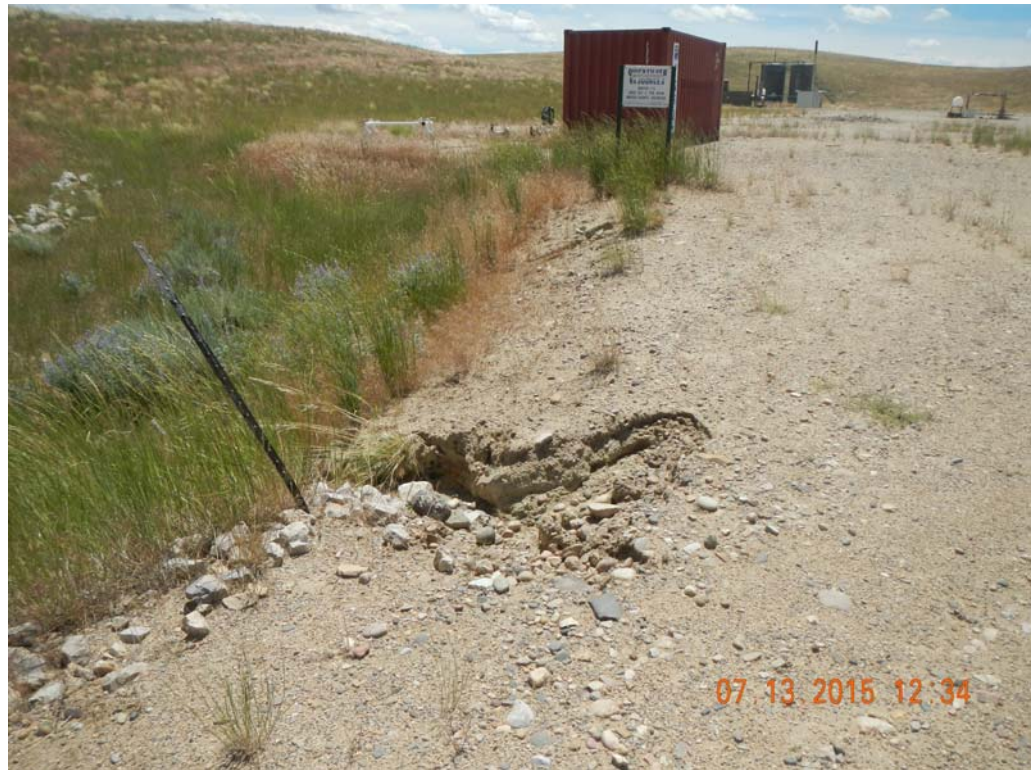
Erosion occurring off of access road at entrance. Seacan and materials in background.

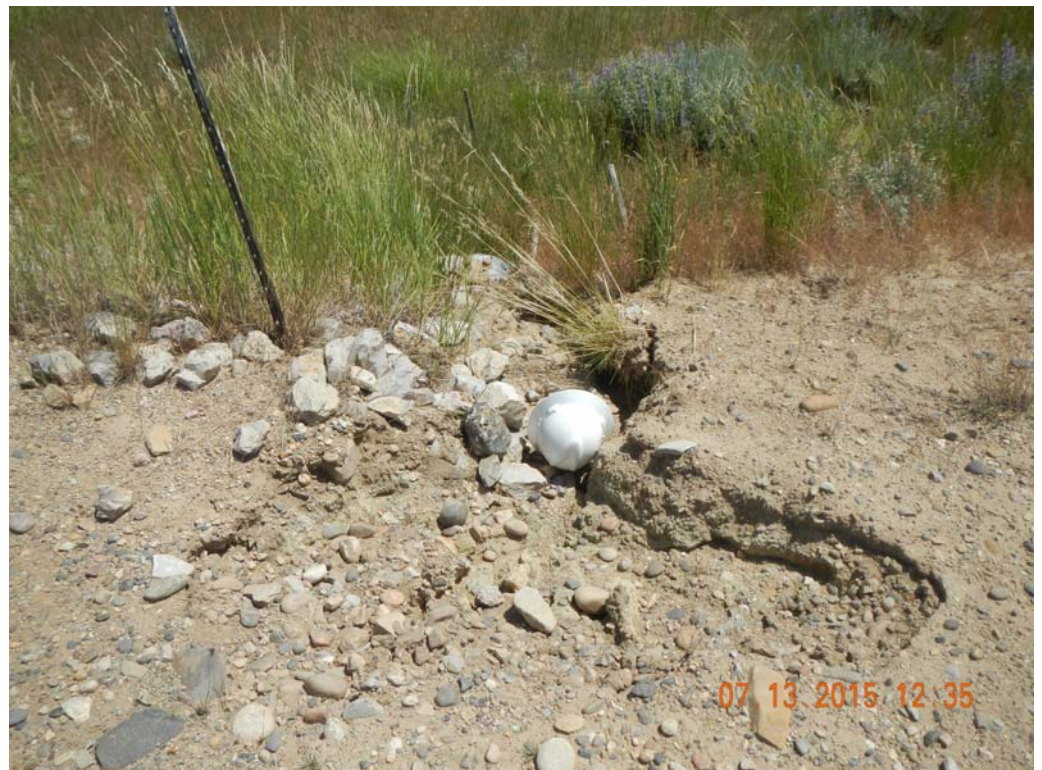
Close up of access road erosion. Hard hat for scale.

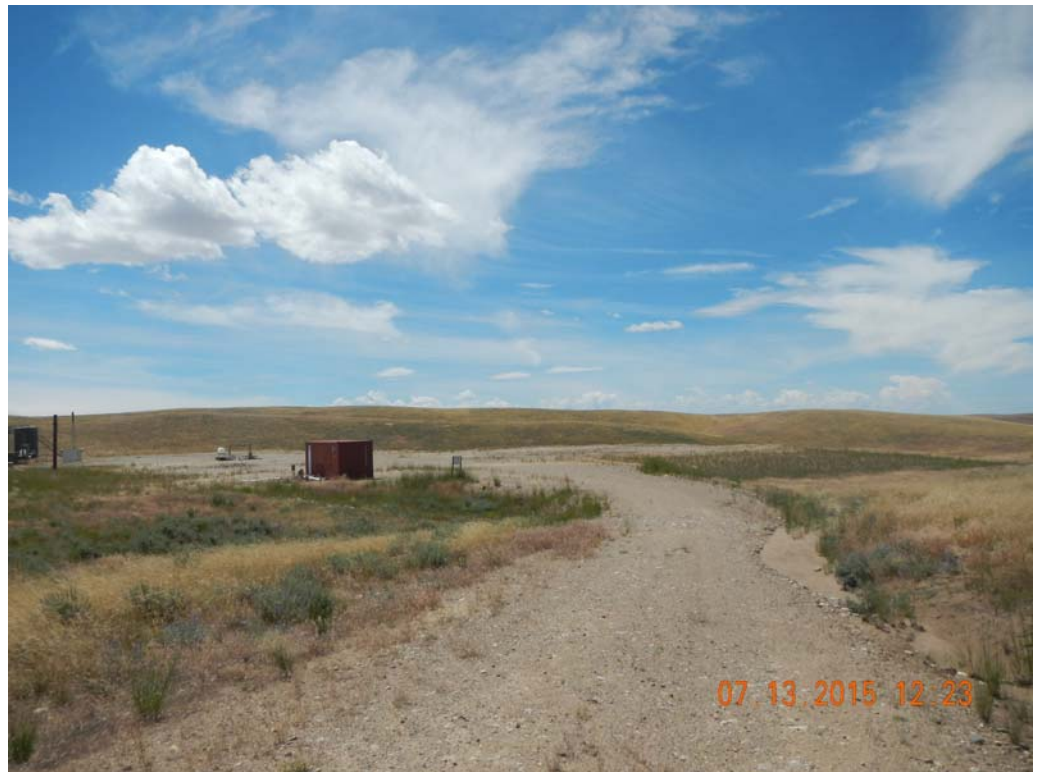
Erosion on access road and location overview illustration no interim reclamation has been performed.
