Voloshin 3-25

Inspection# 673402254

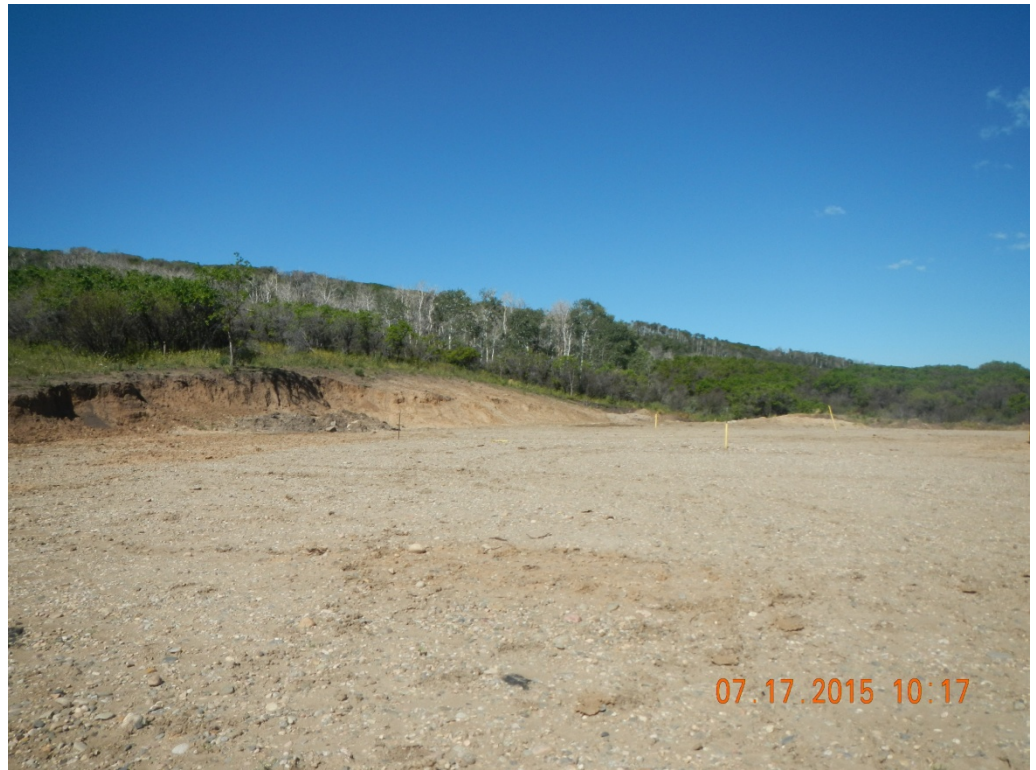
Inspection 673402254
7/17/2015

Sloughing onto location. No
BMPs apparent.

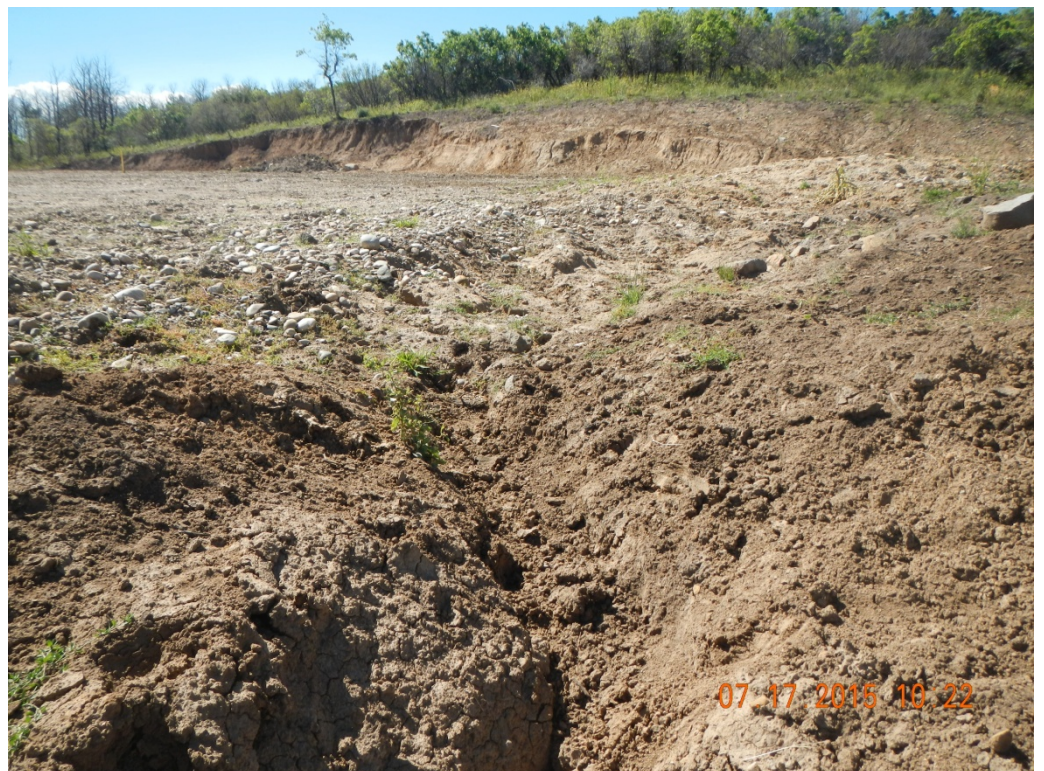
Inspection 673402254
7/17/2015

Rill leaving west side of
location. Sloughing
material visible in
background.

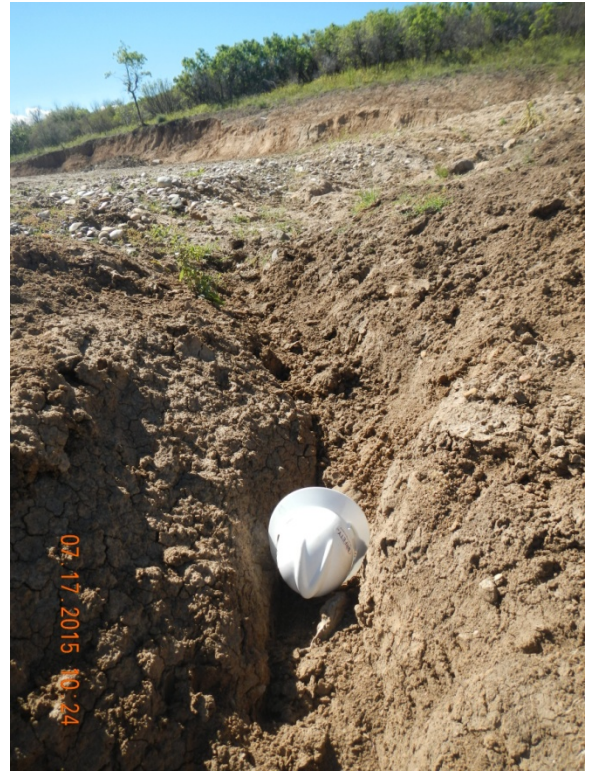
Inspection 673402254
7/17/2015

Rill leaving location on west side. Hard hat for scale.

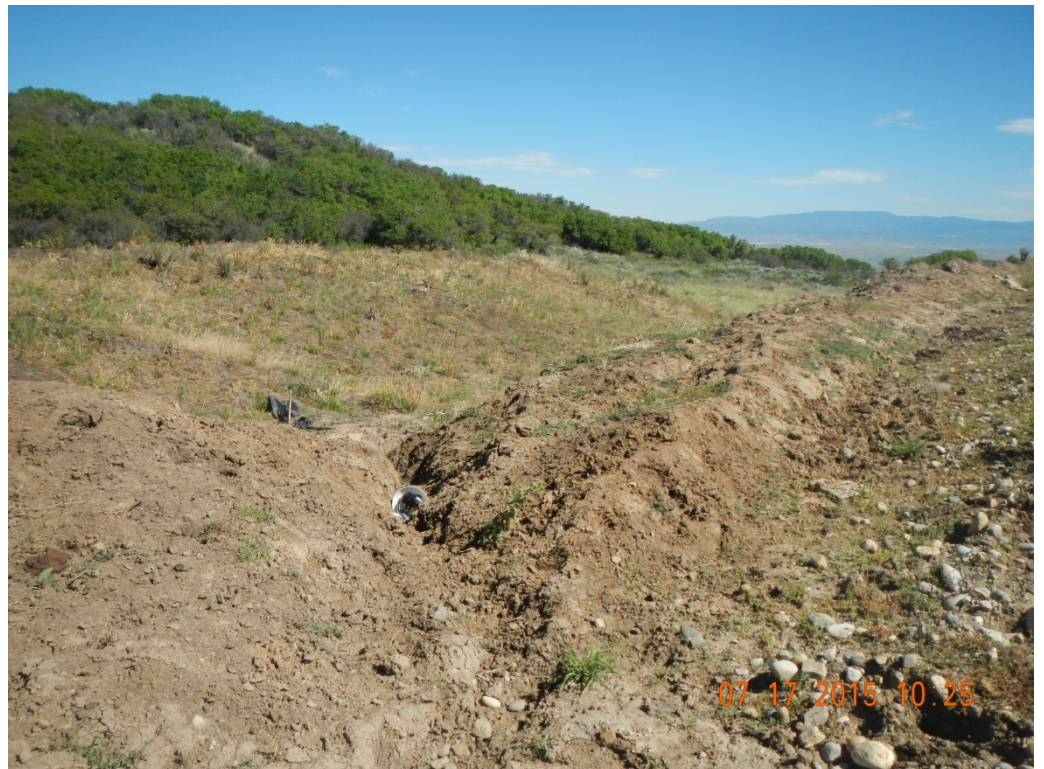
Inspection 673402254
7/17/2015

View looking down on rill and hard hat from previous photo. Location borders drainage on west side.

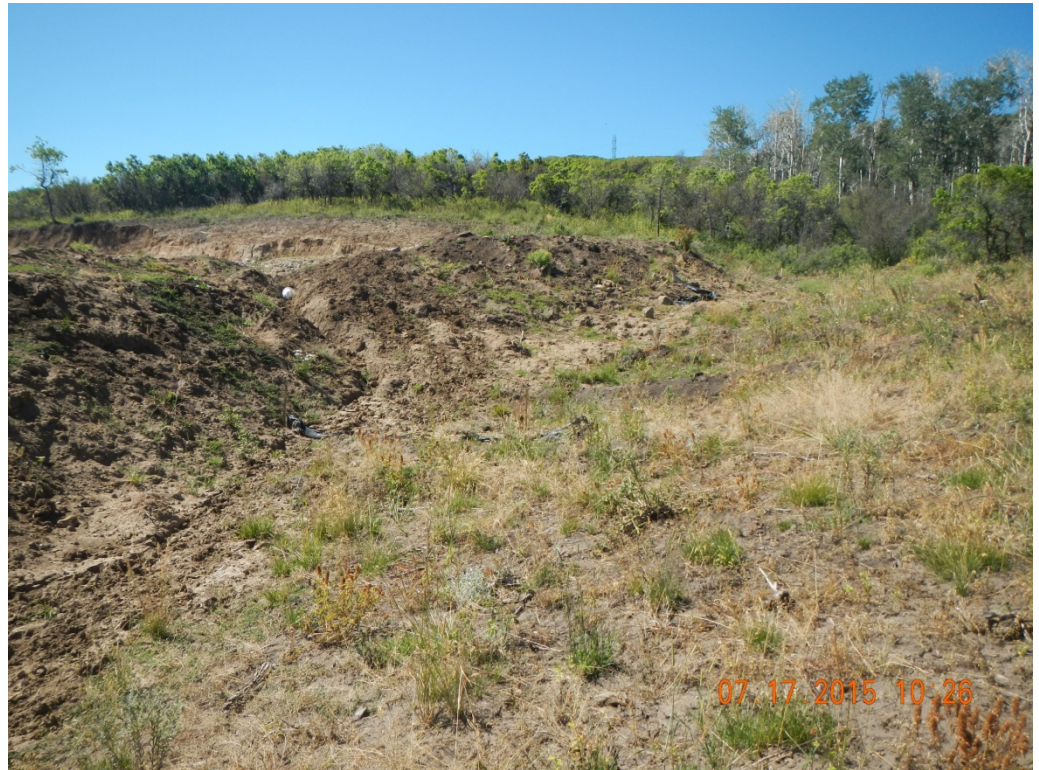
Inspection 673402254
7/17/2015

Sloughing in far background,
rill with hard hat in middle
and sediment migration in
foreground.

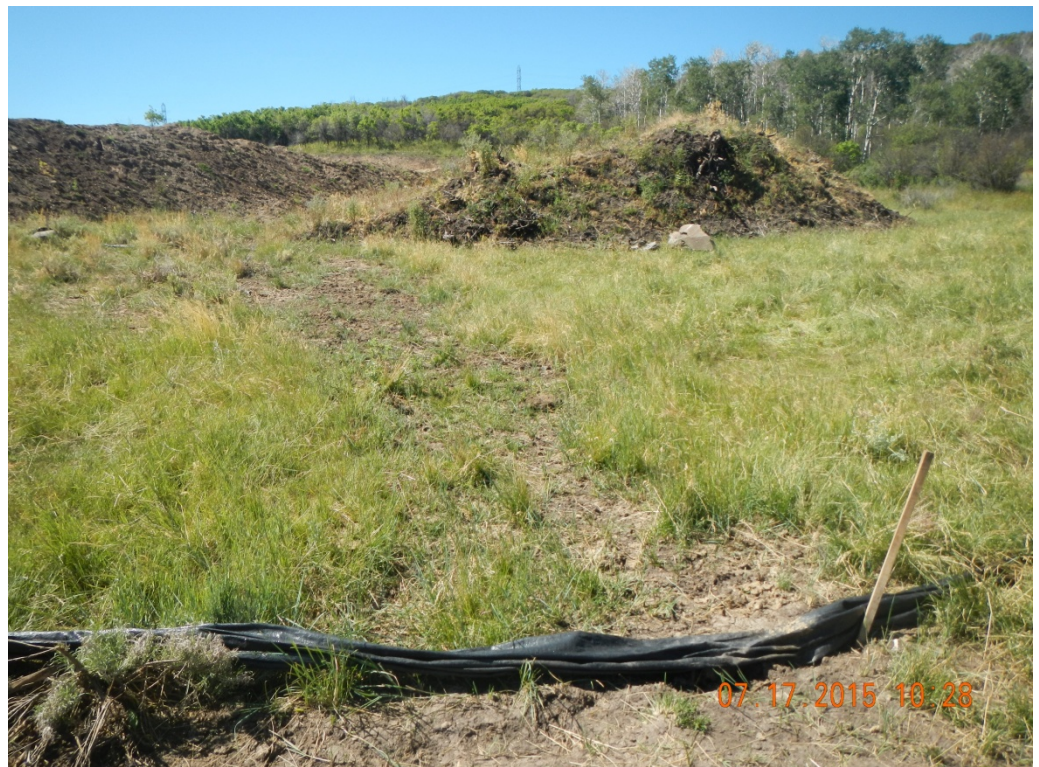
Inspection 673402254
7/17/2015

Sediment migration
approximately 30 feet from
location perimeter. Silt
fence is damaged and no
longer in place. Sediment
migrating through fence. Silt
fence is only BMP apparent.

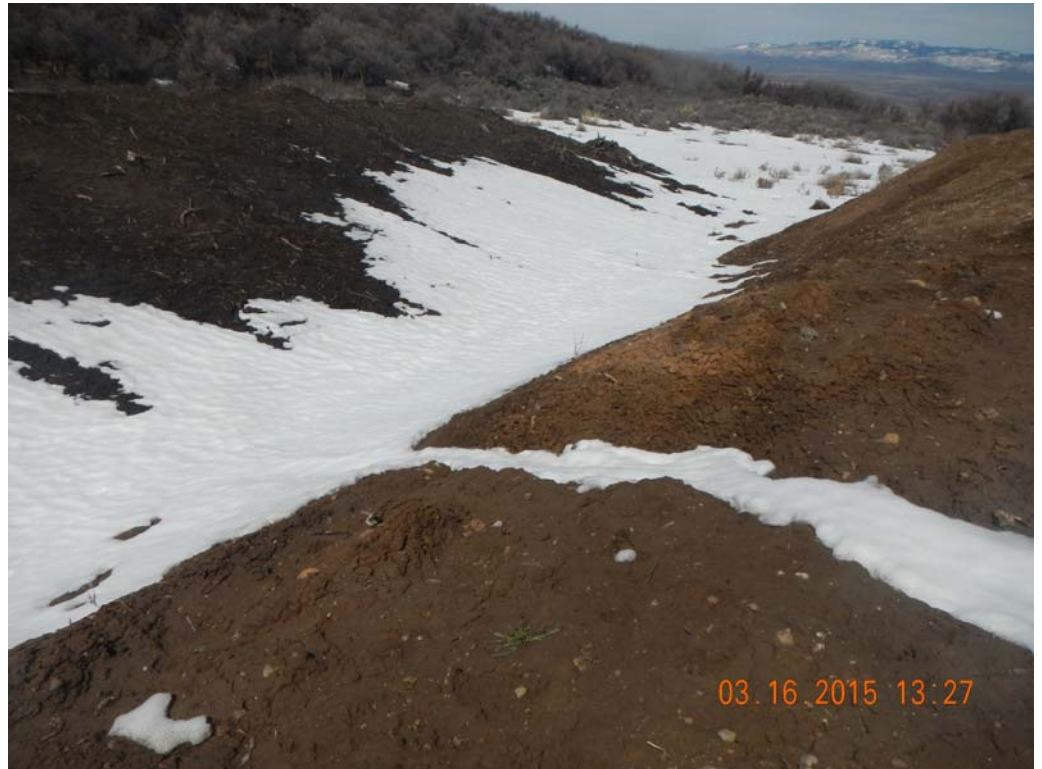
Inspection 673401910
3/16/2015

Rill leaving location during
runoff. No stormwater
BMPs apparent.
