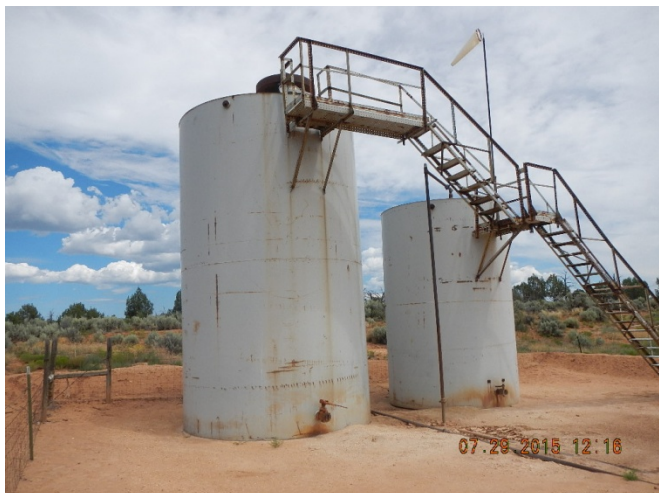
Unlabeled production tanks on location.

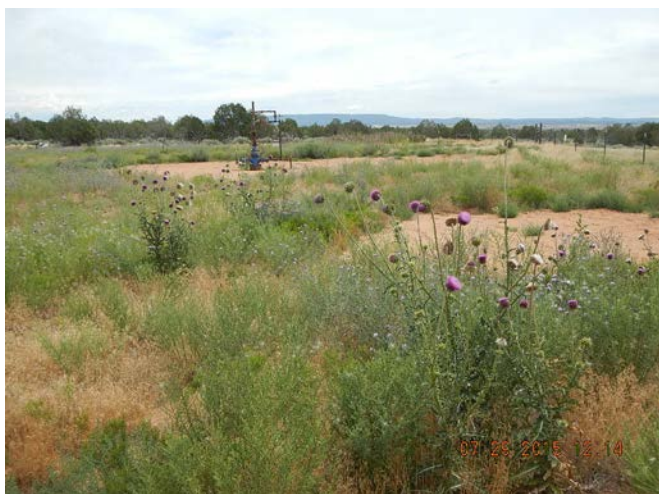
Excessive weed growth on location (View to SW)

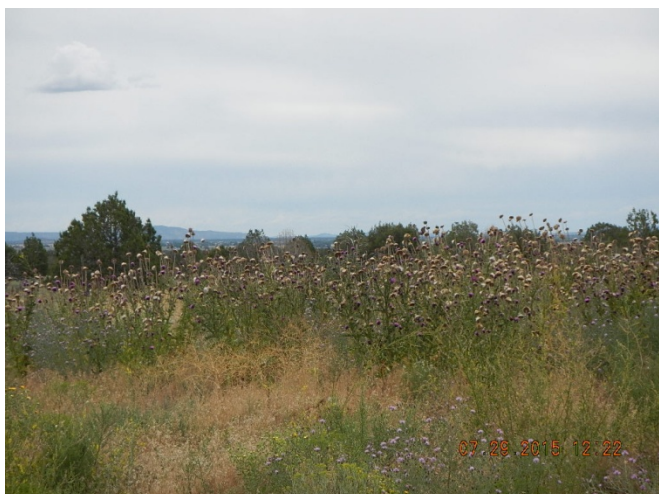
Weeds (Thistles/ Noxious) on well pad (SE Corner location)

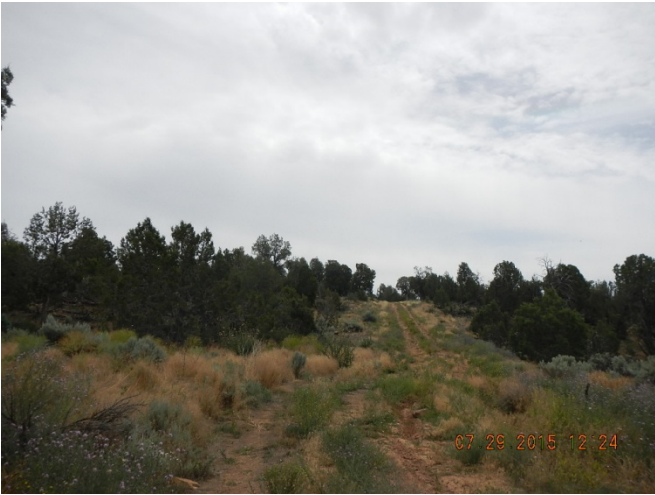
Weeds/ excessive vegetation on access road near well pad entrance.

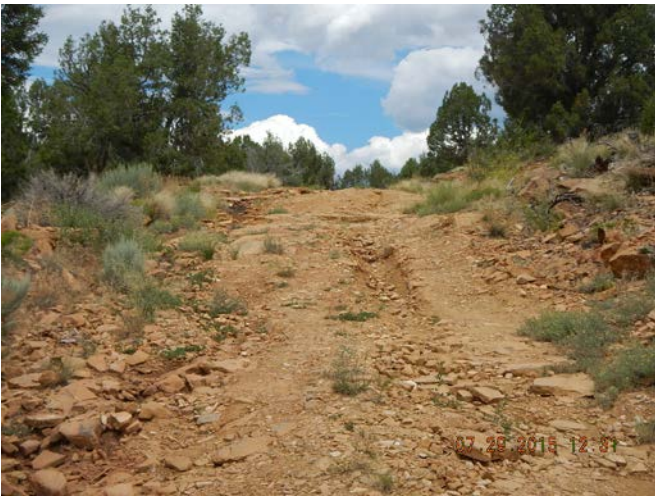
Stormwater damage/ erosion on well site access road.

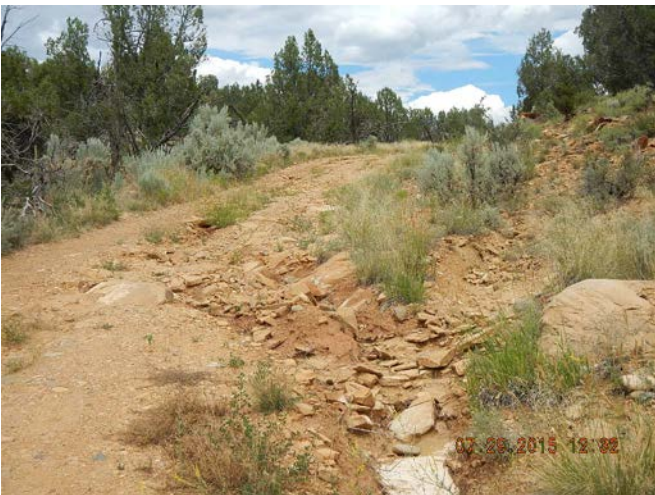
Stormwater damage on well site access road; Stormwater channel in access road.

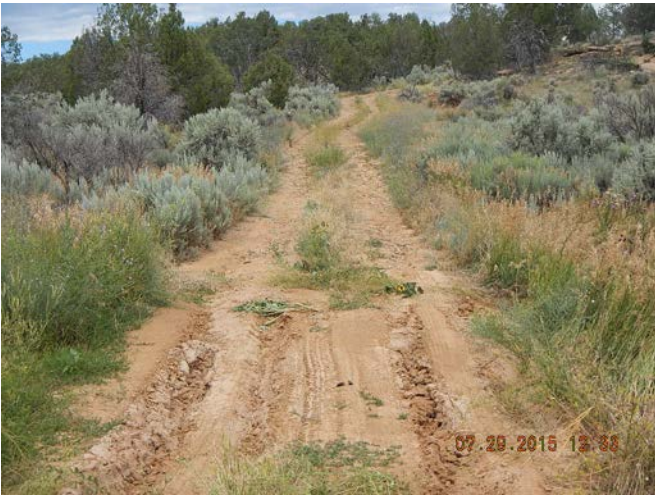
Wash crossing/ low lying area with deep vehicle rutting; Difficult crossing in wet weather.

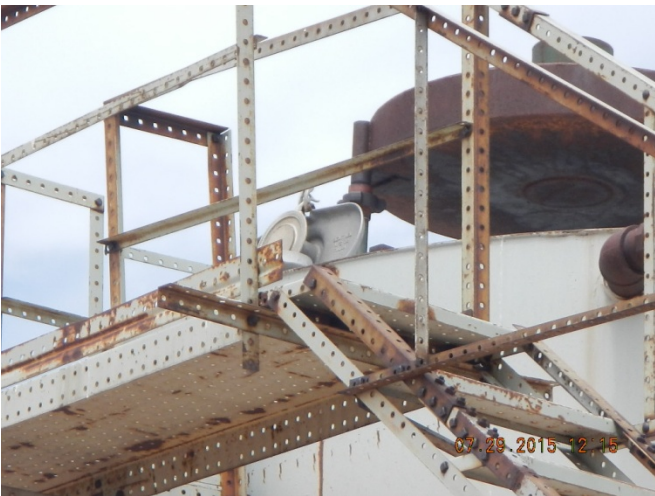
Open thief hatch on production tank.
