photo 1: Well sign. Cargo-Frian 34-27

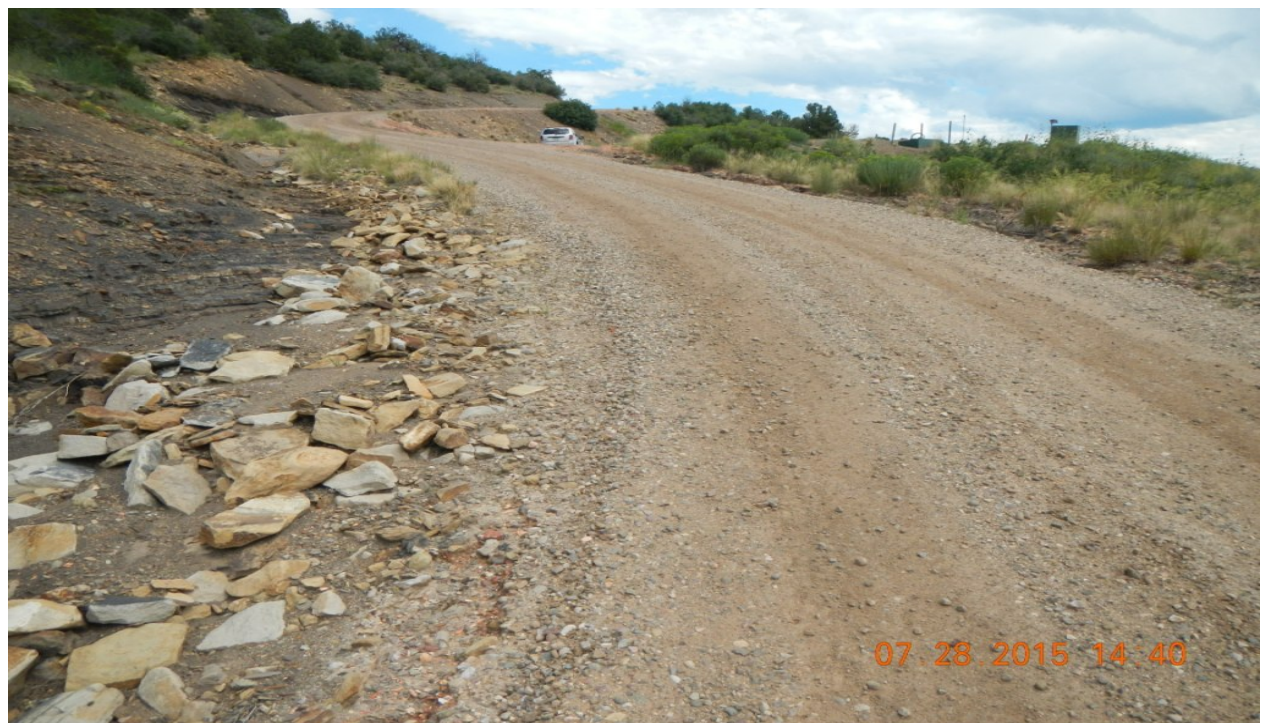
photo 2: Facing east along the main access road towards the location. Erosion is occurring along the side of the road.

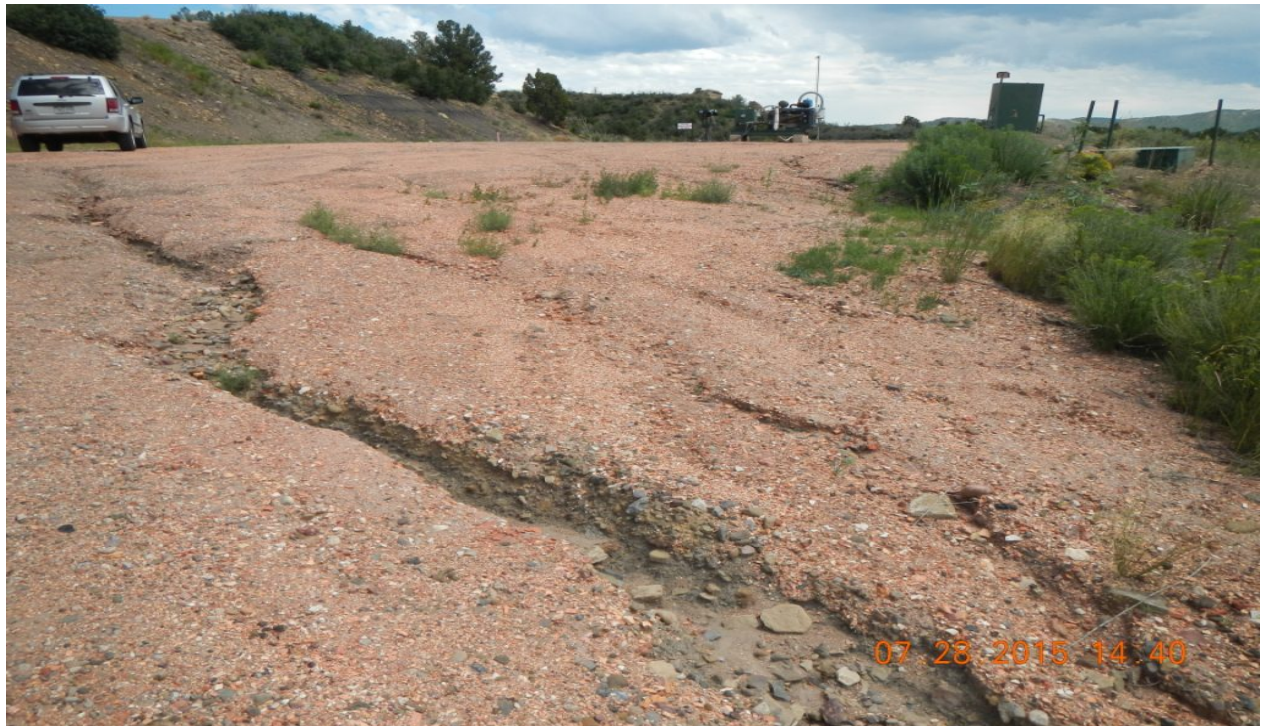
photo 3: Facing southeast towards the location. Erosion channels have developed transporting sediment off the location.

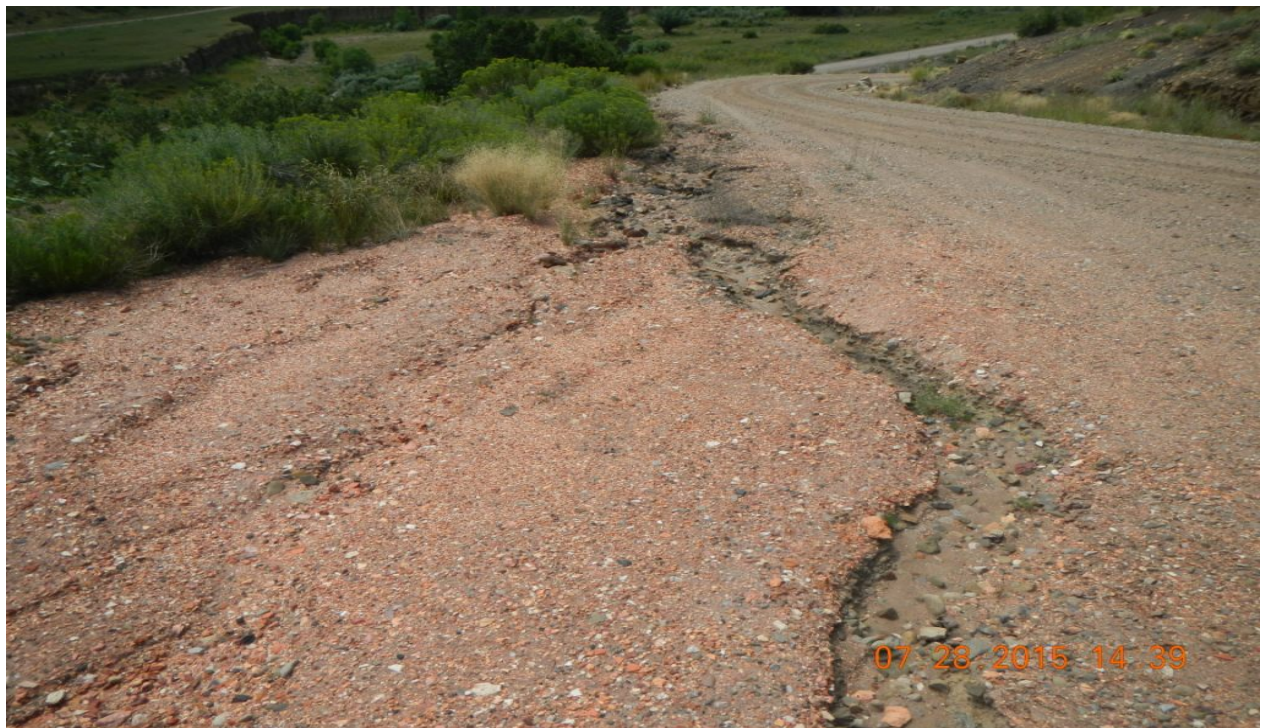
photo 4: Facing west at edge of location near the main access road. Erosion channels are shown.

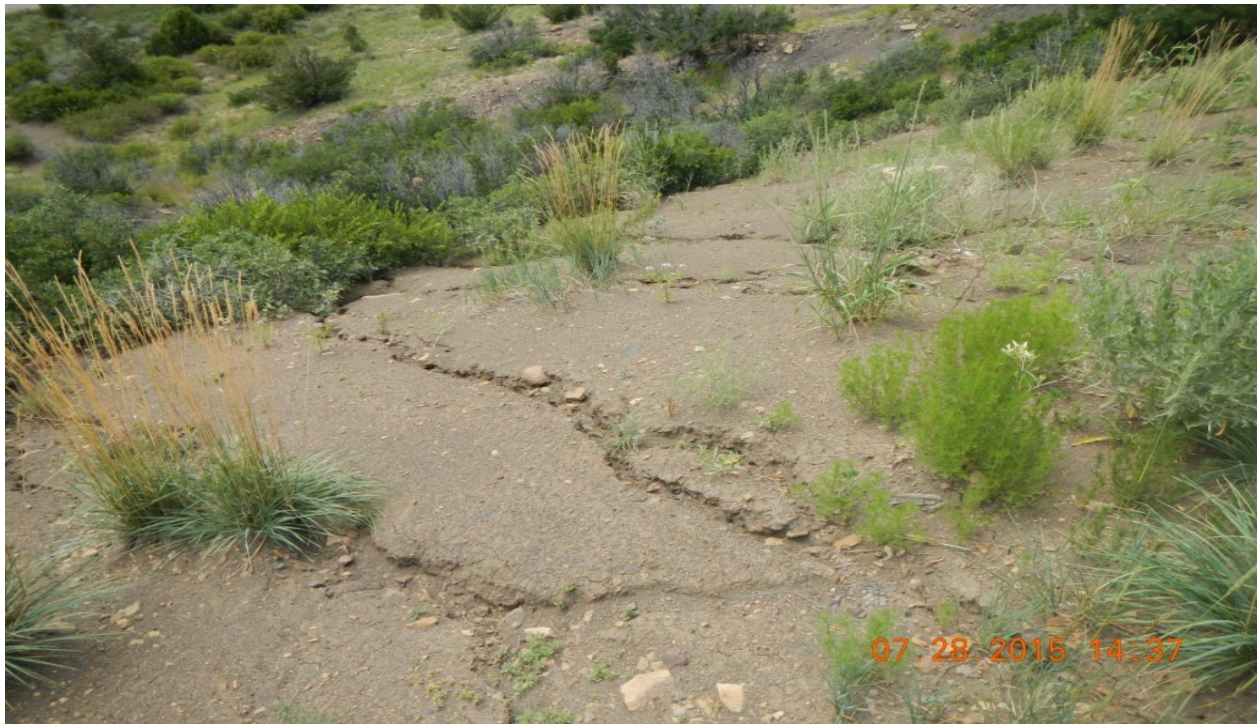
photo 5: West side of the location. There is minimal vegetation and erosion is occurring.

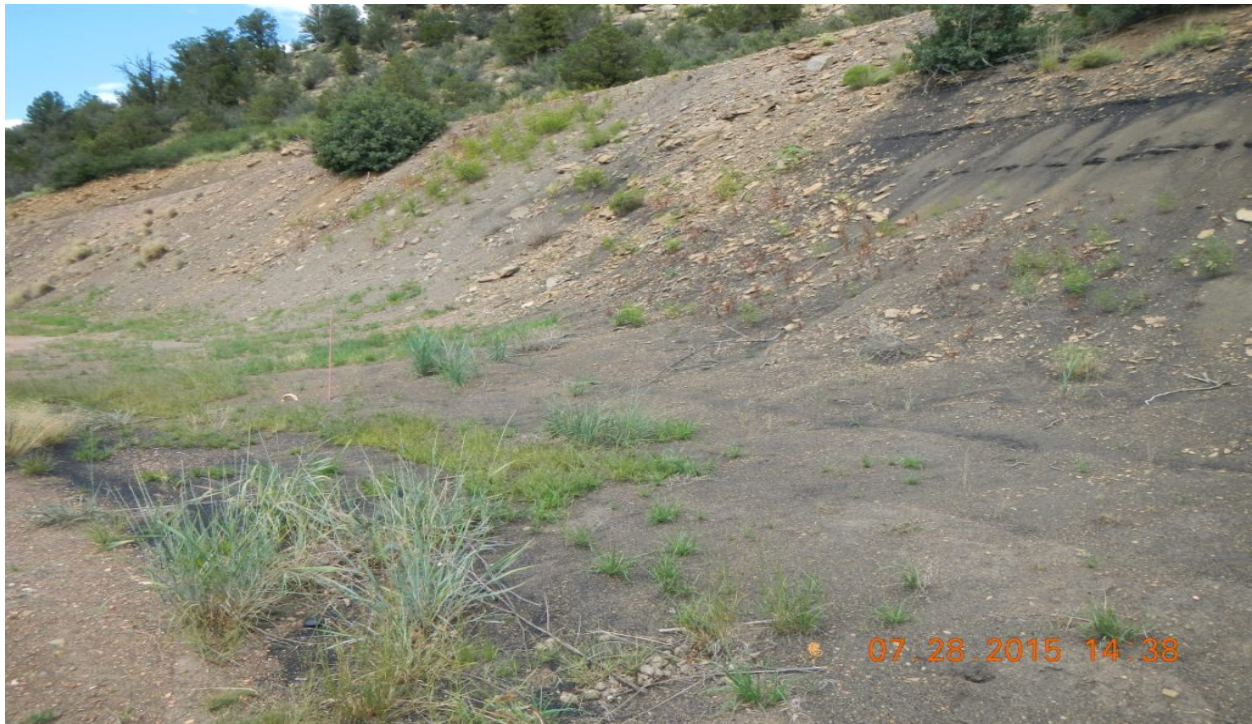
photo 7: Southeast side of the location facing north. Area has minimal vegetation growth.

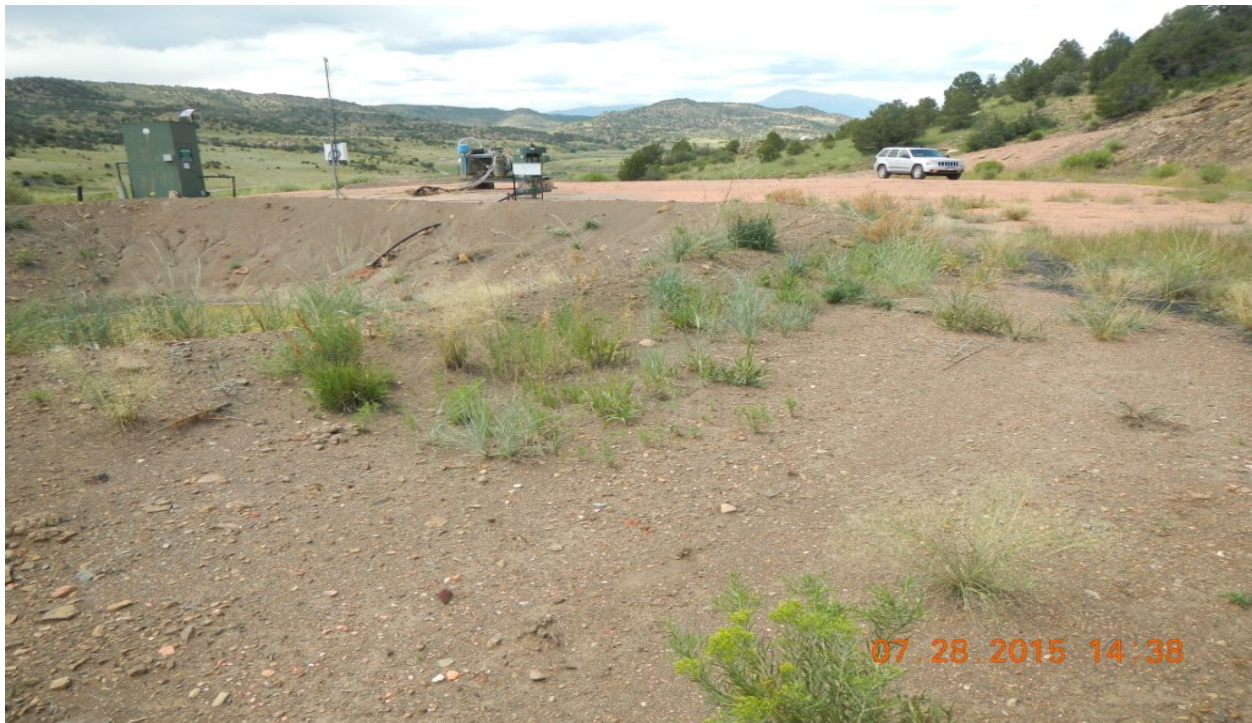
photo 8: Southeast side of the location facing northwest. Area around the pit has minimal vegetation growth.
