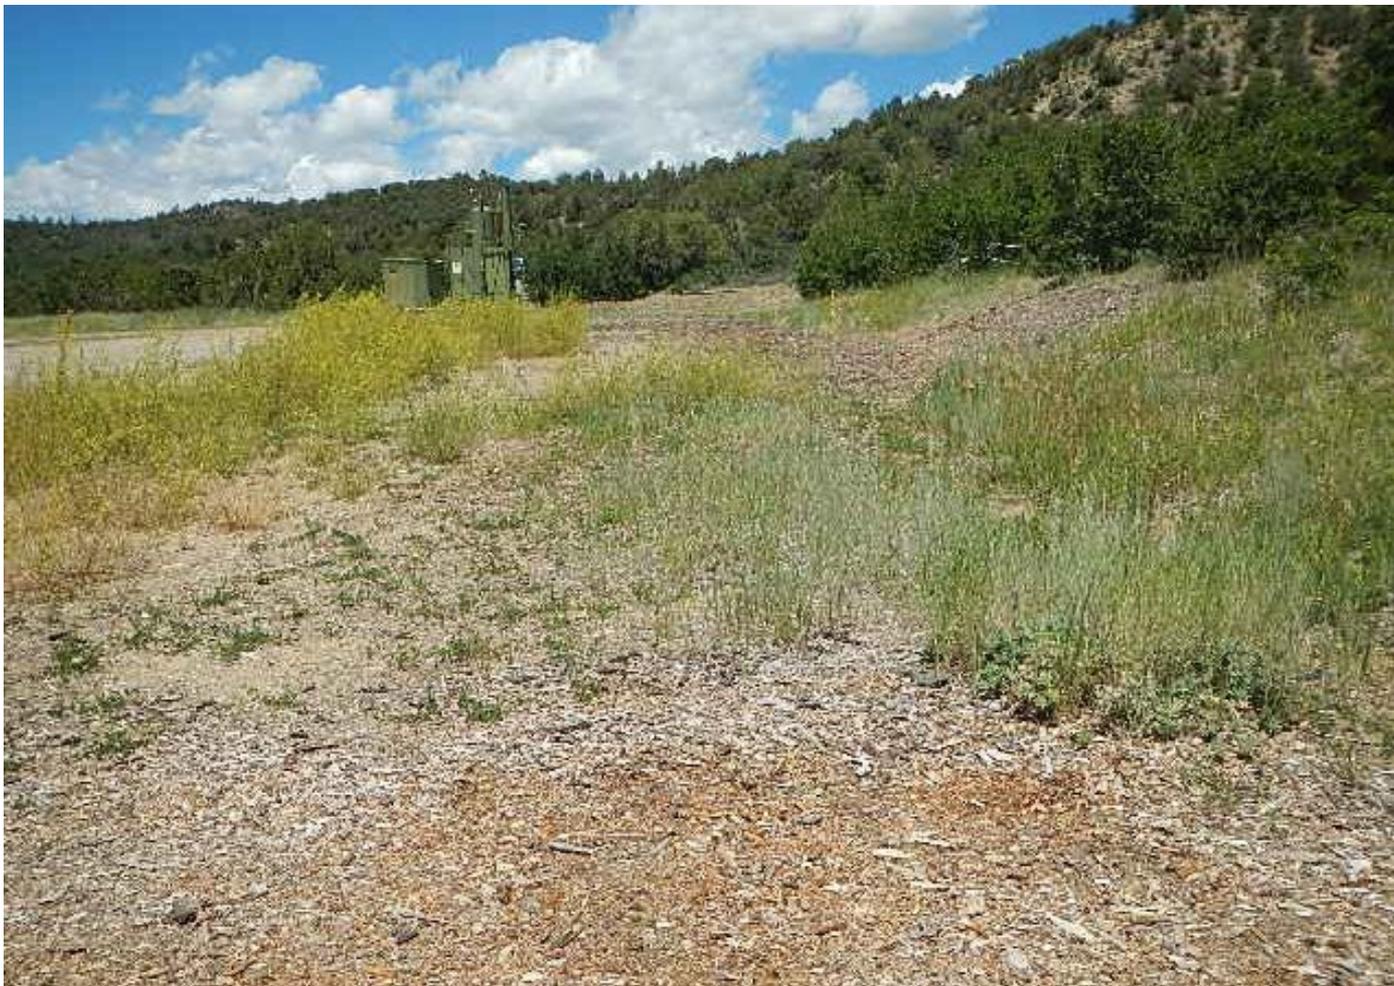
Photo 1. View of eastern portion of project area facing northward. Junk and debris have been removed from this portion of the project area.

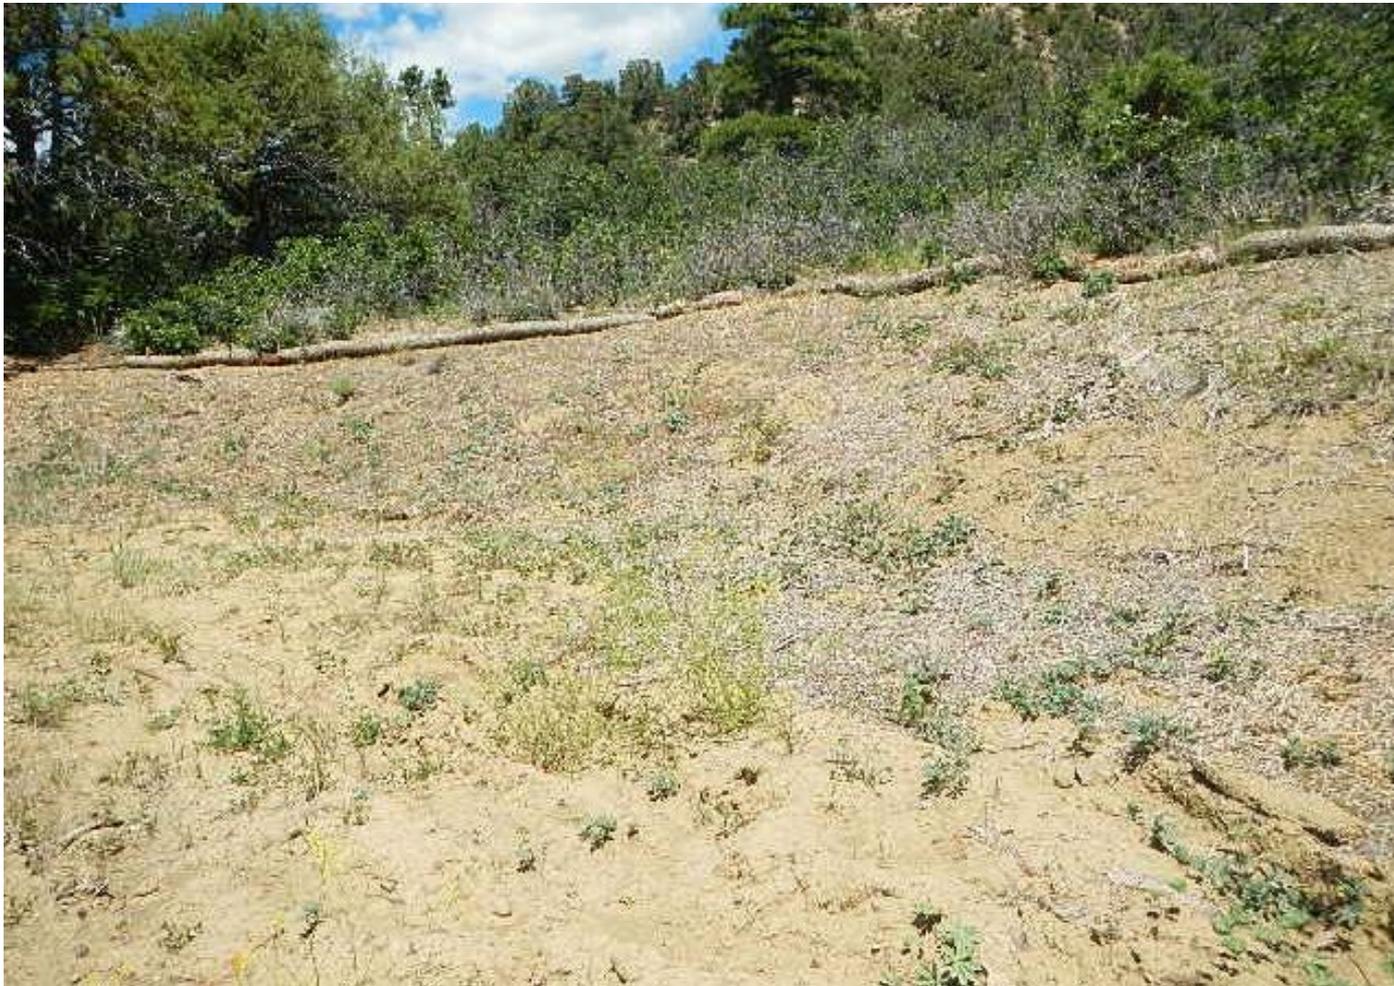
Photo 2. View of straw wattle and straw mulch in northeastern corner of project area. These appear to be stabilizing erosion at this time.

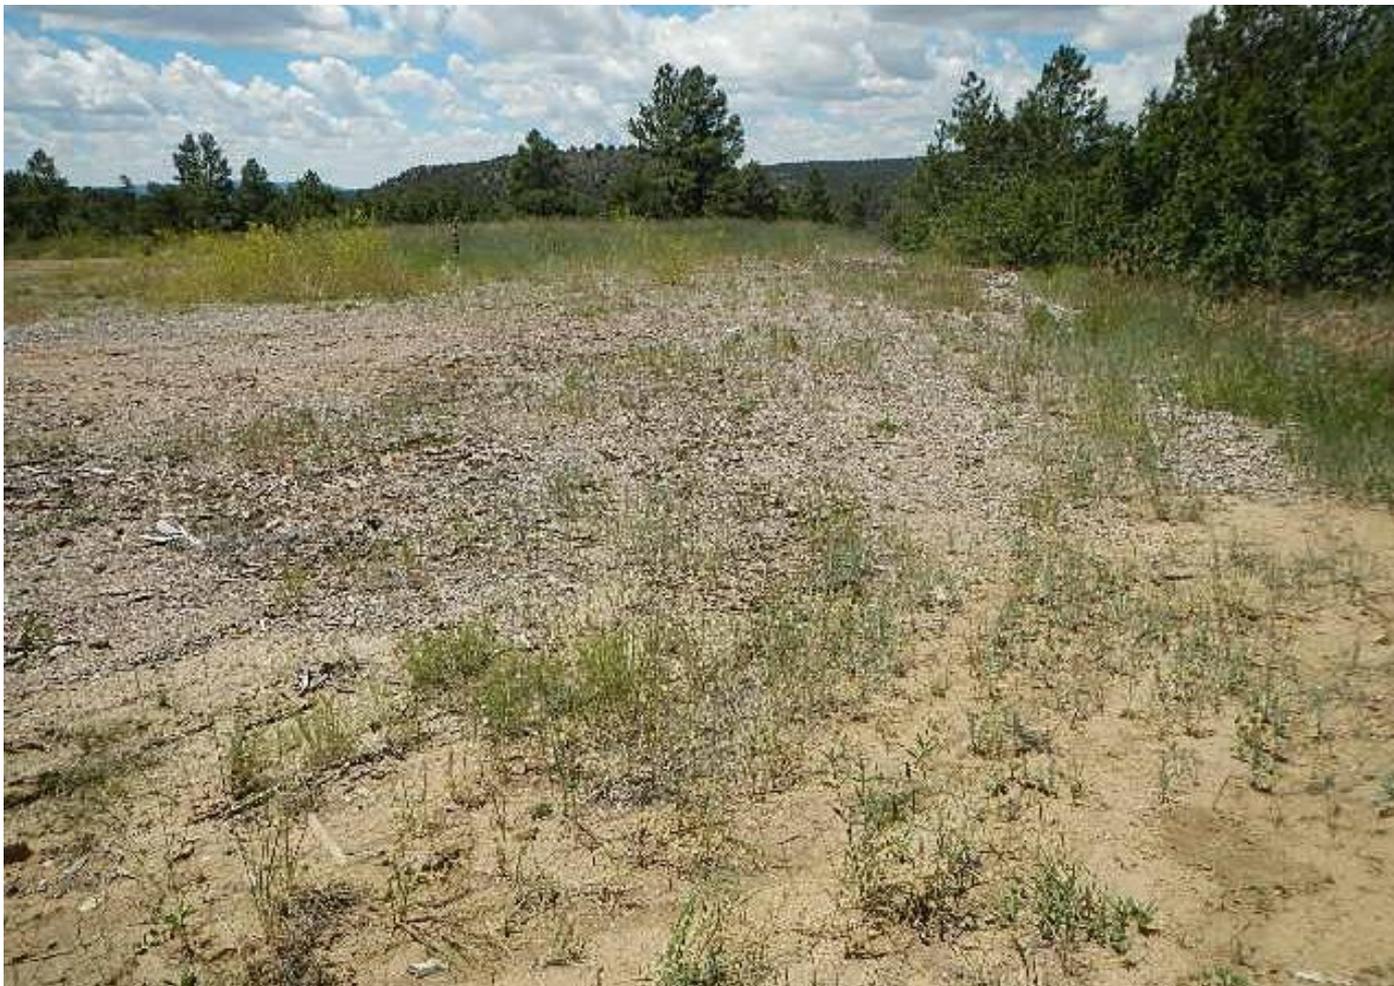
Photo 3. View of northern portion of project area from northeastern corner facing westward. Junk and debris has been removed.

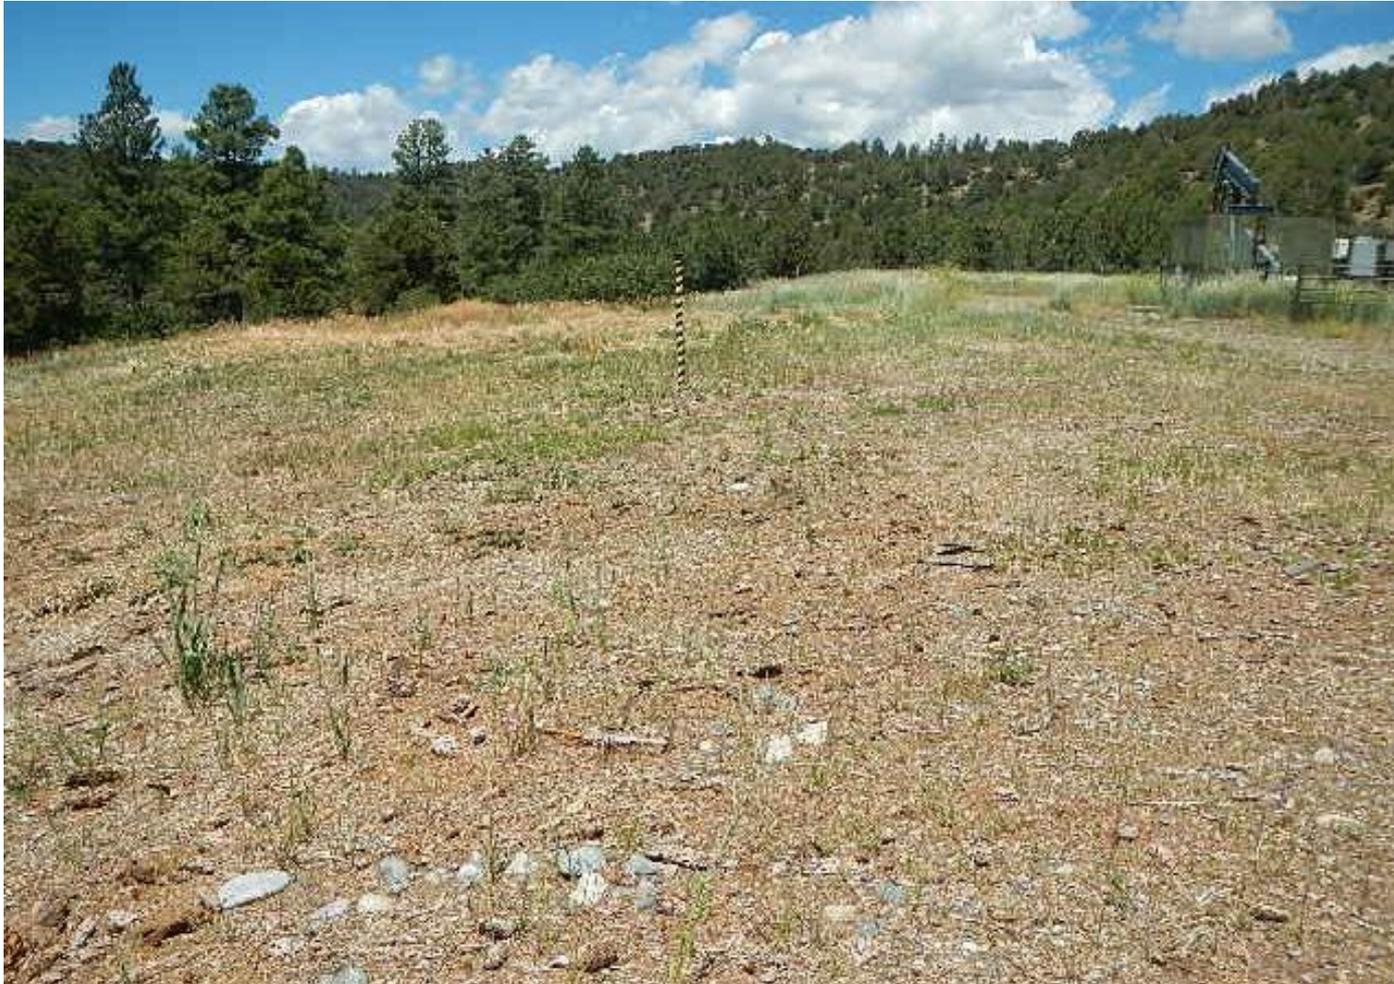
Photo 4. View of western portion of project area from southwestern edge facing northward. Junk and debris has been removed.

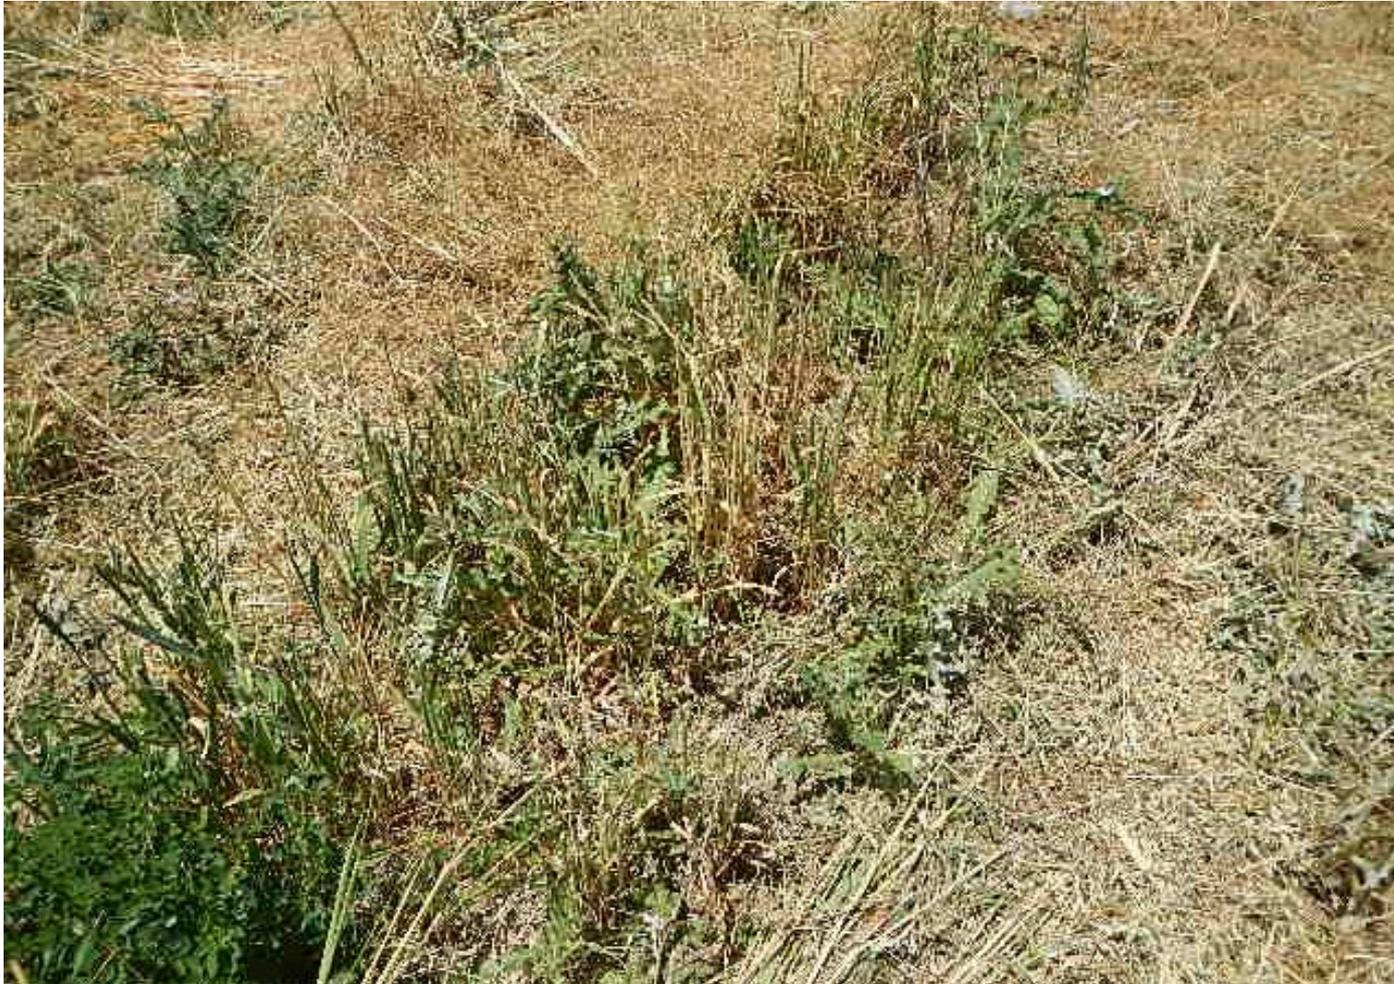
Photo 5. View of Canada thistle plants within interim reclamation area. These have recently been mowed.

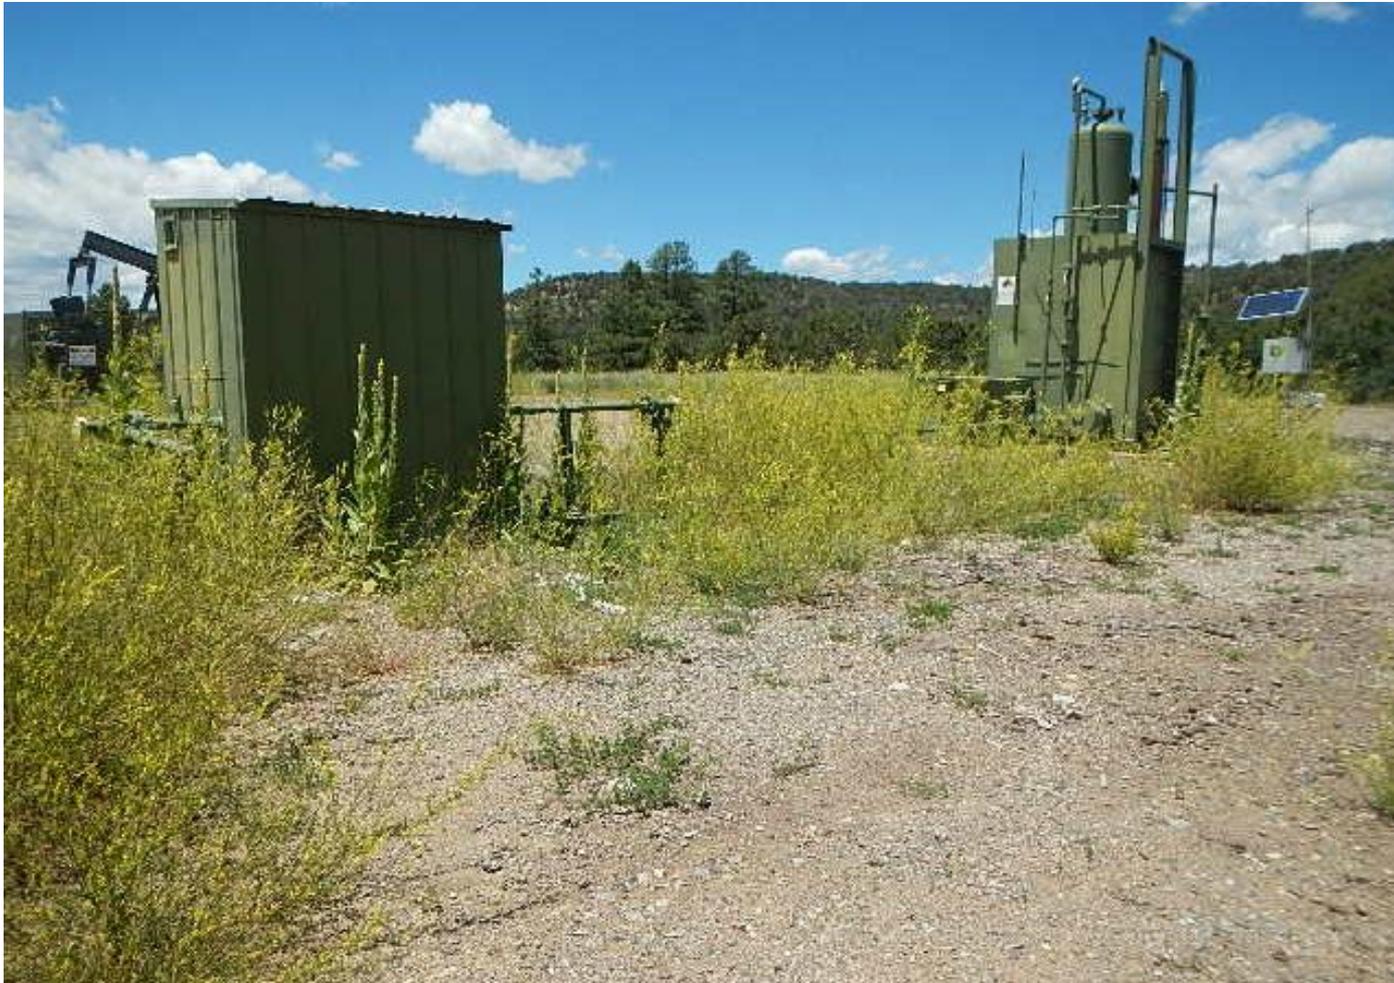
Photo 6. View of yellow sweetclover (*Melilotus officinalis*) and mullein (*Verbascum thapsus*) growing around project facilities. These need to be controlled.
