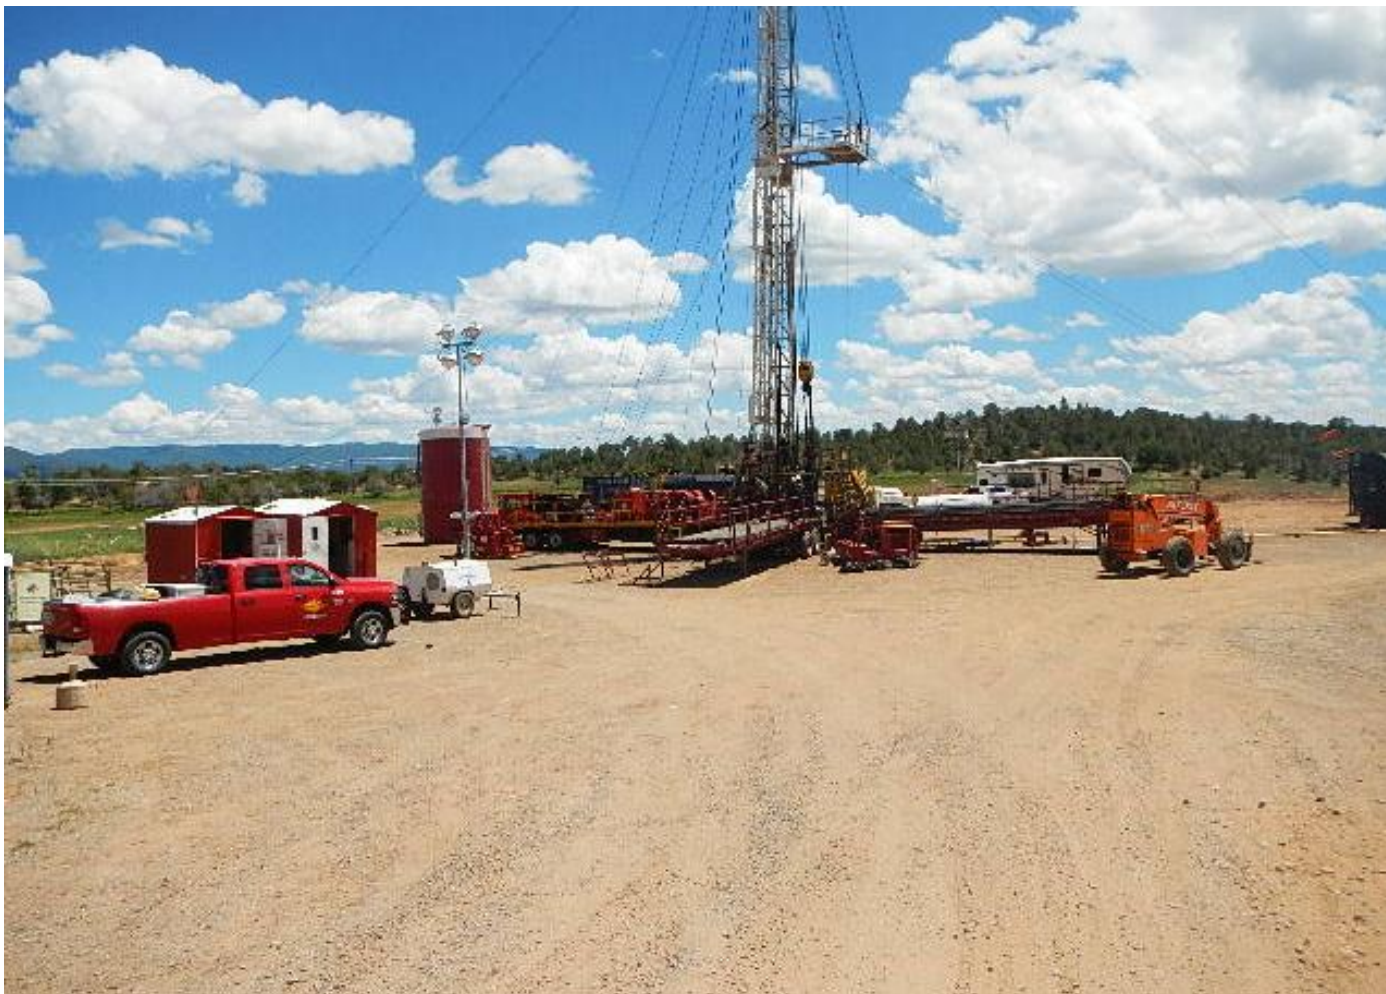
Photo 1. View of workover operations from well pad entrance facing center.

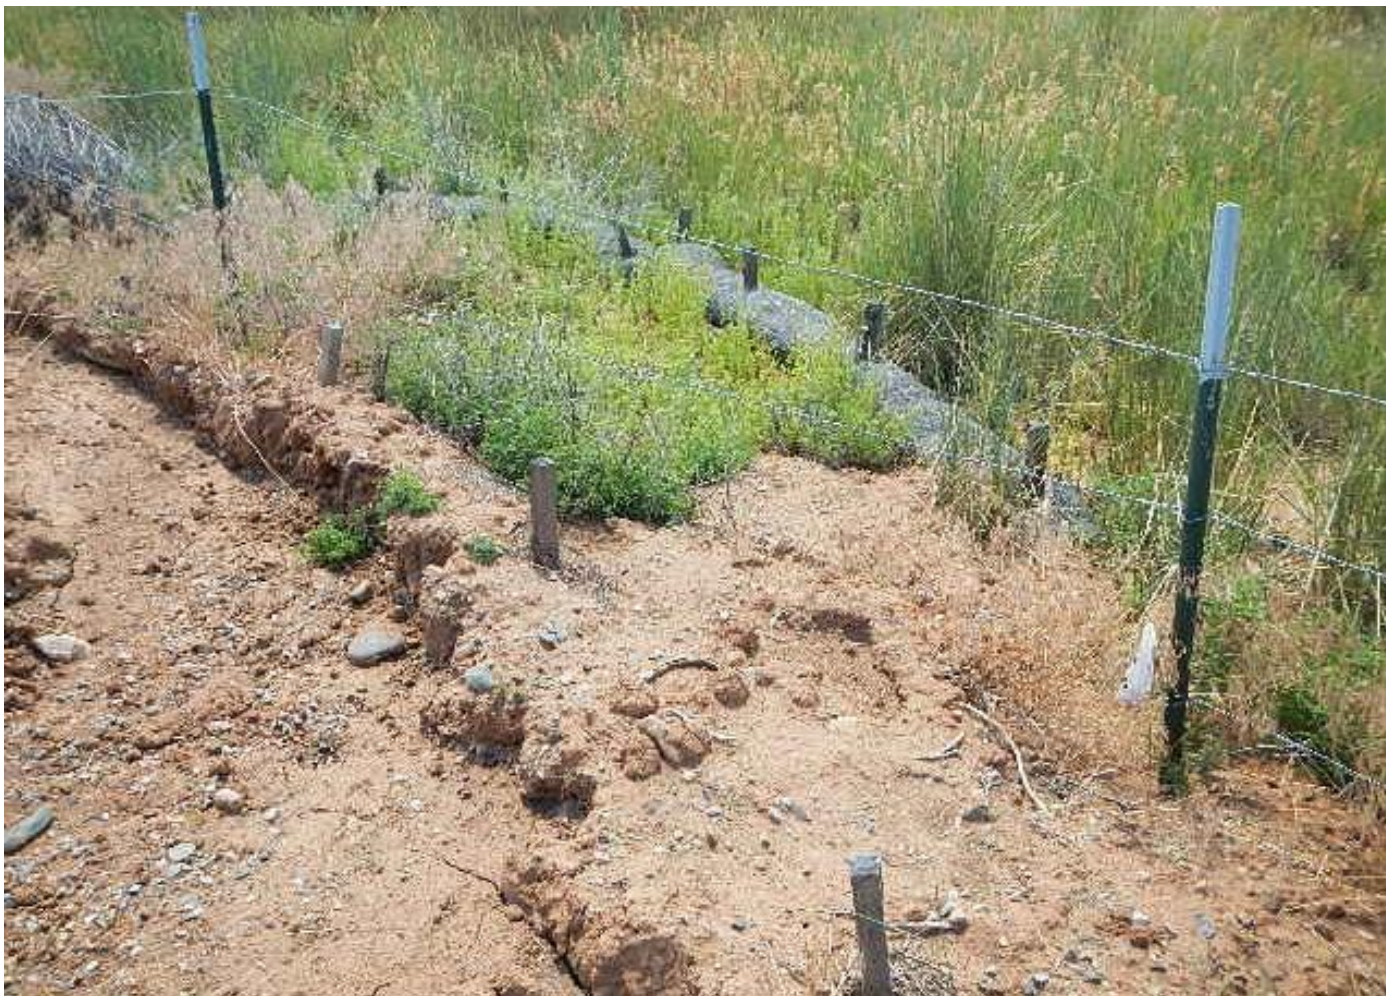
Photo 2. View of sediment overflowing straw wattle that is contained by second wattle. This needs maintenance and needs to be monitored.

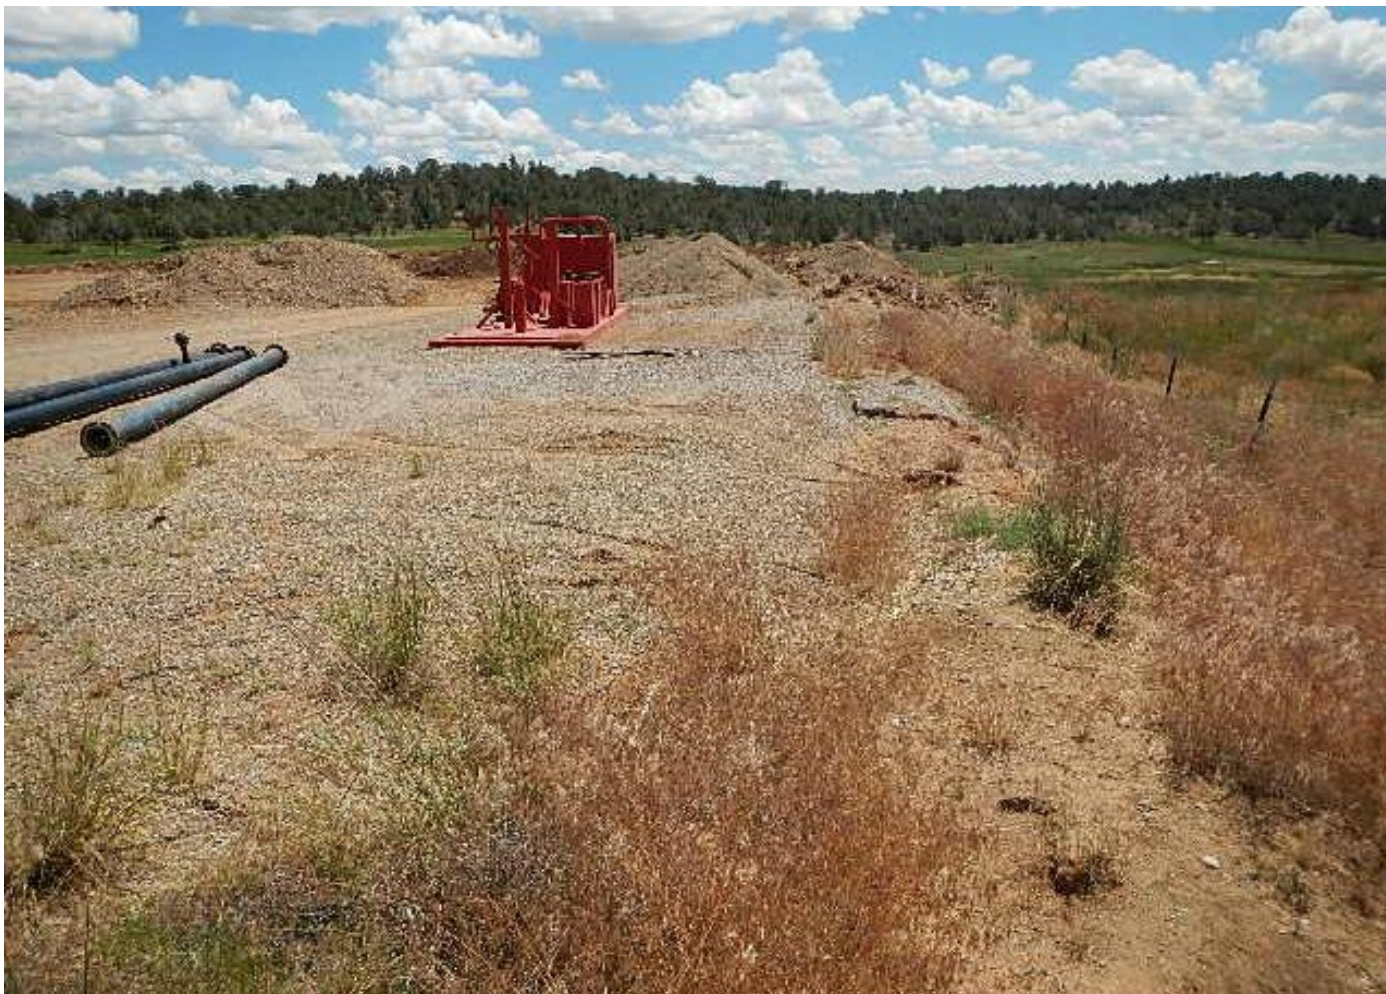
Photo 3. View of western portion of project area from northwestern corner facing southward. Brown vegetation in foreground and along slopes on right is cheatgrass (*Bromus tectorum*).

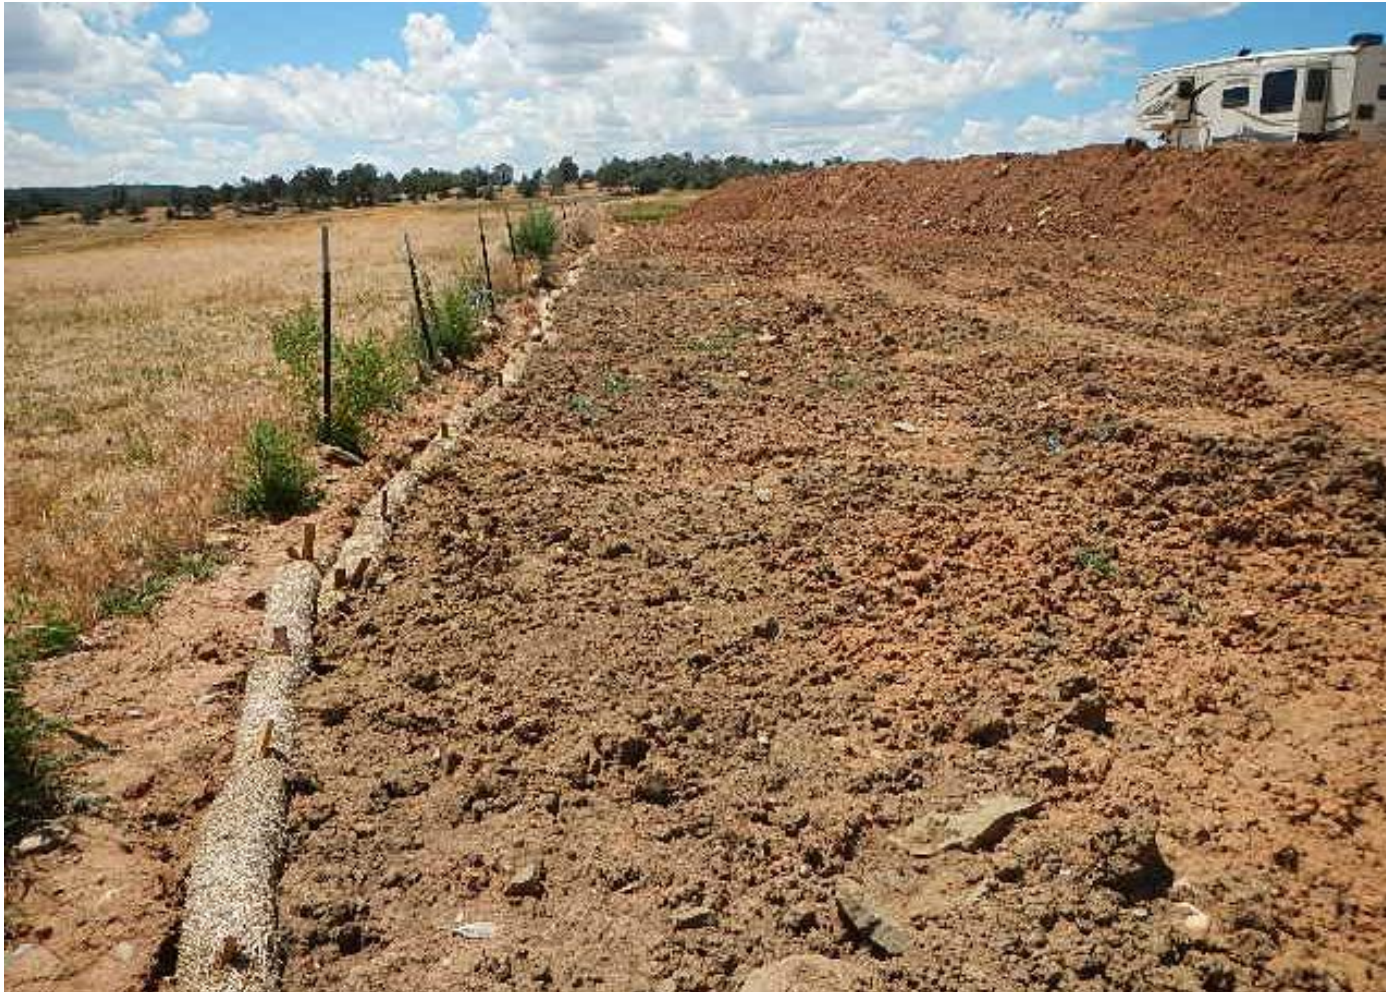
Photo 4. View of southern portion of project area from southeastern corner facing westward. Wattles appear to be properly installed and soil stockpiles are set back from edge of project area.

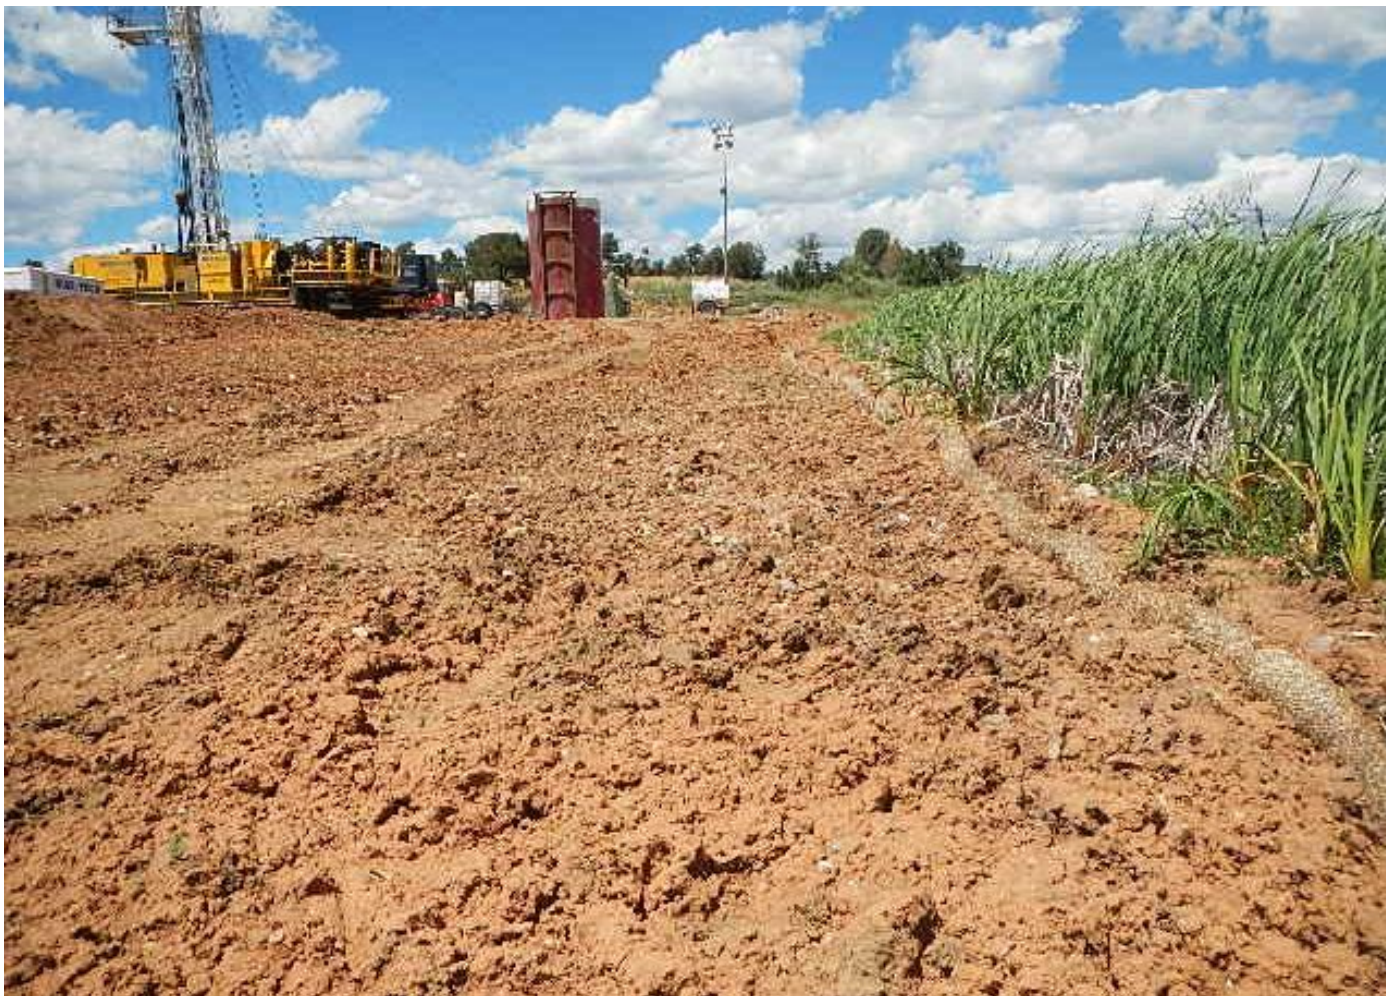
Photo 5. View of eastern portion of project area from southeastern corner facing northward. Cattails (*Typha* sp.), an obligate wetland species is present adjacent to the project area (right of straw wattle).

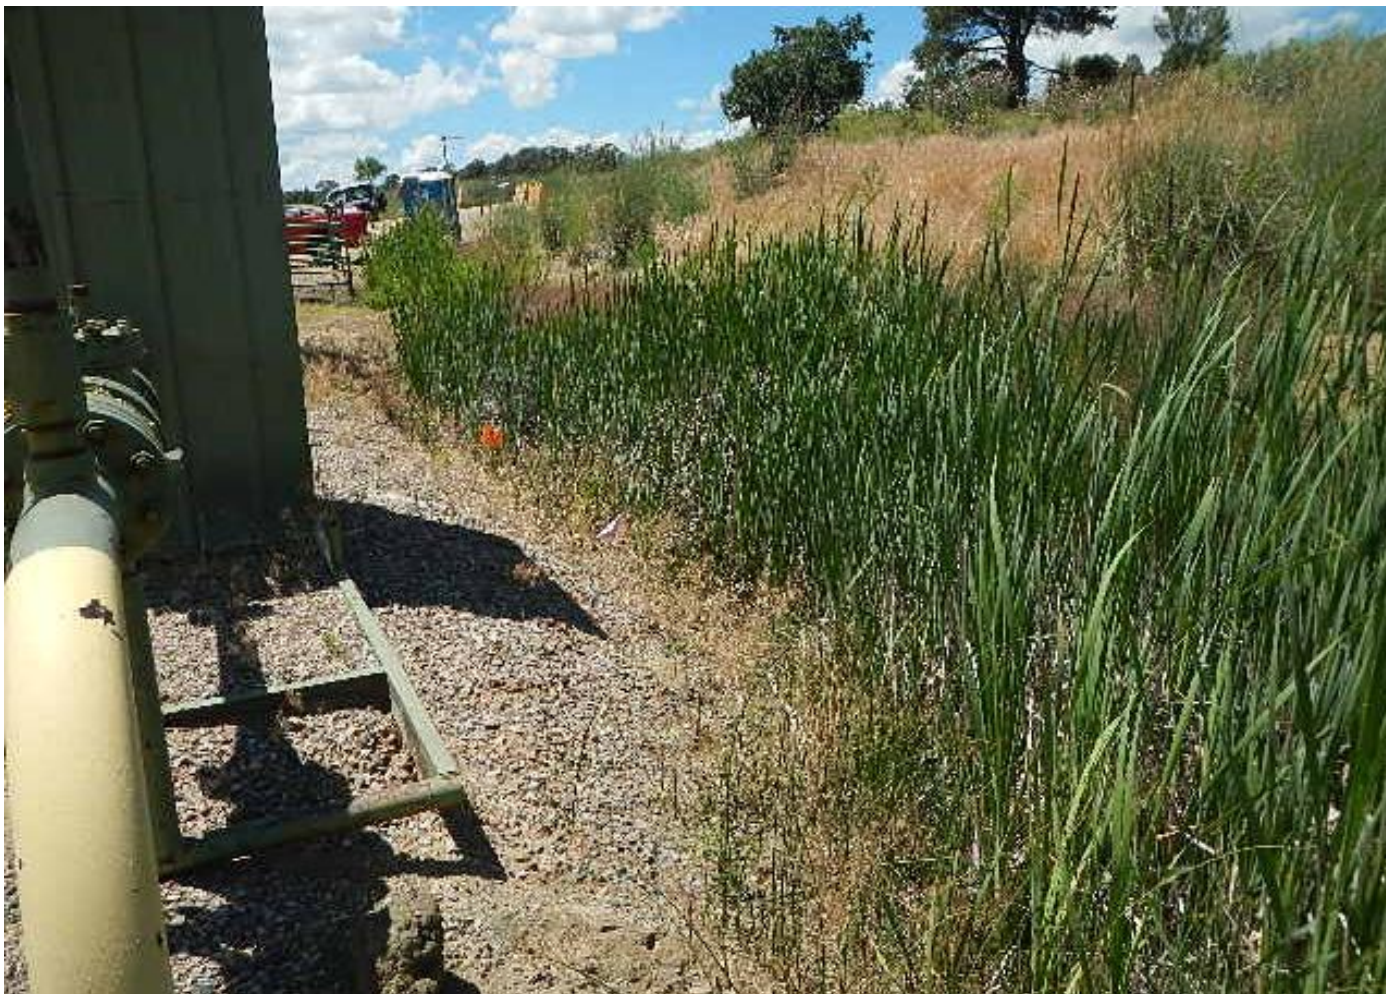
Photo 6. View of northern portion of project area. Wetland vegetation (cattails) is established adjacent to the working area.
