Inspection# 673402266

7/23/2015
Inspection 673402266

7/14/2014
Inspection 673400788

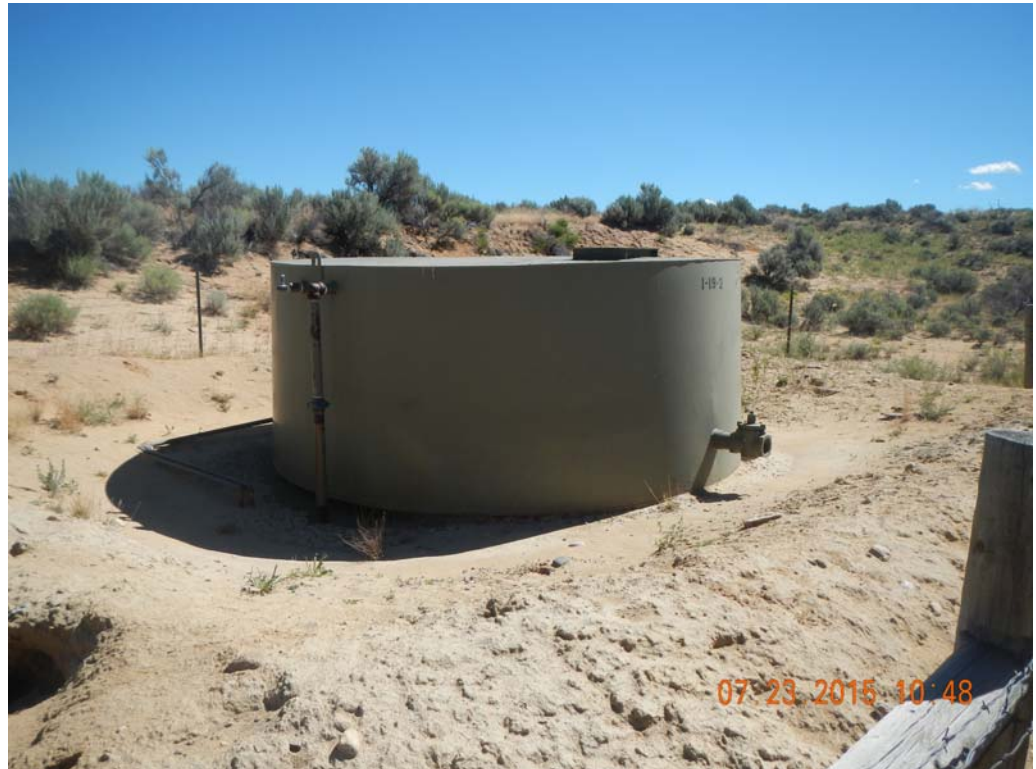
7/23/2015

No tank label.

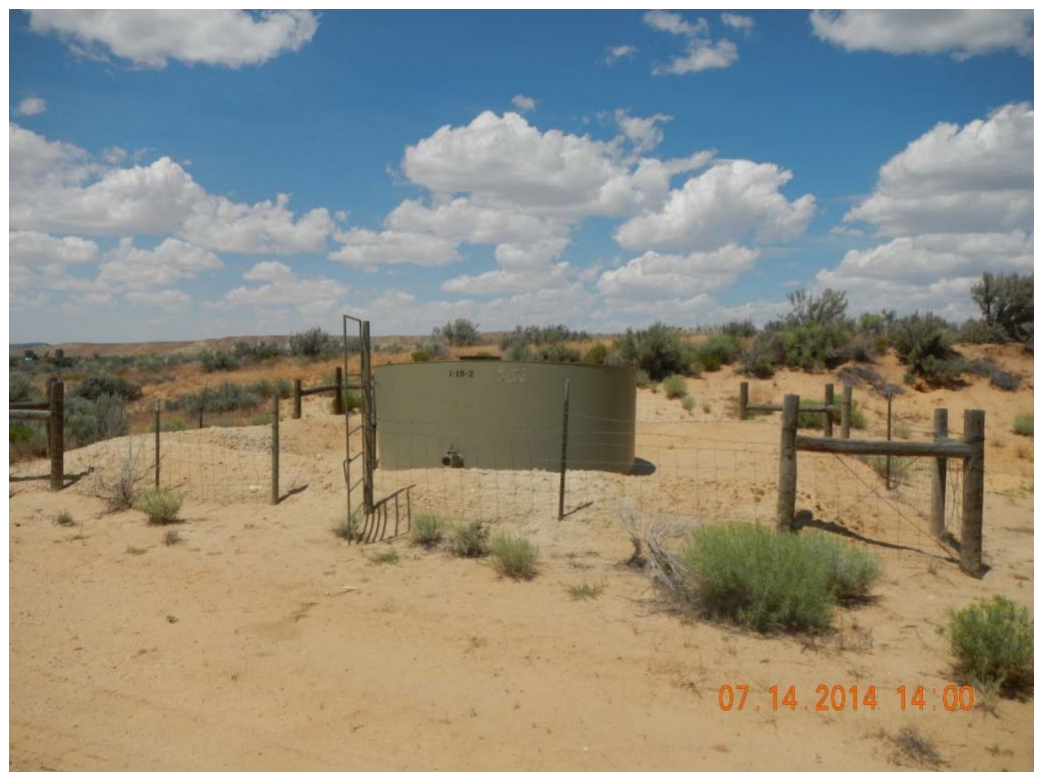
7/14/2014

No tank label.

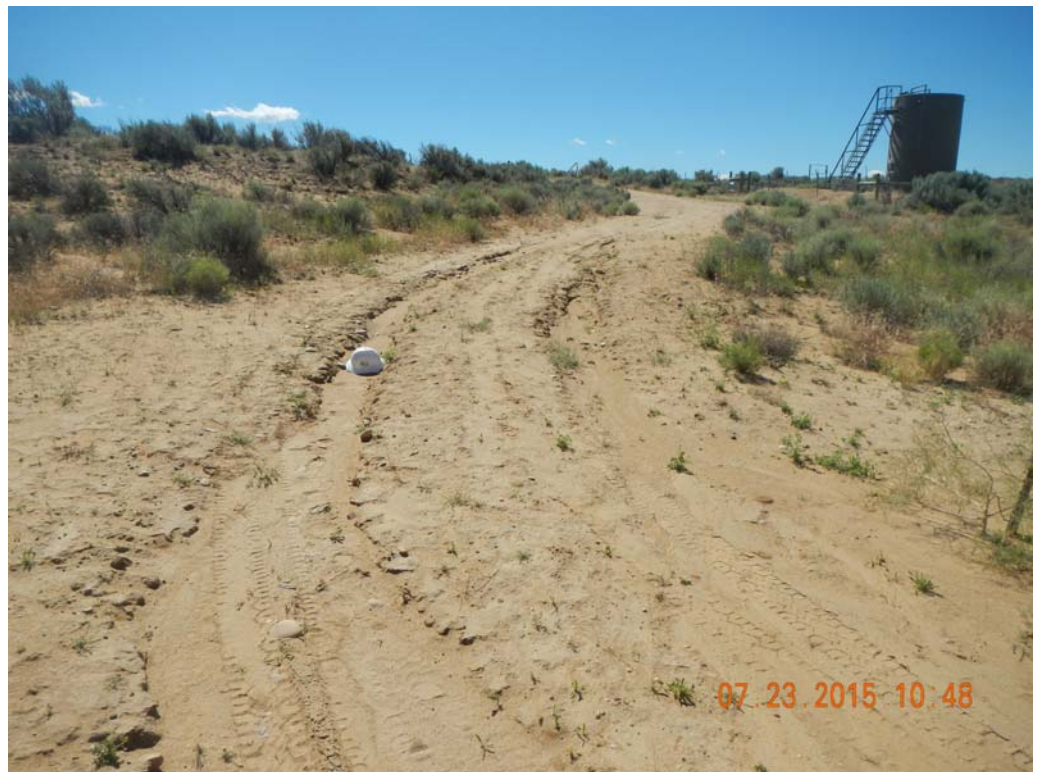
7/23/2015
Inspection 673402266

Sediment being transported
onto location through rills
which have turned into ruts
on access road.

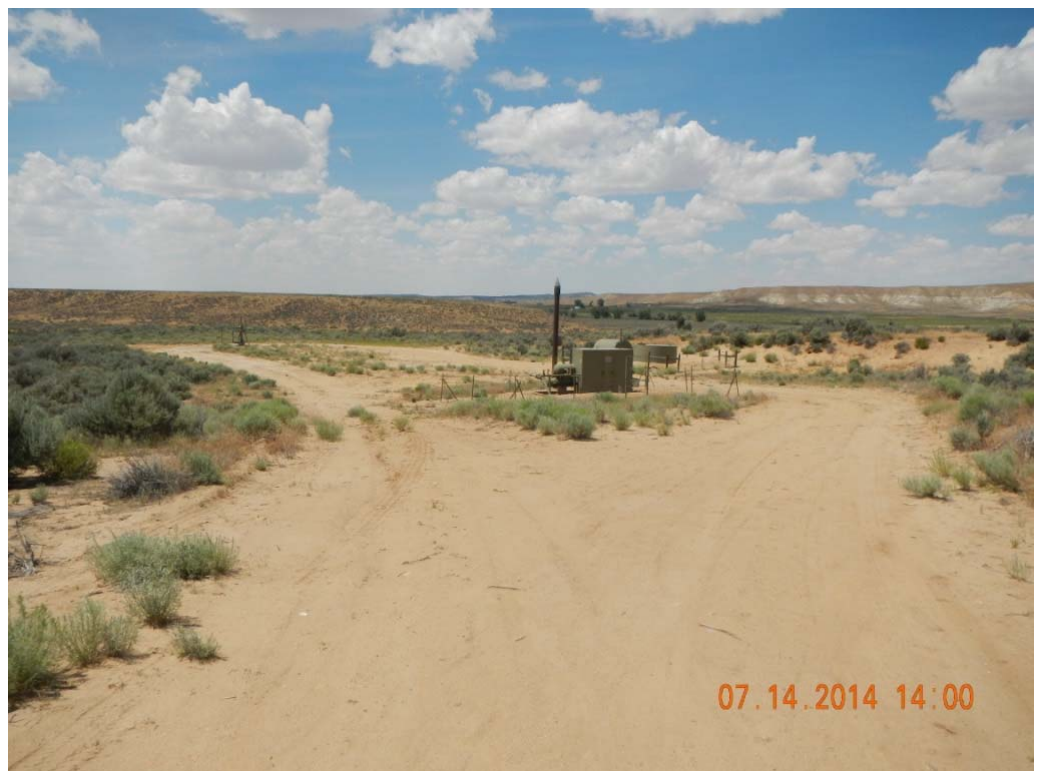
7/14/2014
Inspection 673400788

Sediment migration onto
location via rills on access
road.

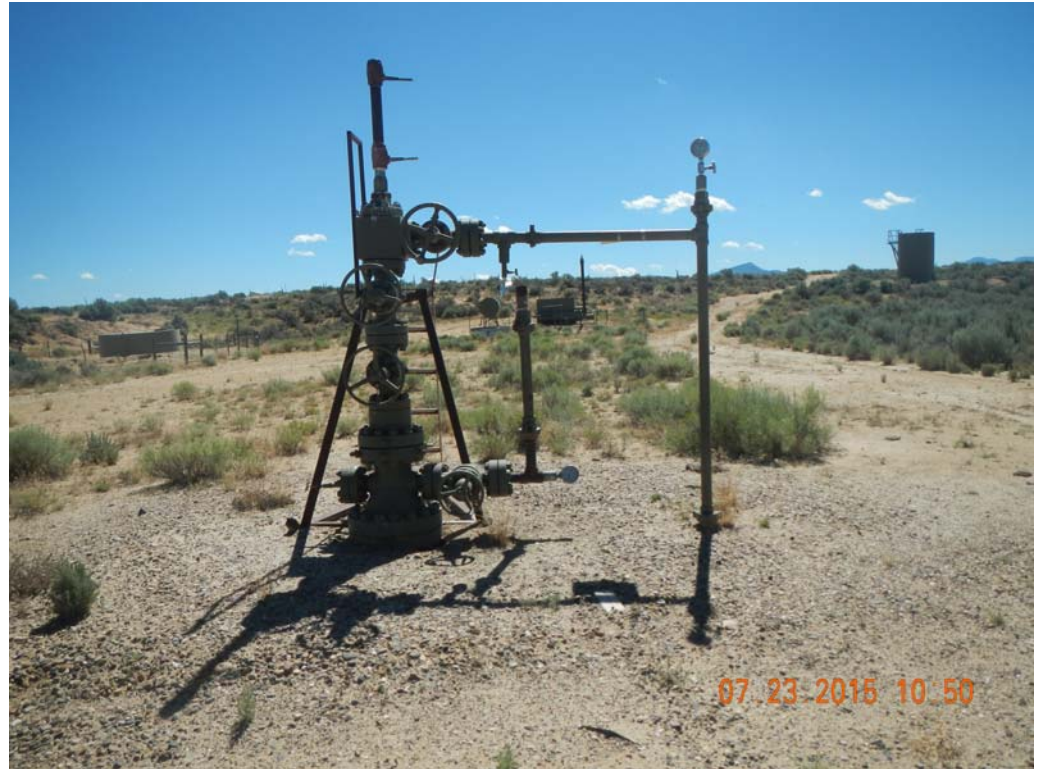
7/23/2015

No wellhead sign.
