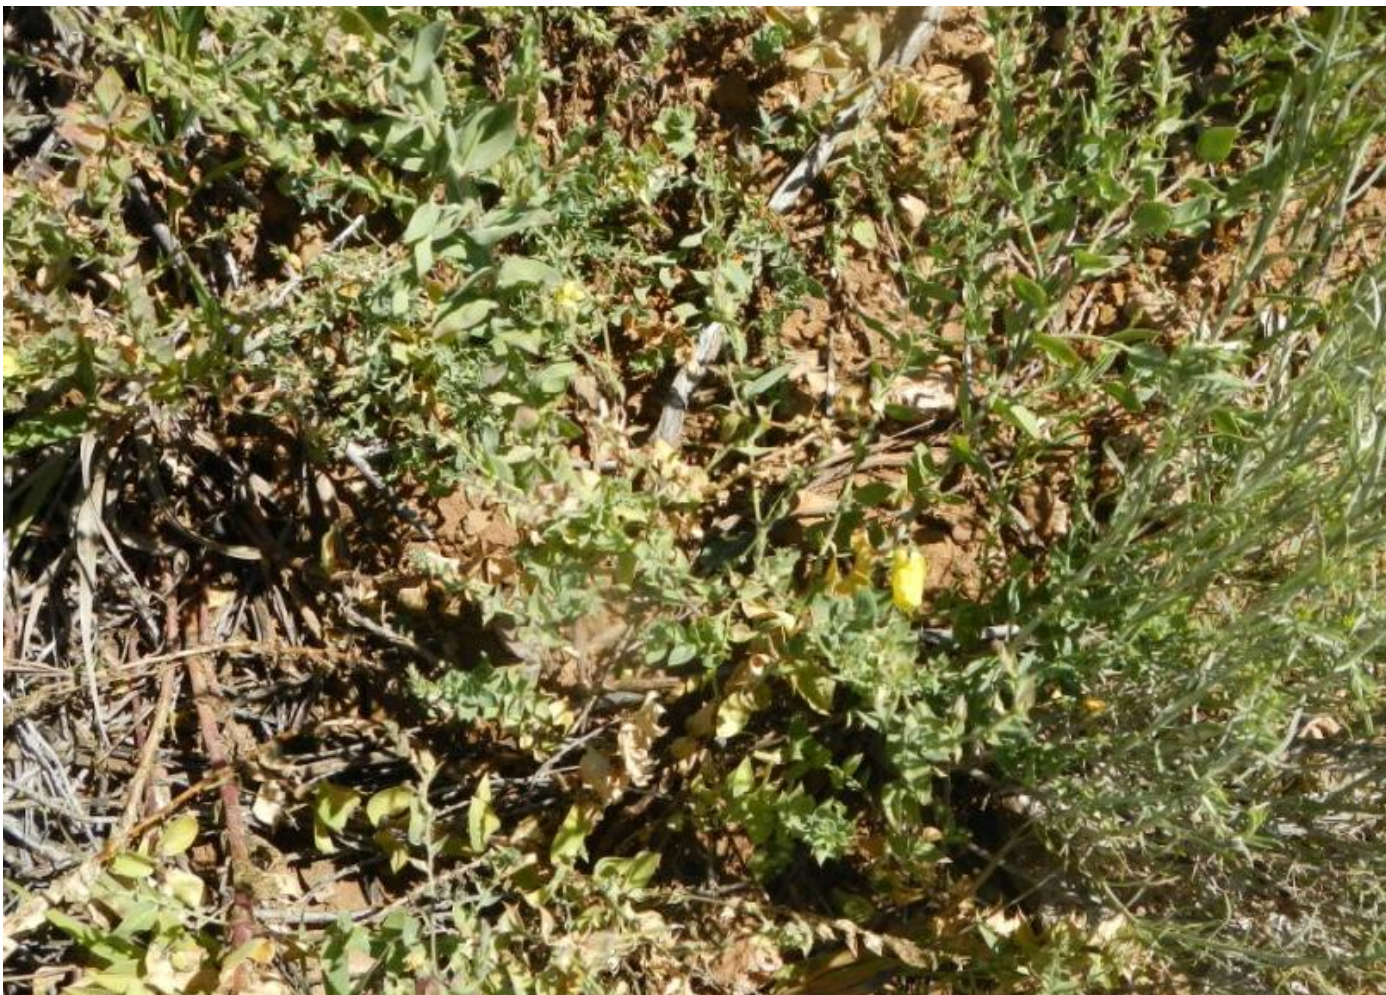
Photo 1. View of dalmatian toadflax (*Linaria dalmatica*) within the southern portion of the project area.

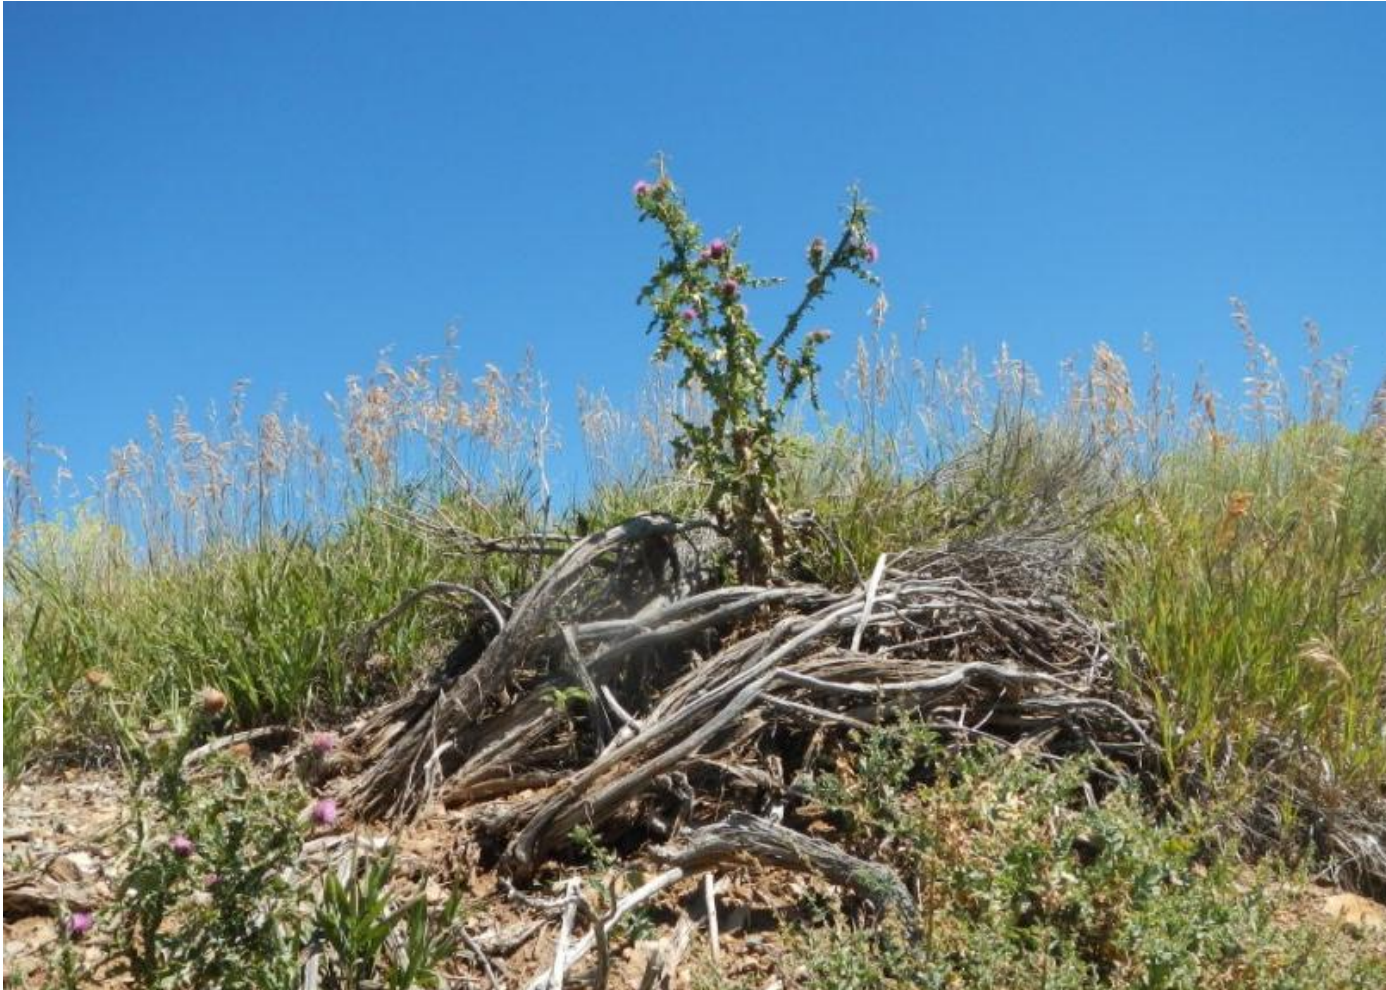
Photo 2. View of musk thistle (*Carduus nutans*; in background and on bottom left) and dalmatian toadflax (on bottom right) within the southern portion of the project area.

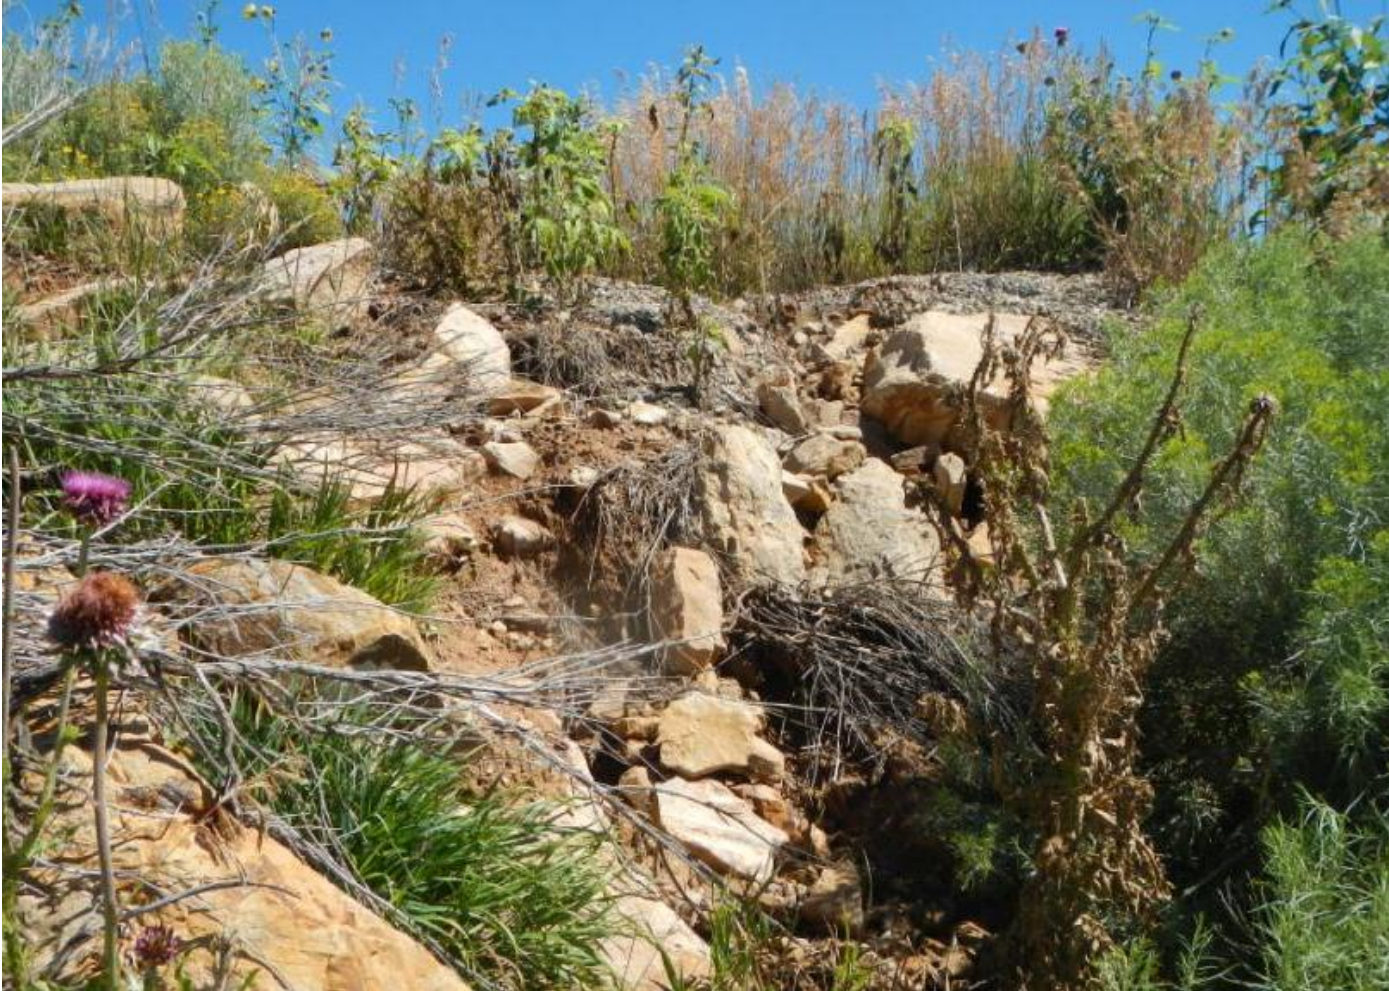
Photo 3. View of area where stormwater flows have eroded a portion of the southern fill slopes on the well pad.

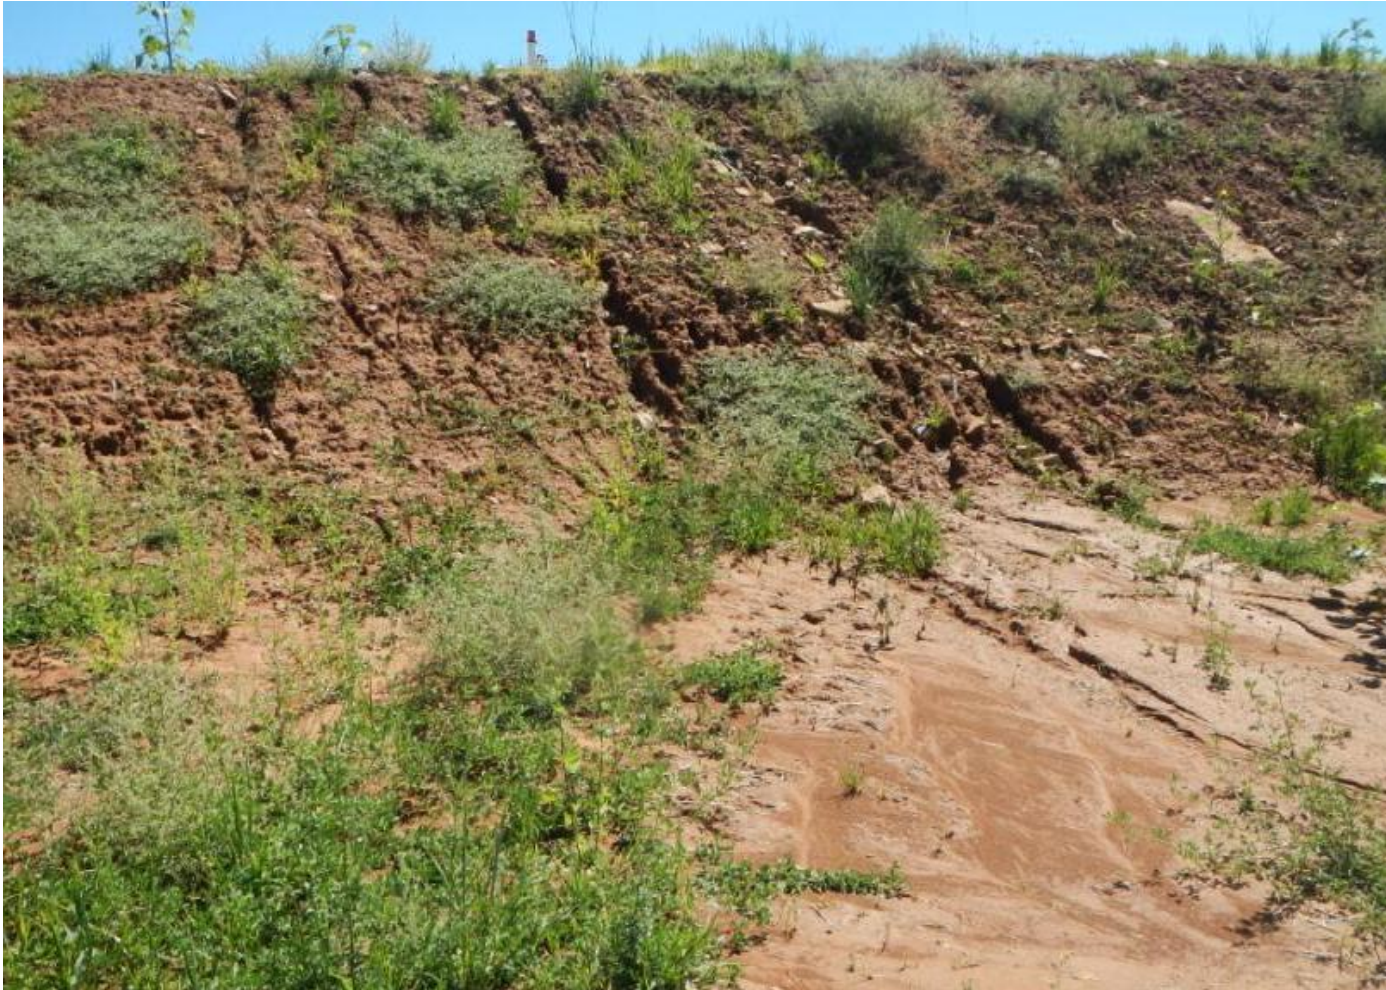
Photo 4. View of rill erosion and sediment deposition in western portion of project area.

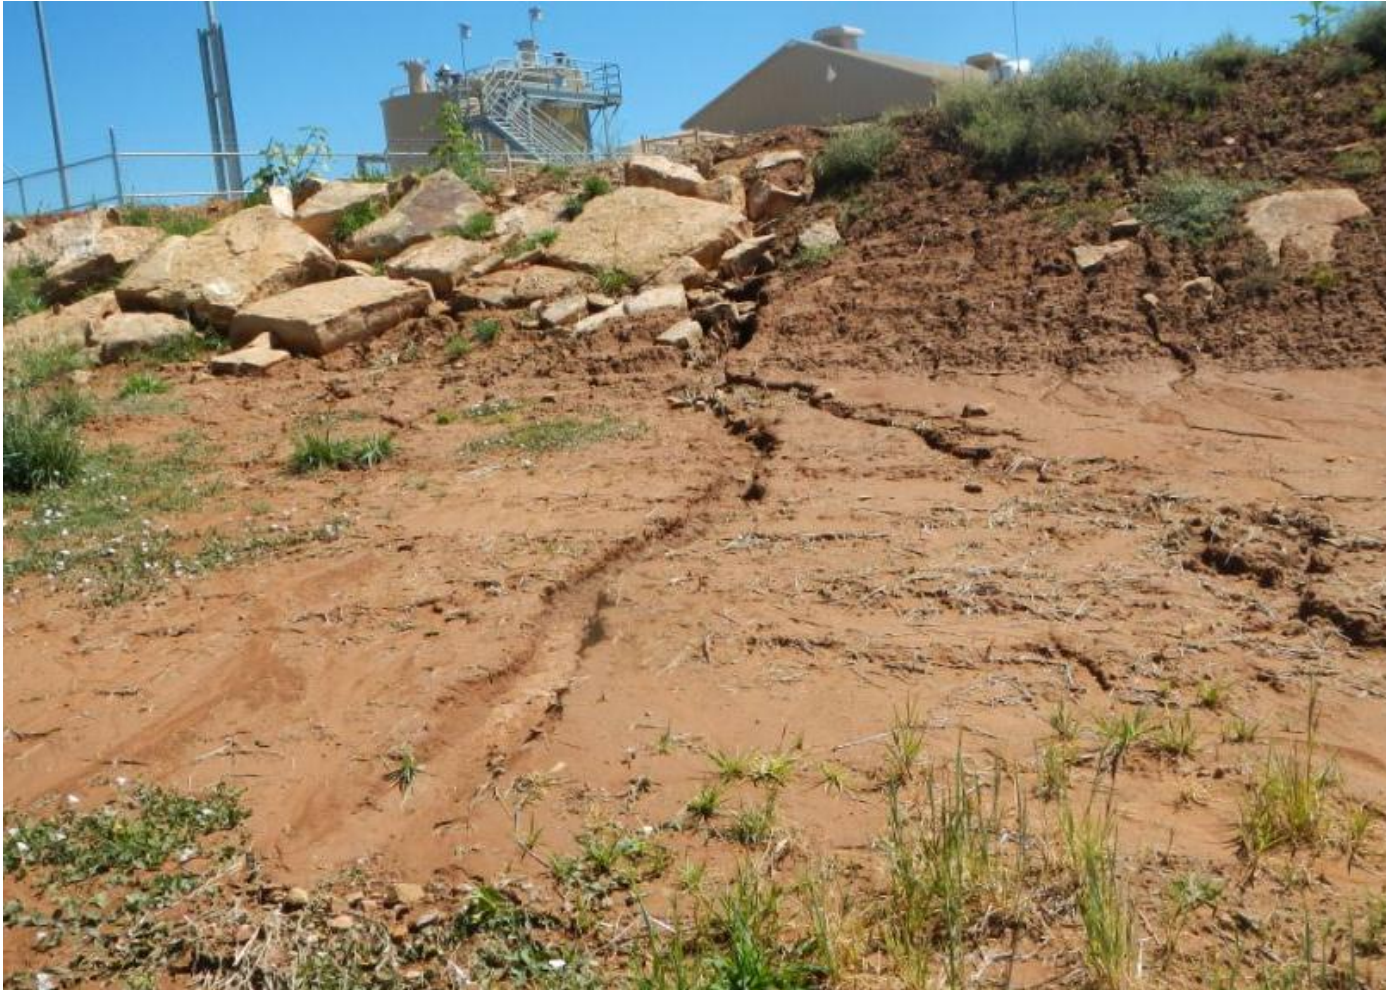
Photo 5. View of deep rills and sediment deposition within the western portion of the project area.

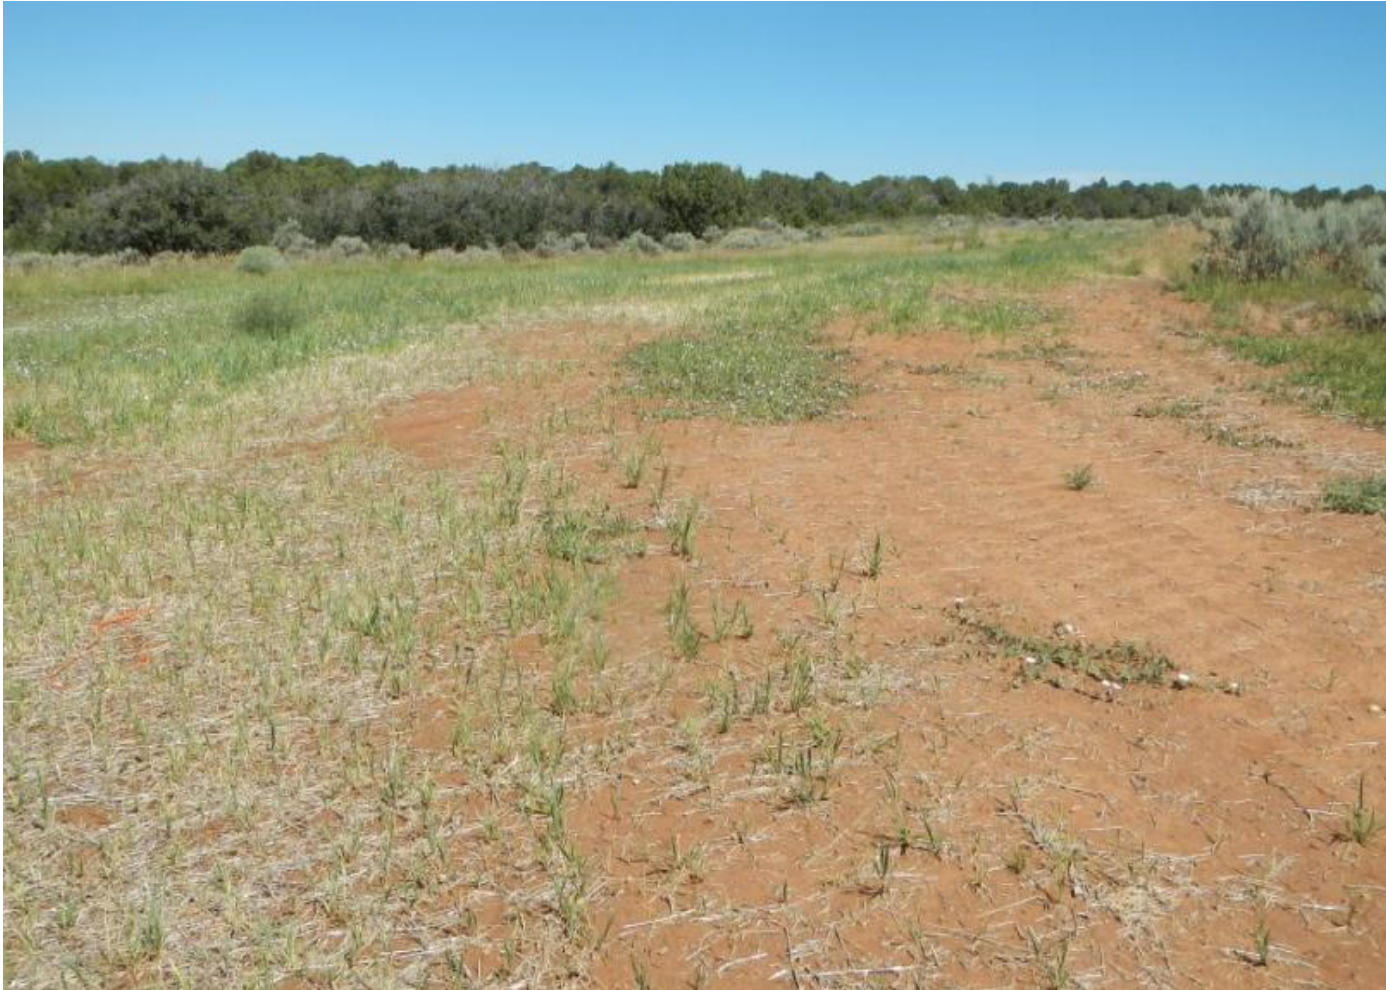
Photo 6. View of the flowline within the northwestern portion of the project area facing northwestward. This area appears to have recently been seeded and grassy vegetation is becoming established.

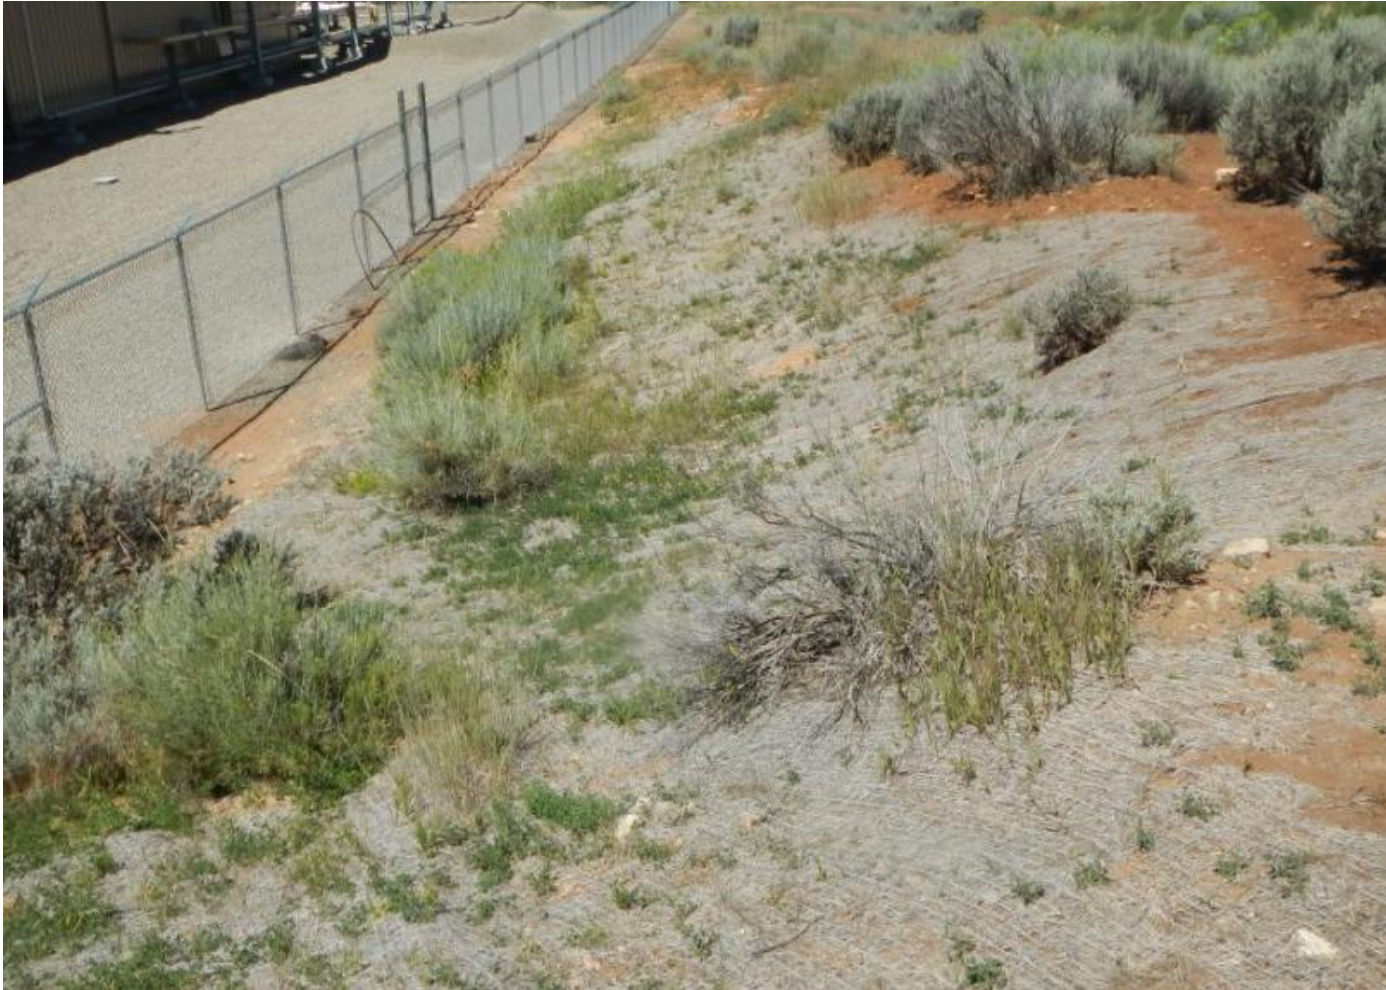
Photo 7. View of cut-slope along northeastern portion of the project area. Straw matting and vegetation appear to be effective at stabilizing this slope.
