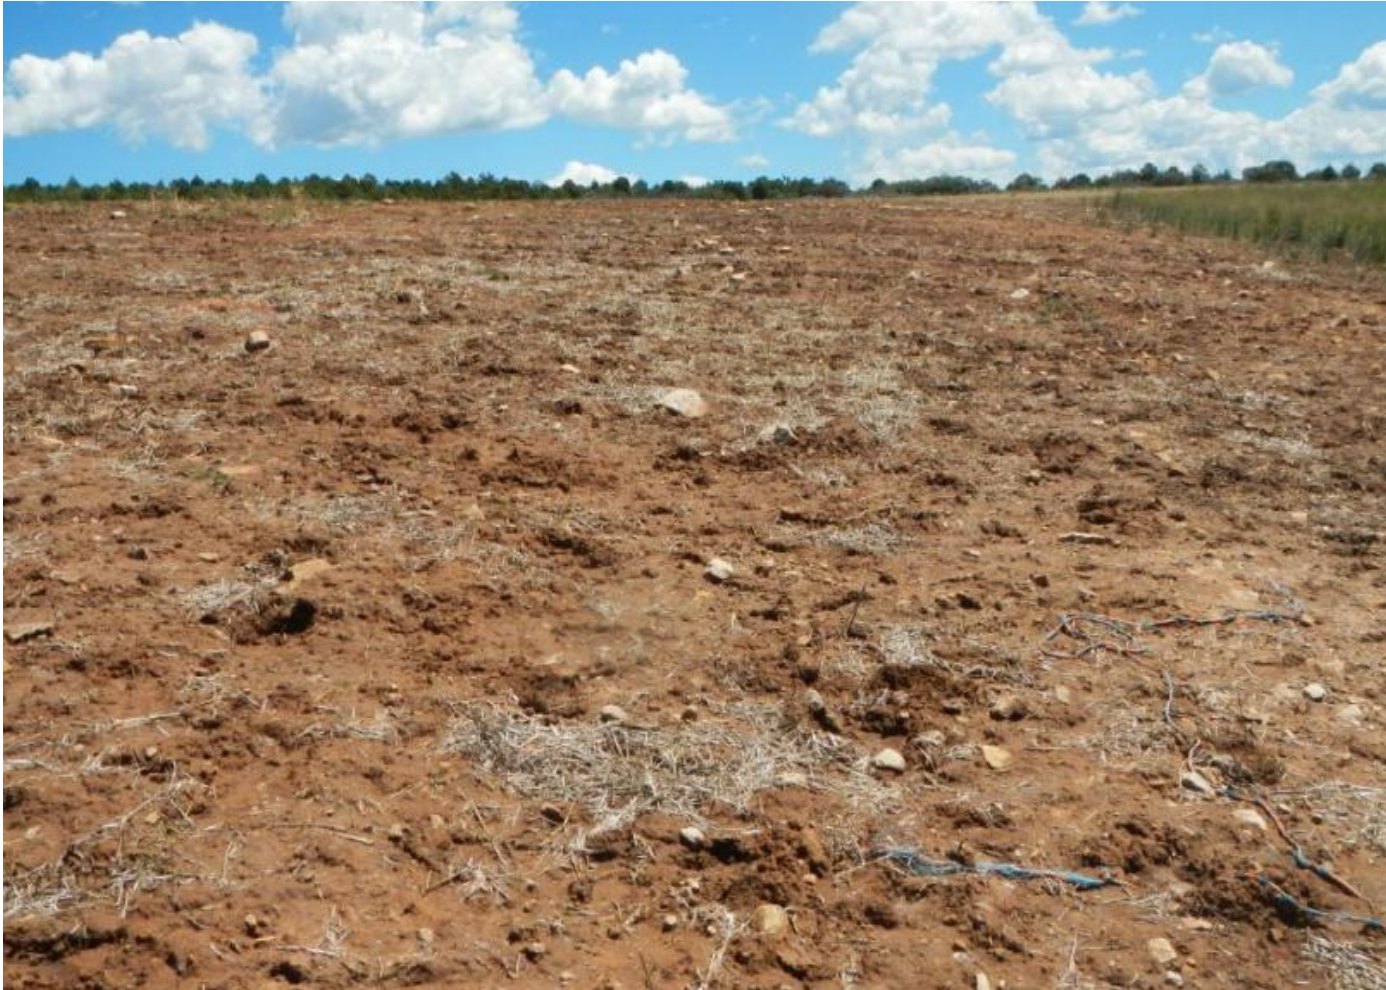
Photo 1. View of southern portion of interim reclamation area from southwestern edge facing eastward. Little vegetation is established here.

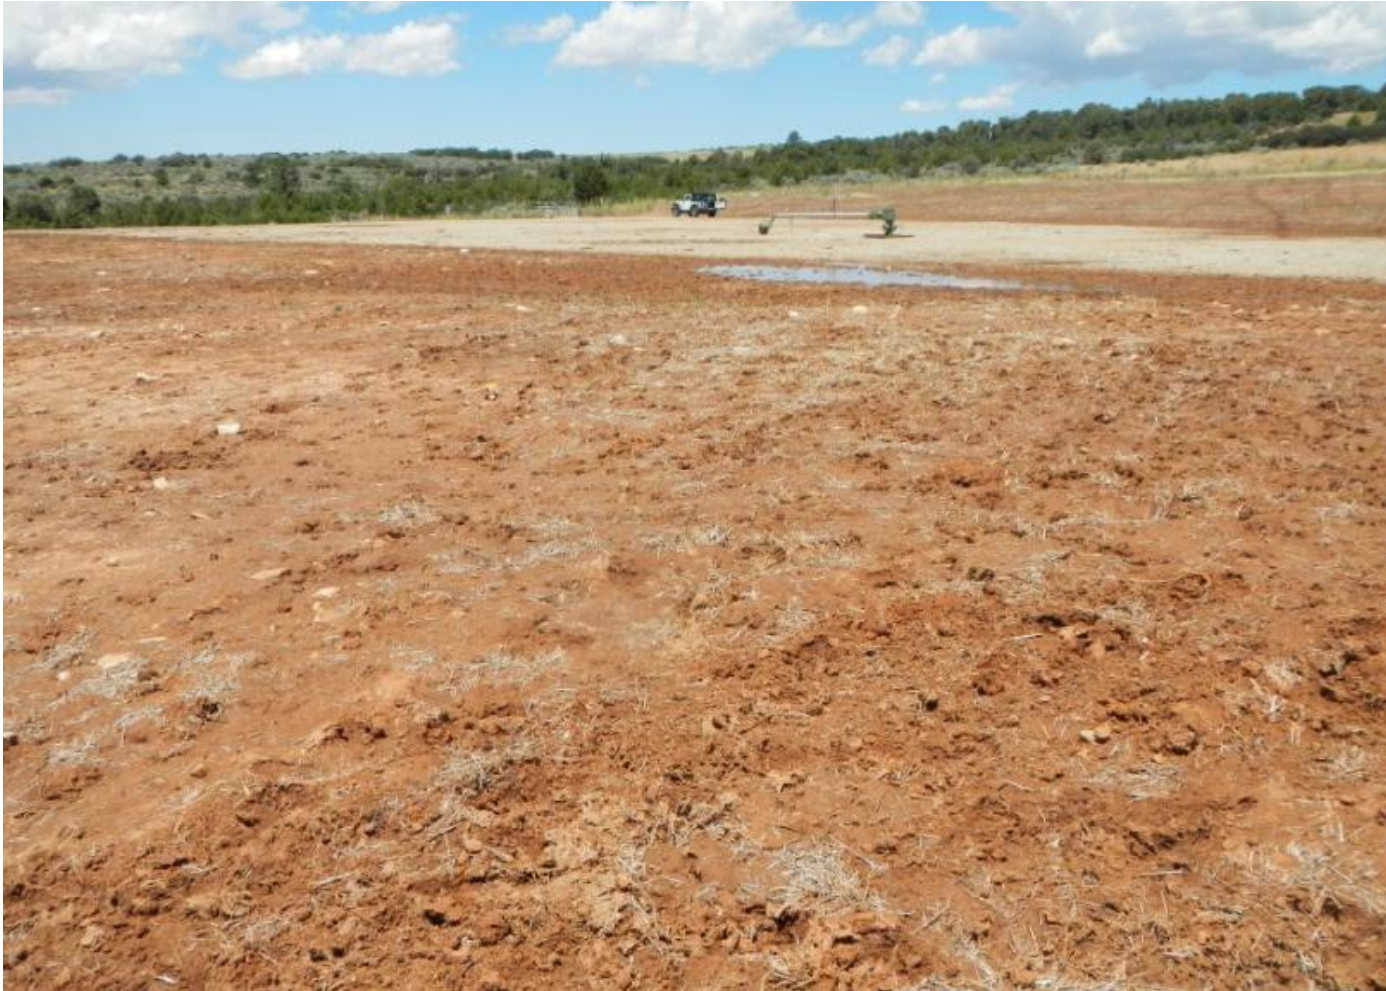
Photo 2. View from southeastern portion of project area facing center. Little vegetation is established here.

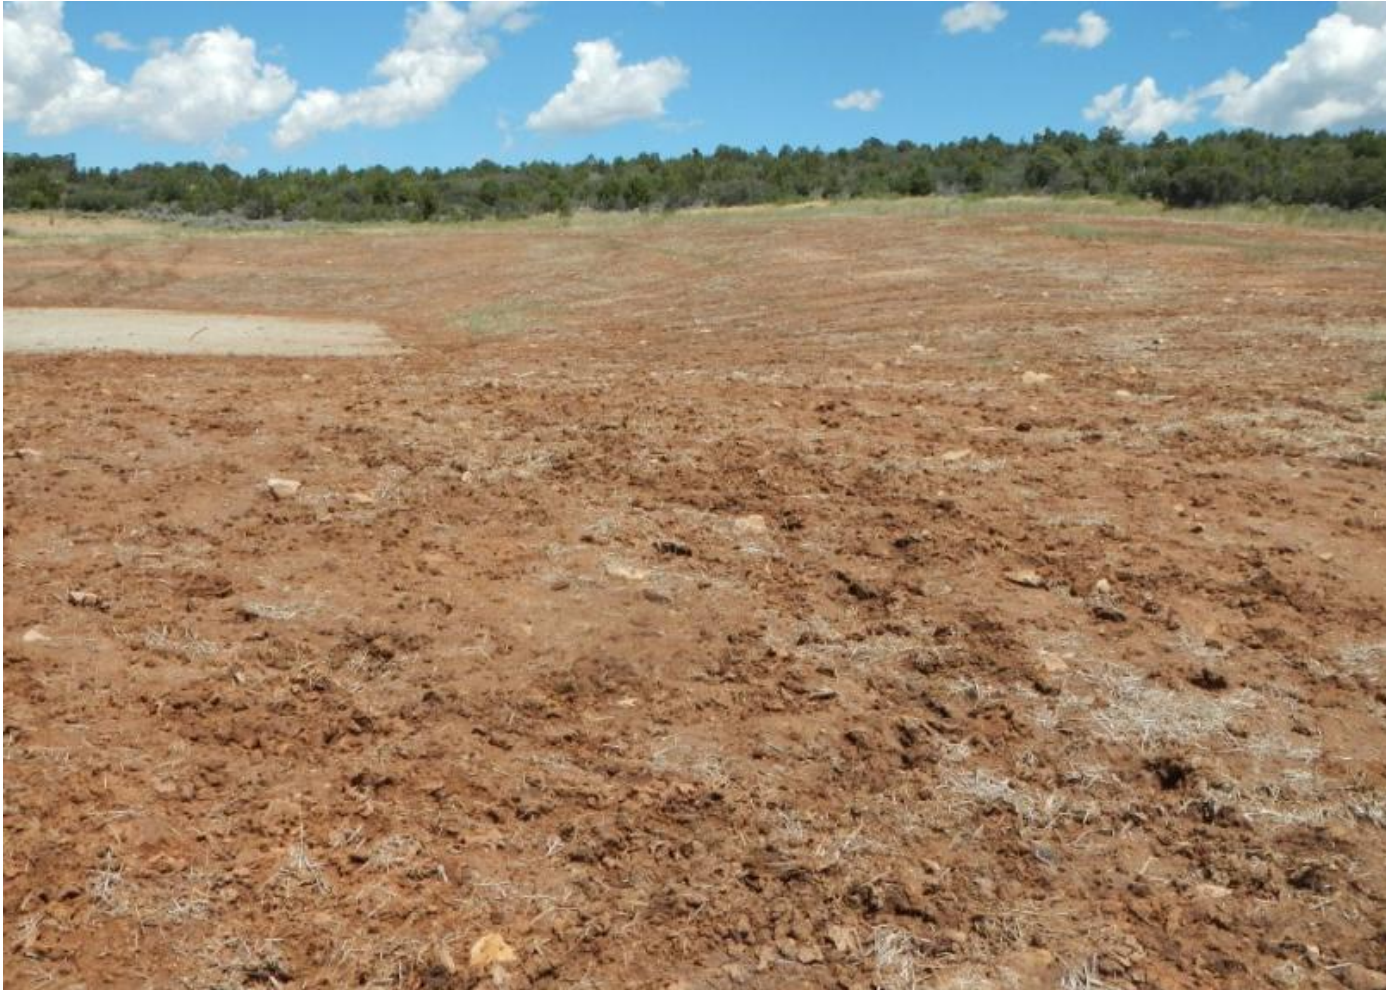
Photo 3. View of eastern portion of project area from southeast facing northward. Little vegetation is established here.

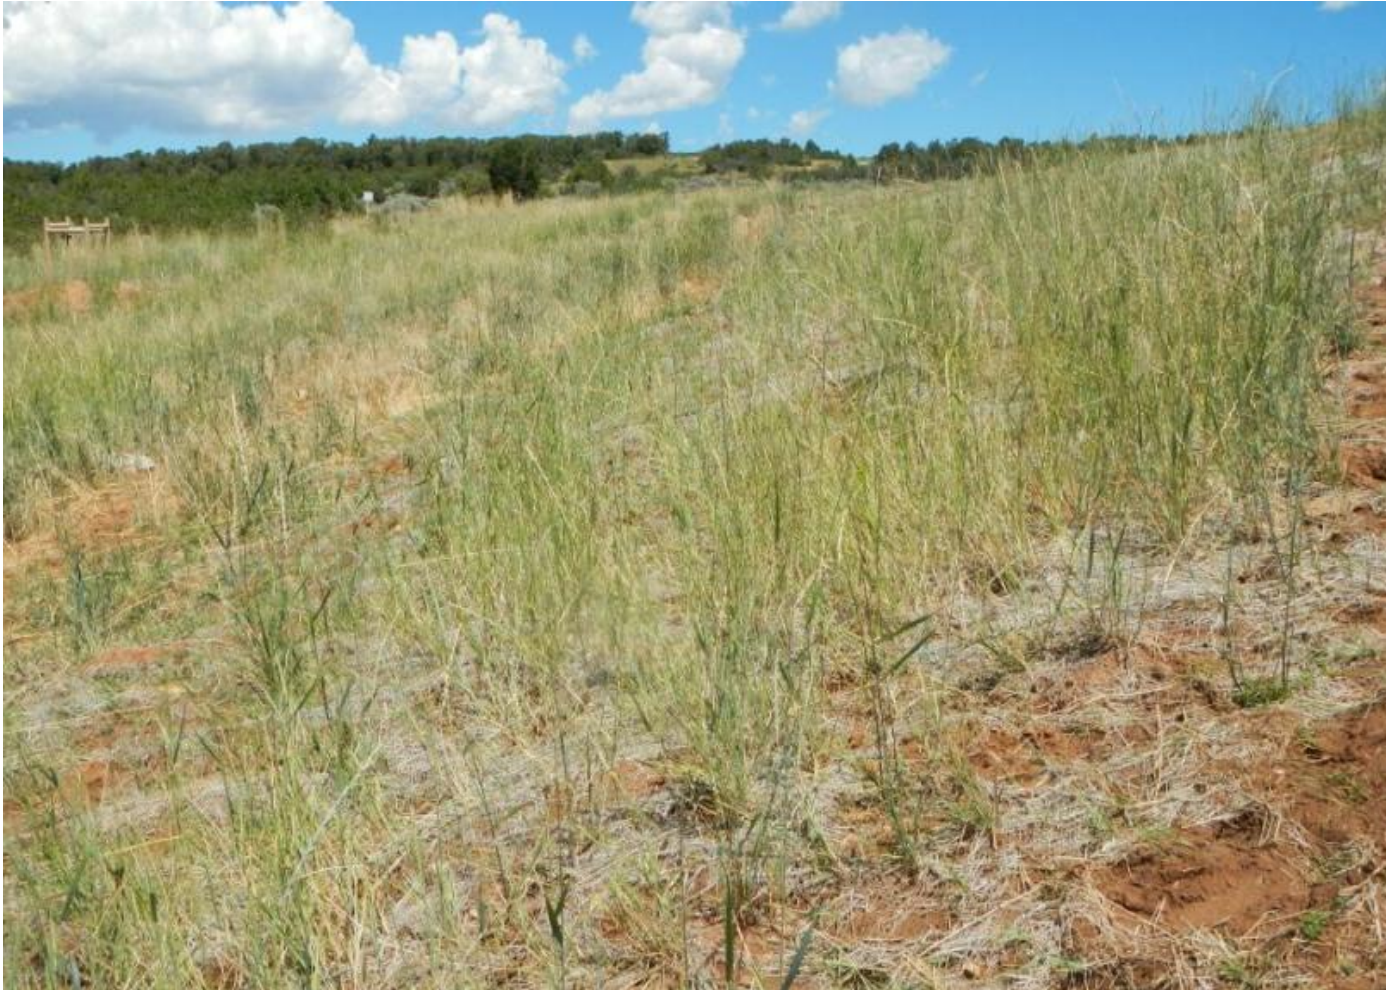
Photo 4. View of western portion of project area from southwestern corner facing northward. Good revegetation along this slope.
