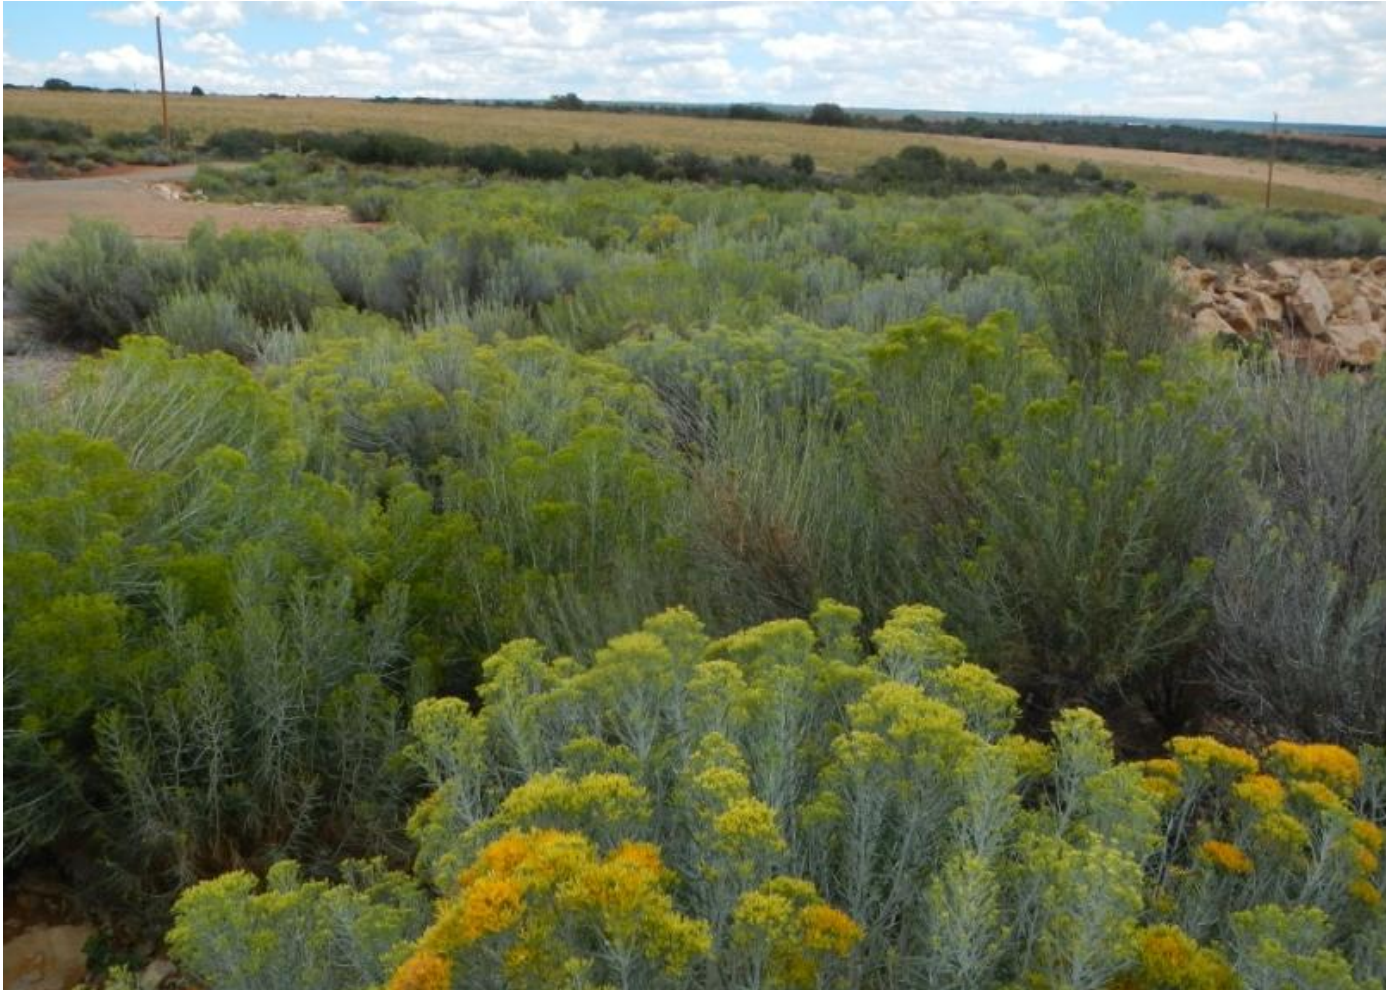
Photo 1. View of southern portion of project area from southwestern corner facing eastward. Vegetation is largely comprised of rubber rabbitbrush (*Ericameria nauseosa*).

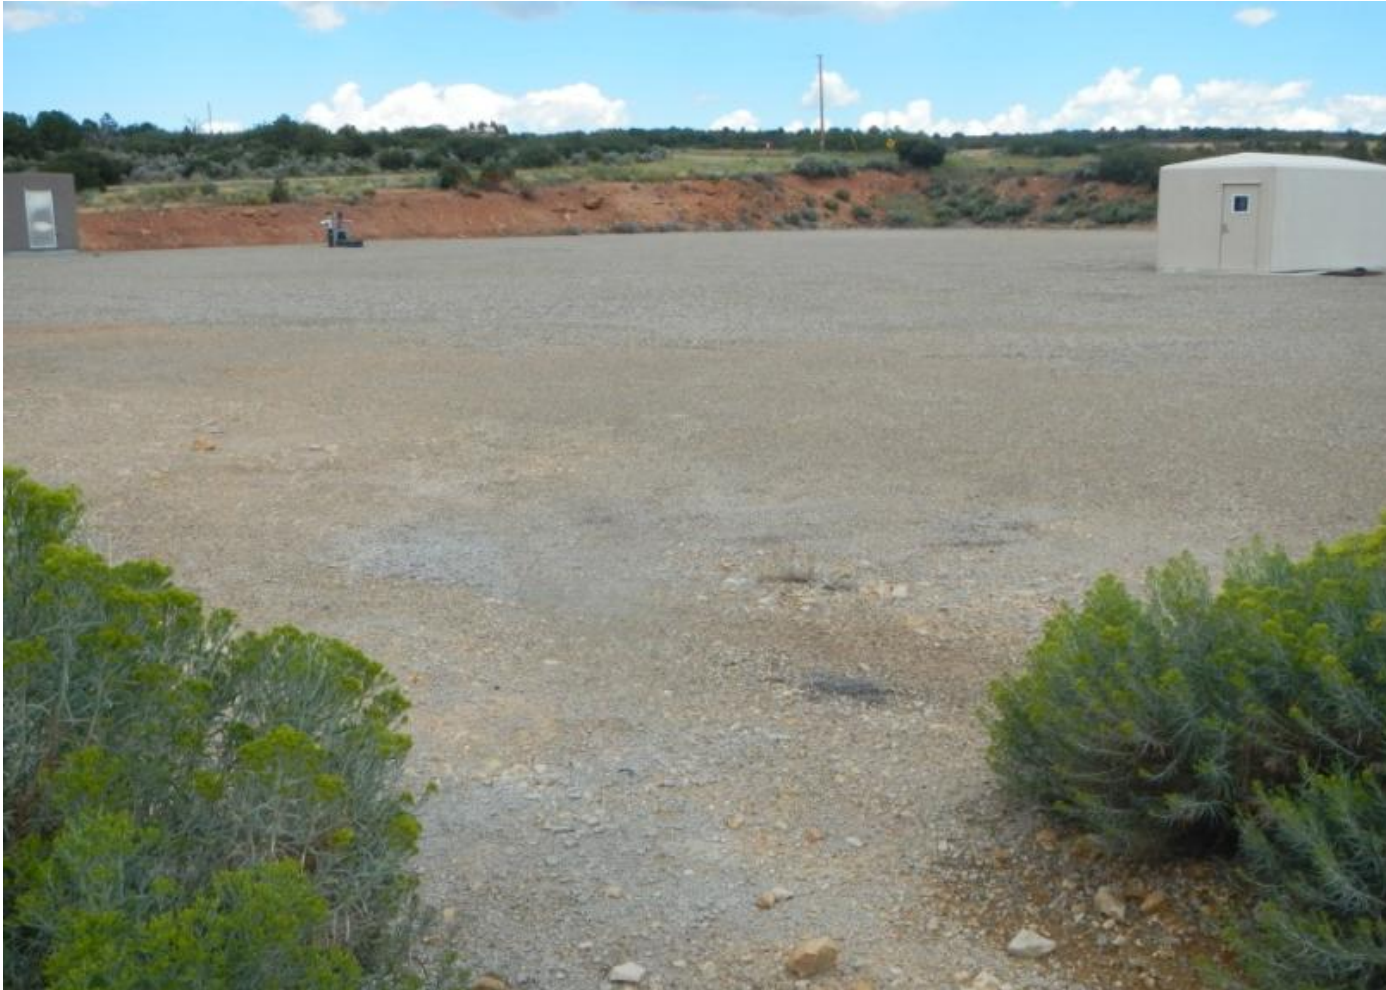
Photo 2. View from southwestern corner of well pad facing center.

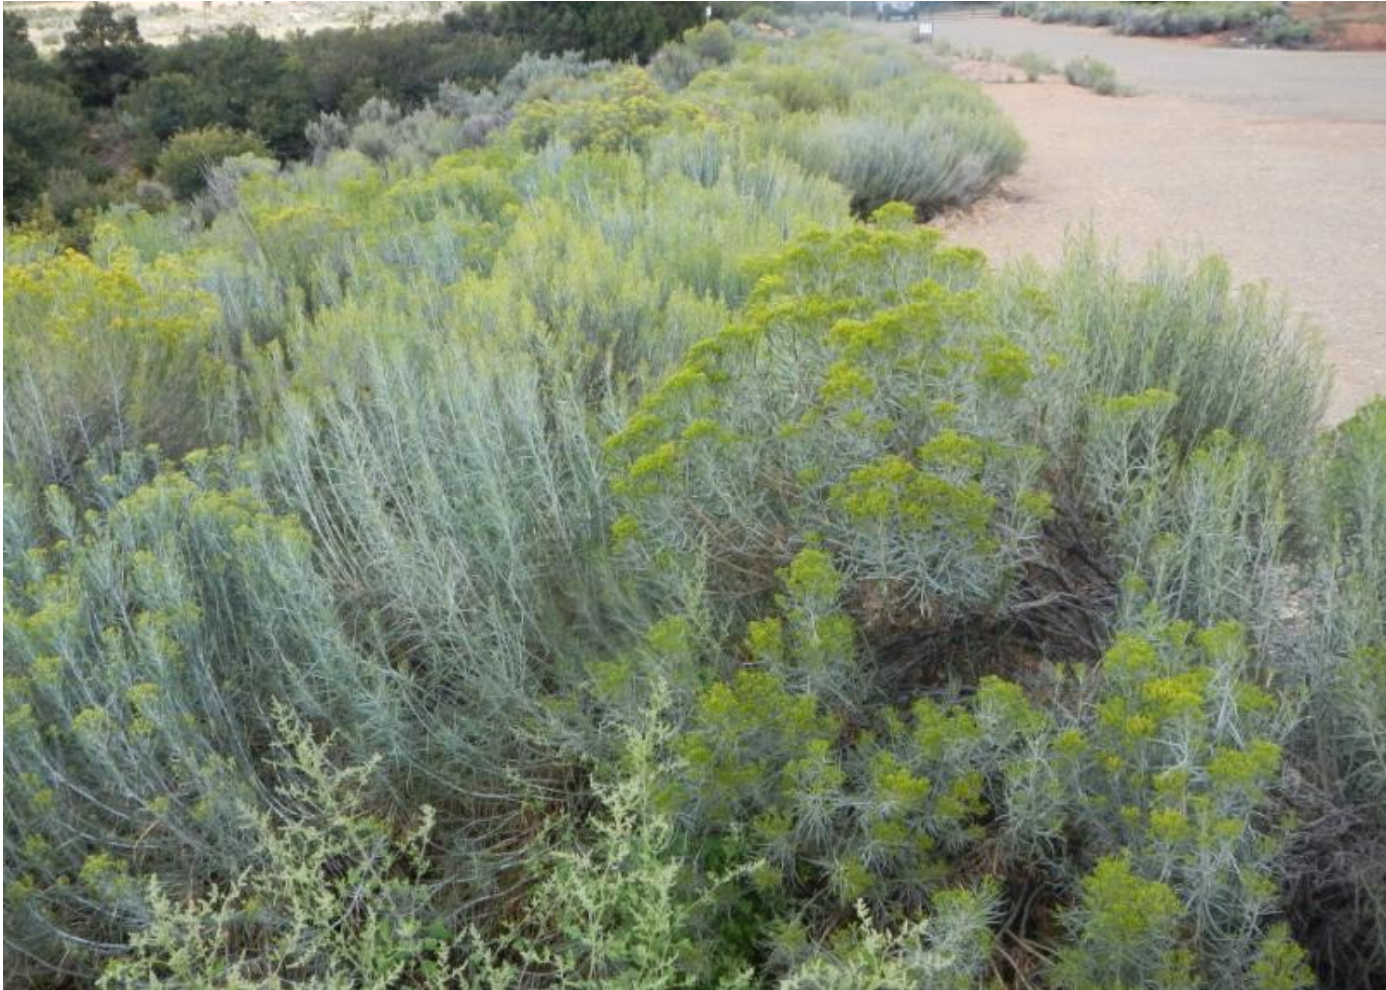
Photo 3. View of western portion of project area from southwestern corner facing northward.

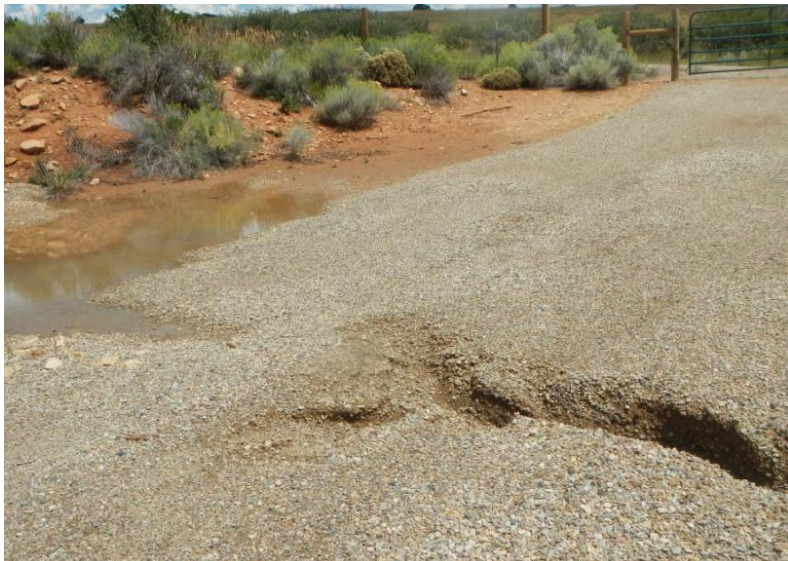
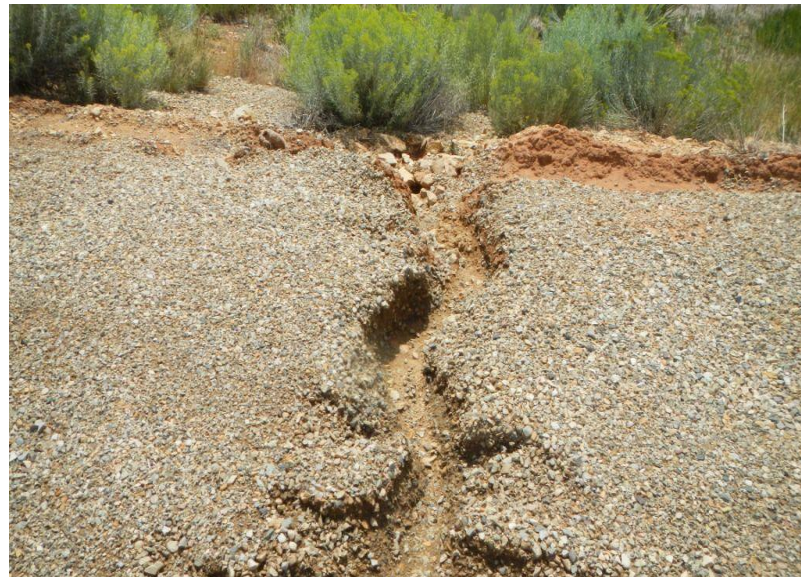
Photo 4. View of erosional feature forming within eastern portion of well pad.
