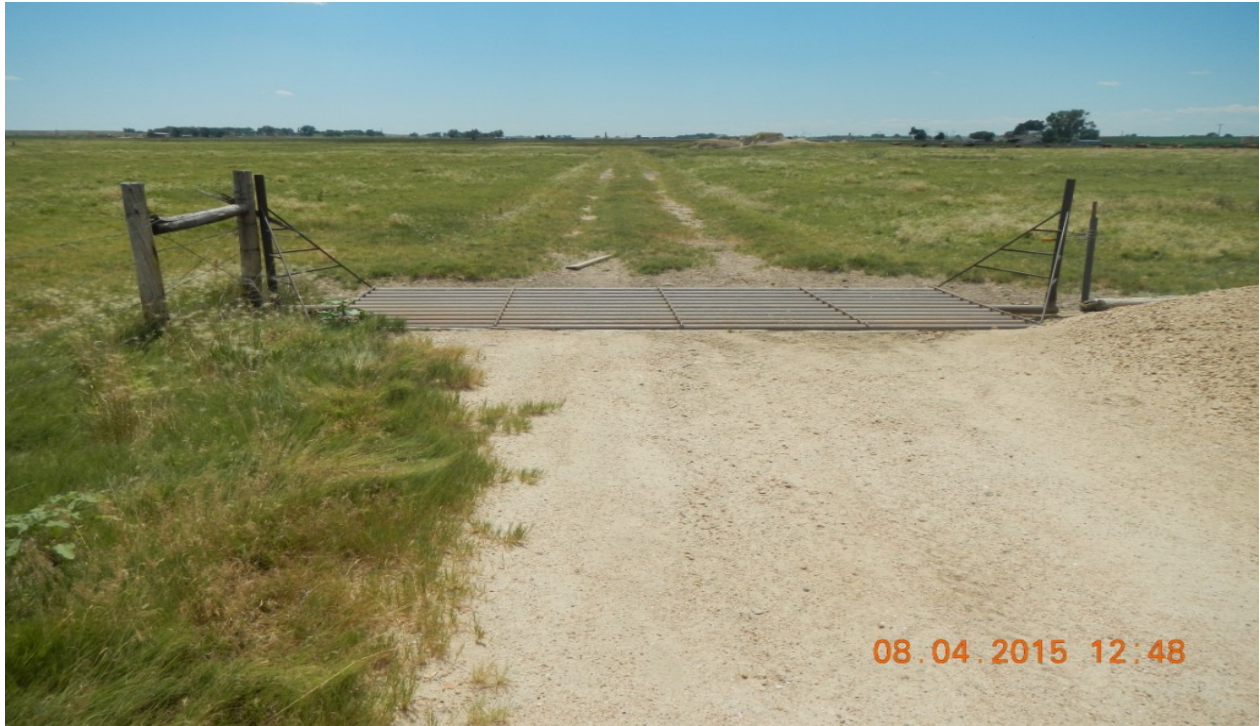
photo 1: Facing south towards the location. Cattle guard has not been removed.

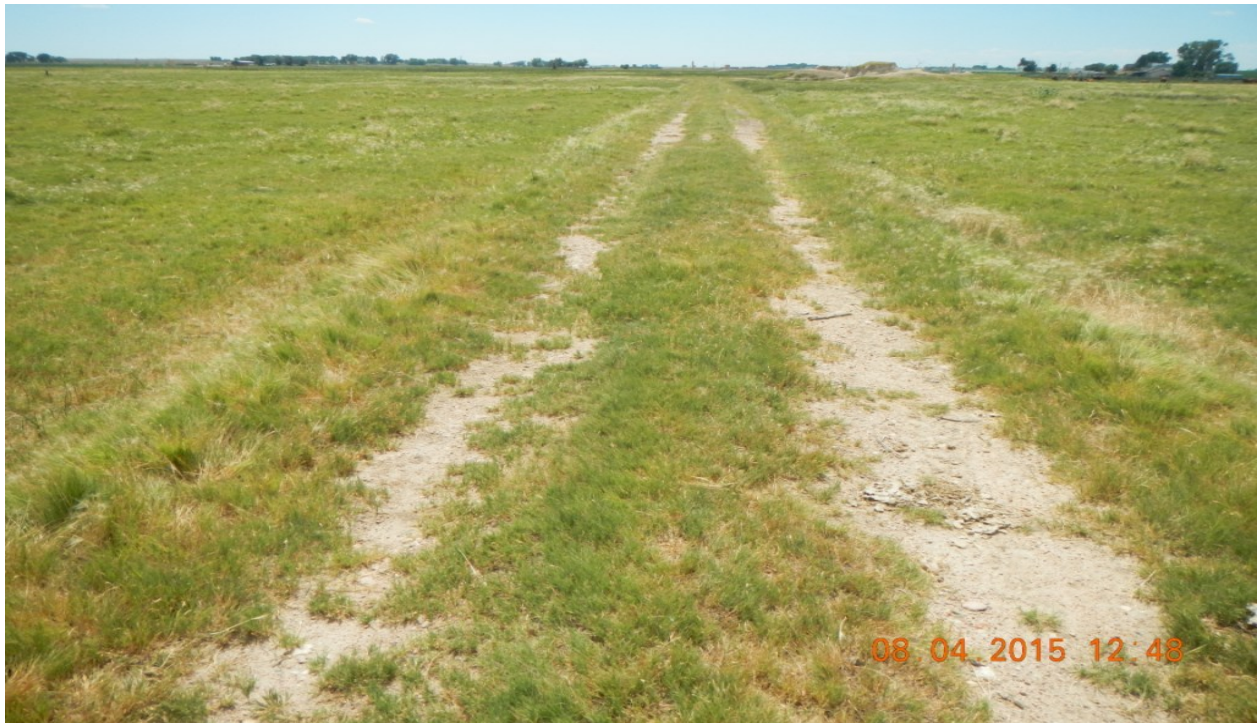
photo 2: Facing south towards the location. Access road has not been recontored and reclaimed.

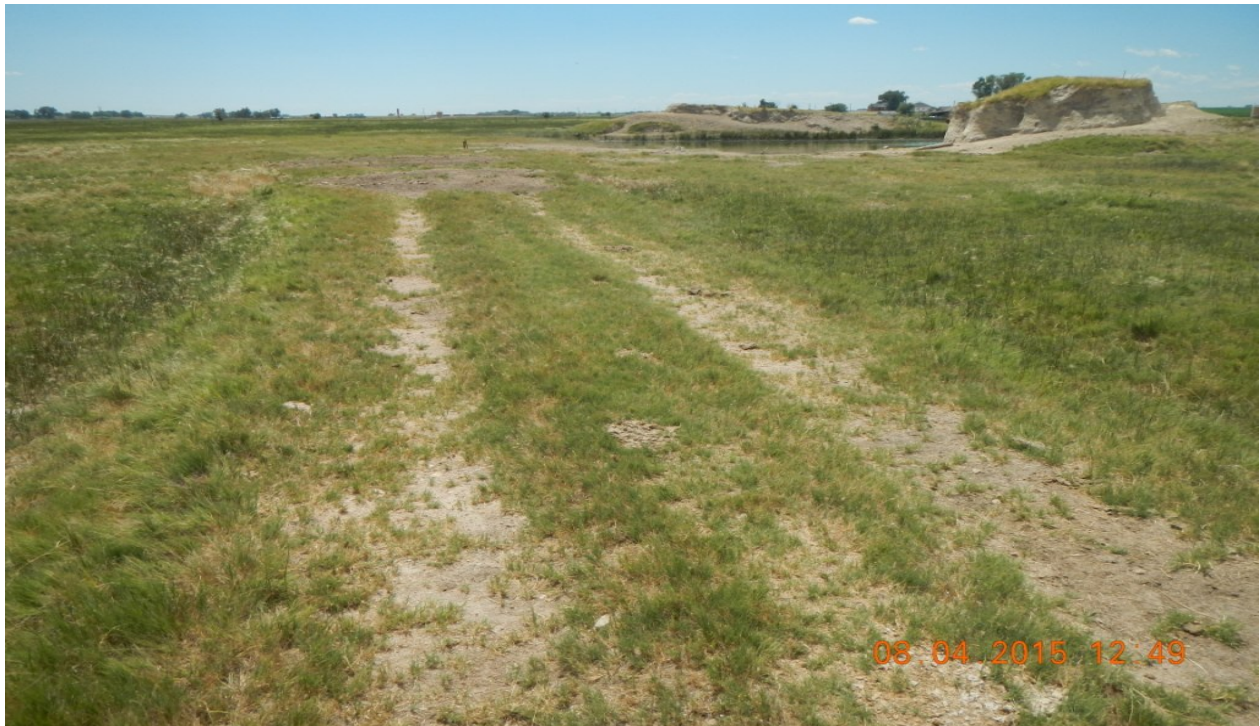
photo 3 : Facing south towards the location along the access road.

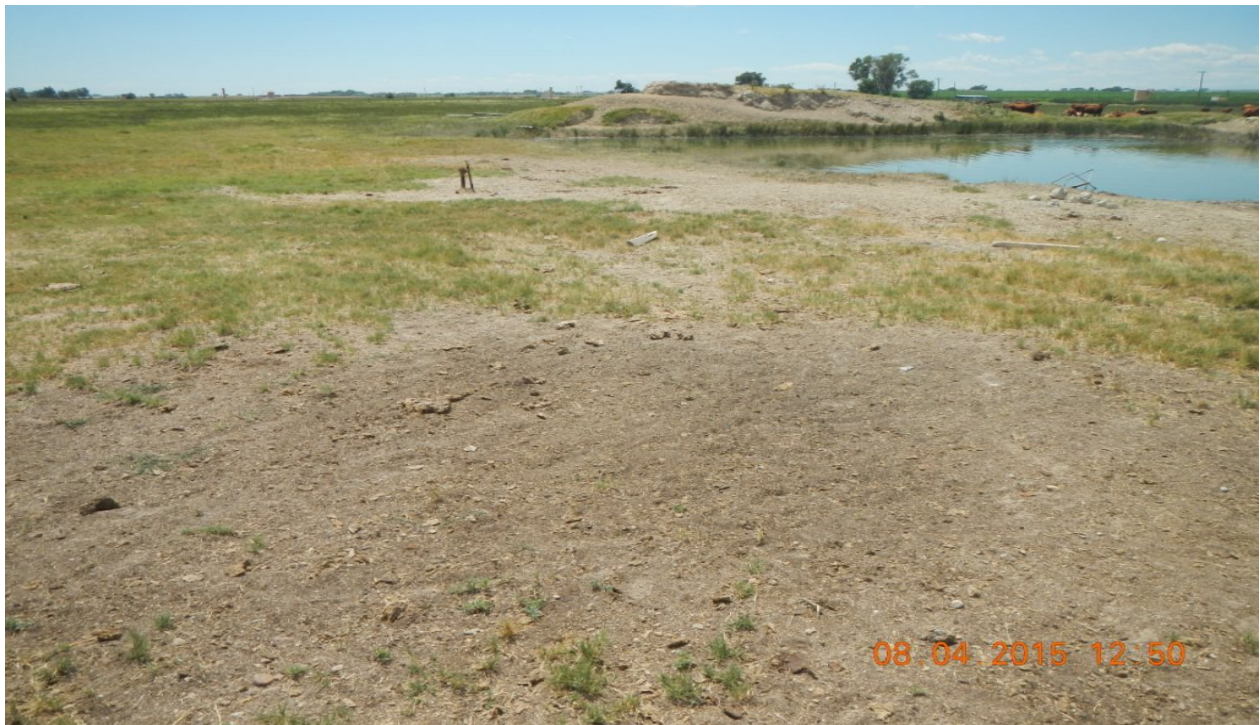
photo 4 : Facing south towards the location.

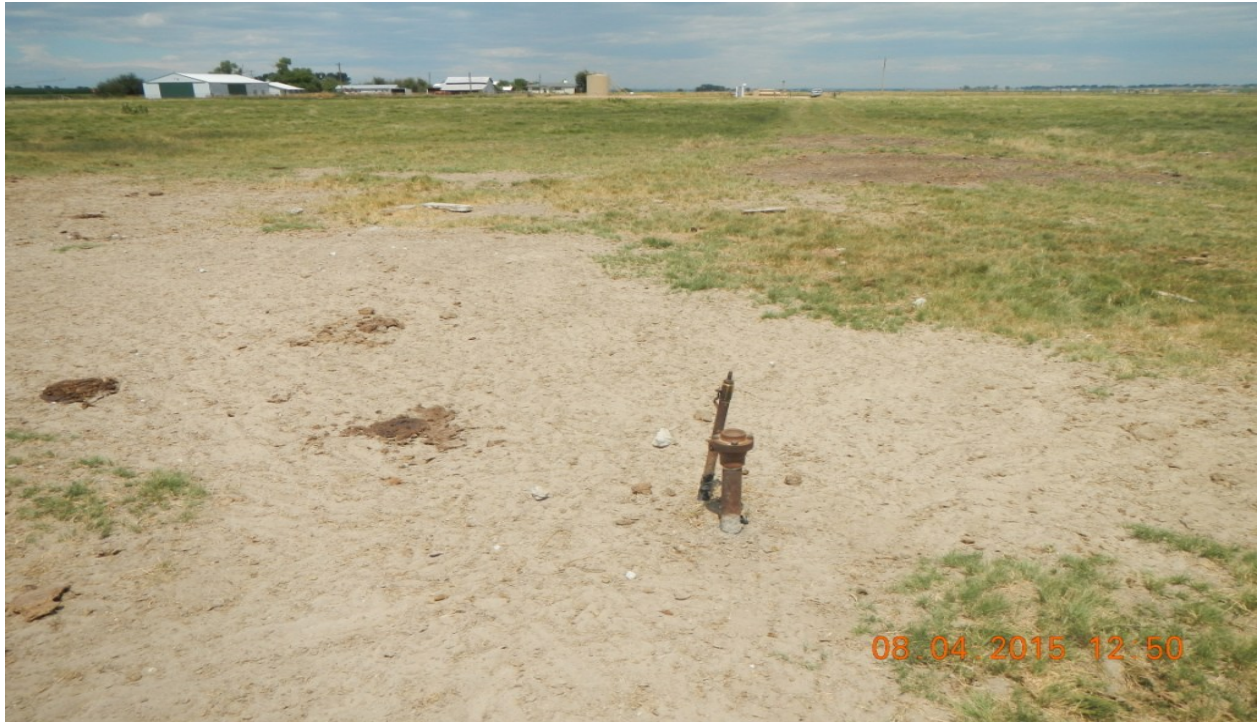
photo 5: Center of the location facing north.

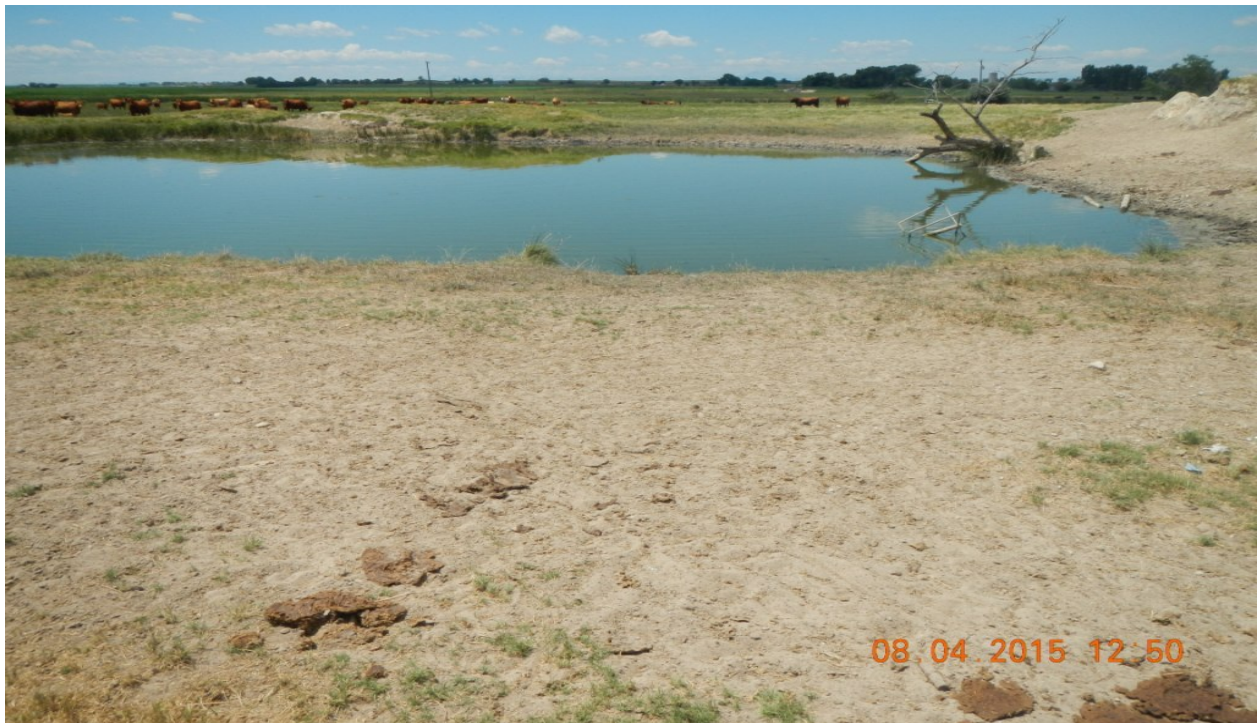
photo 6: Center of the location facing west.

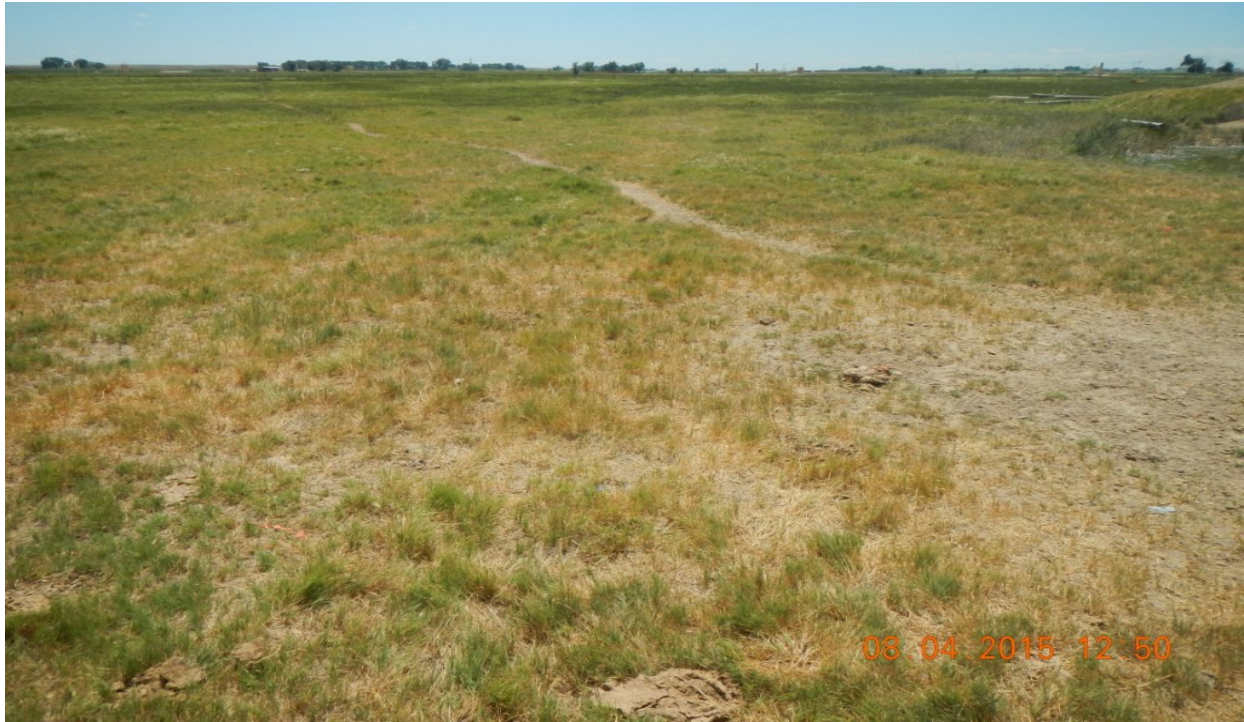
photo 7: Center of the location facing south.

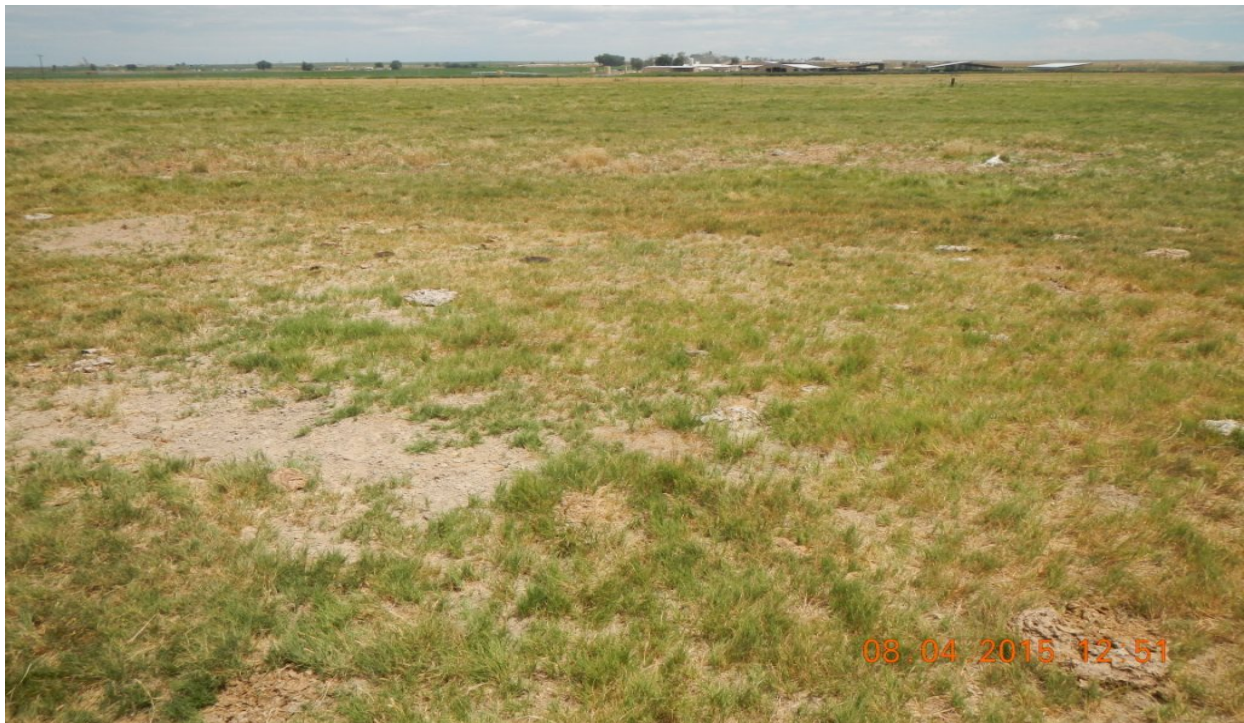
photo 8: Center of the location facing east.

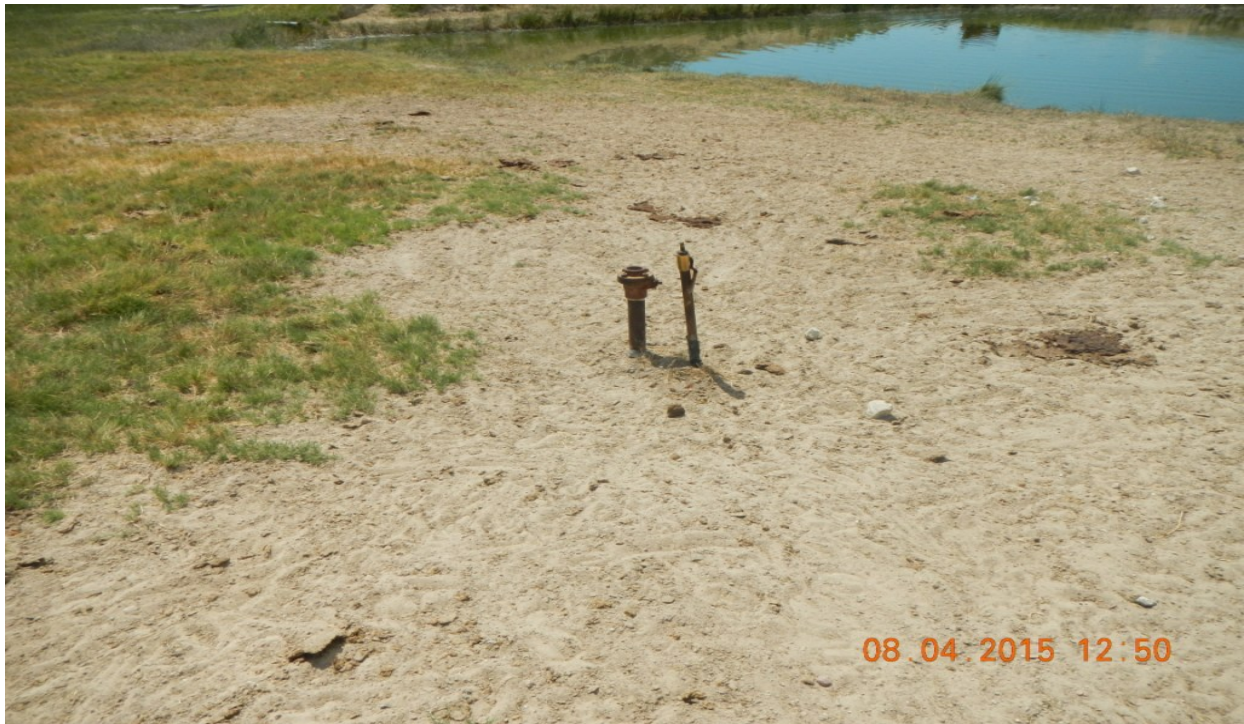
photo 9: Pipe riser found at center of the location. Lat:40.288/Long:-104.637

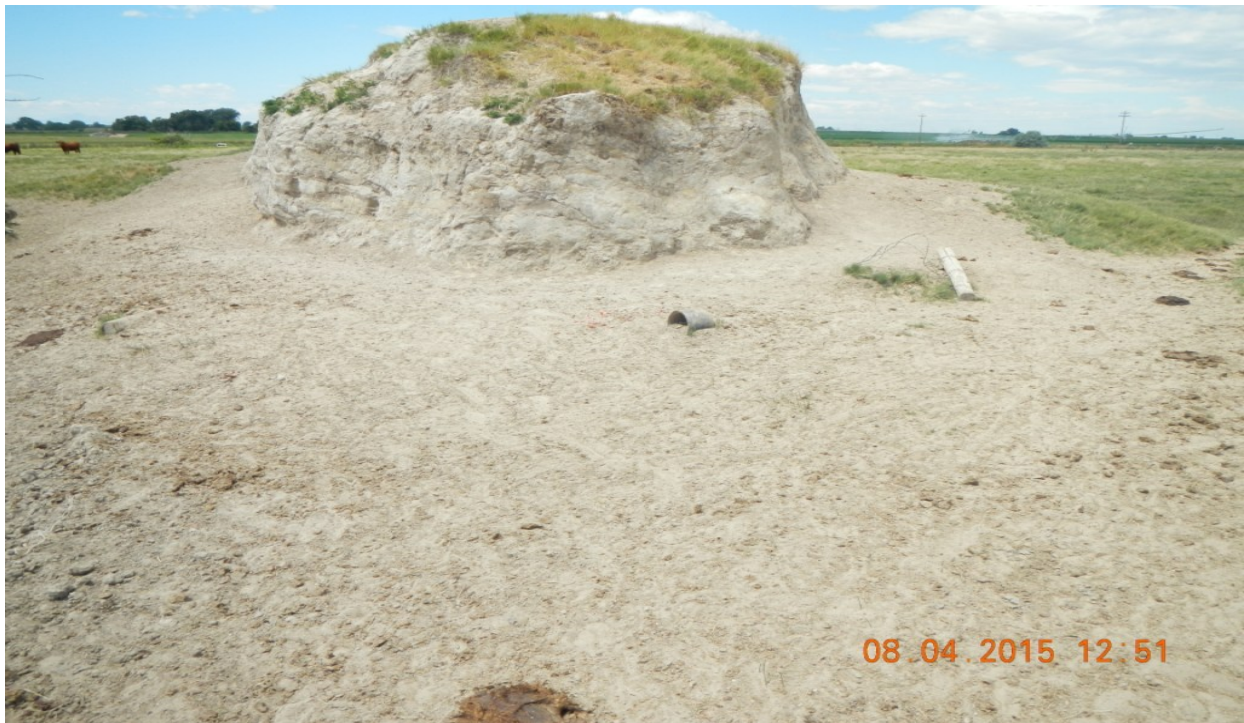
photo 10: Dirt mound has not been recontoured and is susceptible to erosion. Debris found along the base of pile.

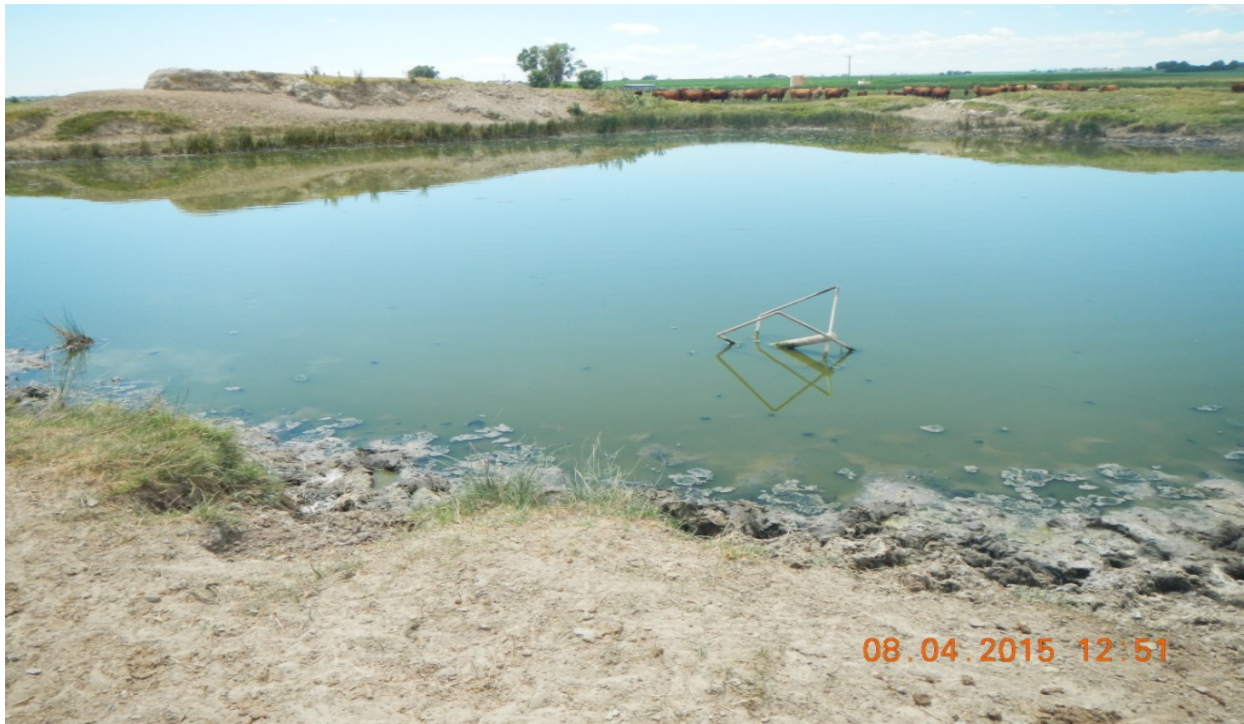
photo 11: Pond at the west side of the location. Metal equipment can be seen extending out of the water.

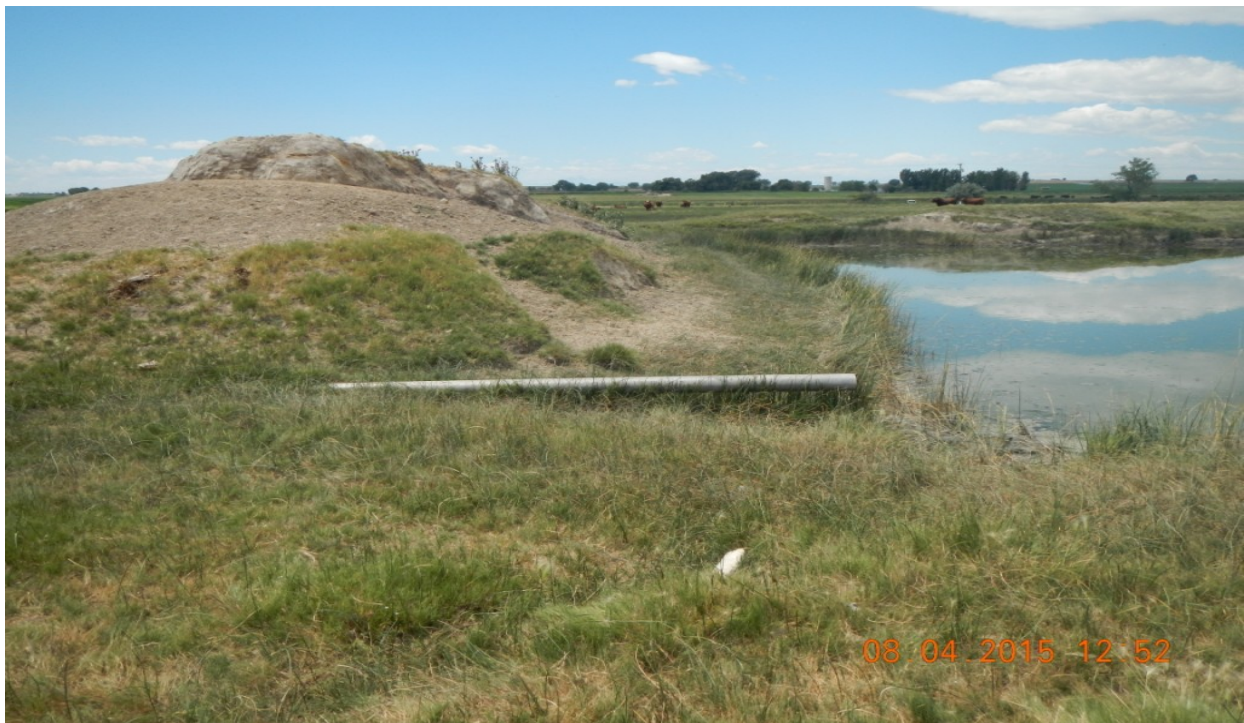
photo 12: Pipe extends between the pond and the pit at the southeast side of the location.

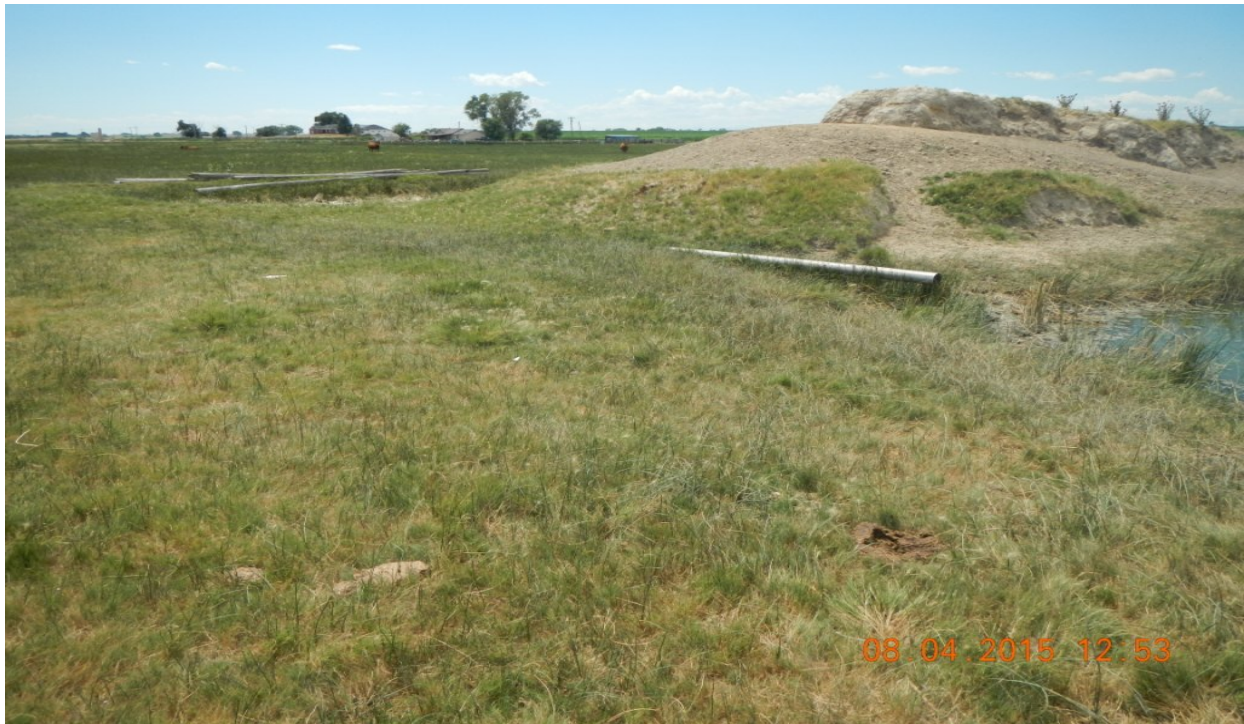
photo 13: Facing southwest towards the pipe and mound of dirt between the two pits.

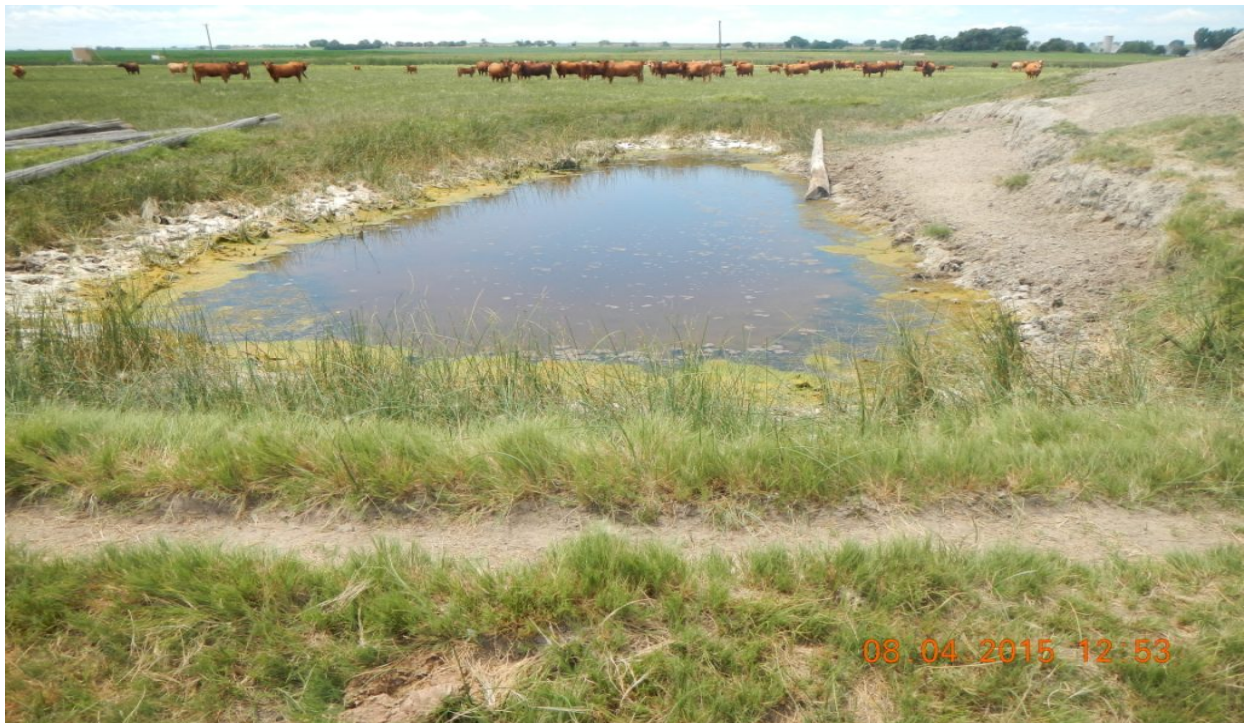
photo 14: Pit at the southwest side of the location.

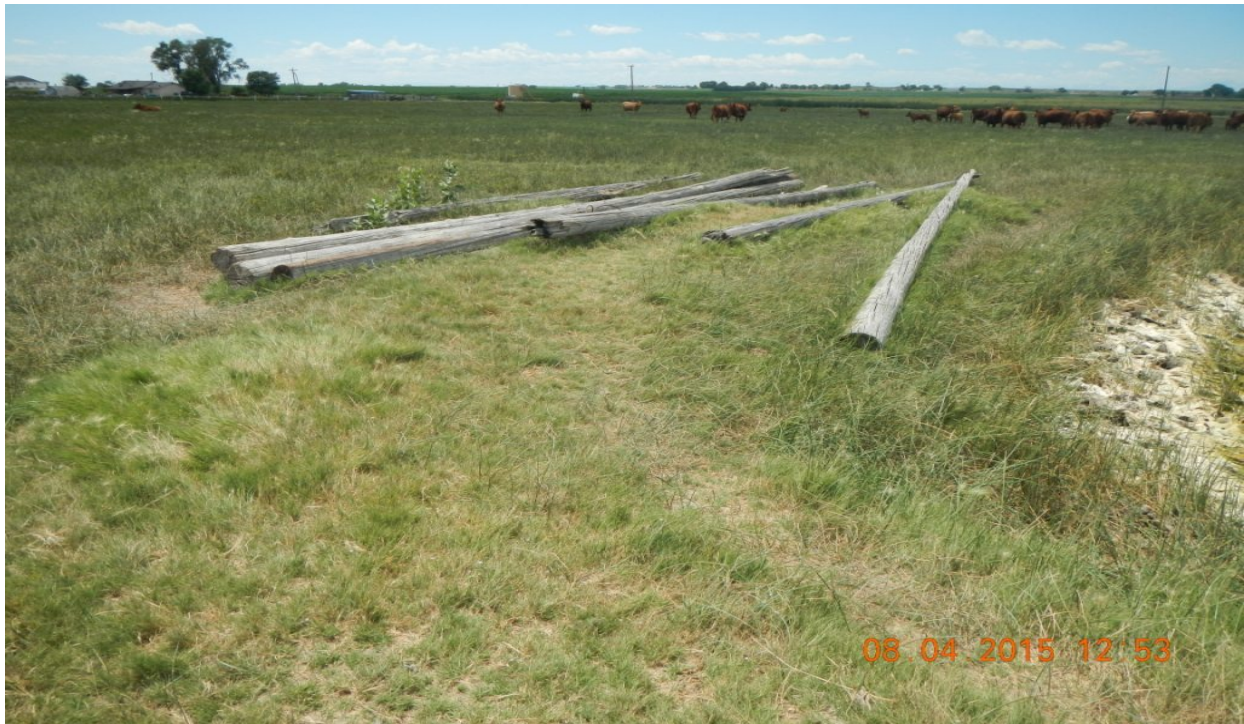
photo 15: Wooden poles remain at the southwest side of the location.

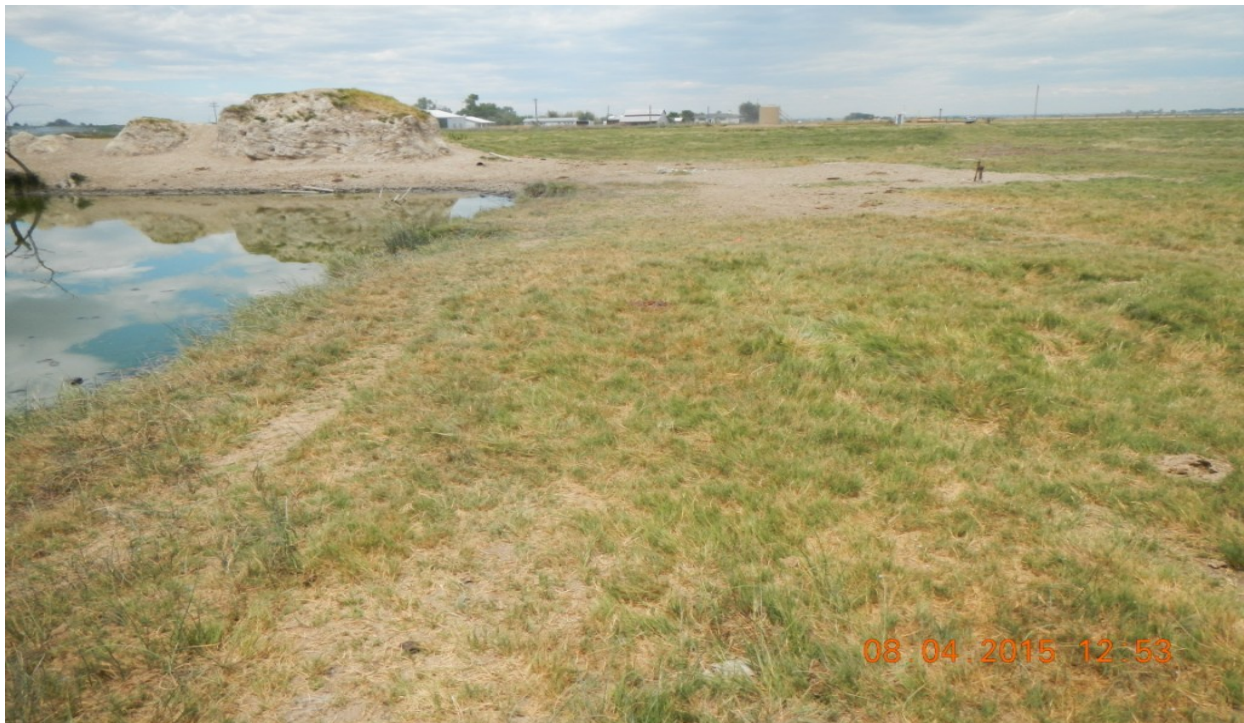
photo 16: Facing north between the two pits.
