34-10 #28-2 Pipeline Spill August 8, 2015

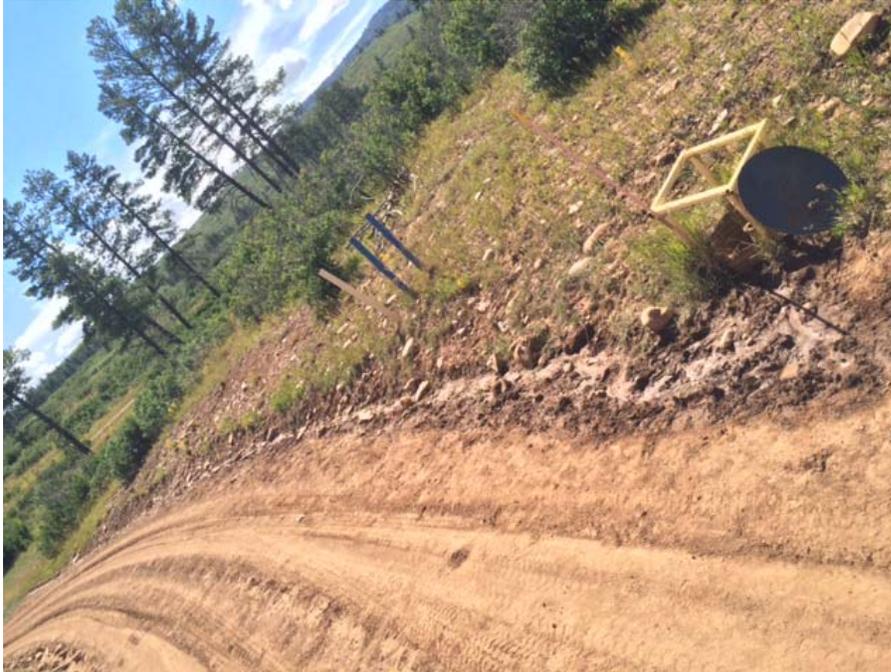
Figure 1. 34-10 #28-2 pipeline spill path. The entire spill path is in the photograph.

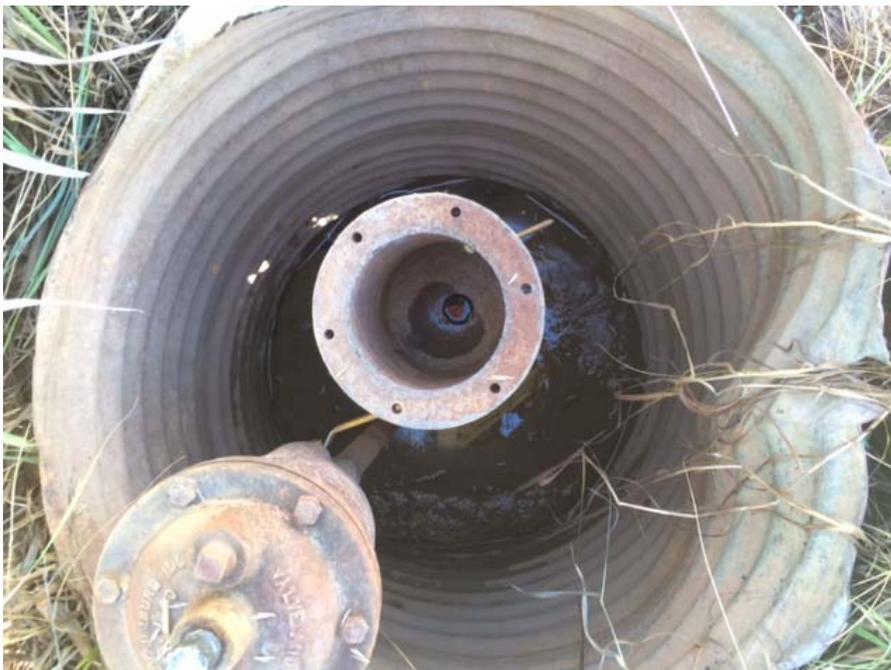
Figure 2. Valve can with the gas eliminator that failed causing 6 bbls to leak into the borrow ditch.

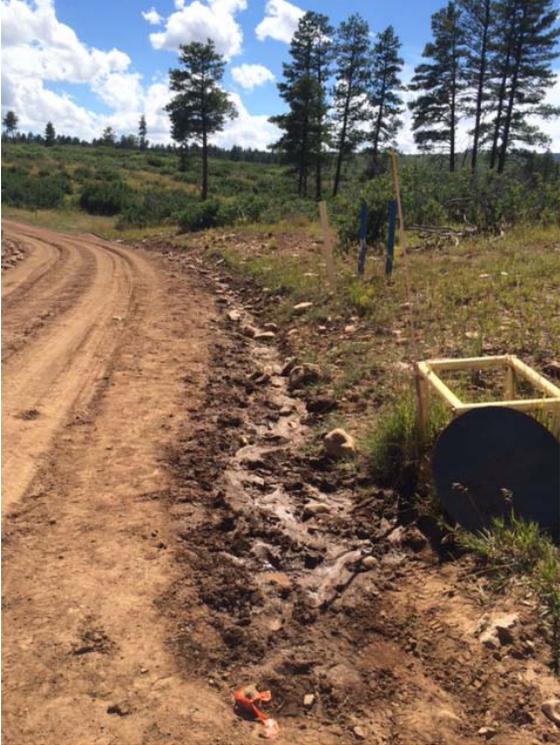
Figure 3. Standing at the spill origin looking down the spill path. The yellow barrier is protecting the valve can.

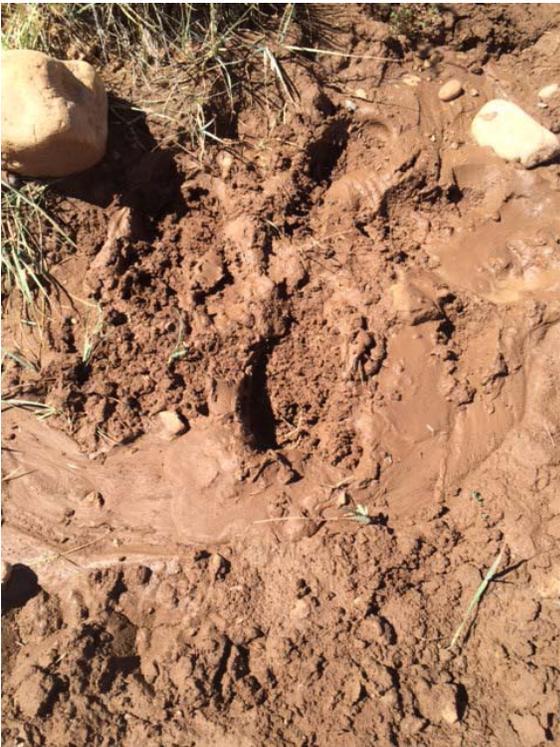
Figure 4. Spill origin sample adjacent to the valve can.

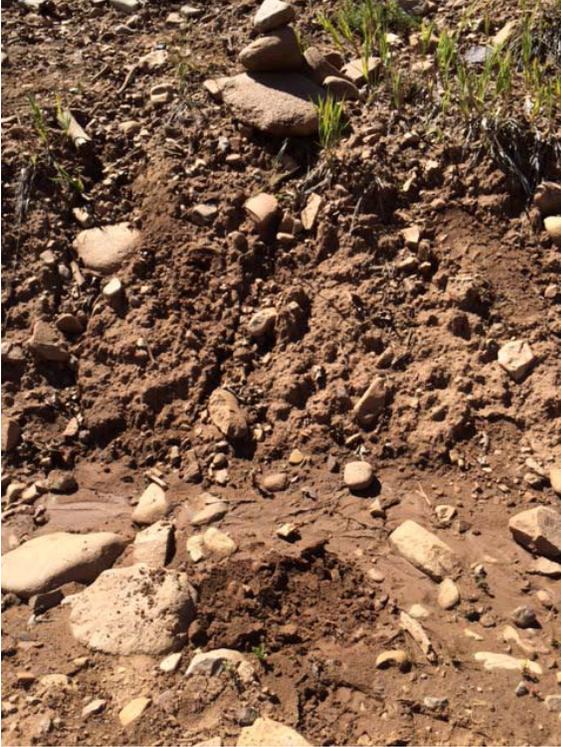
Figure 5. Spill mid sample point.

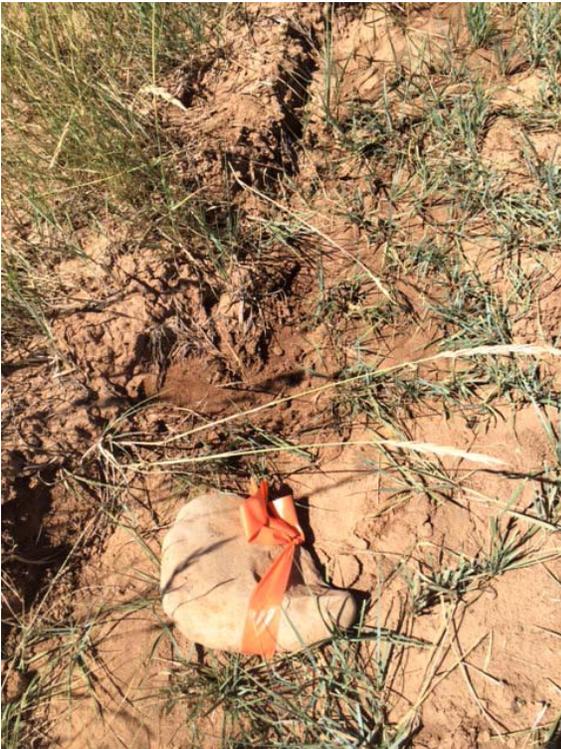
Figure 6. Spill terminus sample point.
