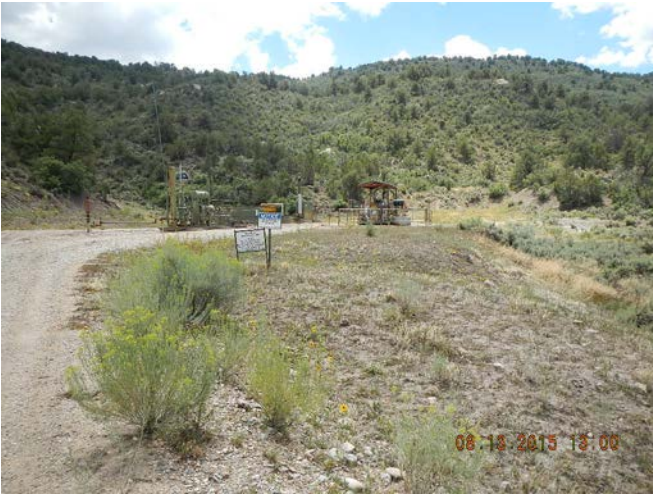
OVERVIEW OF WELL PAD AND EQUIPMENT
LOOKING SOUTH

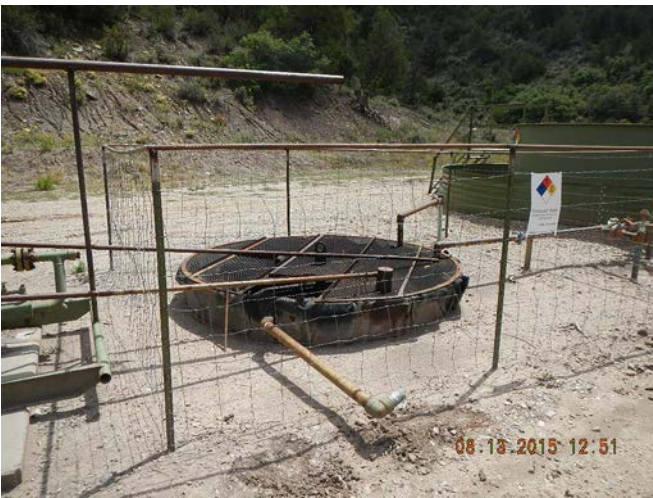
UN-BERMED 30 BBLs OPEN TOP PRODUCED
WATER TANK

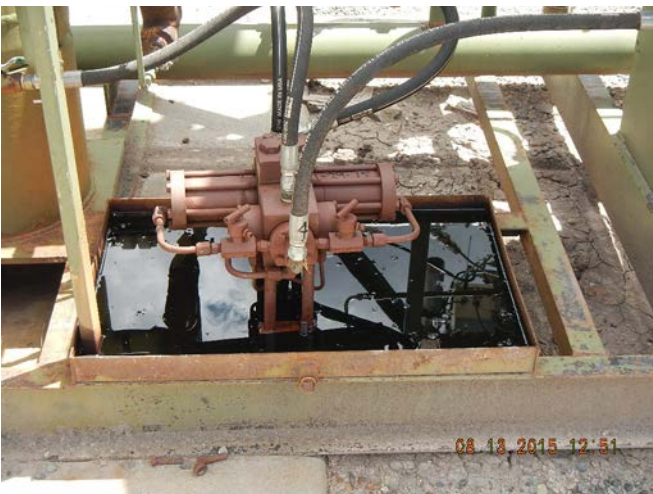
OPEN GLYCOL ACCUMULATION UNDER
PUMP AT DEHYDRATOR

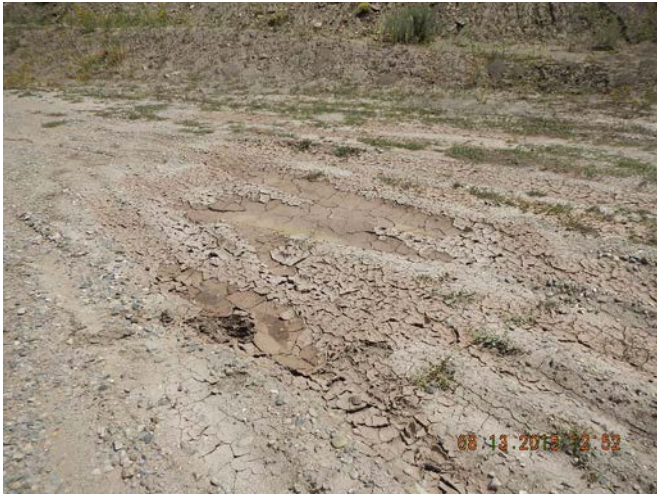
VEHICLE RUTTING ON SOUTH SIDE OF WELL PAD

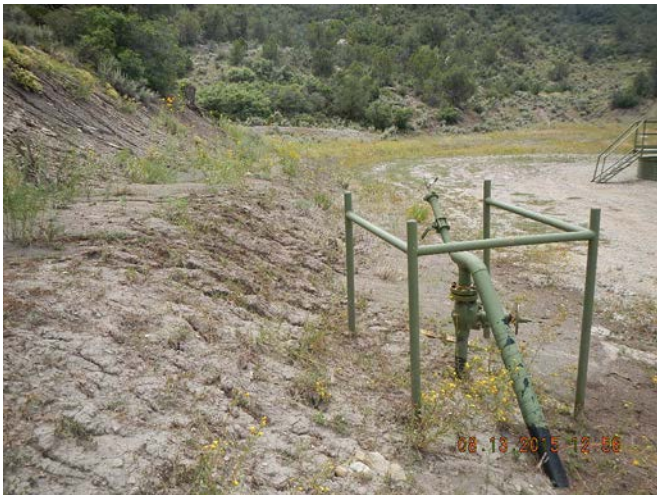
RUN ON CONTROL BERM ON EAST SIDE WELL PAD FULL OF SEDIMENT; CUT SLOPE EROSION FORMING UNDER UNMAINTAINED BMP.

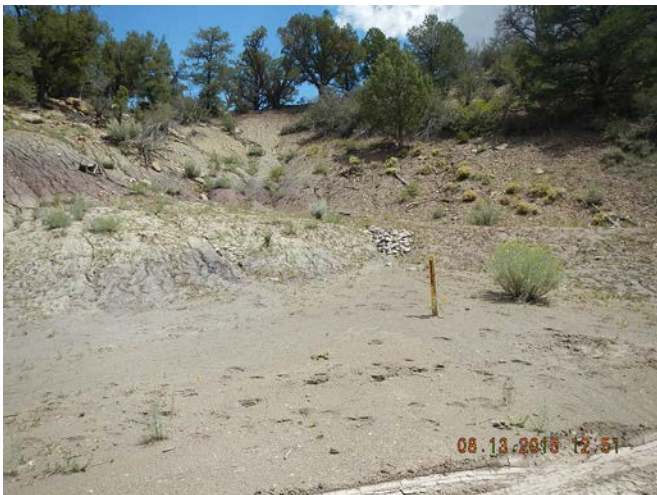
SEDIMENT MIGRATION ON TO LOCATION AT NE CORNER WELL PAD; BMPS UNMAINTAINED.

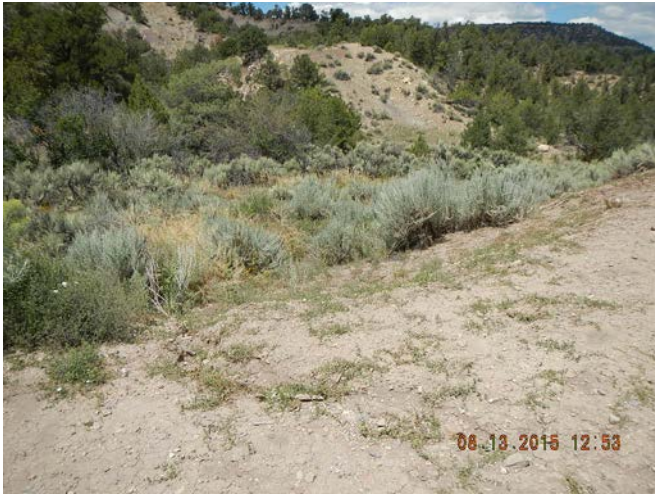
STORMWATER RUN OFF AND EROSION
FORMING ON WEST SIDE WELL PAD; ALONG
FILL SLOPE ADJACENT TO COMPRESSOR.
