Grassy Creek Coal Co 1

Inspection# 673402355

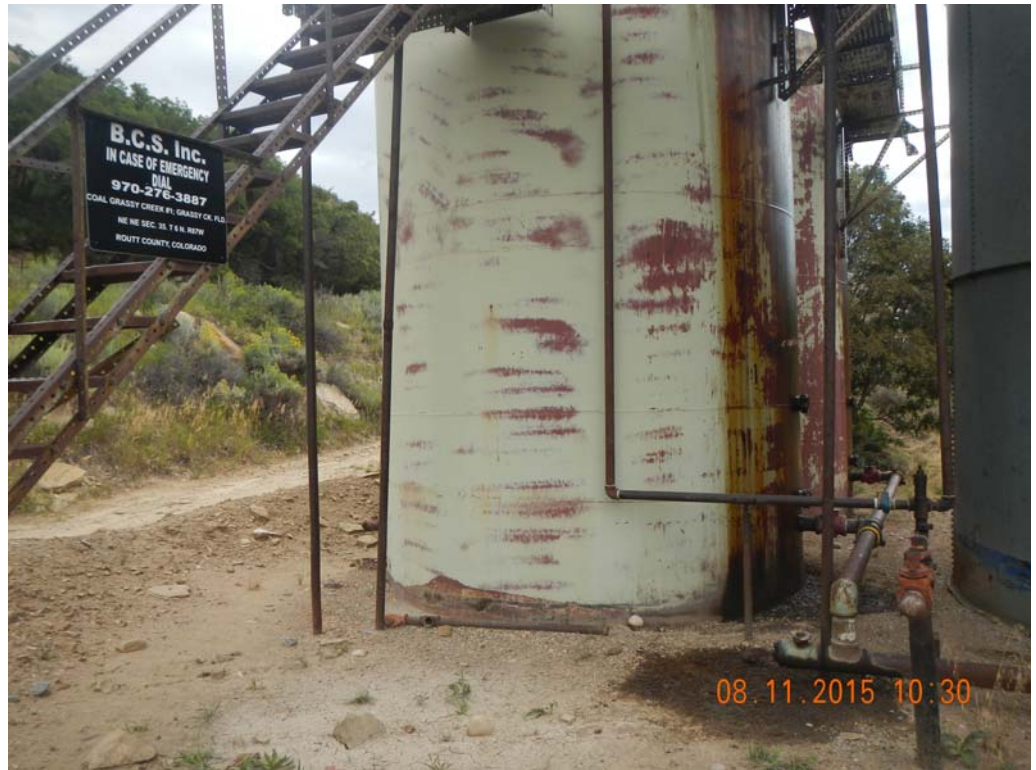
Stained soil at tank base.

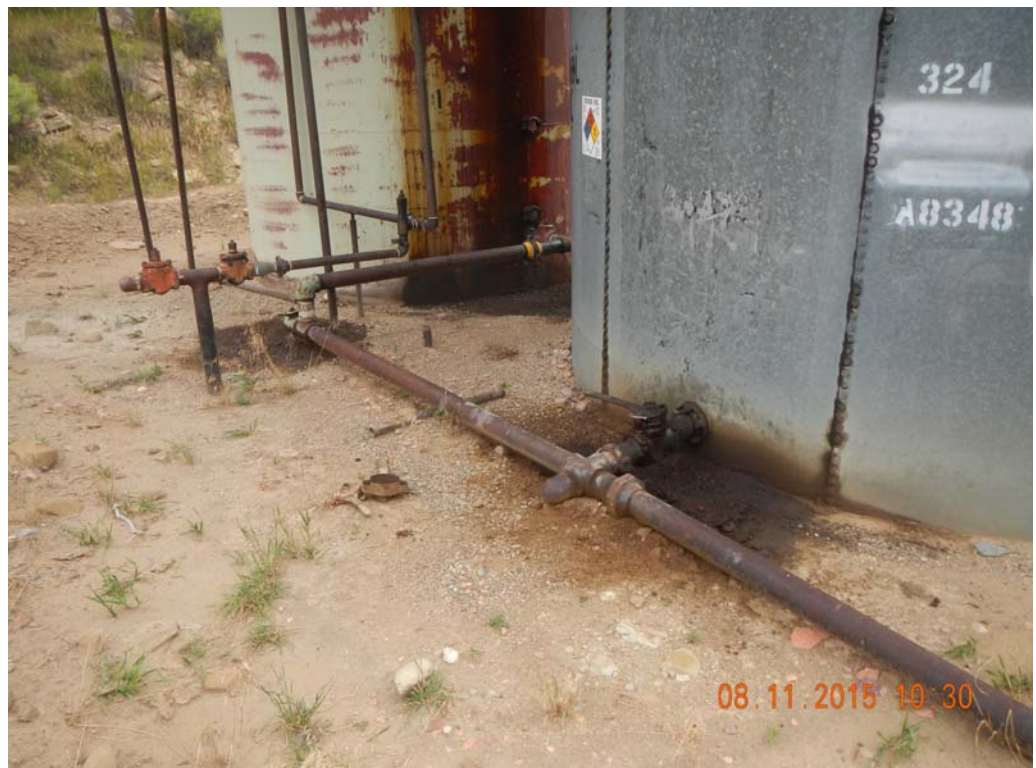
Stained soil at tank base.

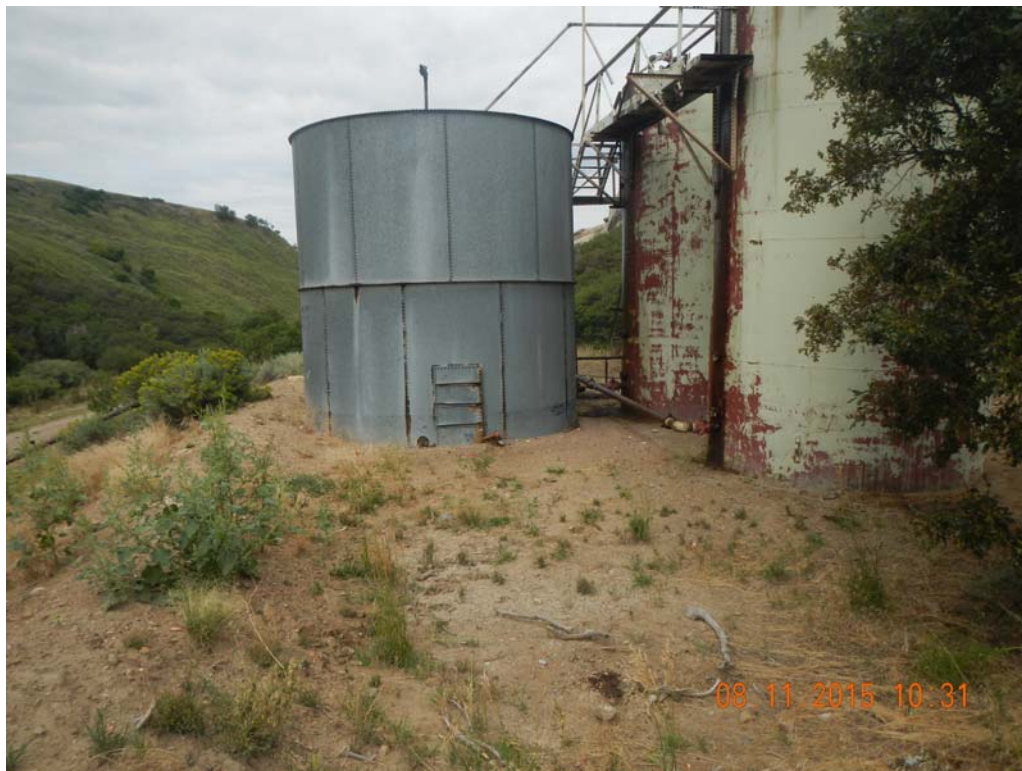
Tree growing in berm. Low
berm on left with vegetation.
Stained soil at tank bases.

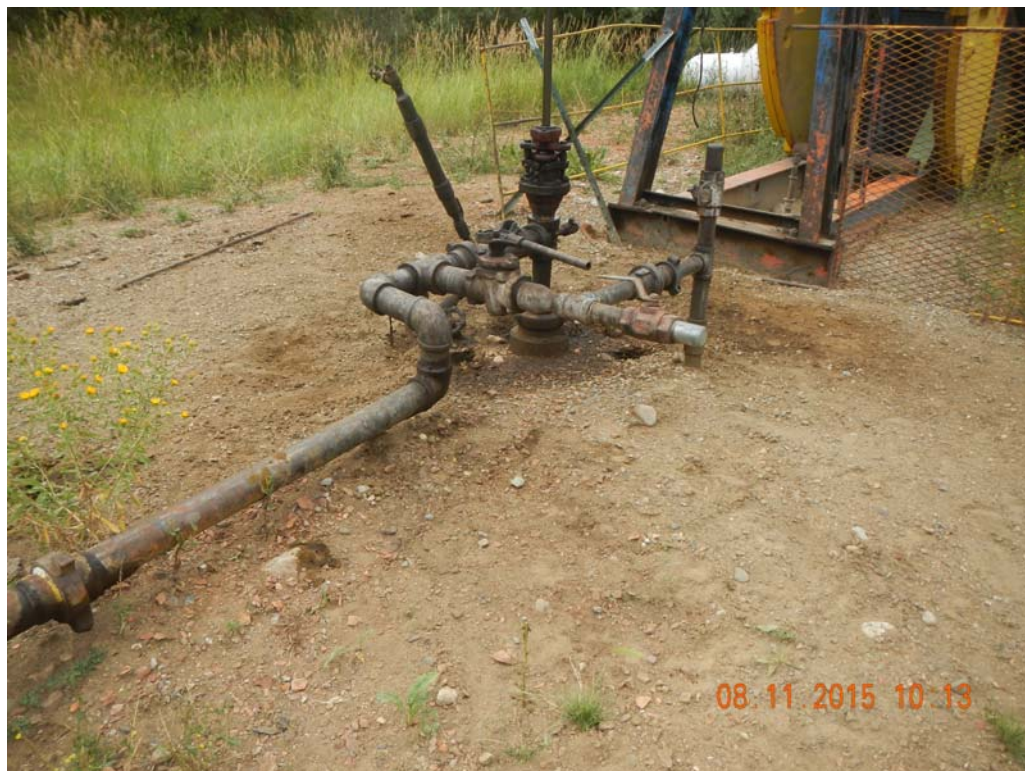
Stained soil at wellhead.

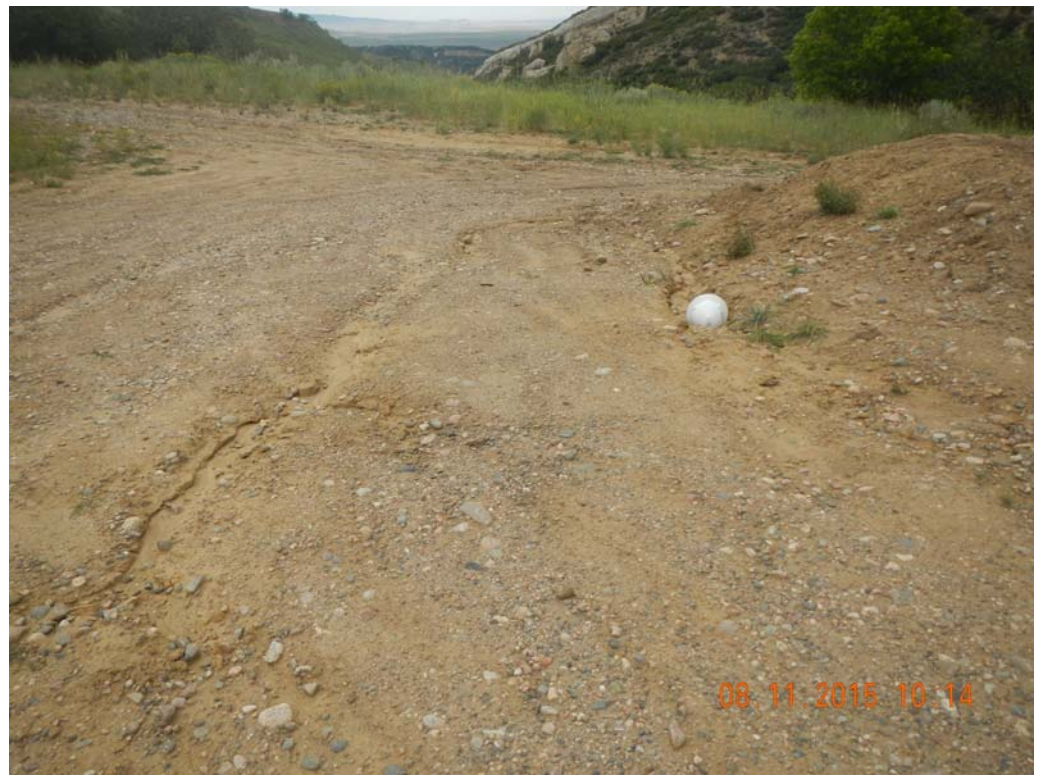
Rills leaving location and
entering access road. Hard
hat for scale.

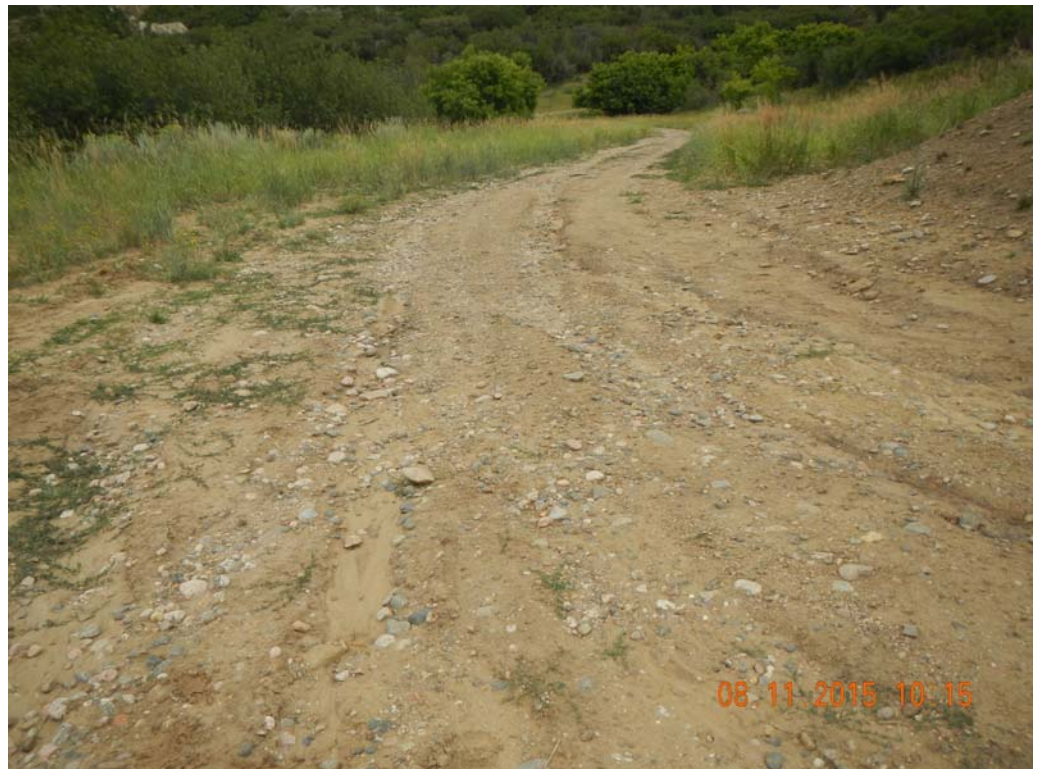
Sediment migration down
access road.
