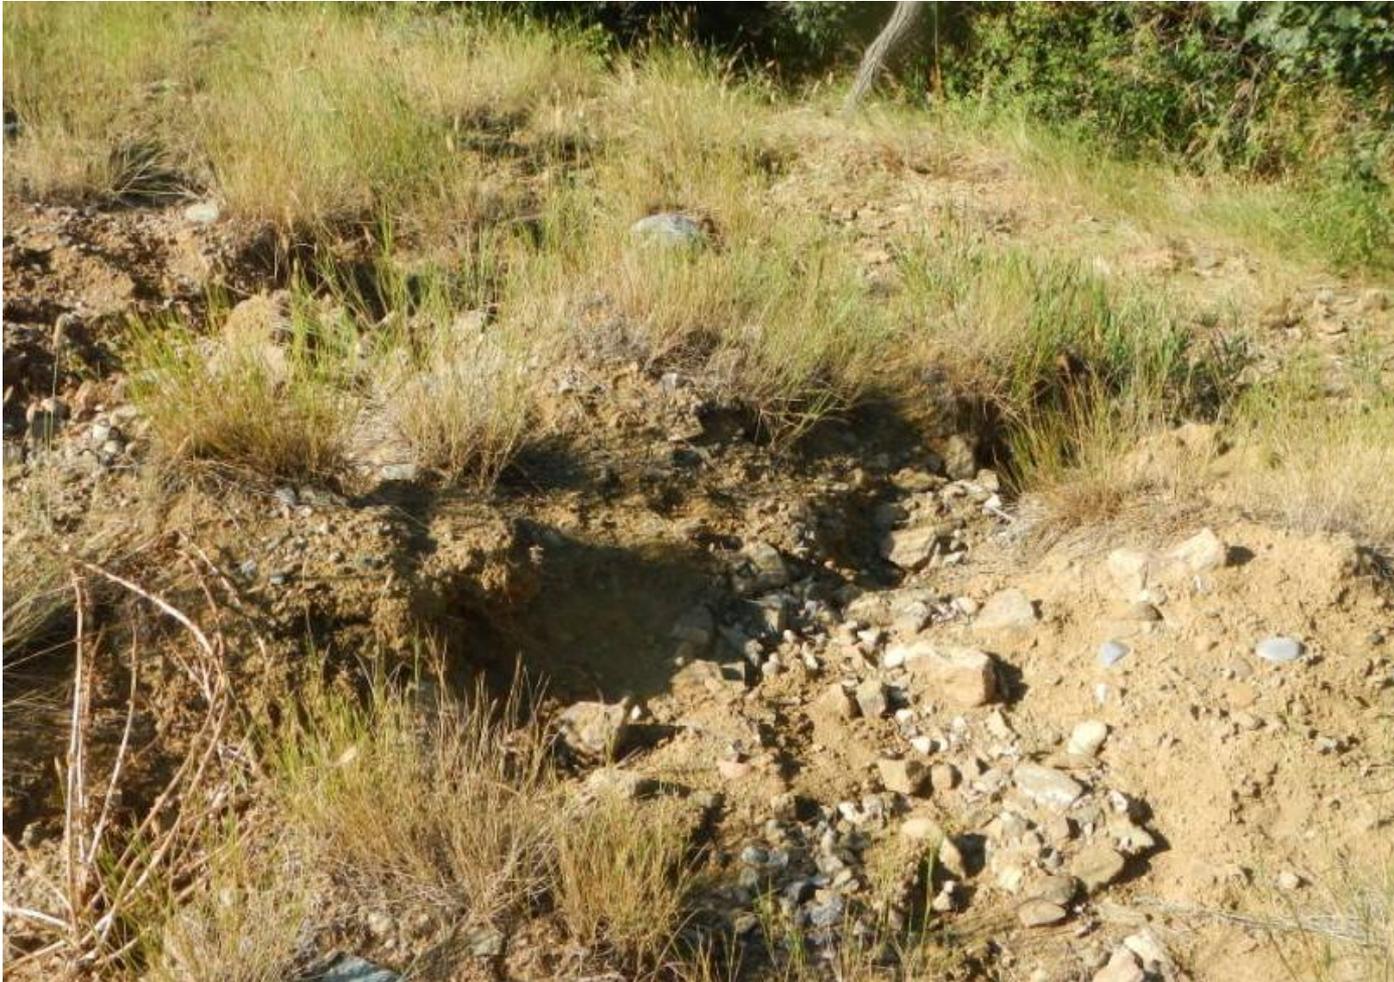
Photo 1. View of erosional channel (approximately 15 inches wide and 10 to 12 inches deep) forming within the western portion of the project area from the southwestern edge of the working area facing down-slope.

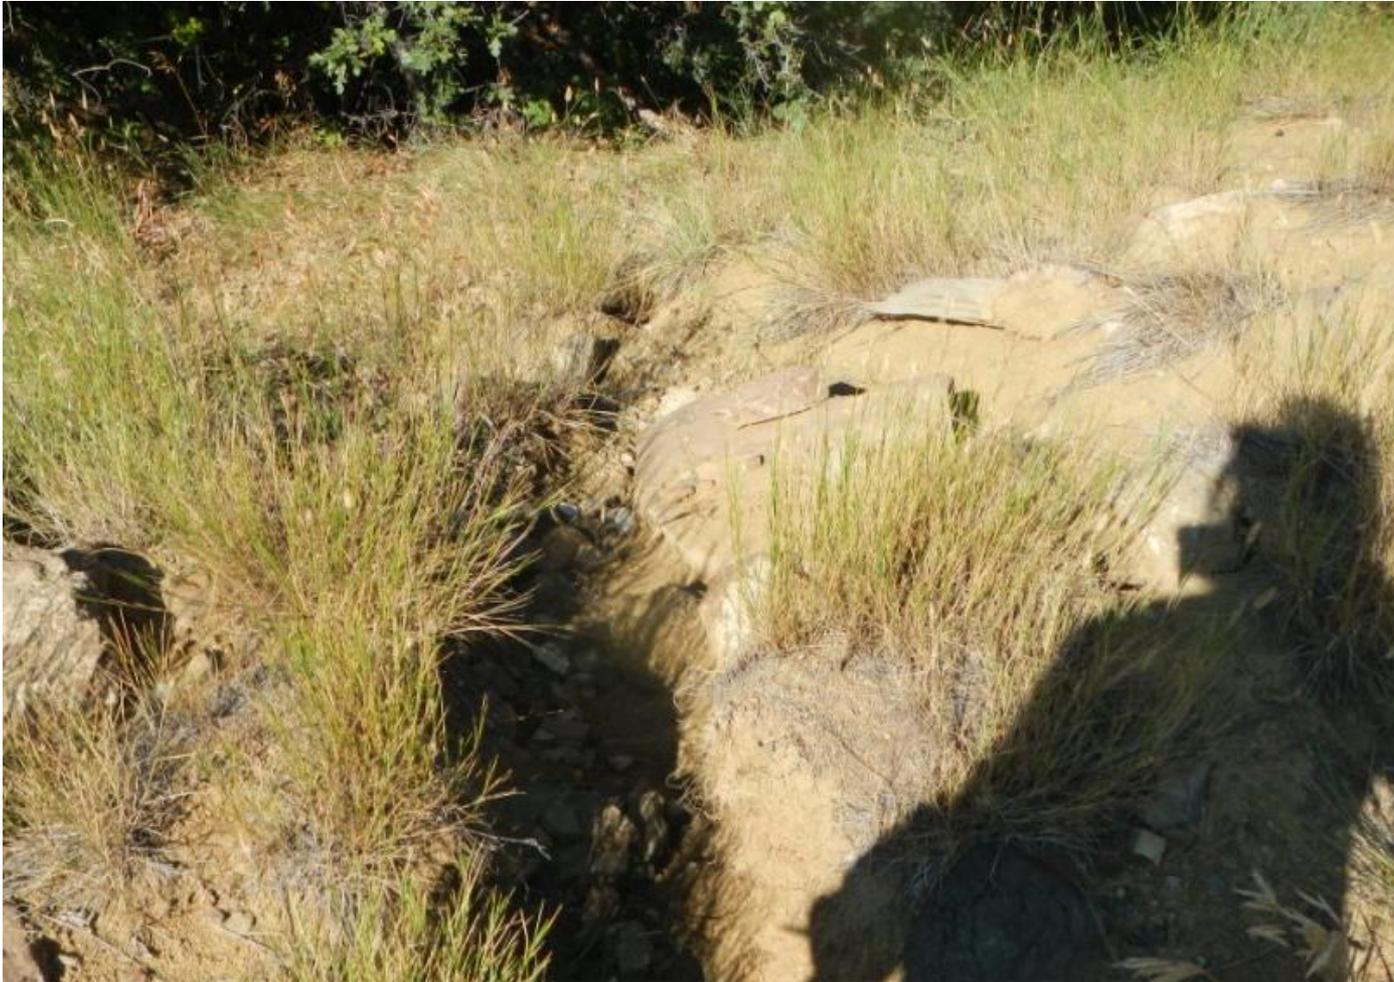
Photo 2. View of another erosional channel (approximately 12 inches wide and 12 to 18 inches deep) forming within the western portion of the project area from the western edge of the working area facing down-slope.

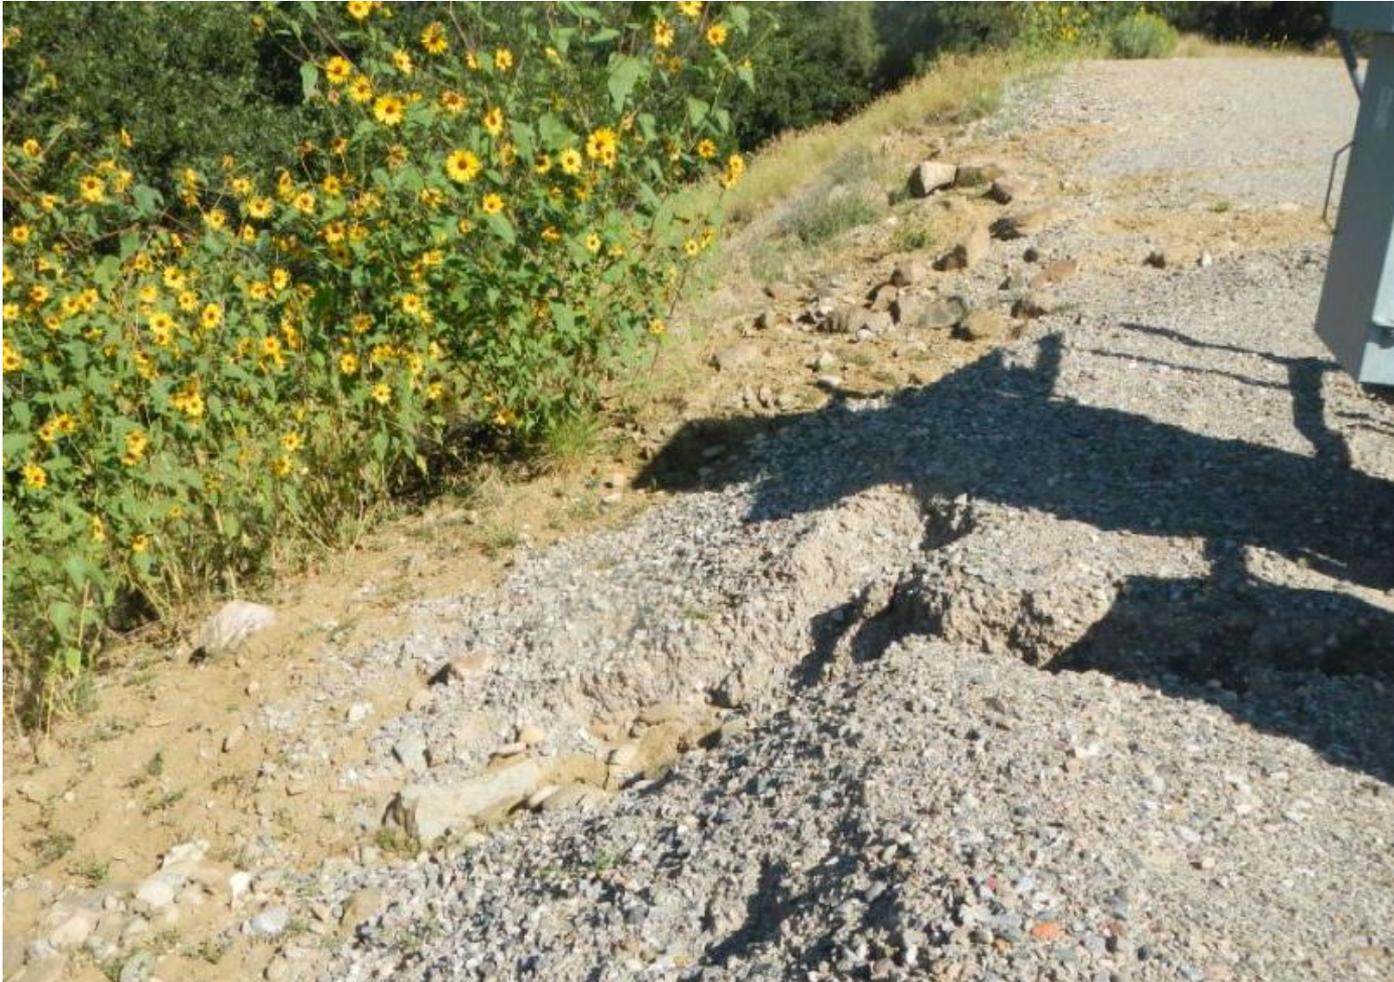
Photo 3. View of erosion along western edge of well pad where stormwater flows are eroding the western edge of the well pad.

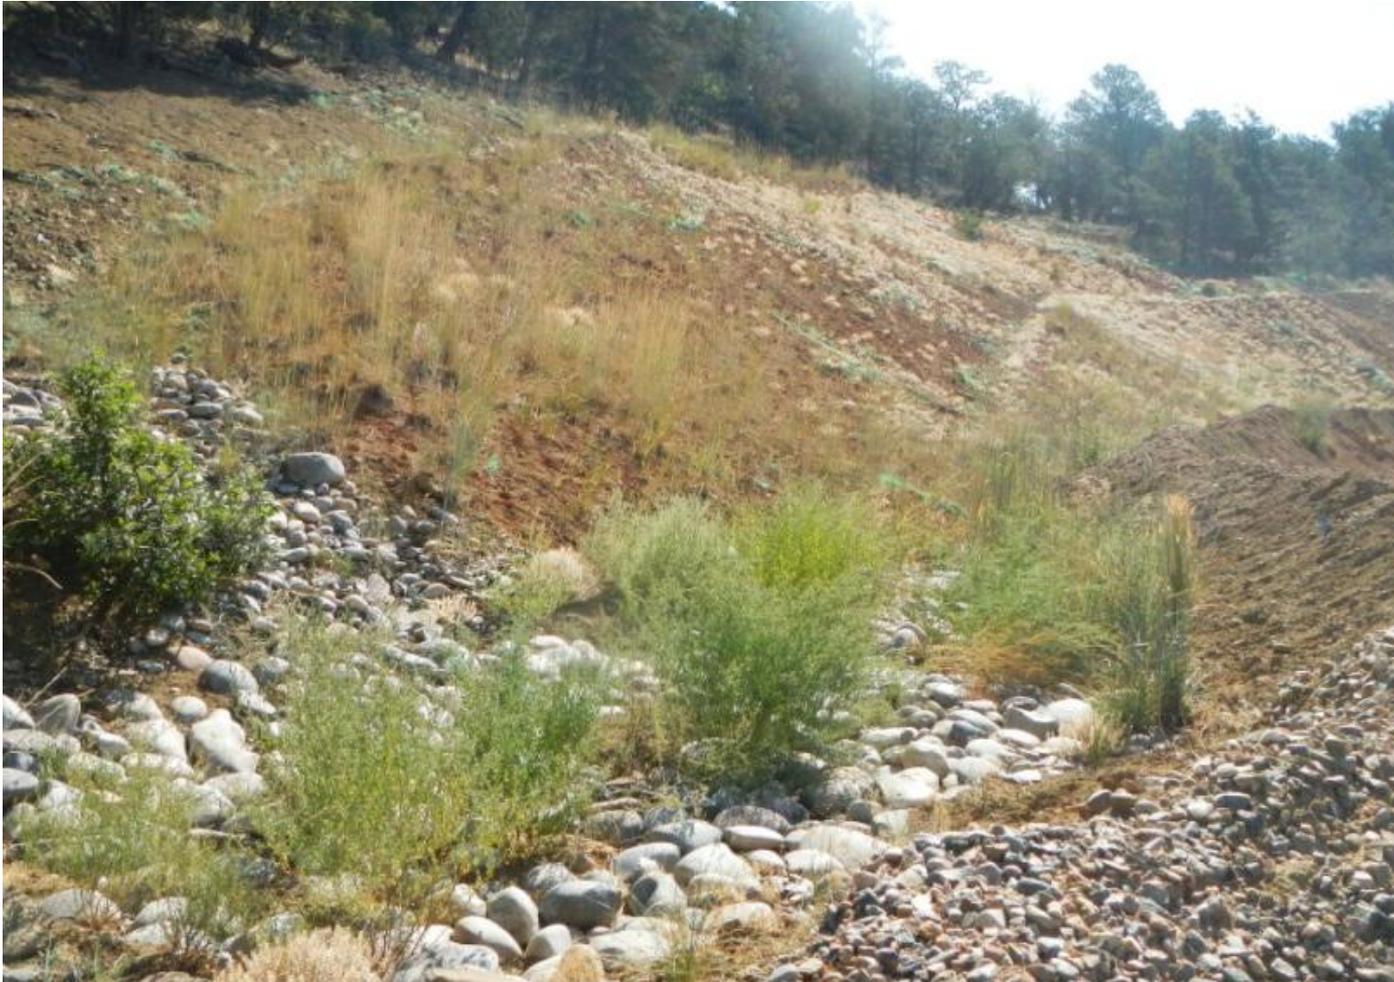
Photo 4. View of revegetation progressing on the tall, cut slope in eastern portion of the project area. Stormwater BMP in foreground appears to be functioning to de-energize stormwater flows coming off of the eastern cut-slope.

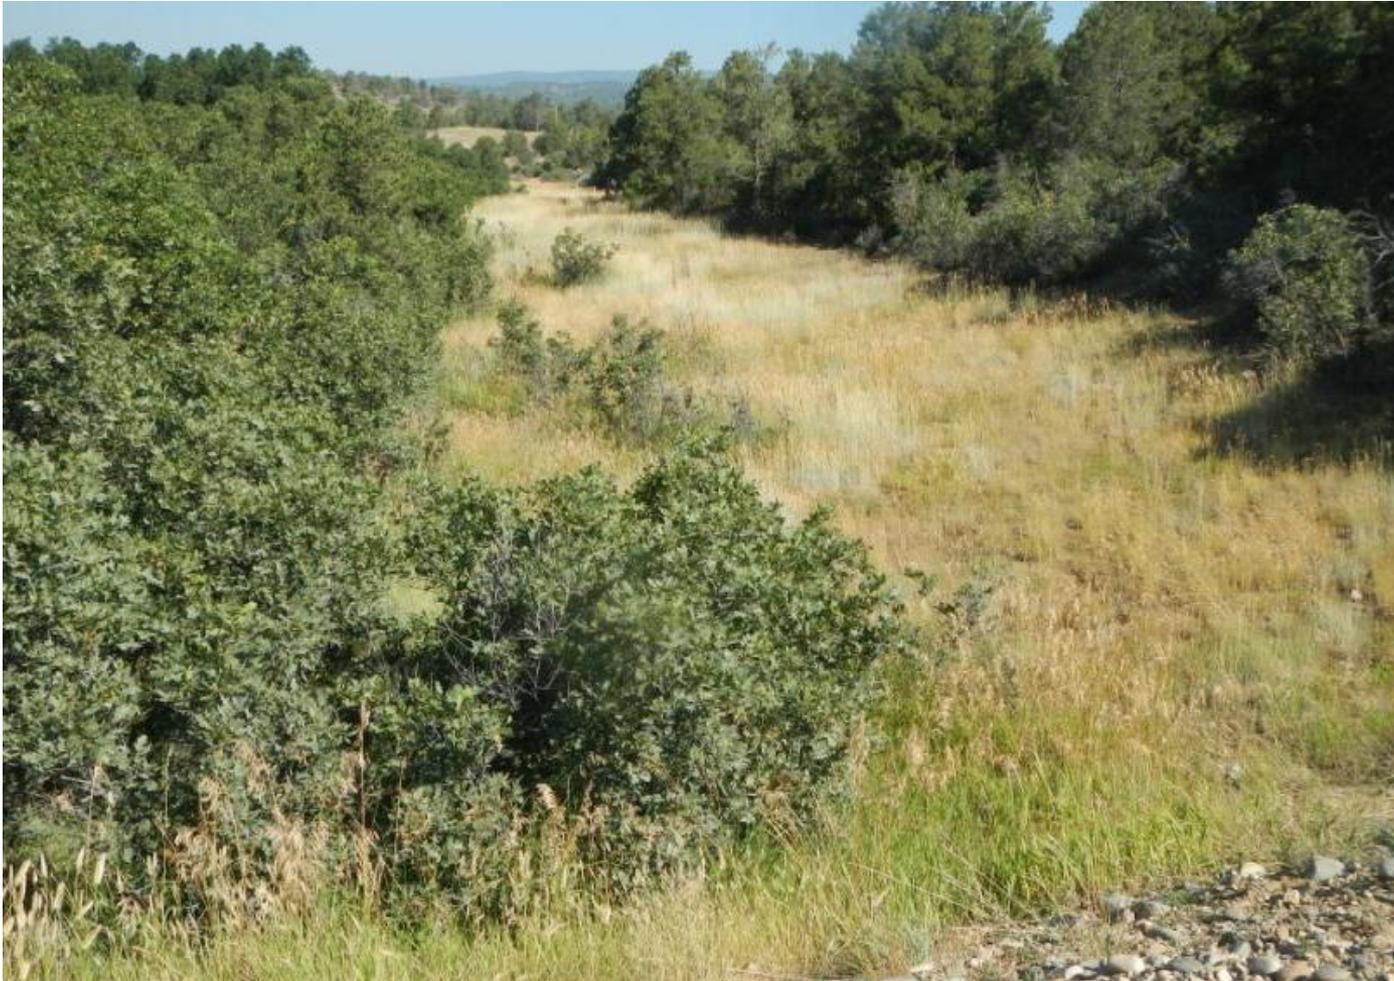
Photo 5. View of revegetation along the flowline in the northern portion of the project area.
