## Federal 16-2

Inspection# 675201959

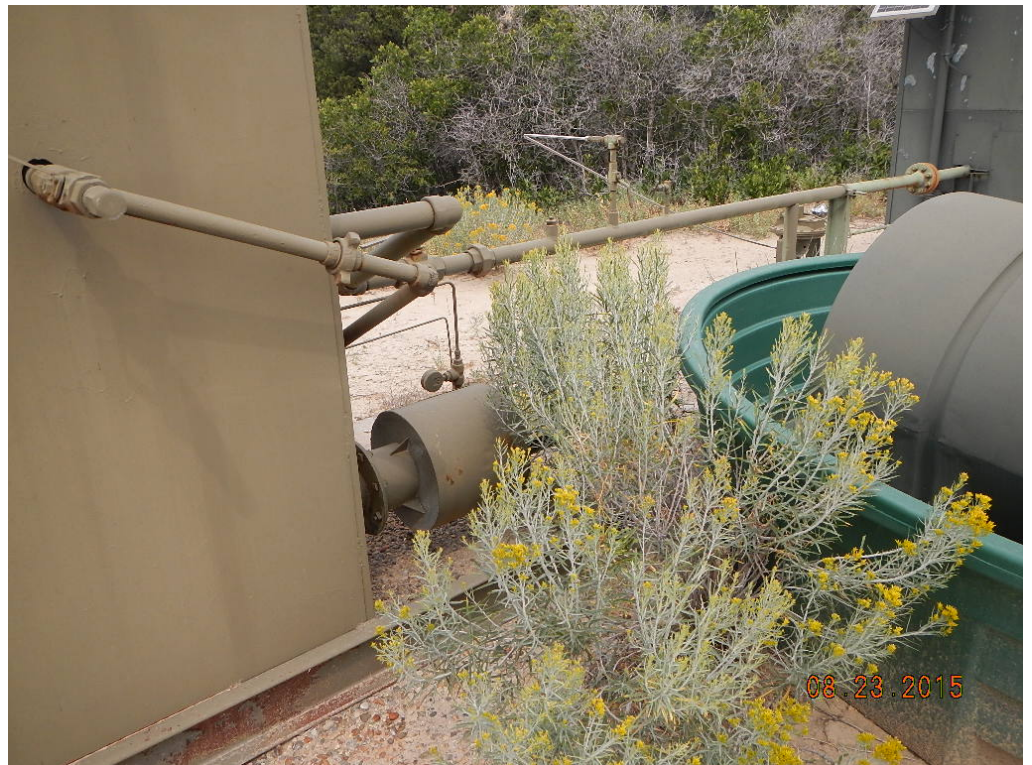
Vegetation around  
equipment.

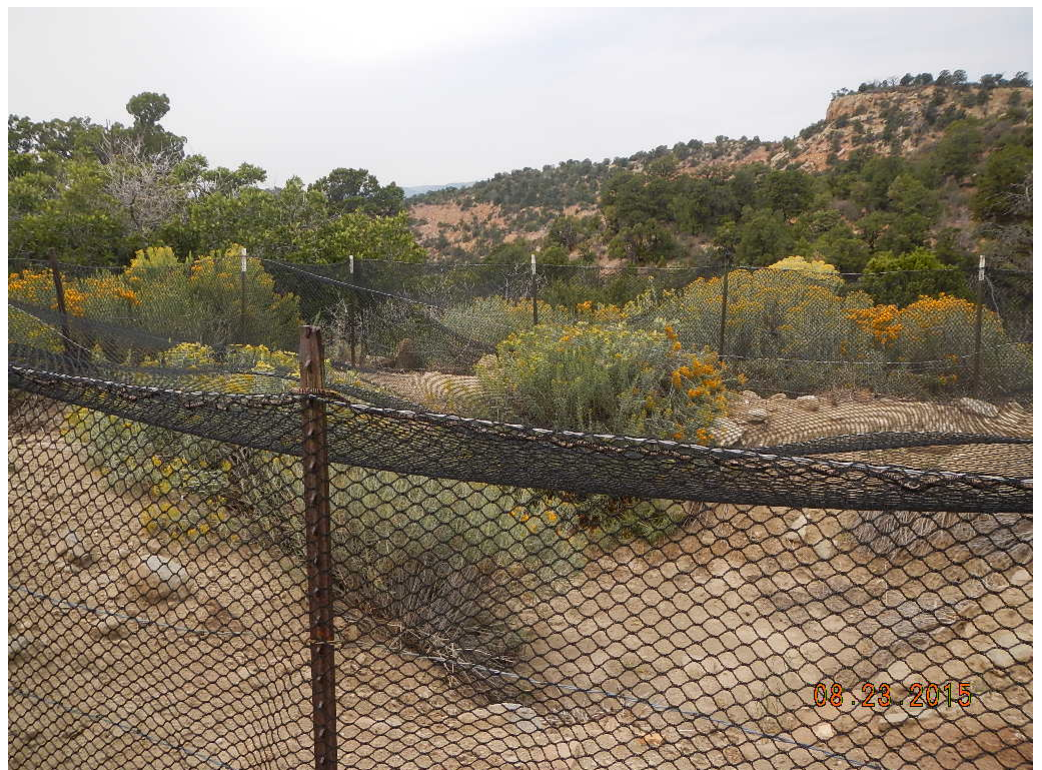
Net is sagging and there is  
vegetation in pit.

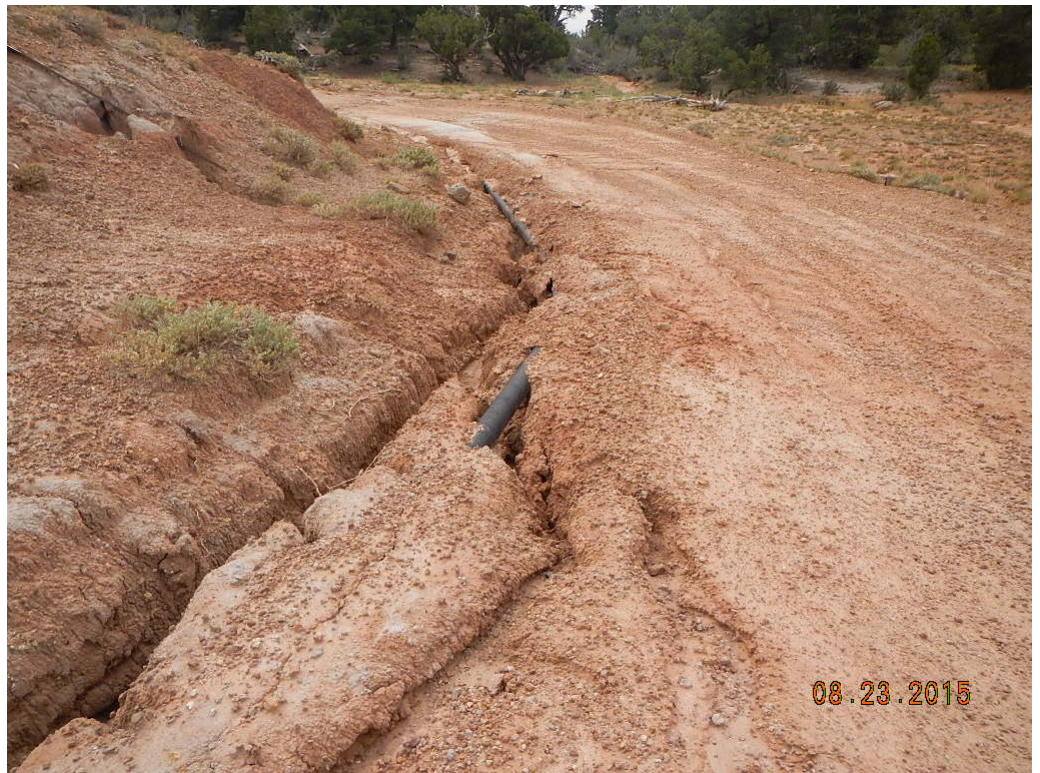
Access road has erosion and  
pipeline is exposed.
