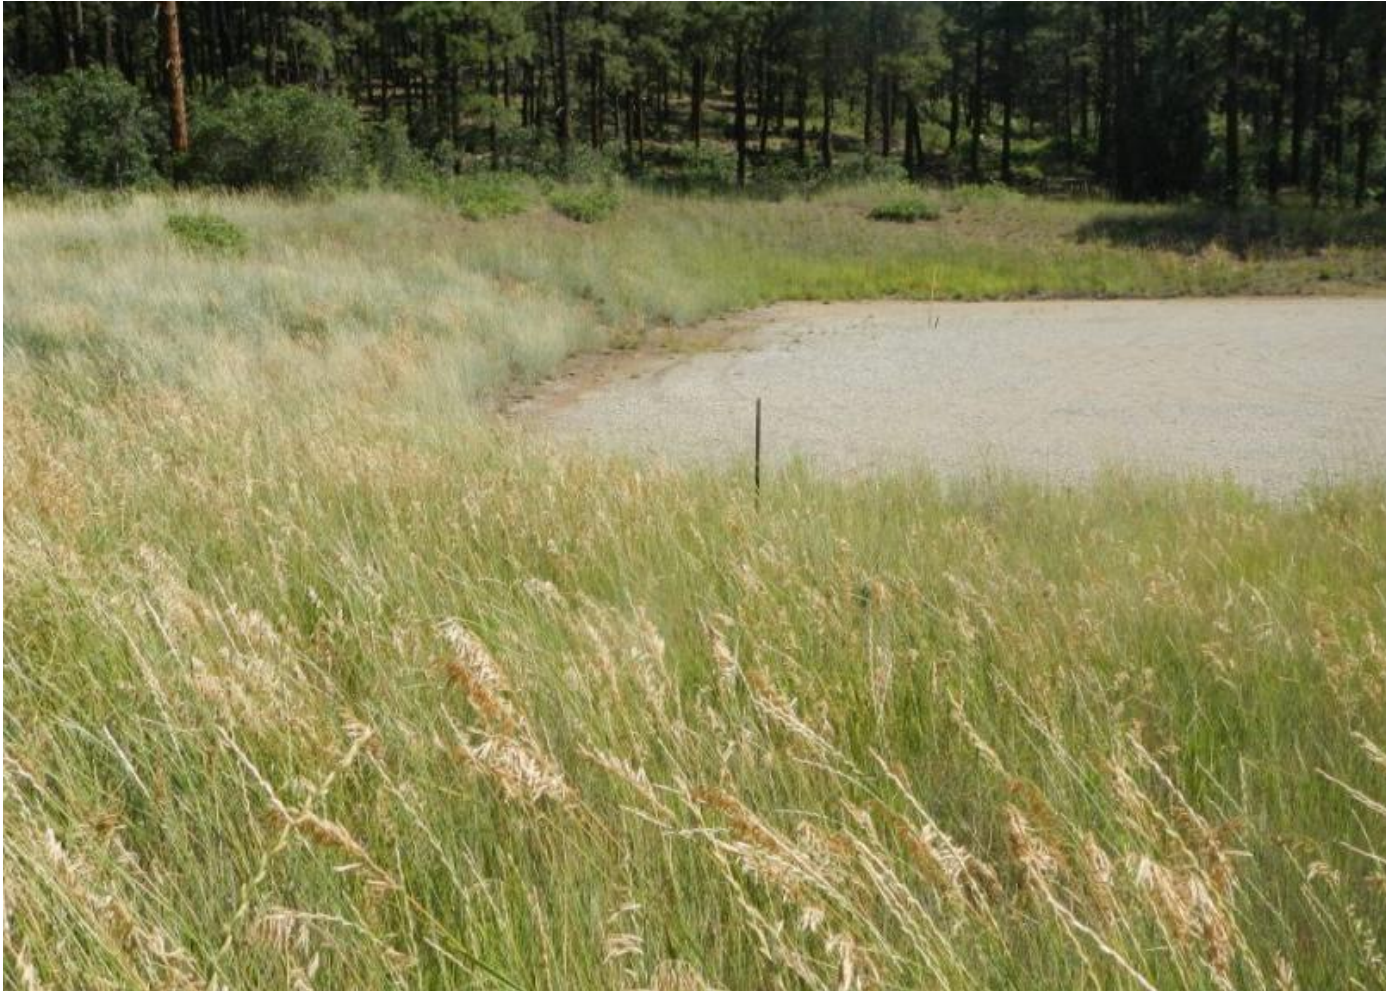
Photo 1. View of northern portion of project area from northwestern corner facing eastward.

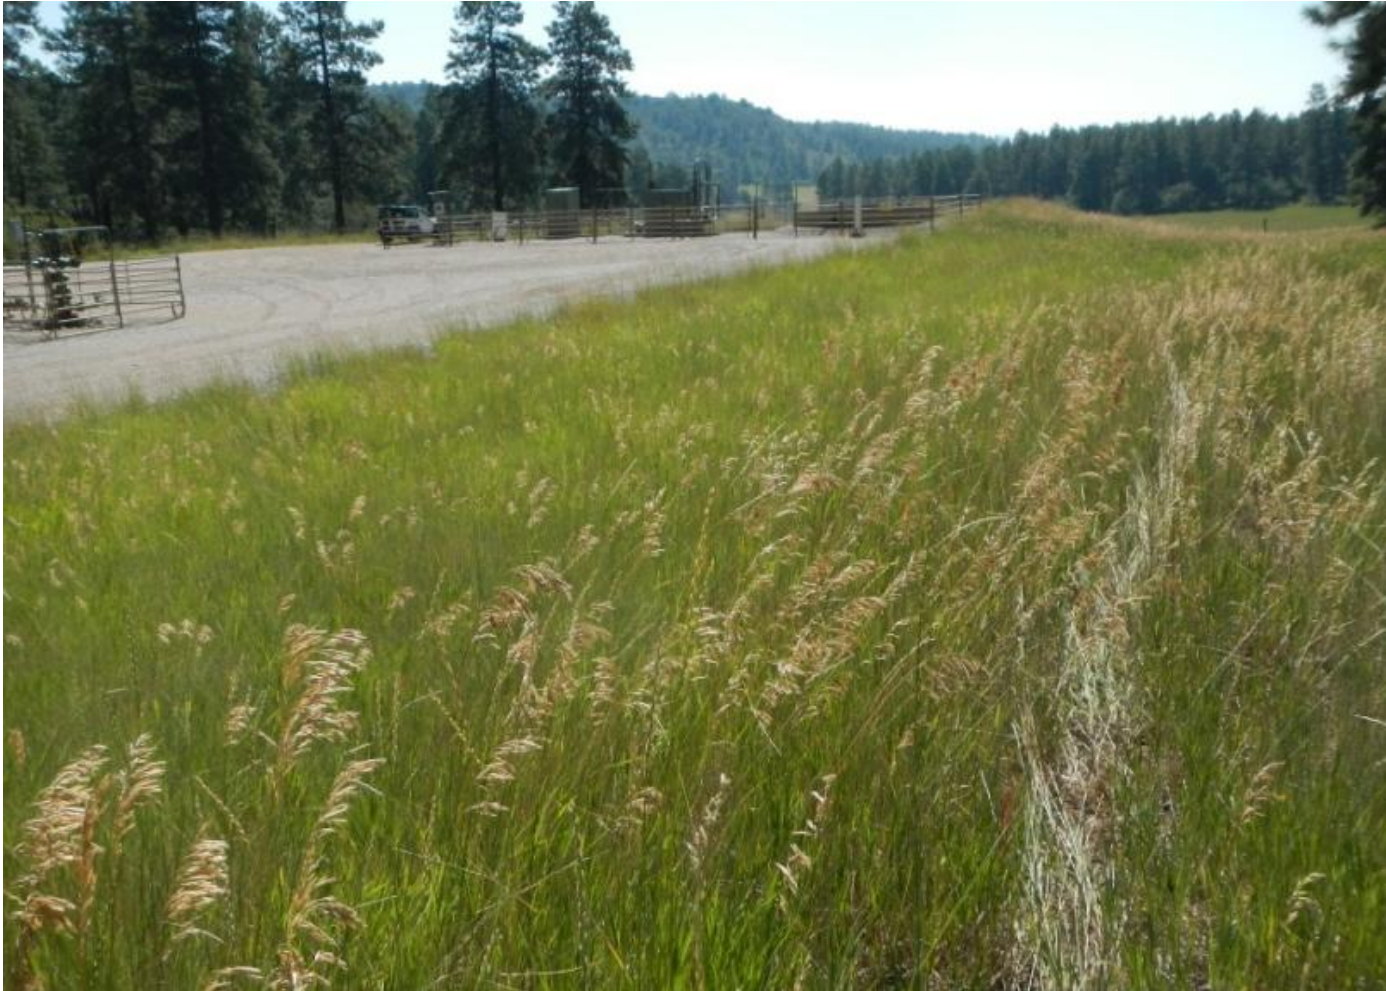
Photo 2. View of western portion of project area from northwestern corner facing southeastward.

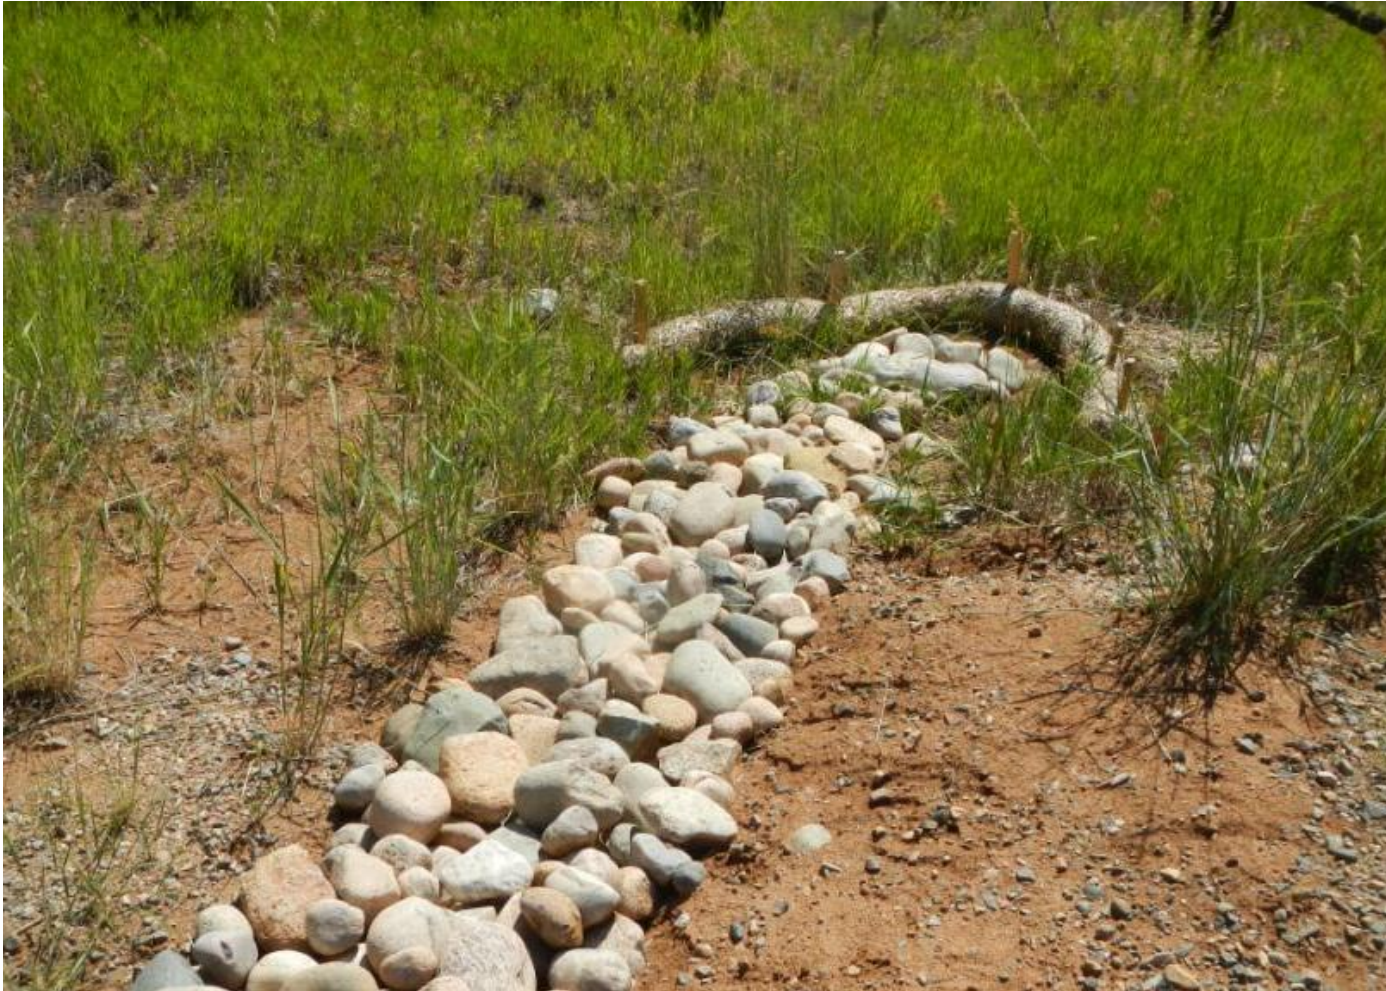
Photo 3. View of stormwater BMP within eastern portion of project area that appears to be functioning properly.
