Johnson 1-28

Inspection# 673402369

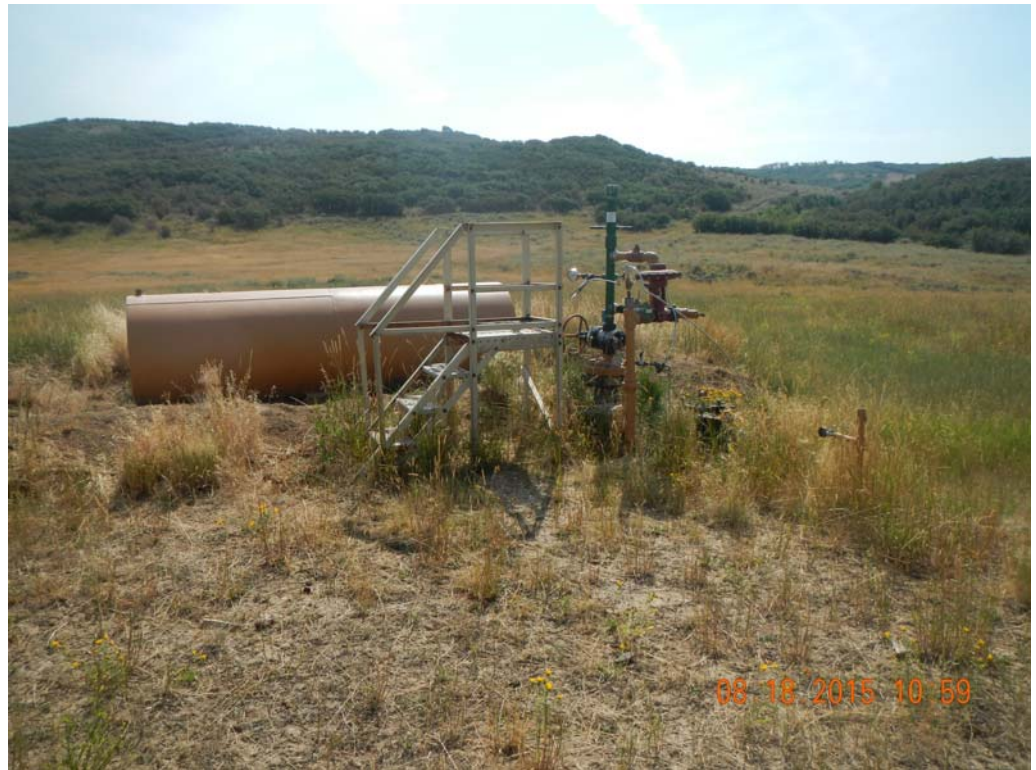
No sign at wellhead.

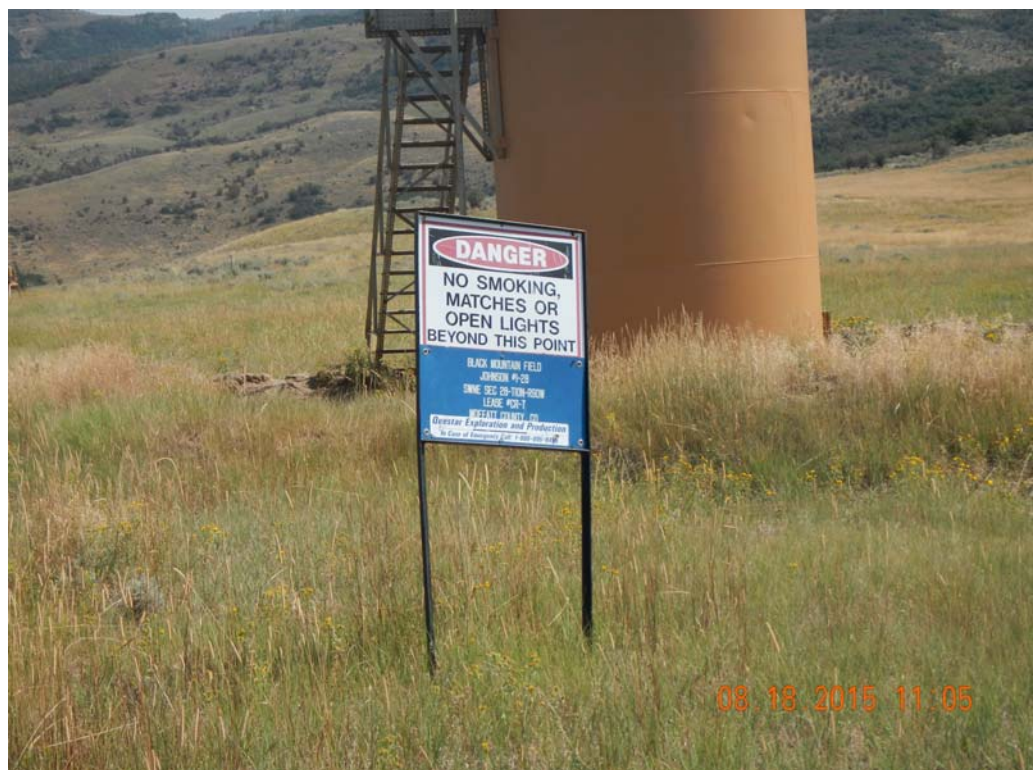
Battery sign listing Questar as operator/emergency contact. No labels on tank.

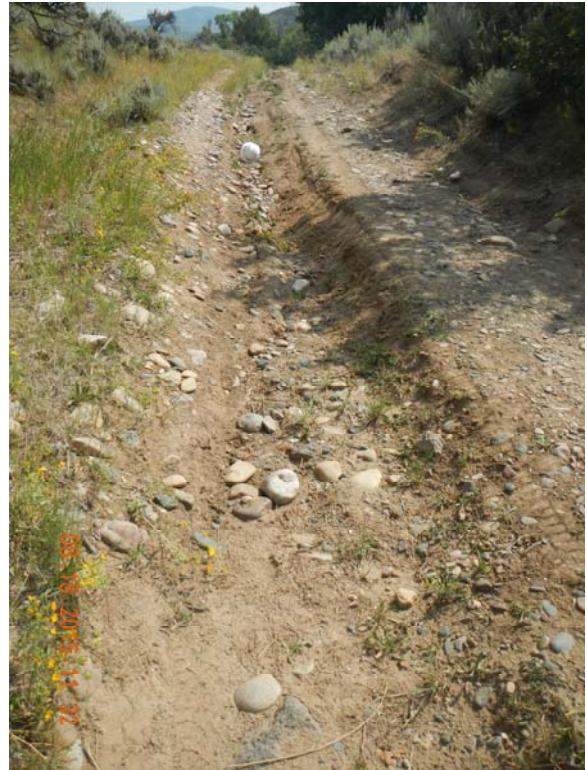
Rill which has developed into a rut in the access road. Evidence of sediment and coarse material being transported. Hard hat for scale.

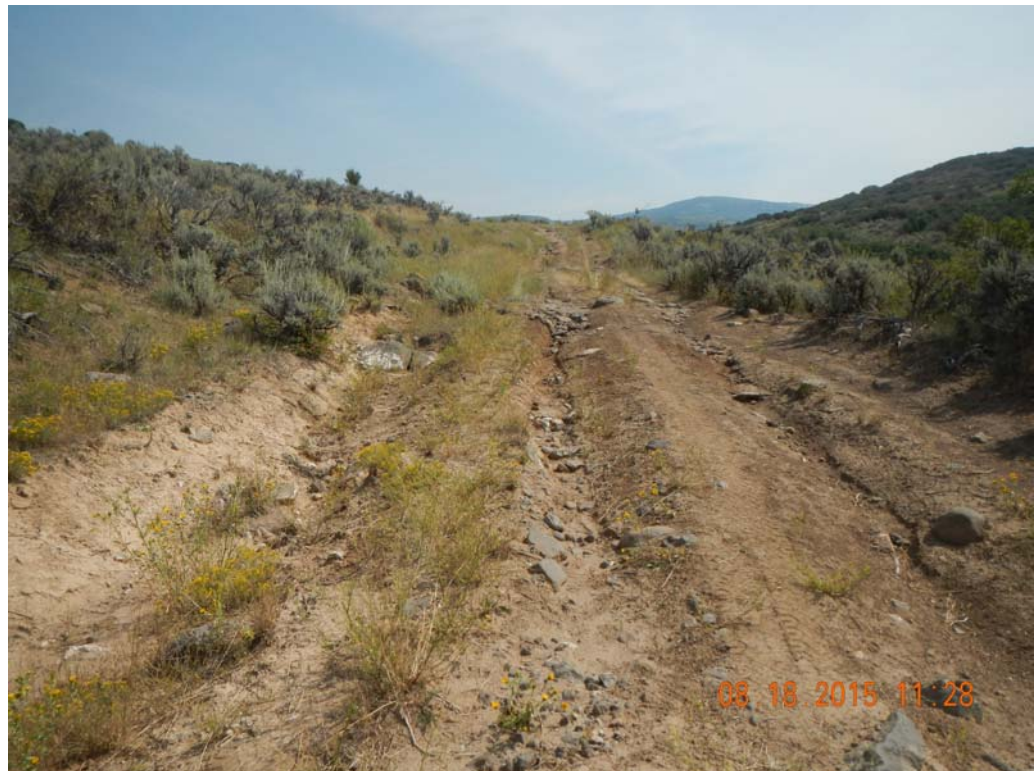
Rills in access road. Evidence of sediment and coarse material being transported.

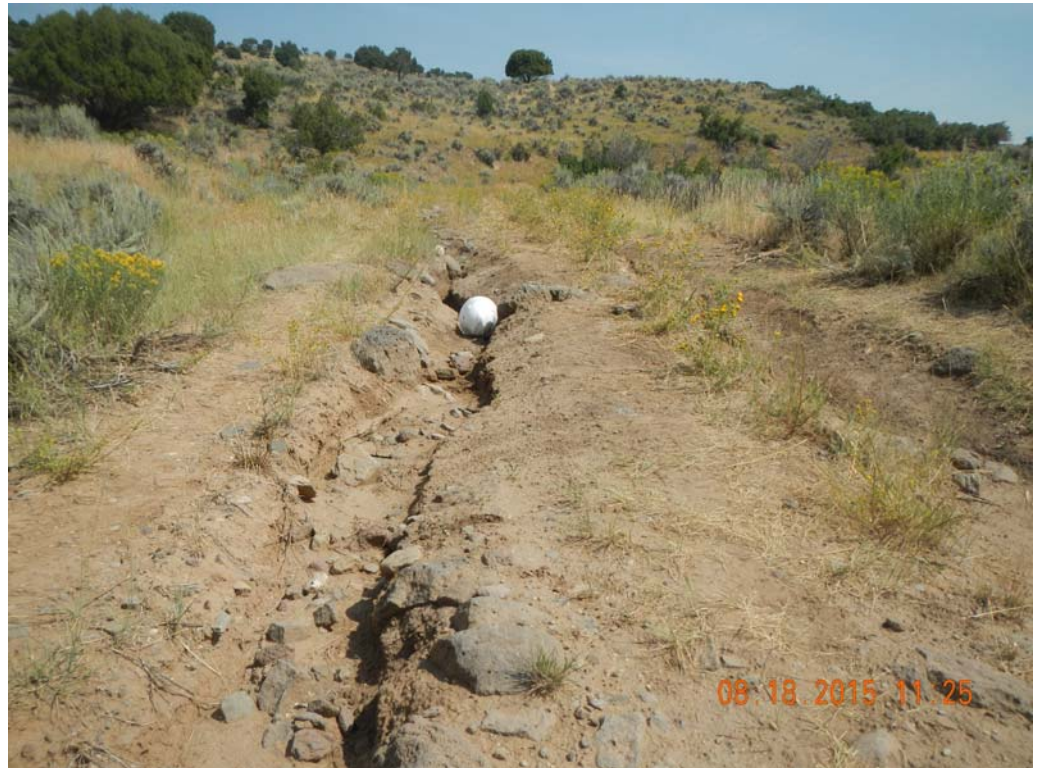
Rill in access road. Evidence of sediment and coarse material being transported. Hard hat for scale.

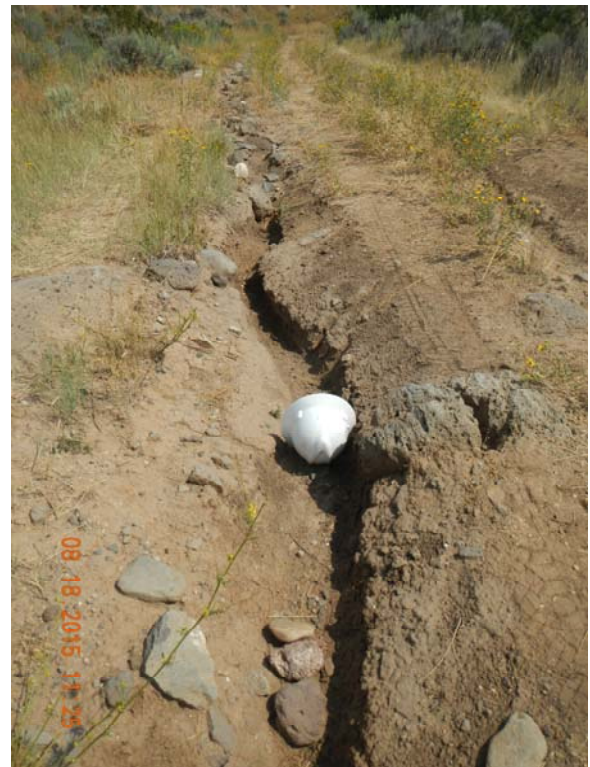
Close up of rill in access road. Evidence of sediment and coarse material being transported. Hard hat for scale.

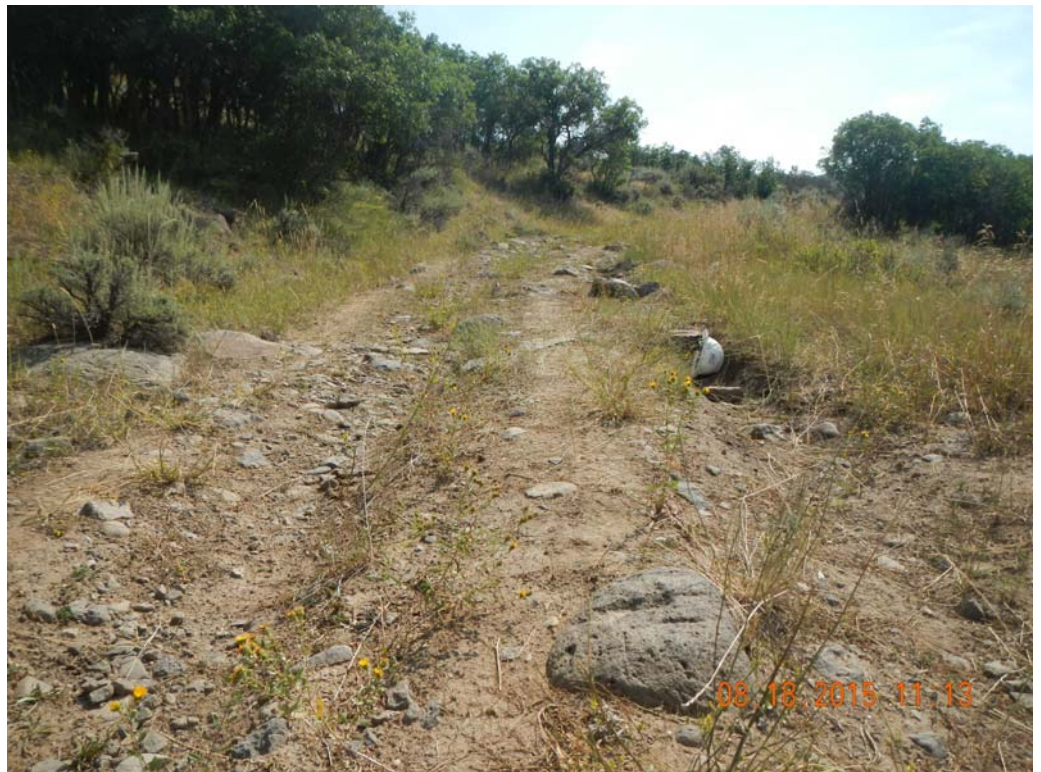
Rills transporting boulders
and smaller sediment
down access road.

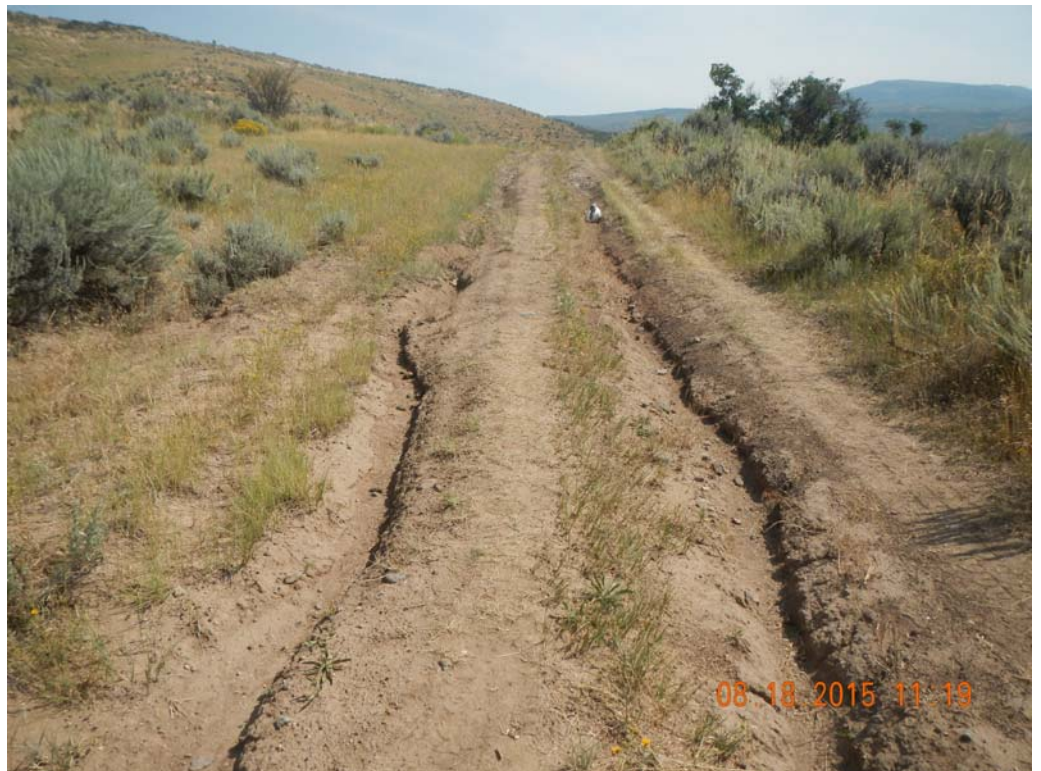
Ruts in access road
transporting sediment.

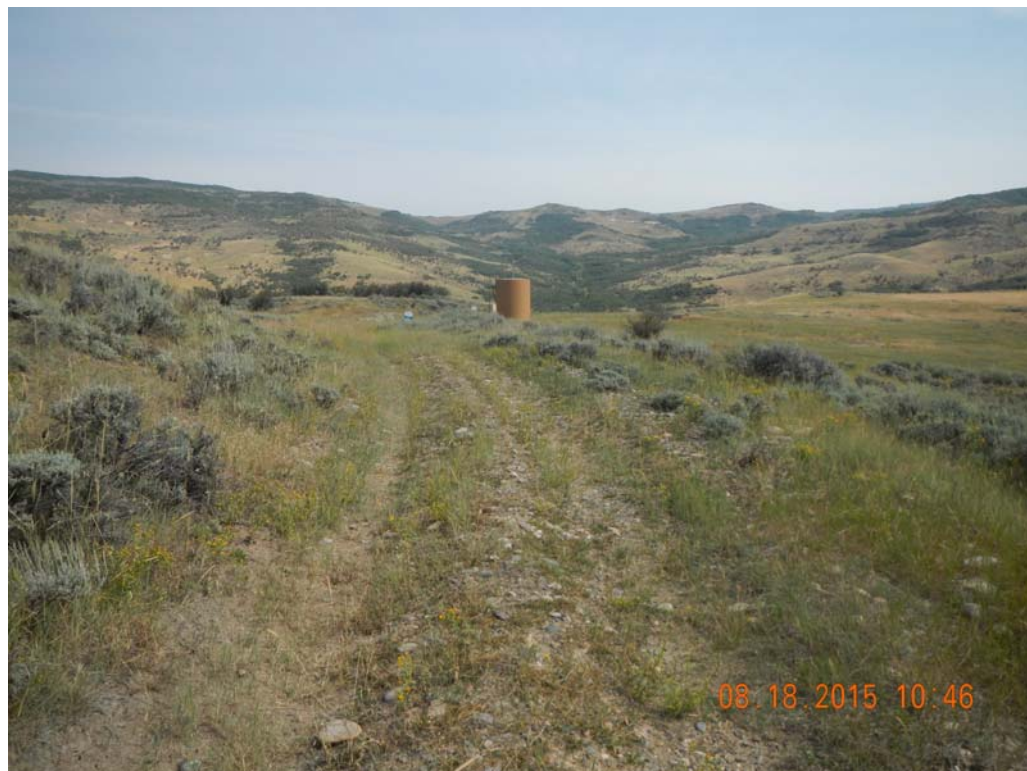
Entrance to location. Road
is overgrown and rough.
