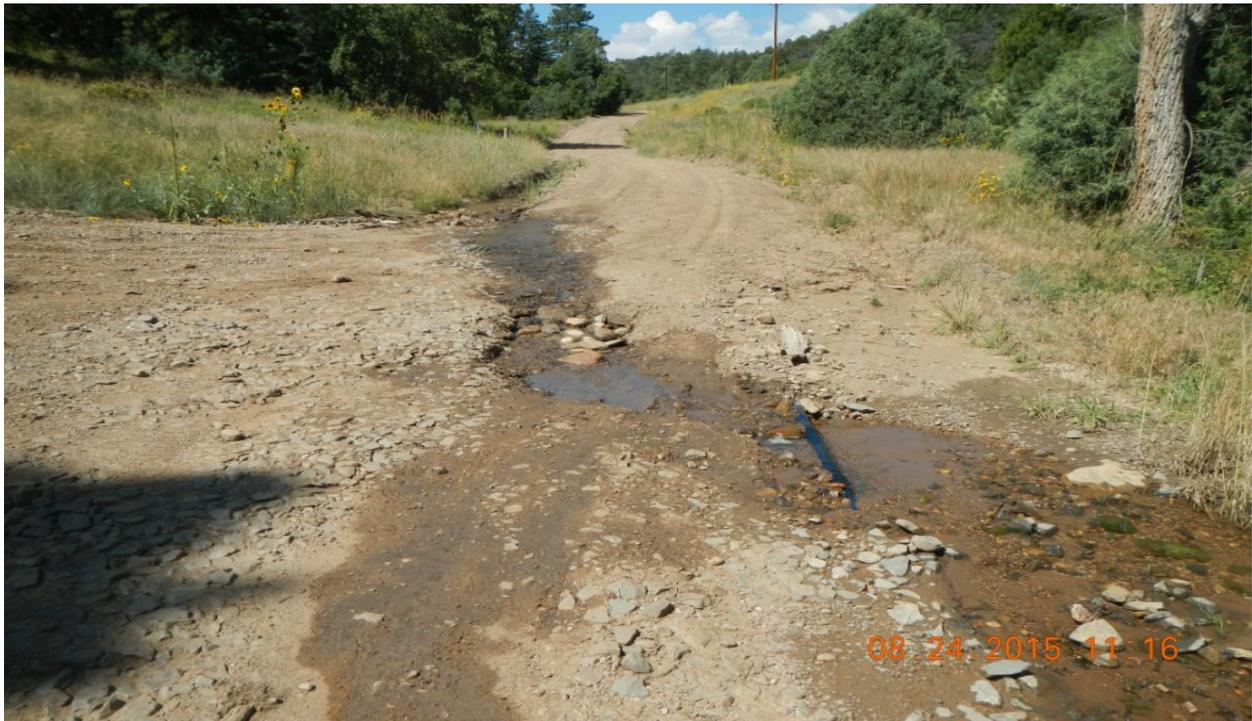
photo 1: Main access road traveling west towards the location. Water is flowing across and eroding the road.

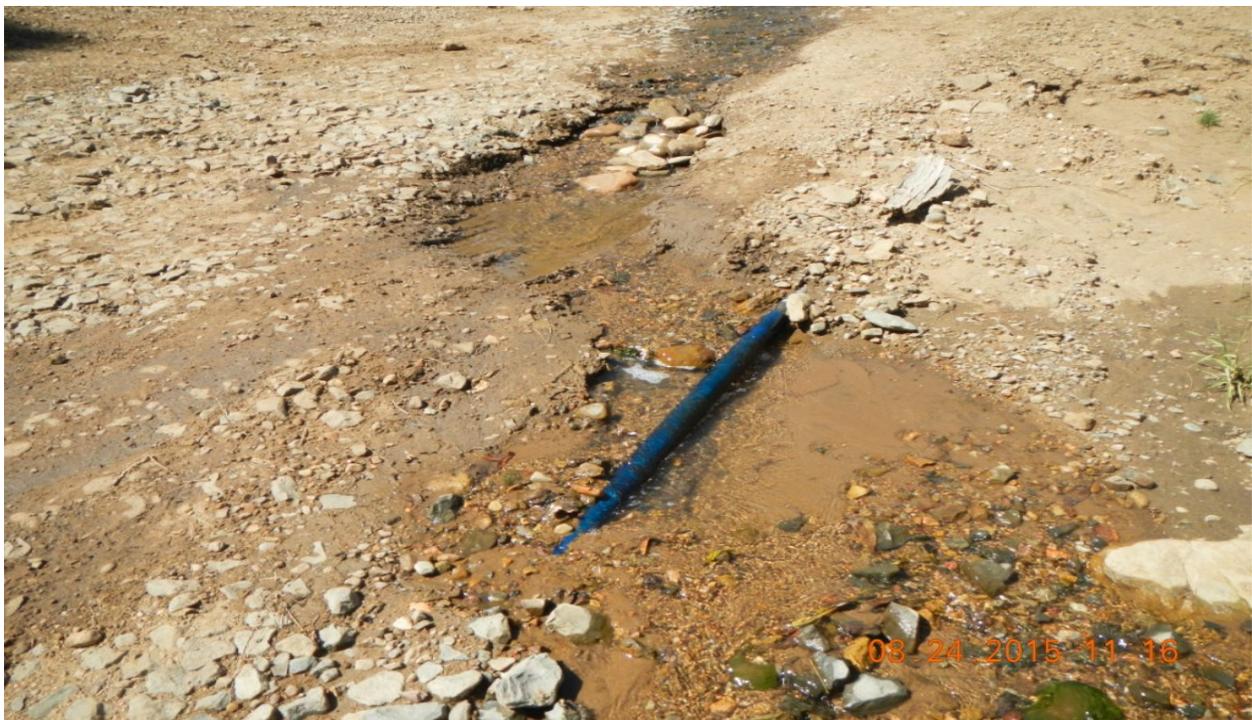
photo 2: Water flowing across the road has exposed a pipeline. Approx. Lat/Long: 37.09117, -104.94348.

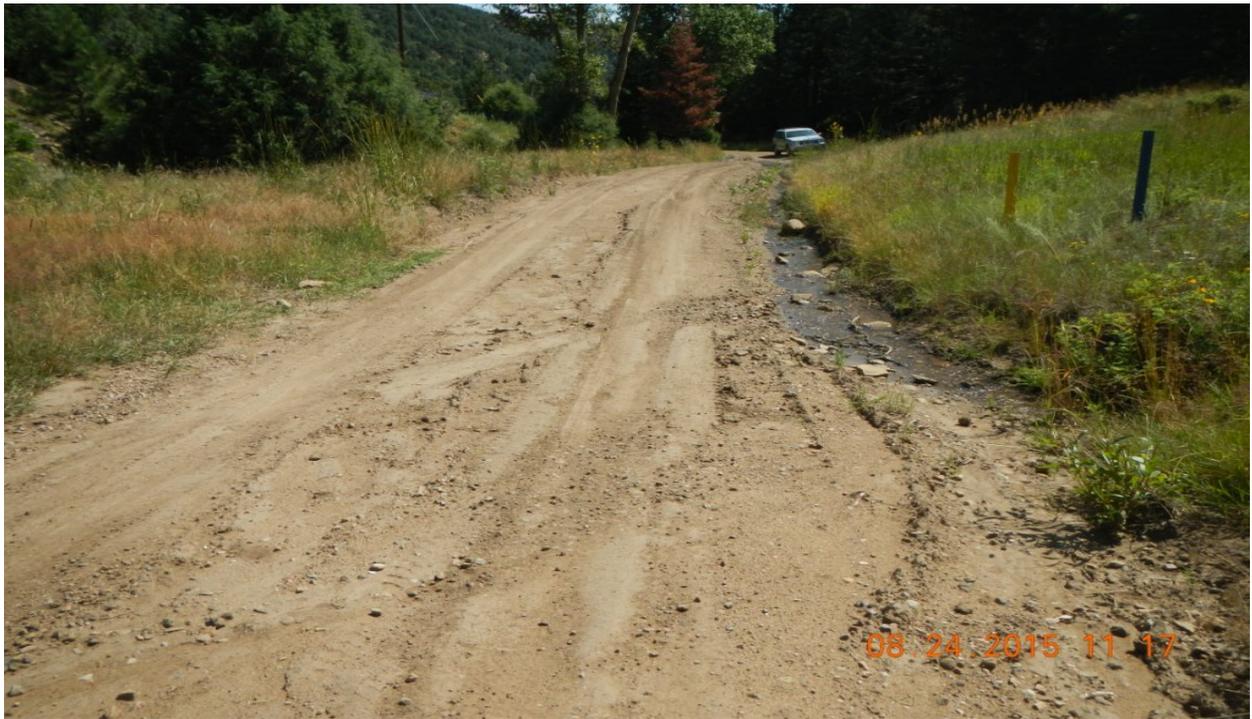
photo 3: There may be a plugged culvert where water source is coming from.

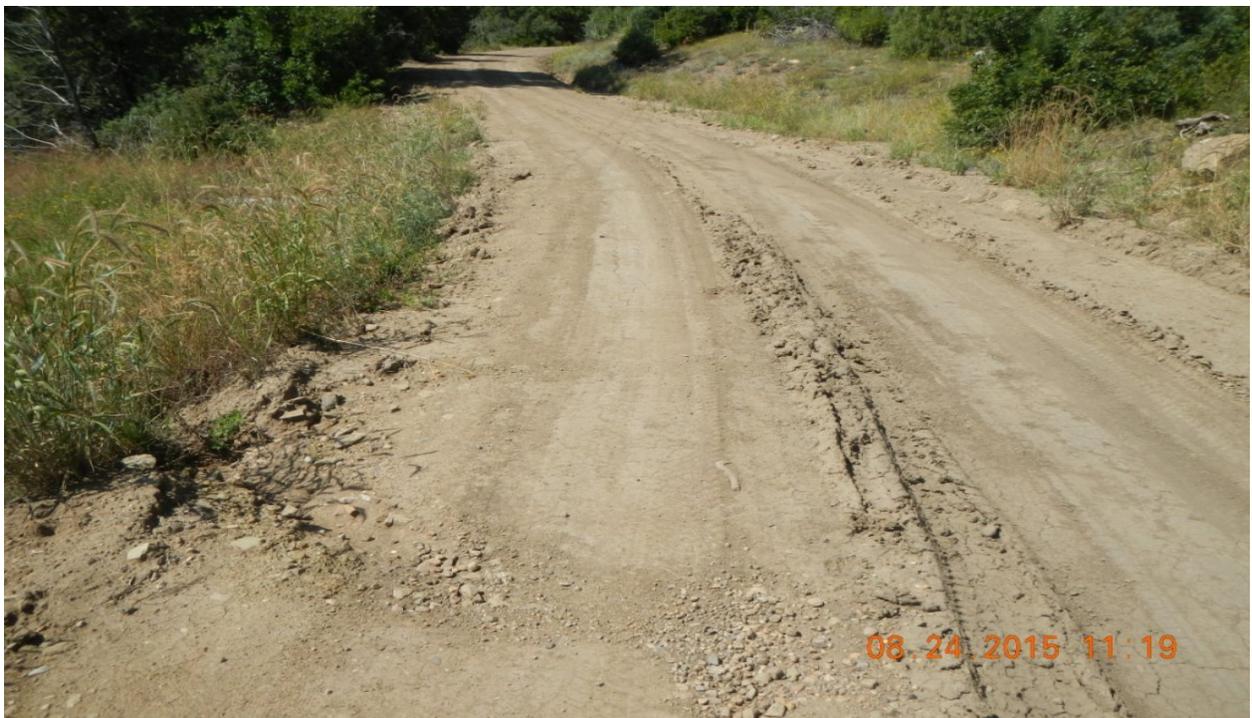
photo 4: Main access road shows signs of erosion and rutting.

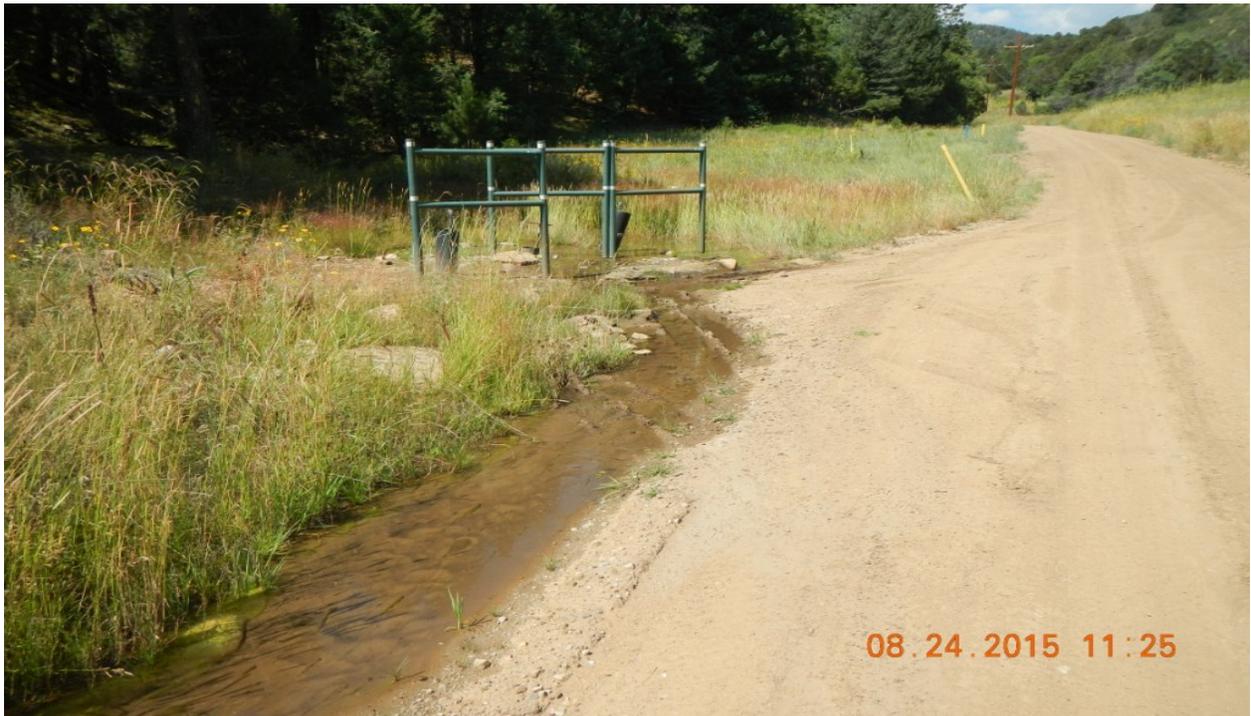
photo 5: Further up the road towards the west the water from stream is running down the side of the road.

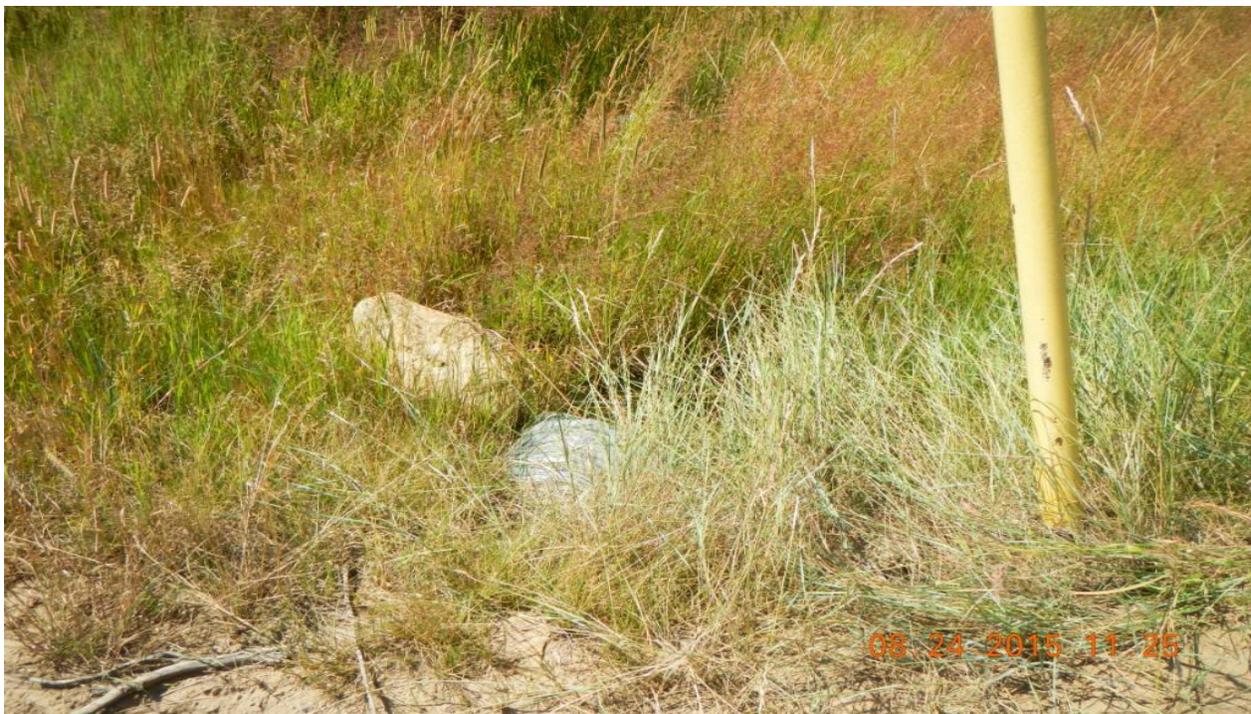
photo 6: Culvert at this point may be partially filled with sediment. Approx. Lat/Long: 37.089,-104.954.

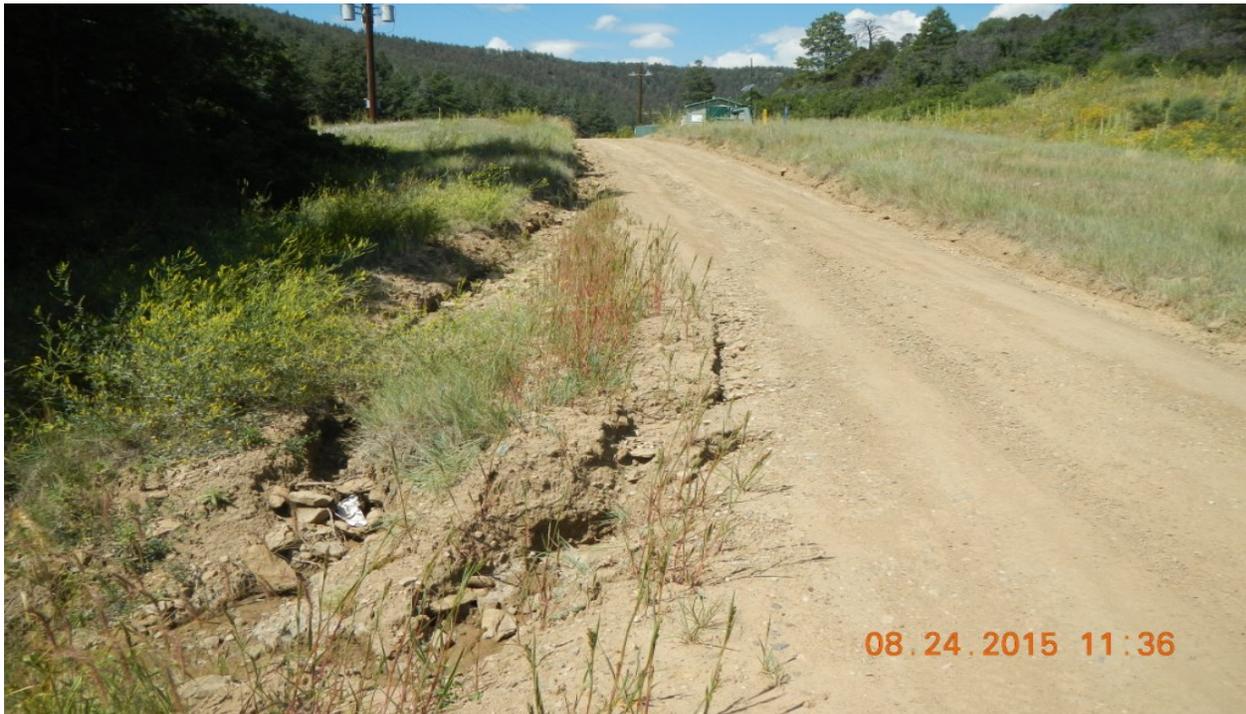
photo 7: Facing west near the location. The main access road shows signs of erosion and vehicle rutting.

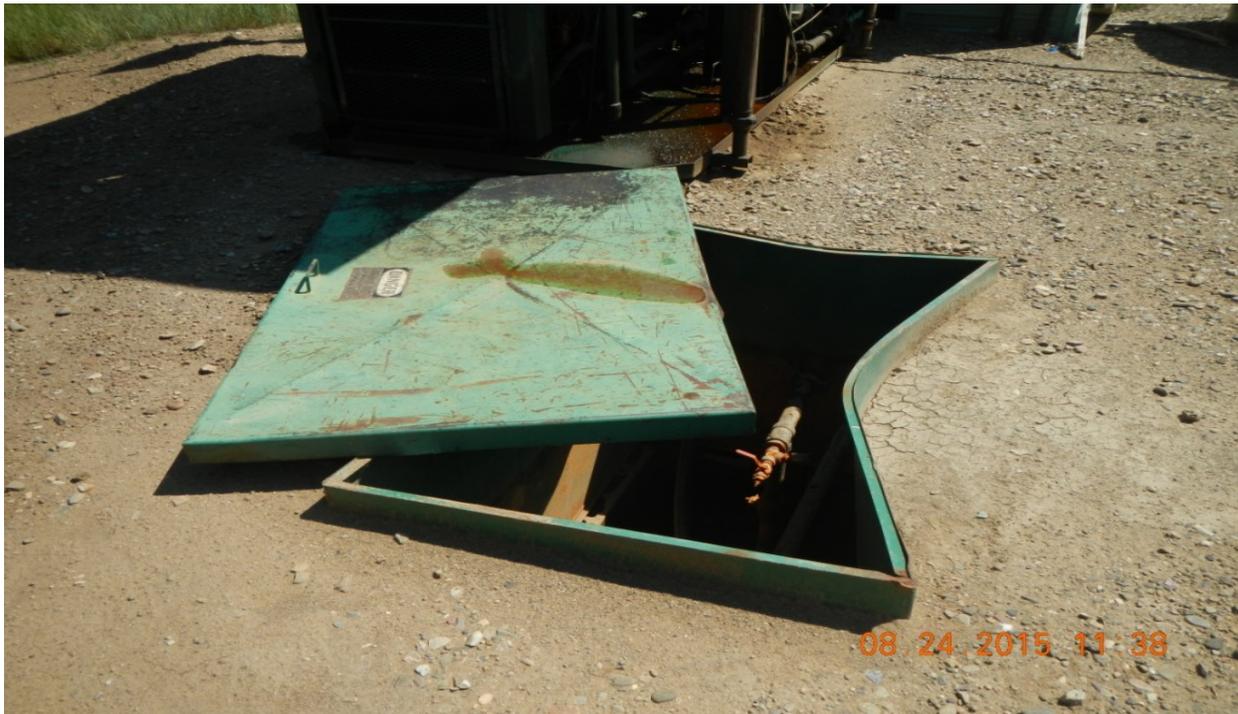
Photo 9: The lid on this cellar near the engine compressor was open and appears to be damaged..
