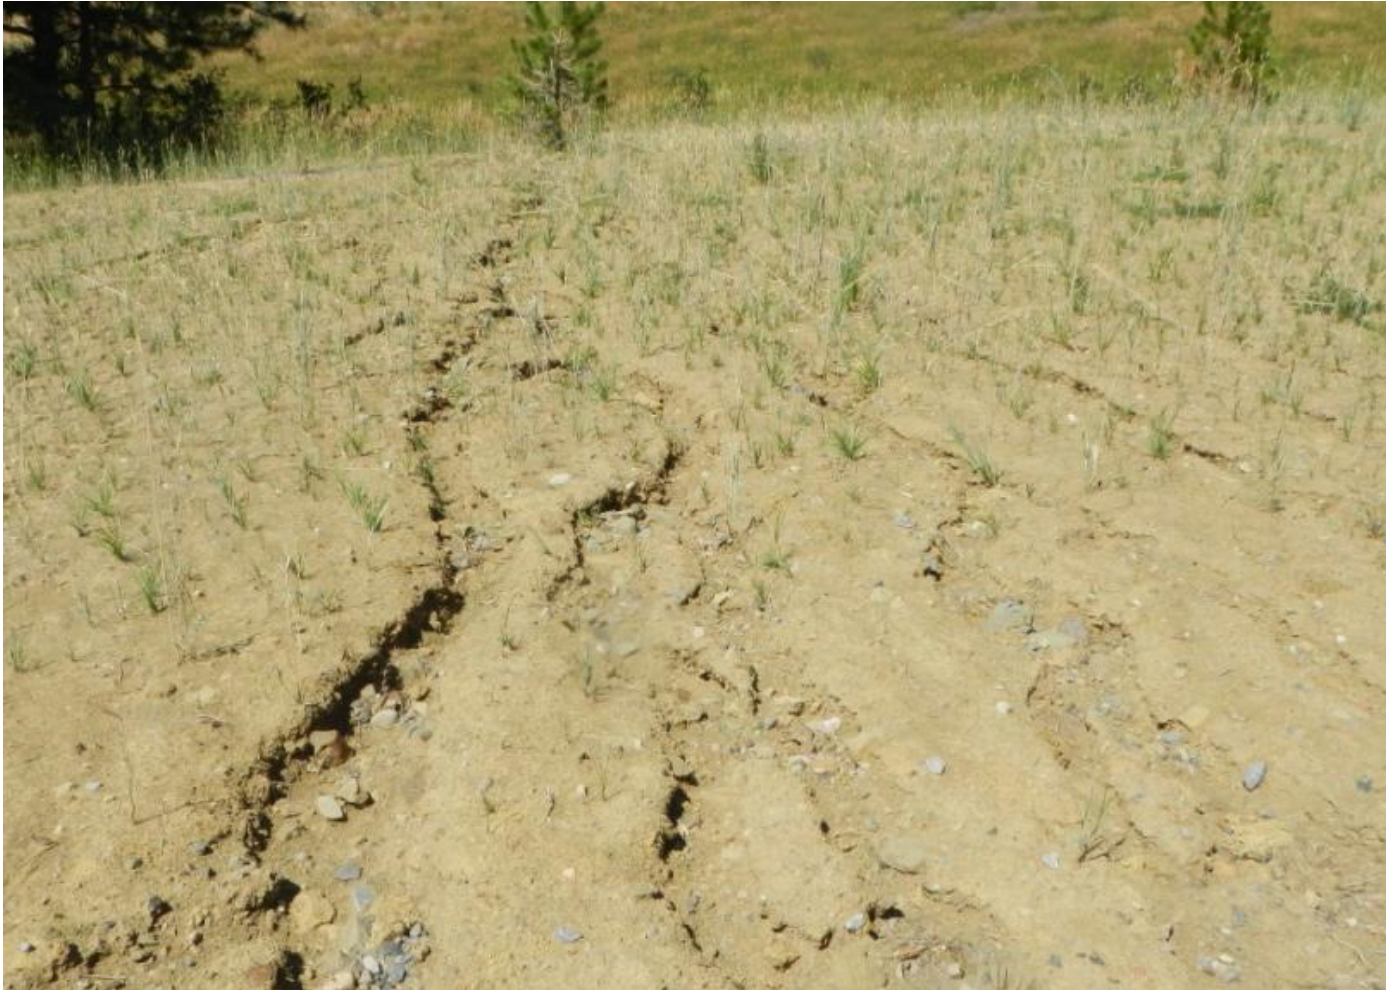
Photo 1. View of rills approximately 8 to 10 inches wide and 4 to 8 inches deep within the western portion of the project area facing down-slope.

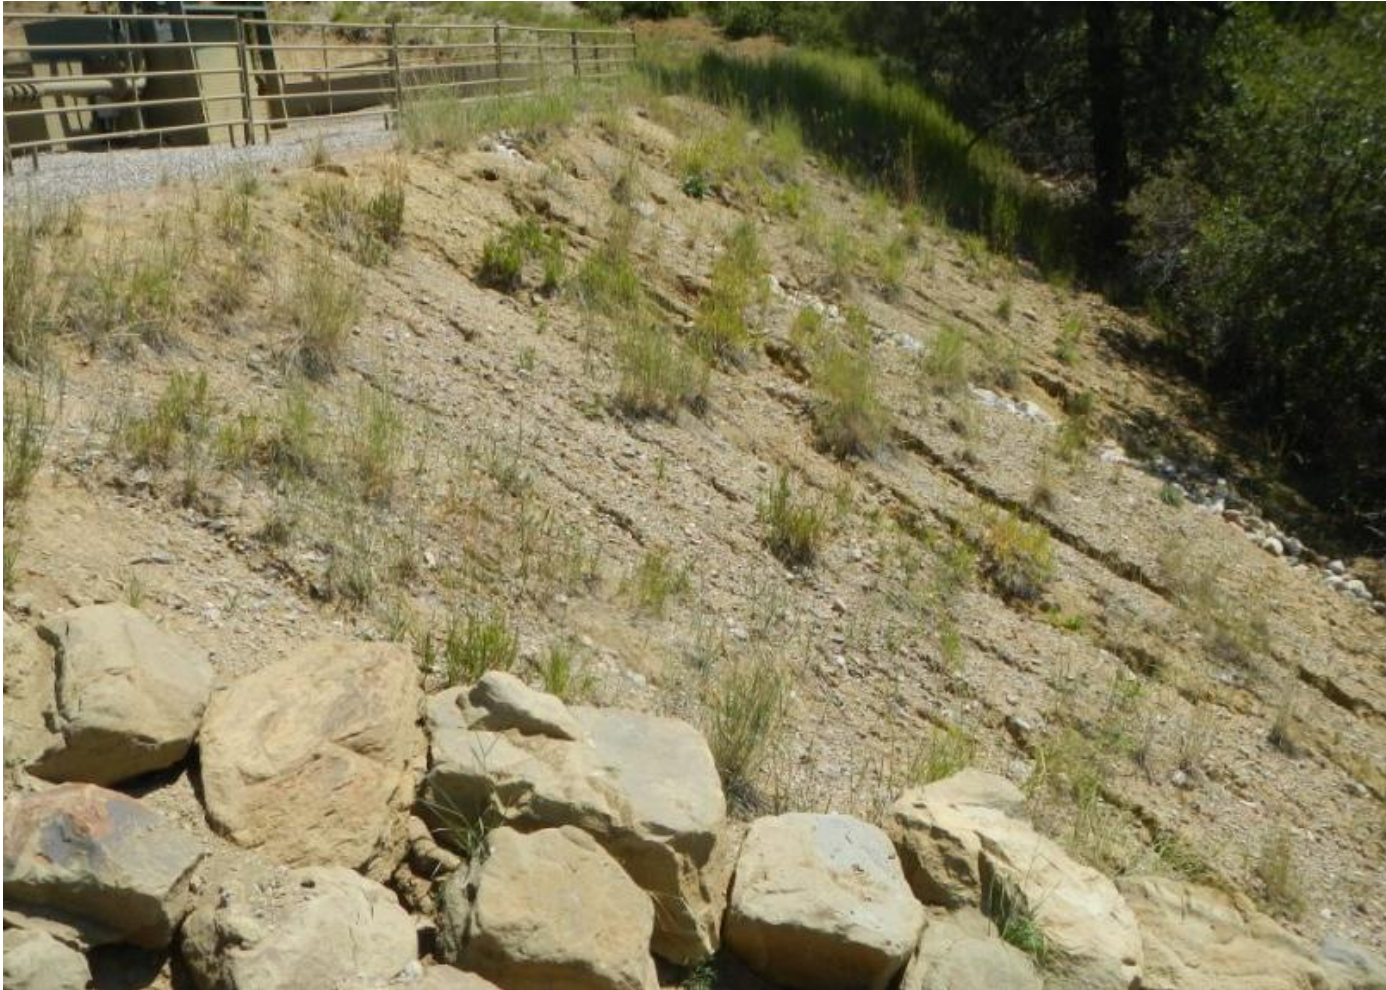
Photo 2. View of rills within the southern portion of the project area from the access road facing eastward.

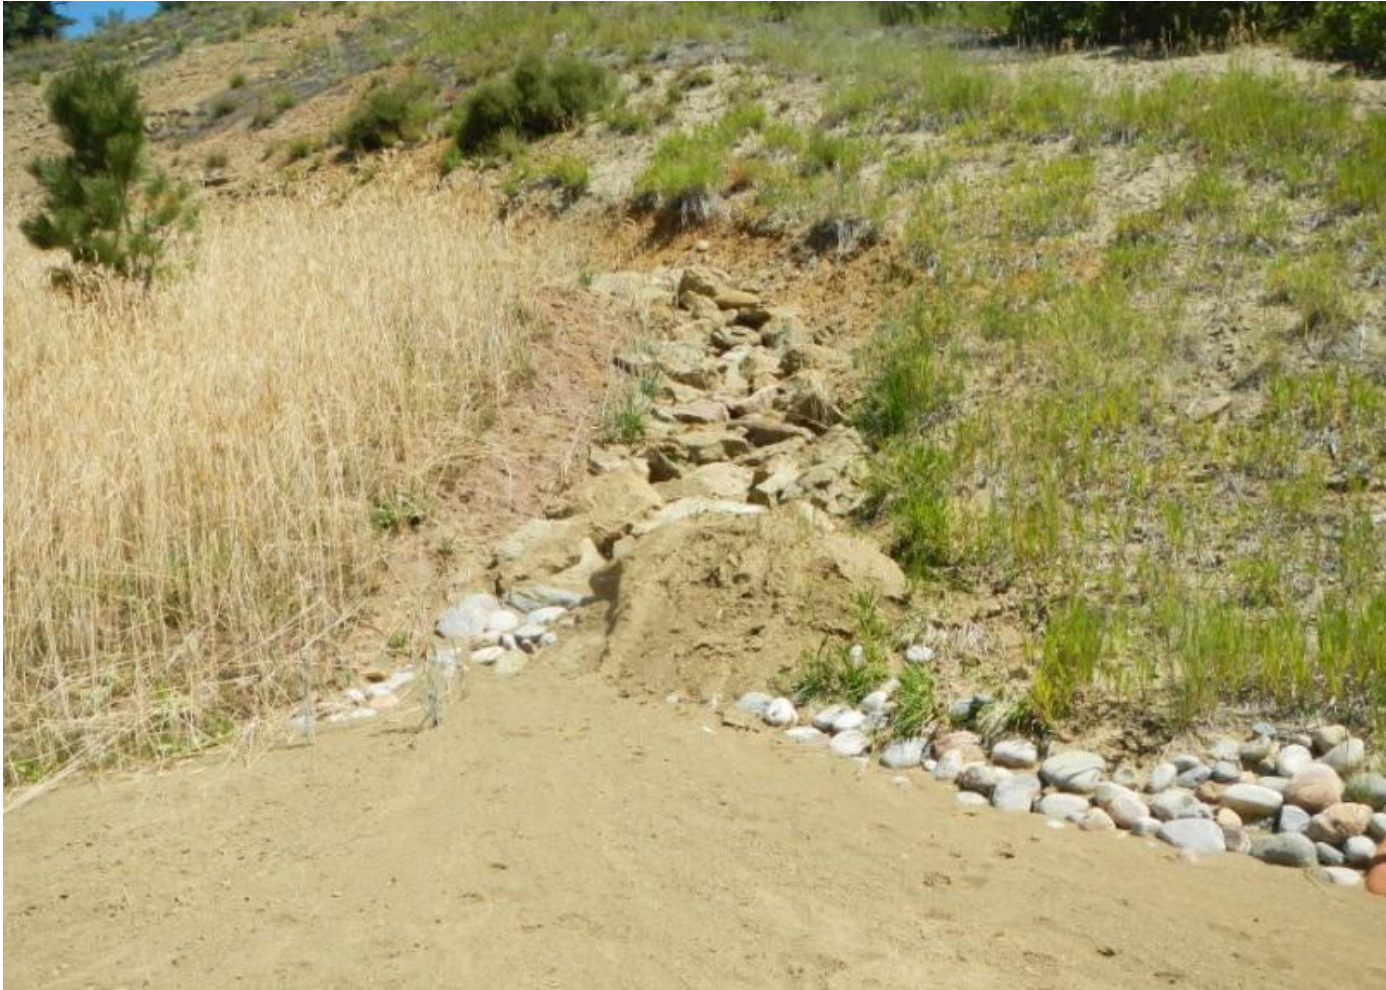
Photo 3. View of cut-slope diversion facing up-slope. Sediment plume in foreground appears to have been carried from the cut-slope and deposited here. This needs to be cleaned for continued functioning of the diversion.

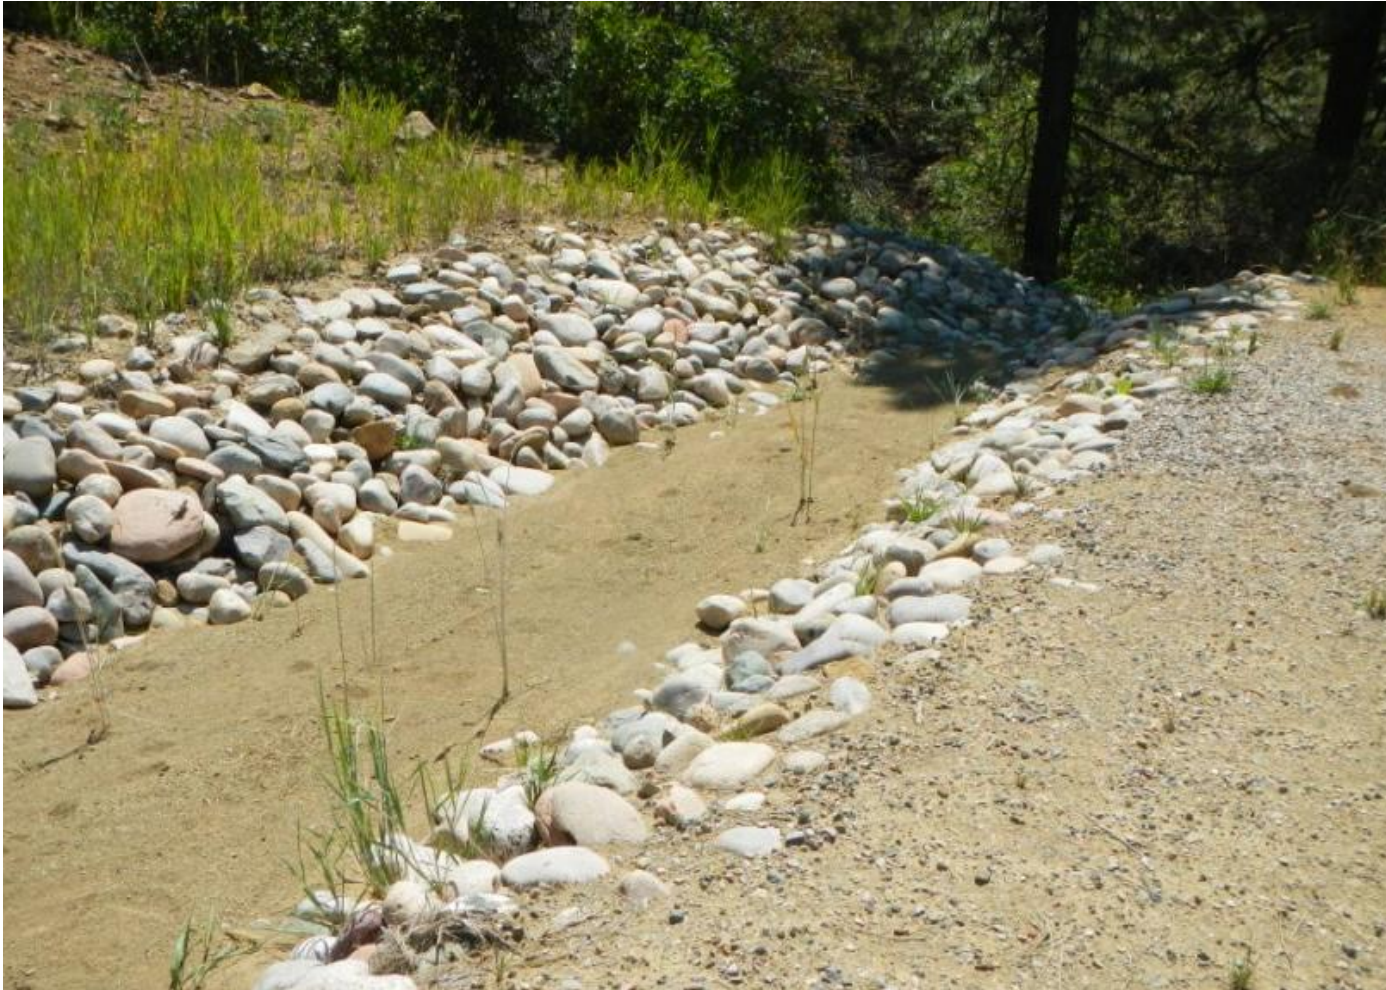
Photo 4. View of Sediment within cut-slope diversion where it flows off of the southern edge of the project area. It appears that sediment is being carried off of the project area.

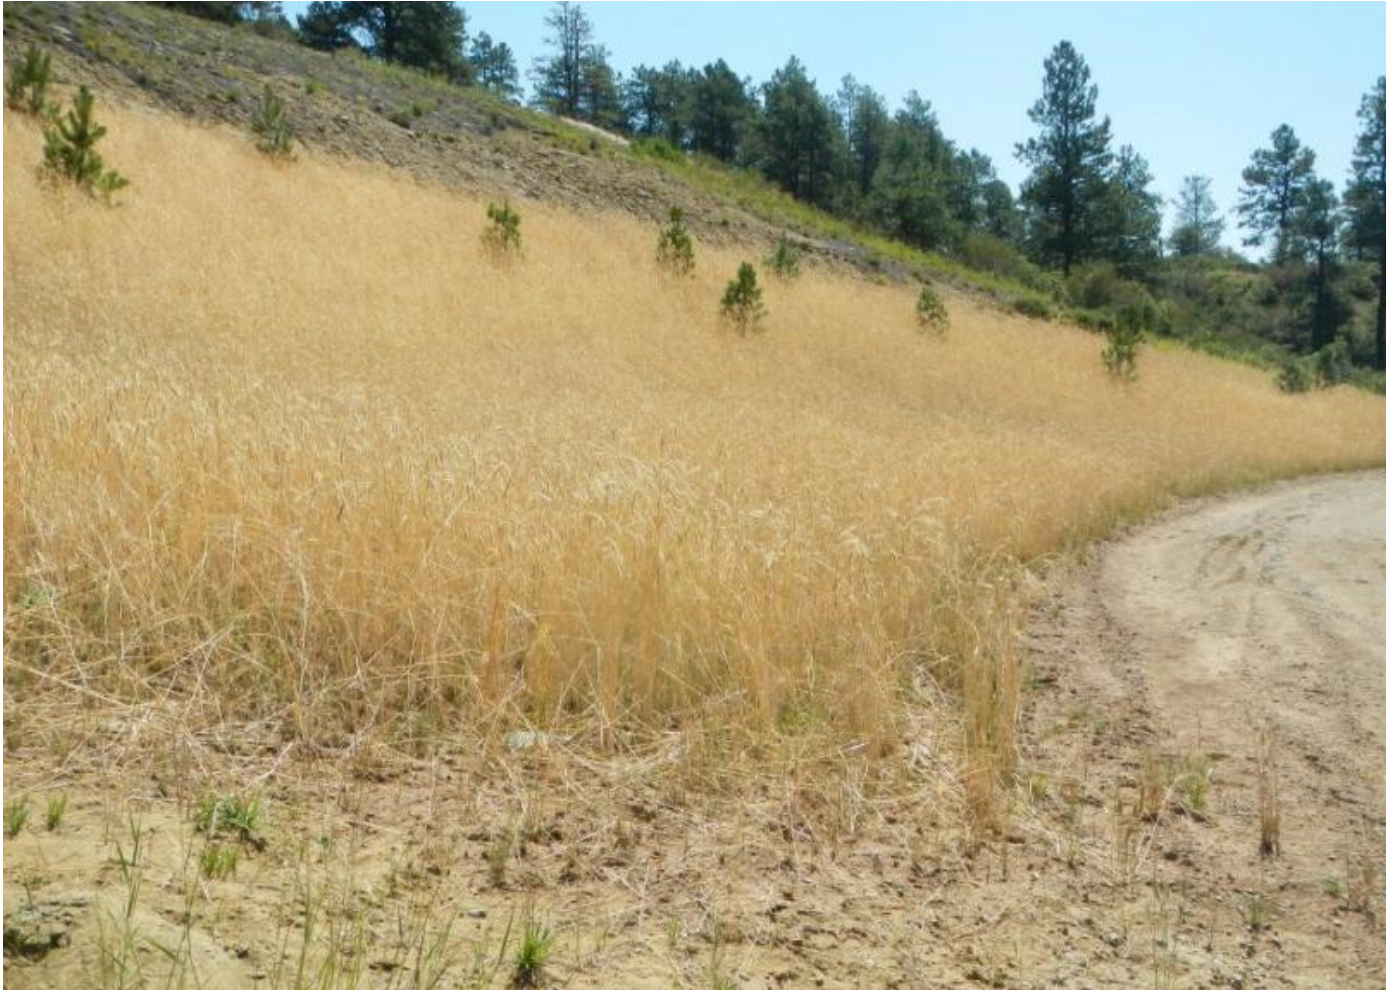
Photo 5. View of cover-crop on lower portion of cut-slope with scattered ponderosa pines (*Pinus ponderosa*). Erosion blankets can be seen in the background and appear to be in disrepair.

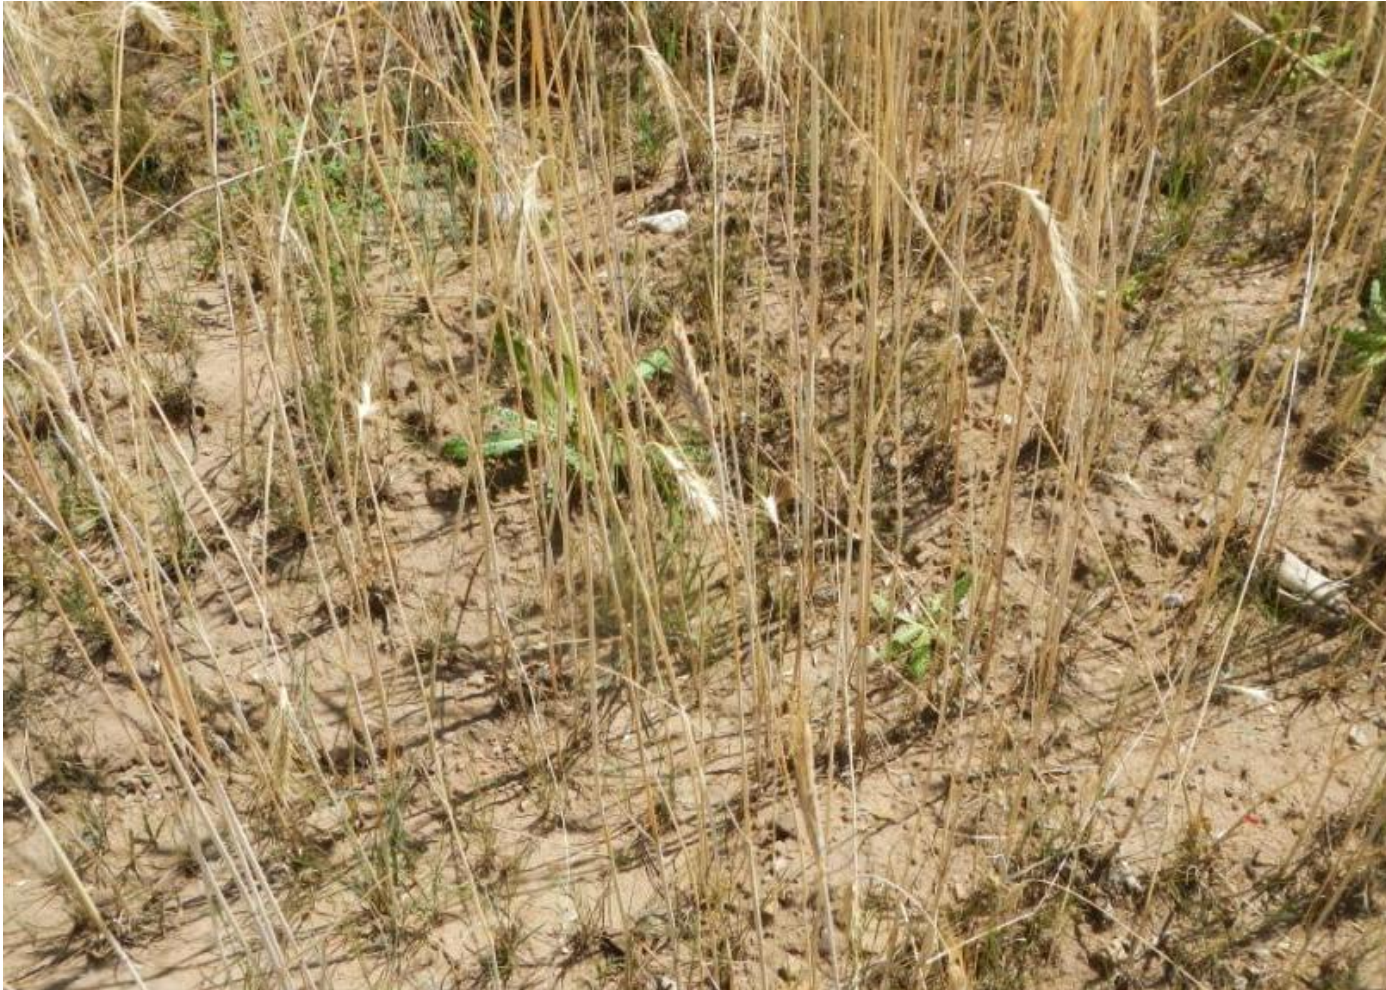
Photo 6. View of what appears to be Canada thistle (*Cirsium arvense*) rosettes growing in the understory of the annual cover-crop. Hundreds of these rosettes were observed.
