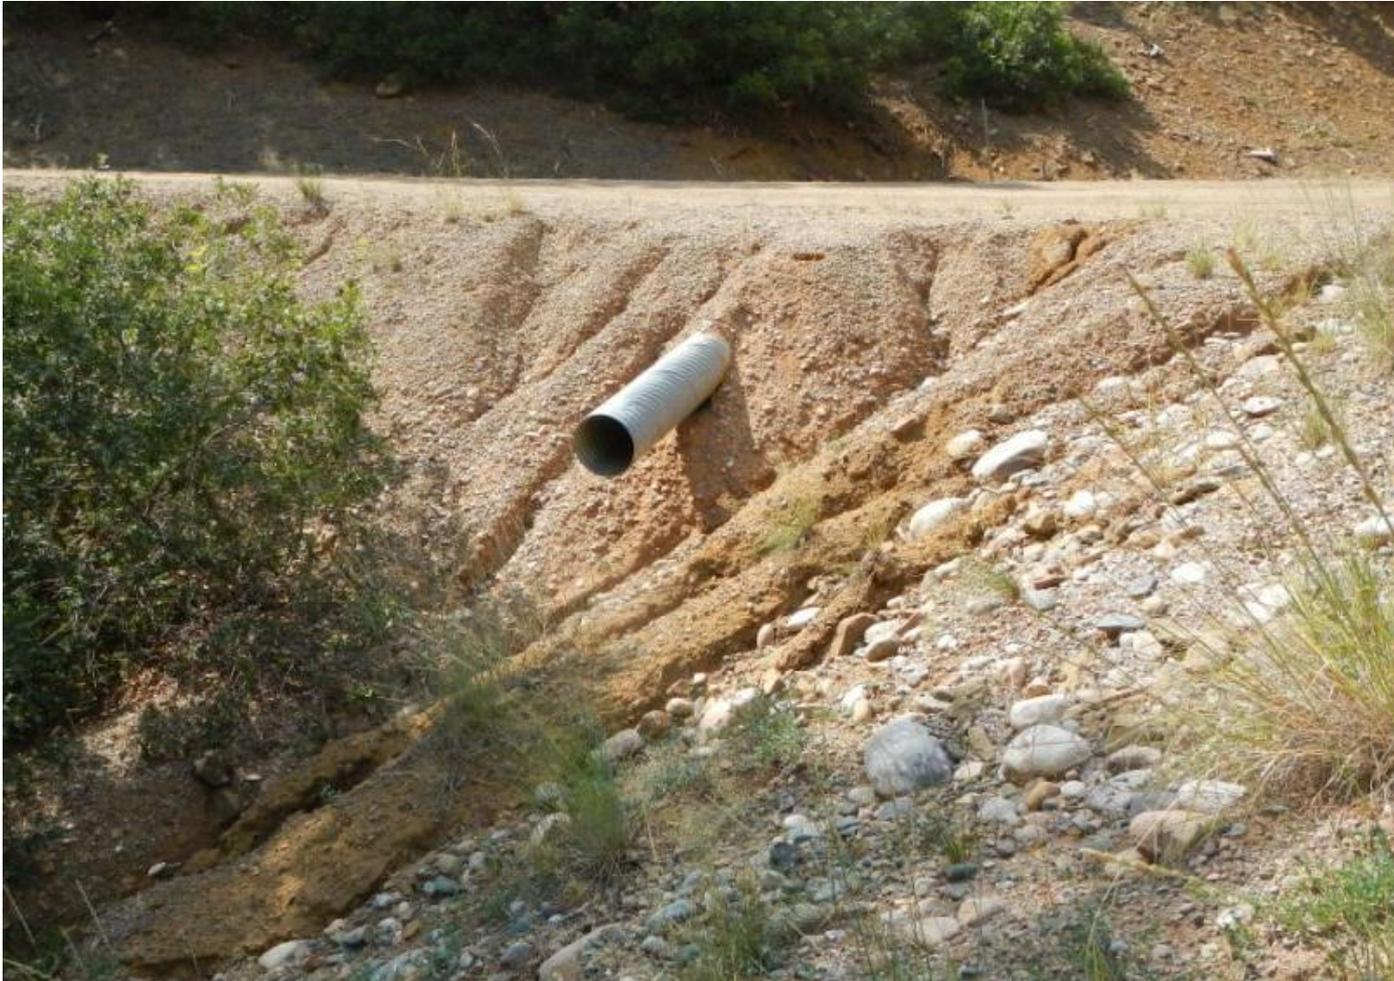
Photo 1. View of erosion at culvert outlet facing toward access road at entrance. Erosional channels are approximately 1 to 2 feet wide and deep.

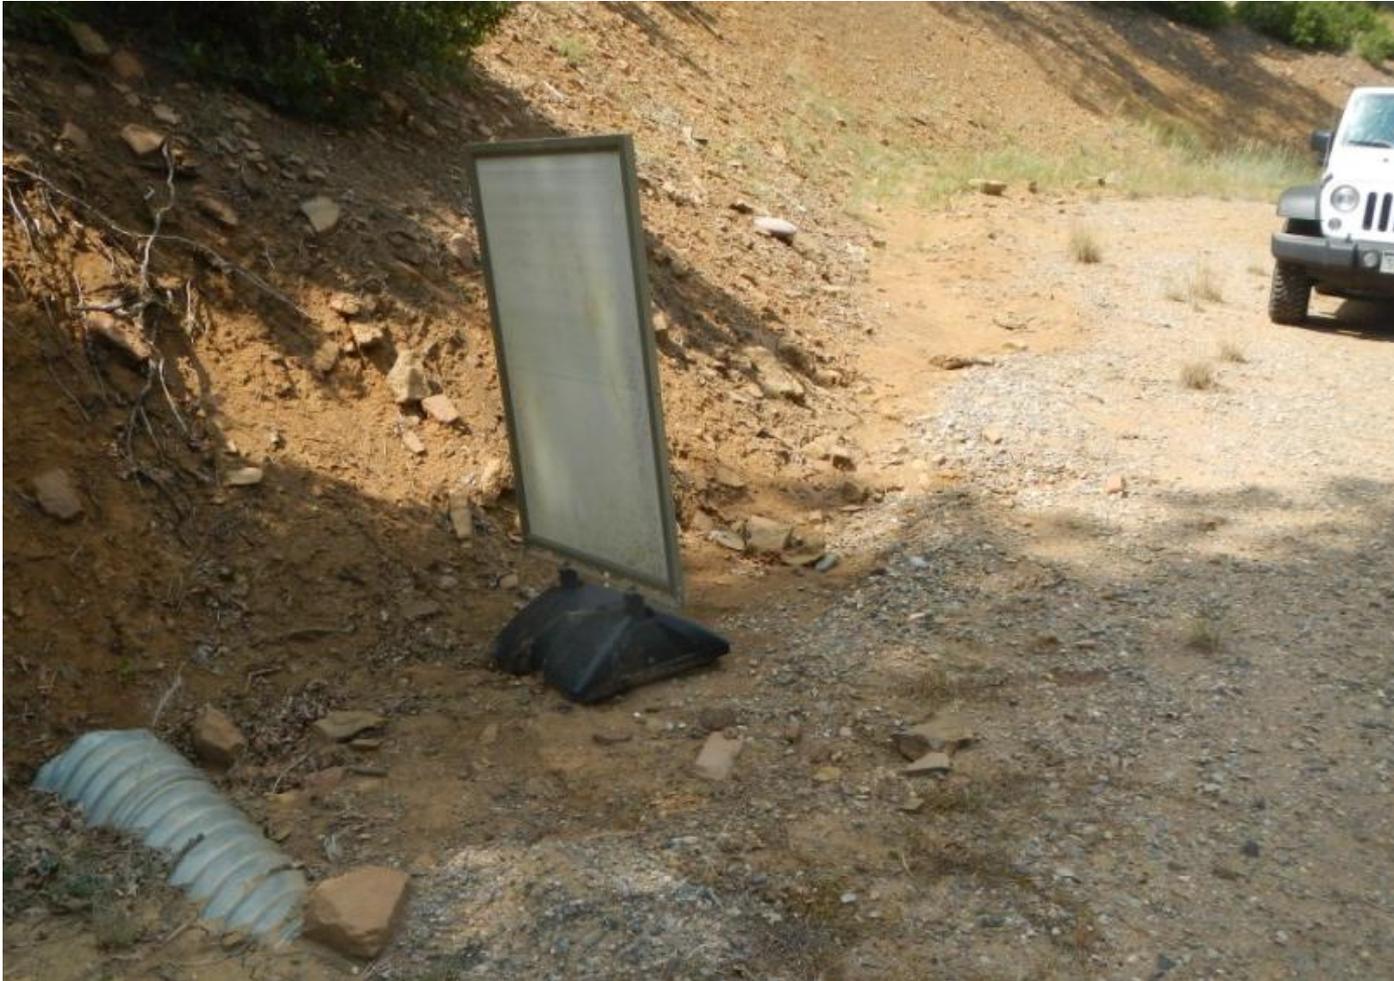
Photo 2. View of culvert and diversion that is full of sediment and not large enough for capacity. It appears that stormwater flows circumvent the culvert here and flow over the road, eroding the fill slope at the culvert outlet shown in Photo 1.

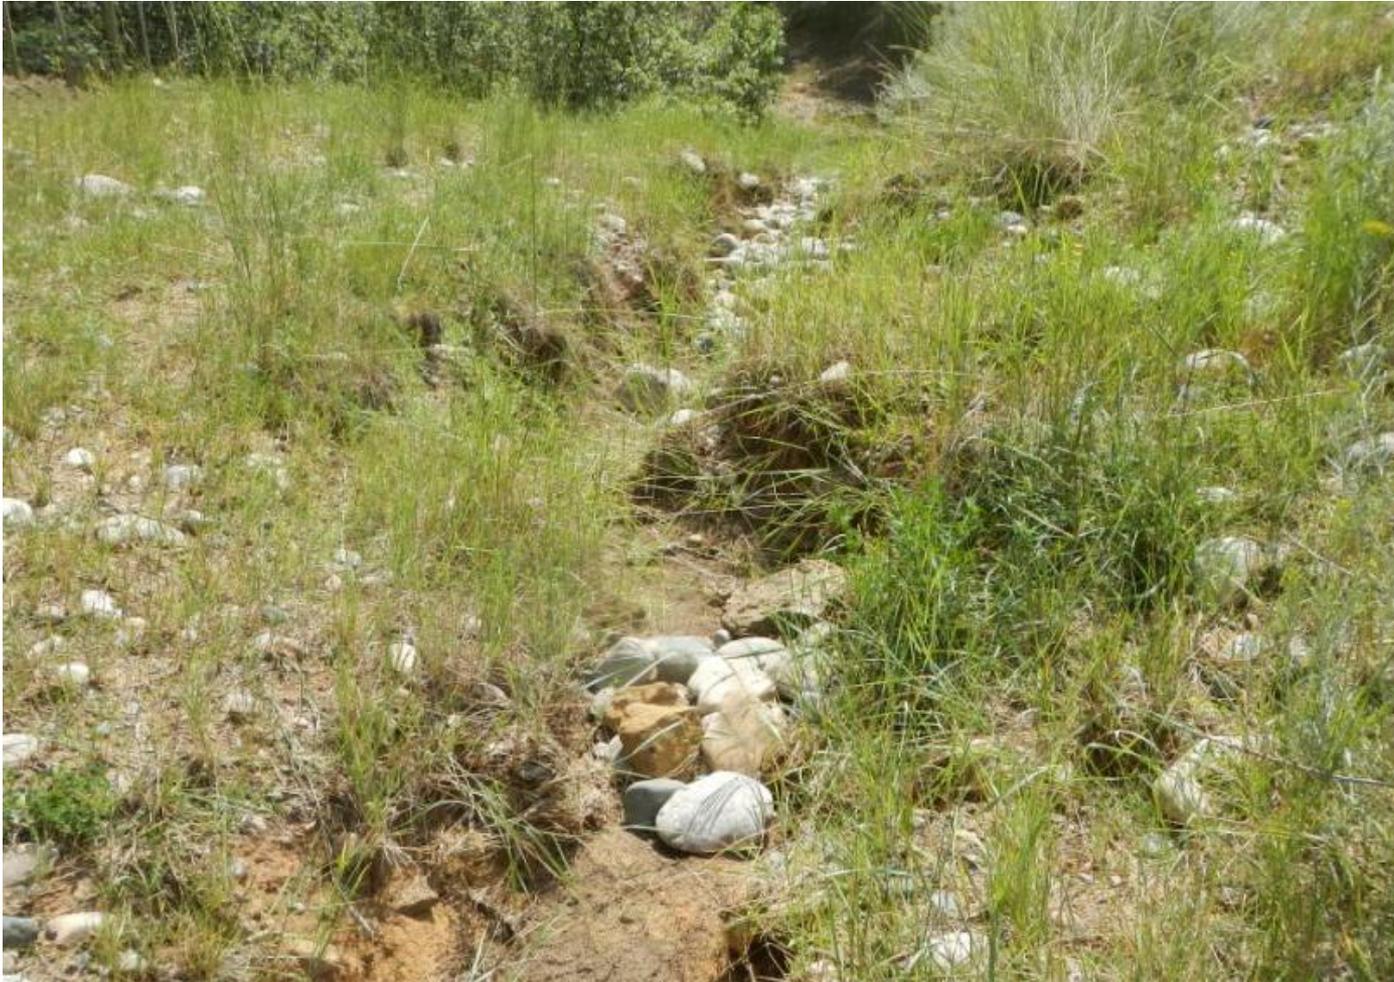
Photo 3. View of headcut that is approximately 2 to 4 feet wide and deep, within the eastern portion of the project area.

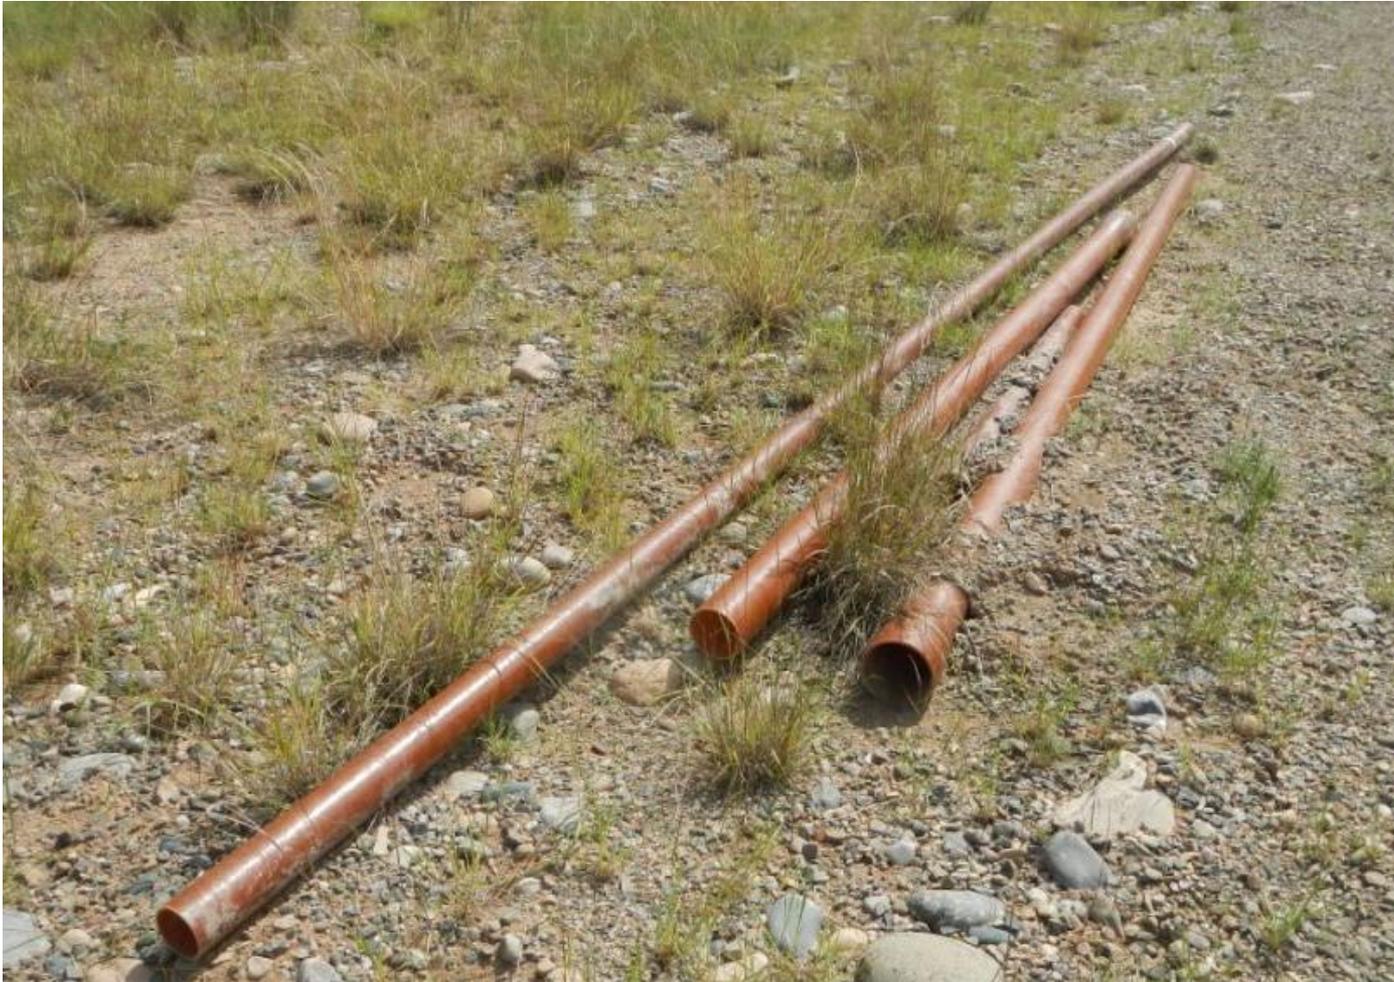
Photo 4. View of unused pipe material on the eastern edge of the working area.

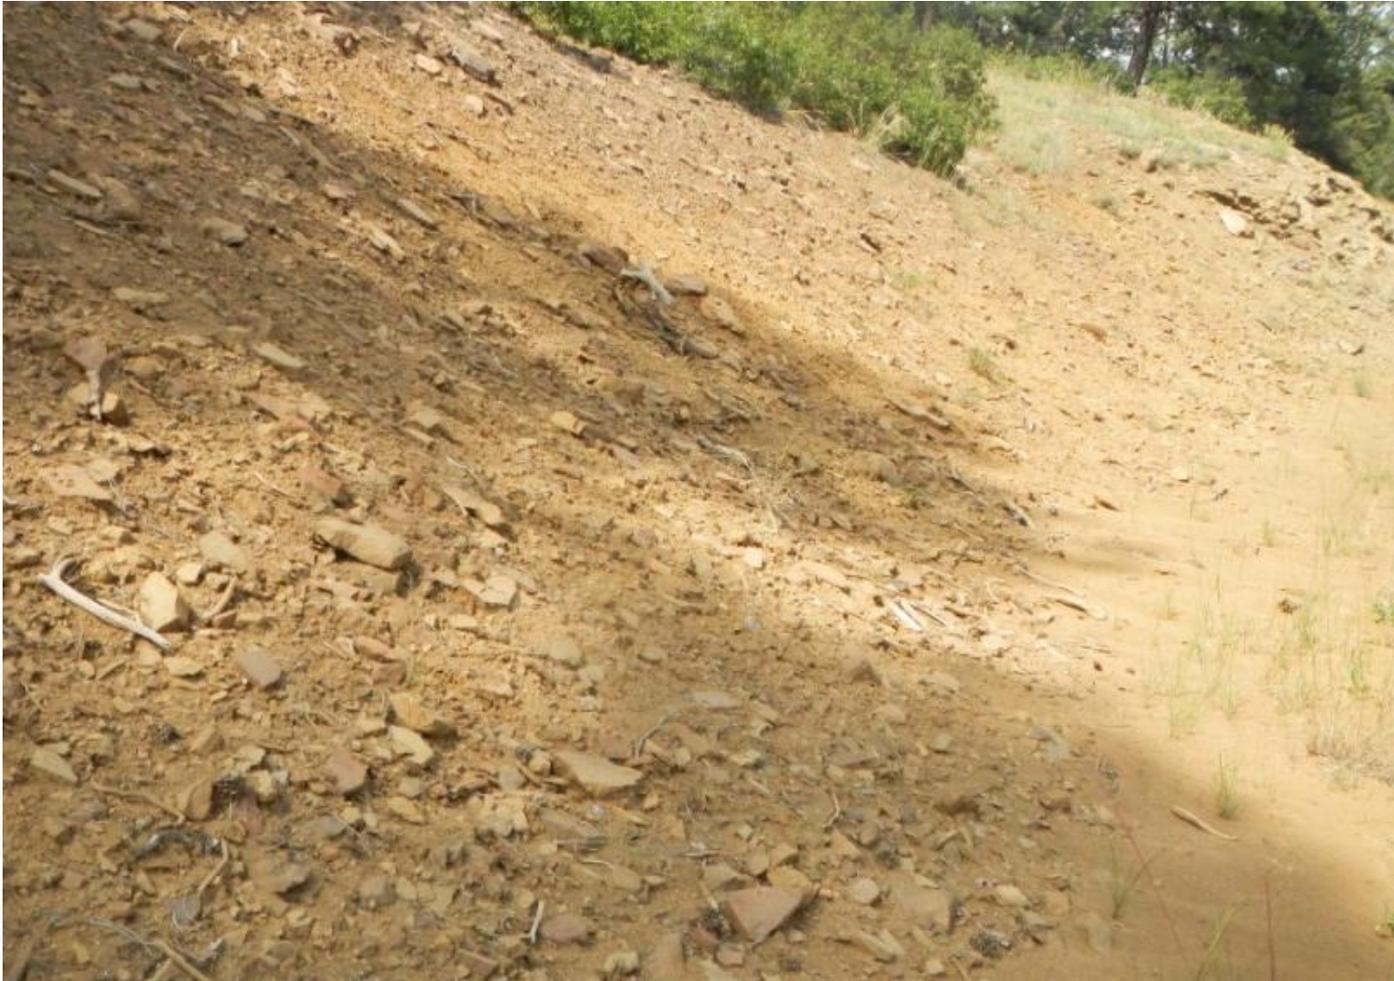
Photo 5. View of poor revegetation in the western portion of the project area. This should be monitored and re-seeded if needed.

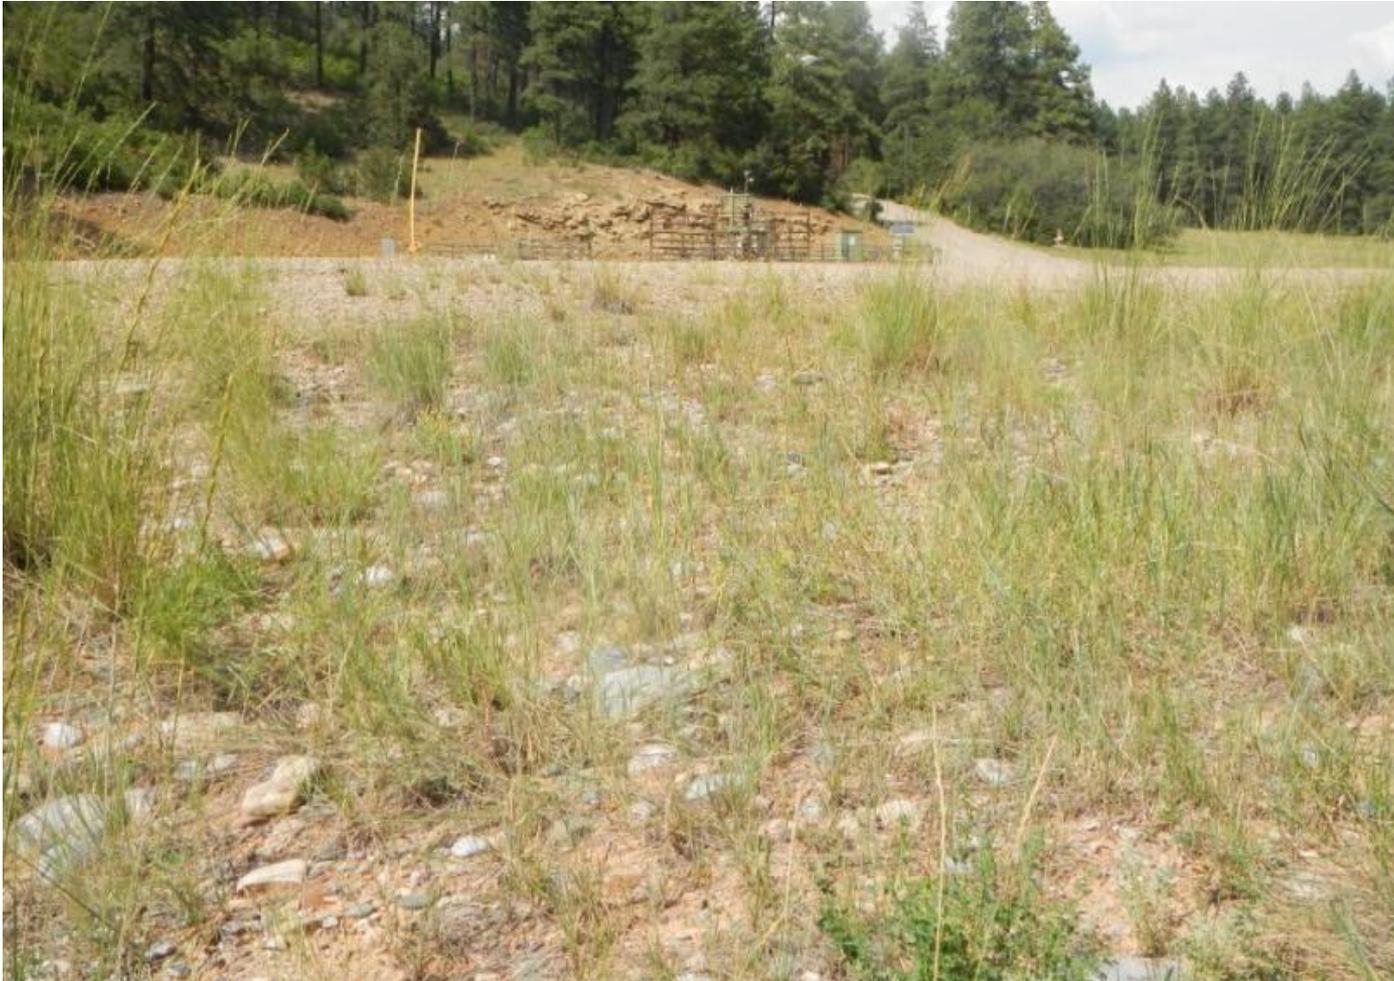
Photo 6. View from southeastern corner of well pad facing center. Revegetation is progressing within the eastern portion of the project area.
