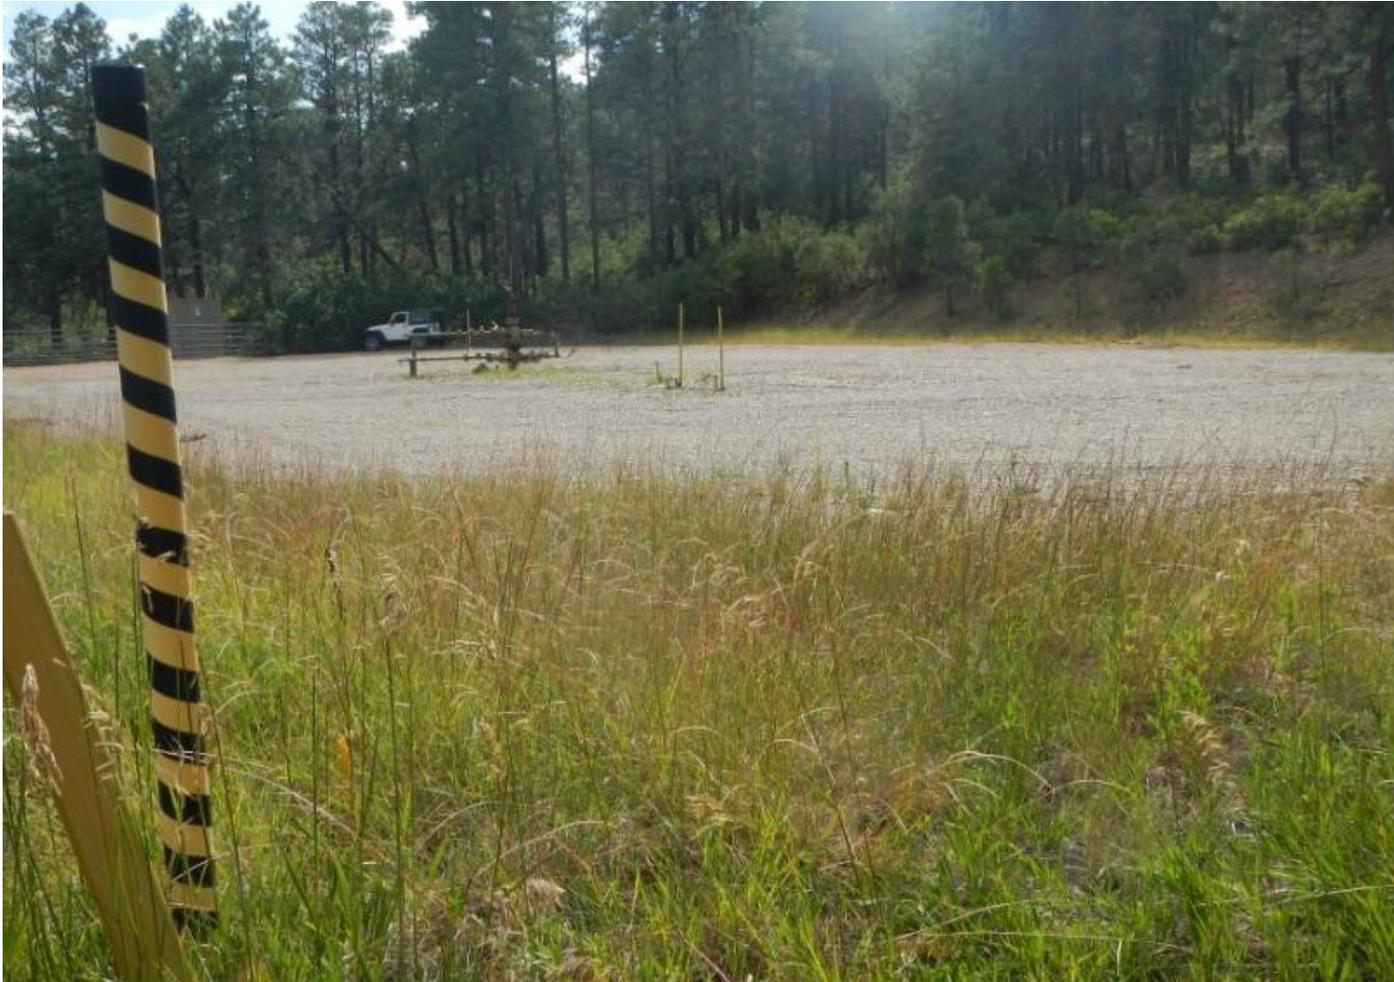
Photo 1. View from northeastern corner of project area facing center. Grasses such as smooth brome (*Bromus inermis*) and dropseed (*Sporobolus* sp.) are established here.

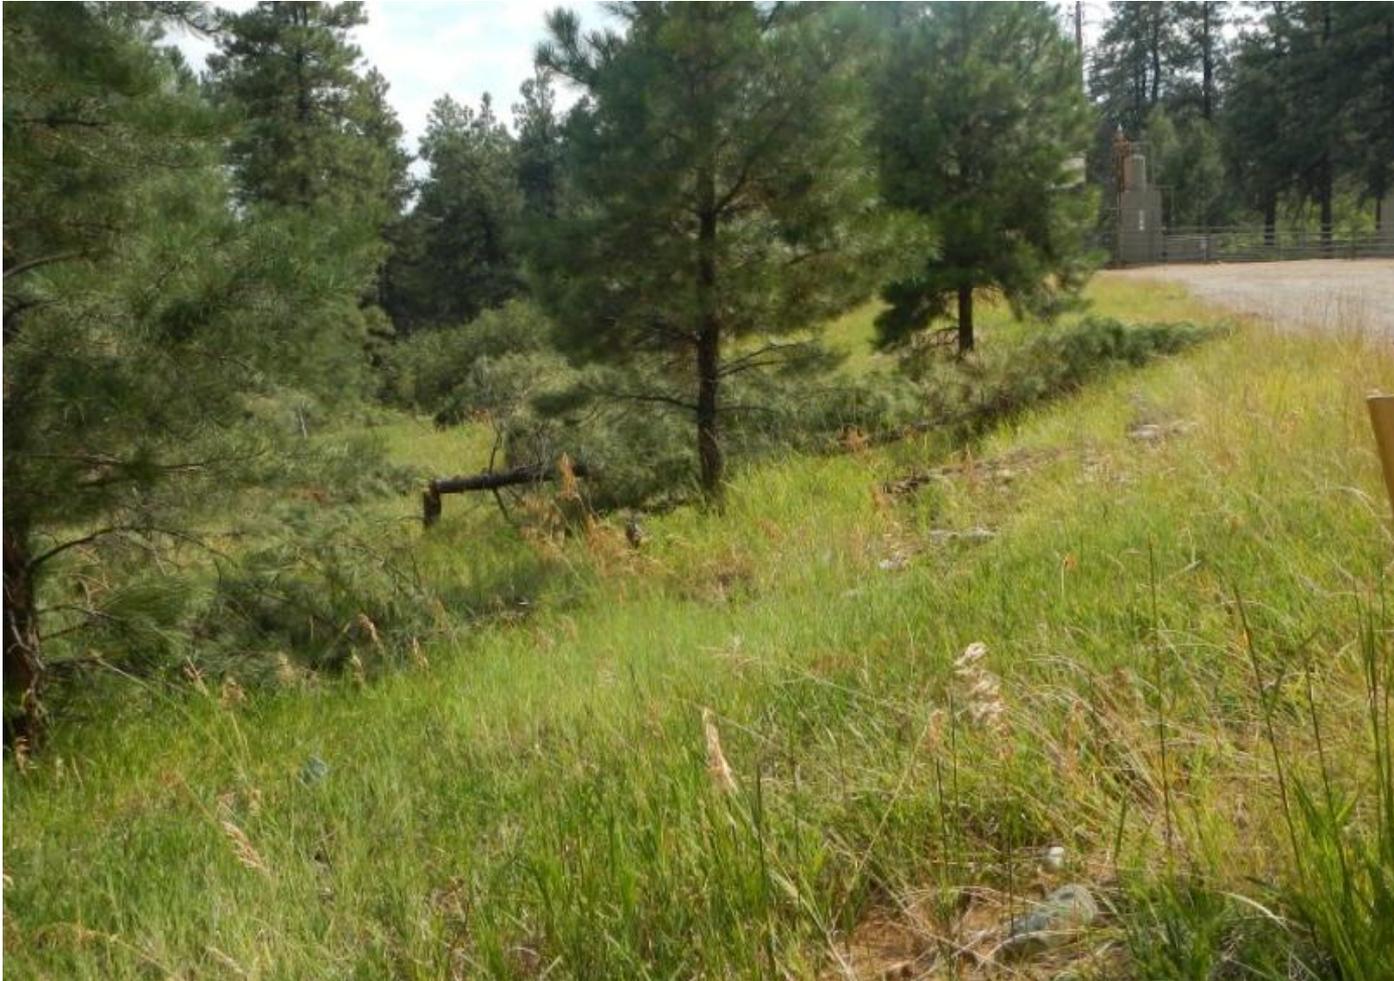
Photo 2. View of eastern portion of project area from northeastern corner facing southward.

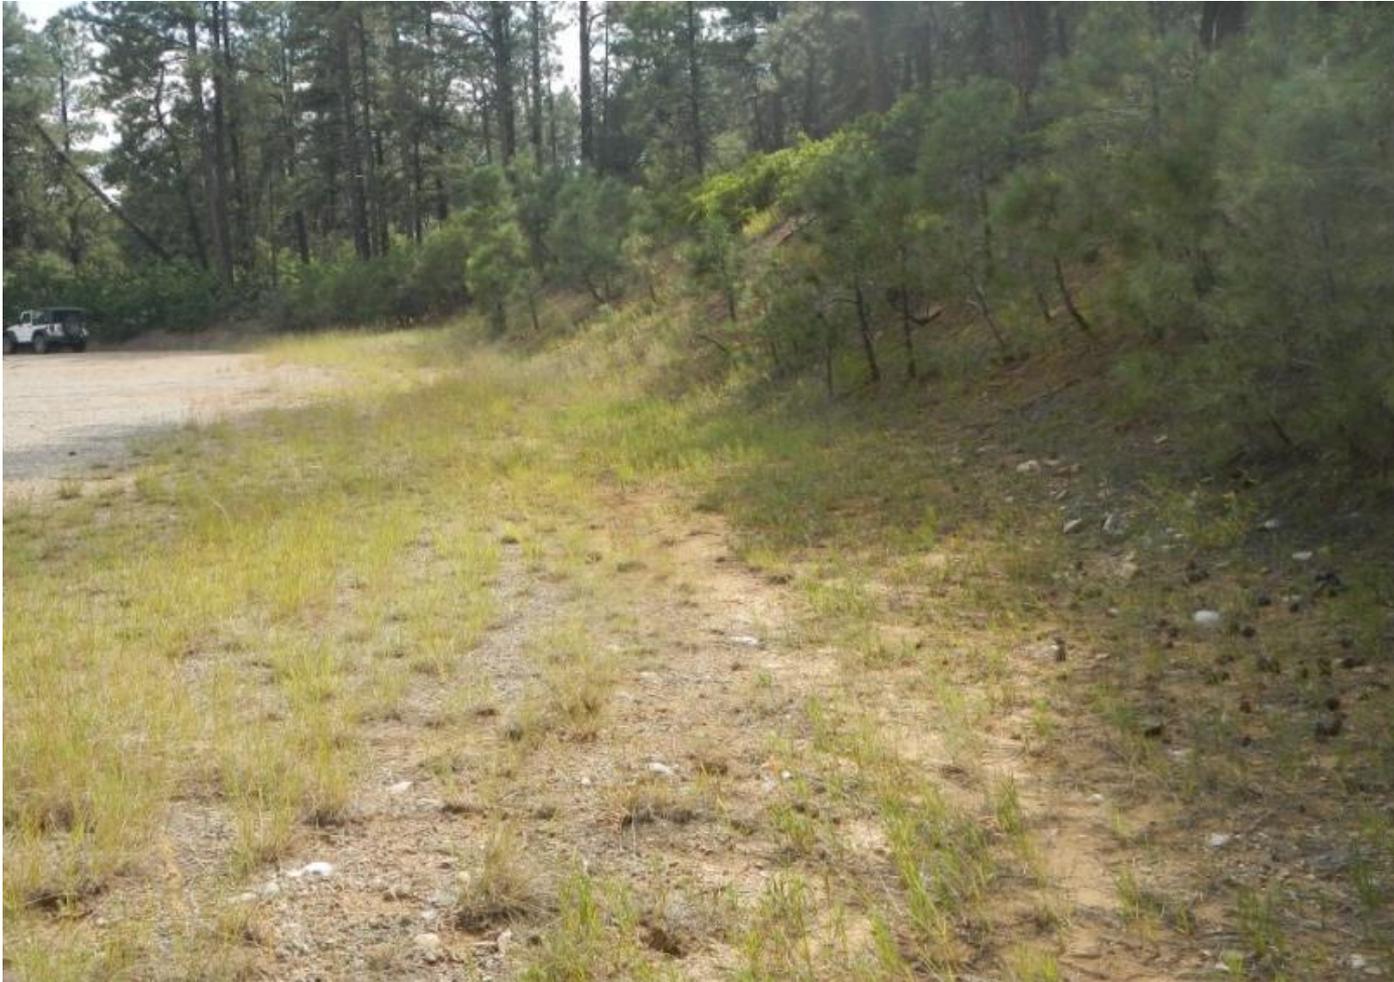
Photo 3. View of western portion of project area from northwestern corner facing southward. Vegetation on slopes and flat surface appear to be effectively stabilizing the cut-slope.

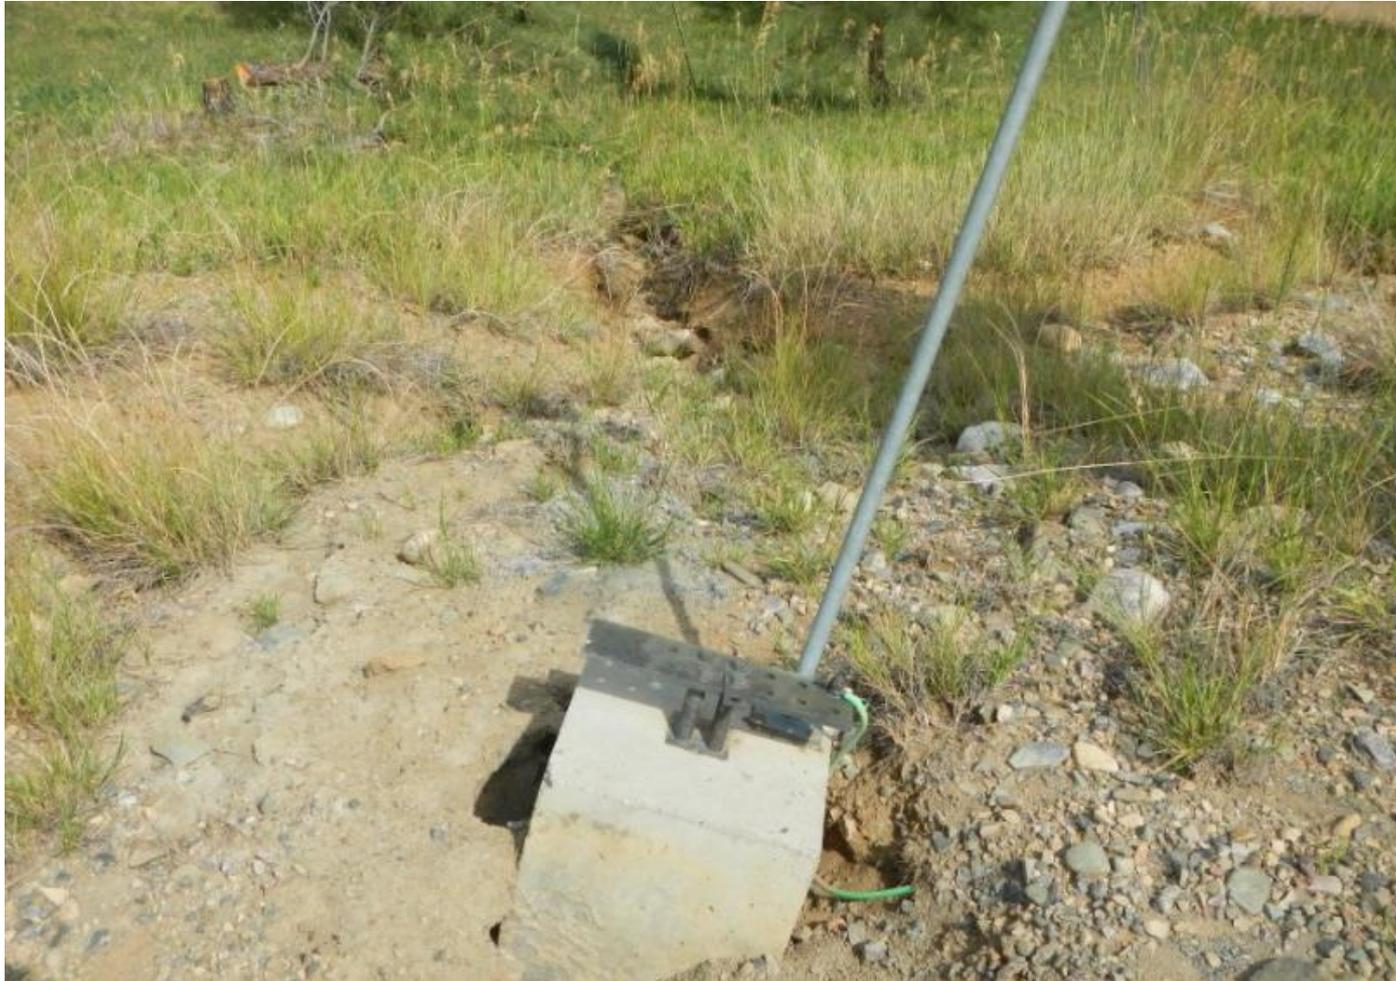
Photo 4. View of stormwater erosion occurring around project facilities in the eastern portion of the project area. This should be stabilized.
