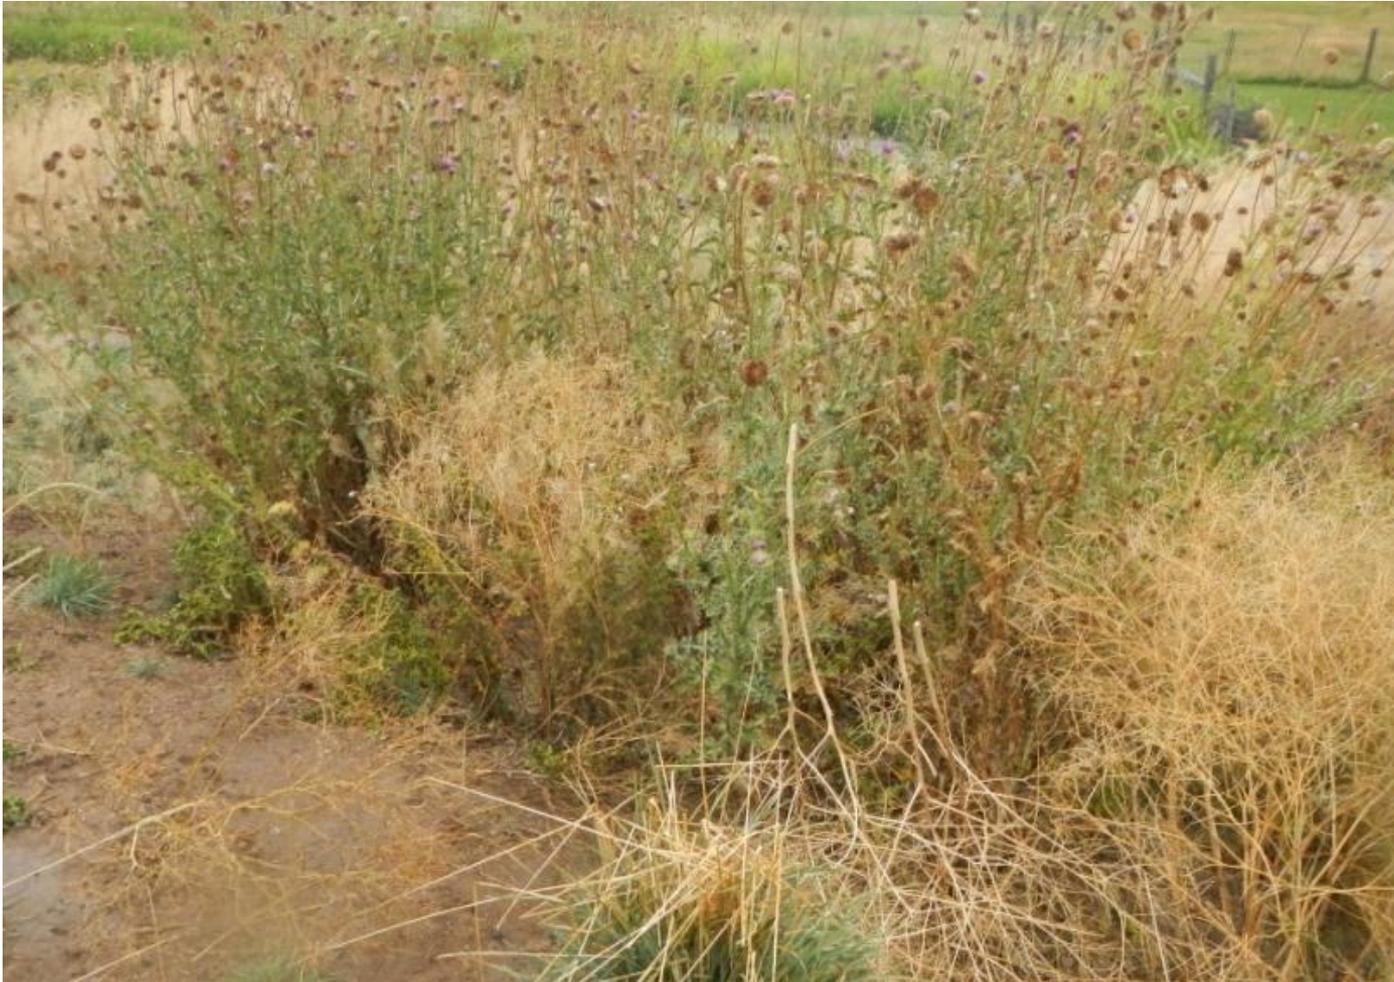
Photo 1. View of musk thistles (*Carduus nutans*) within the interim reclamation area.

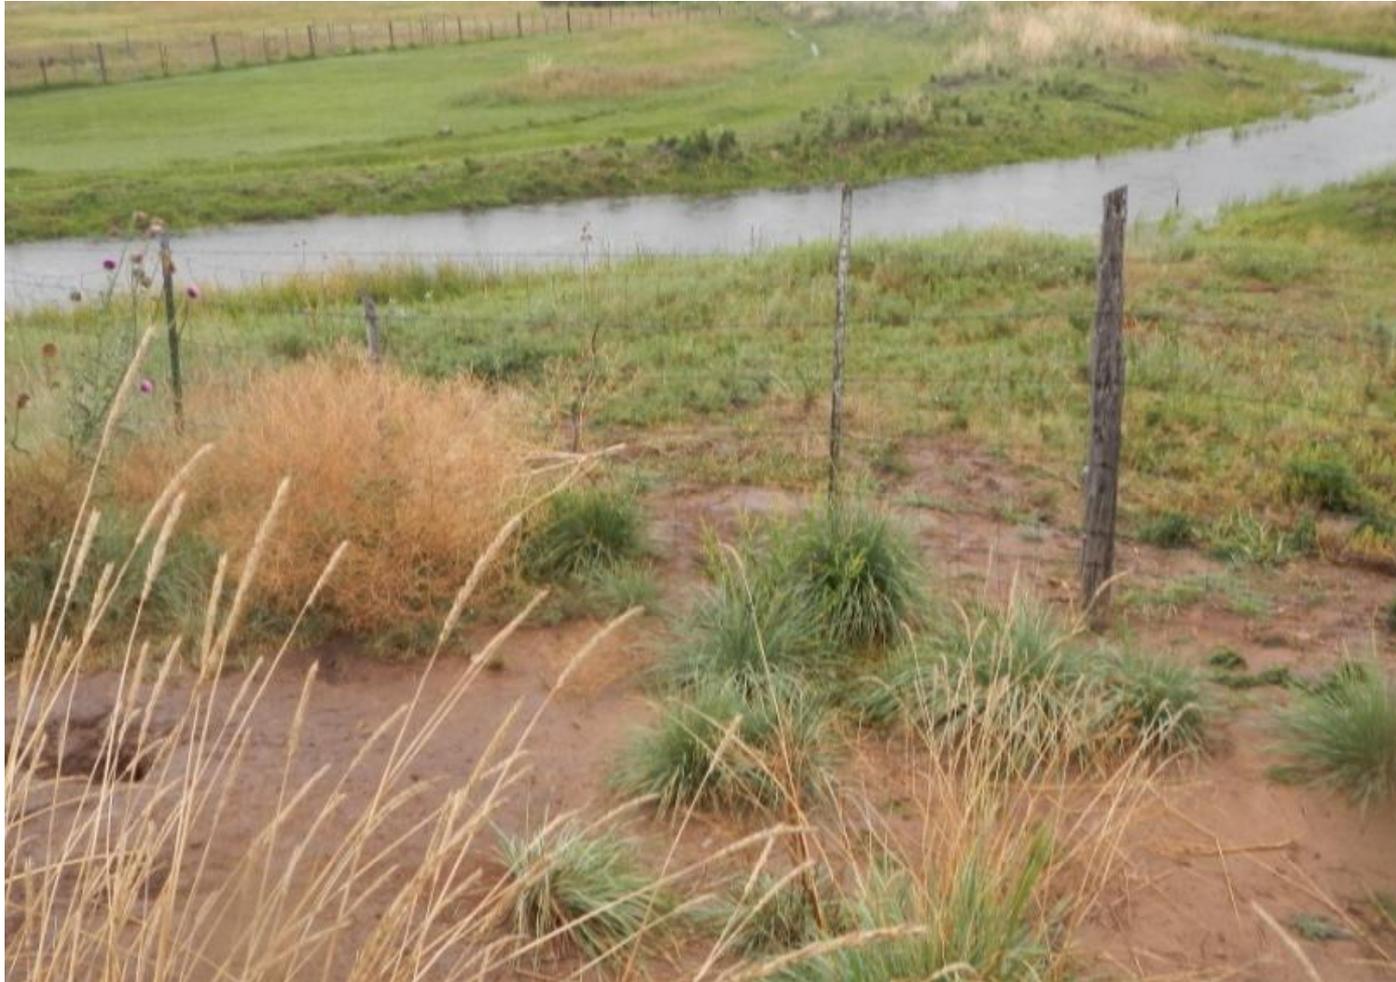
Photo 2. View of gaps in revegetation (foreground), what appears to be sediment transported outside of the project area (mid-ground), and irrigation canal adjacent to project area (background).

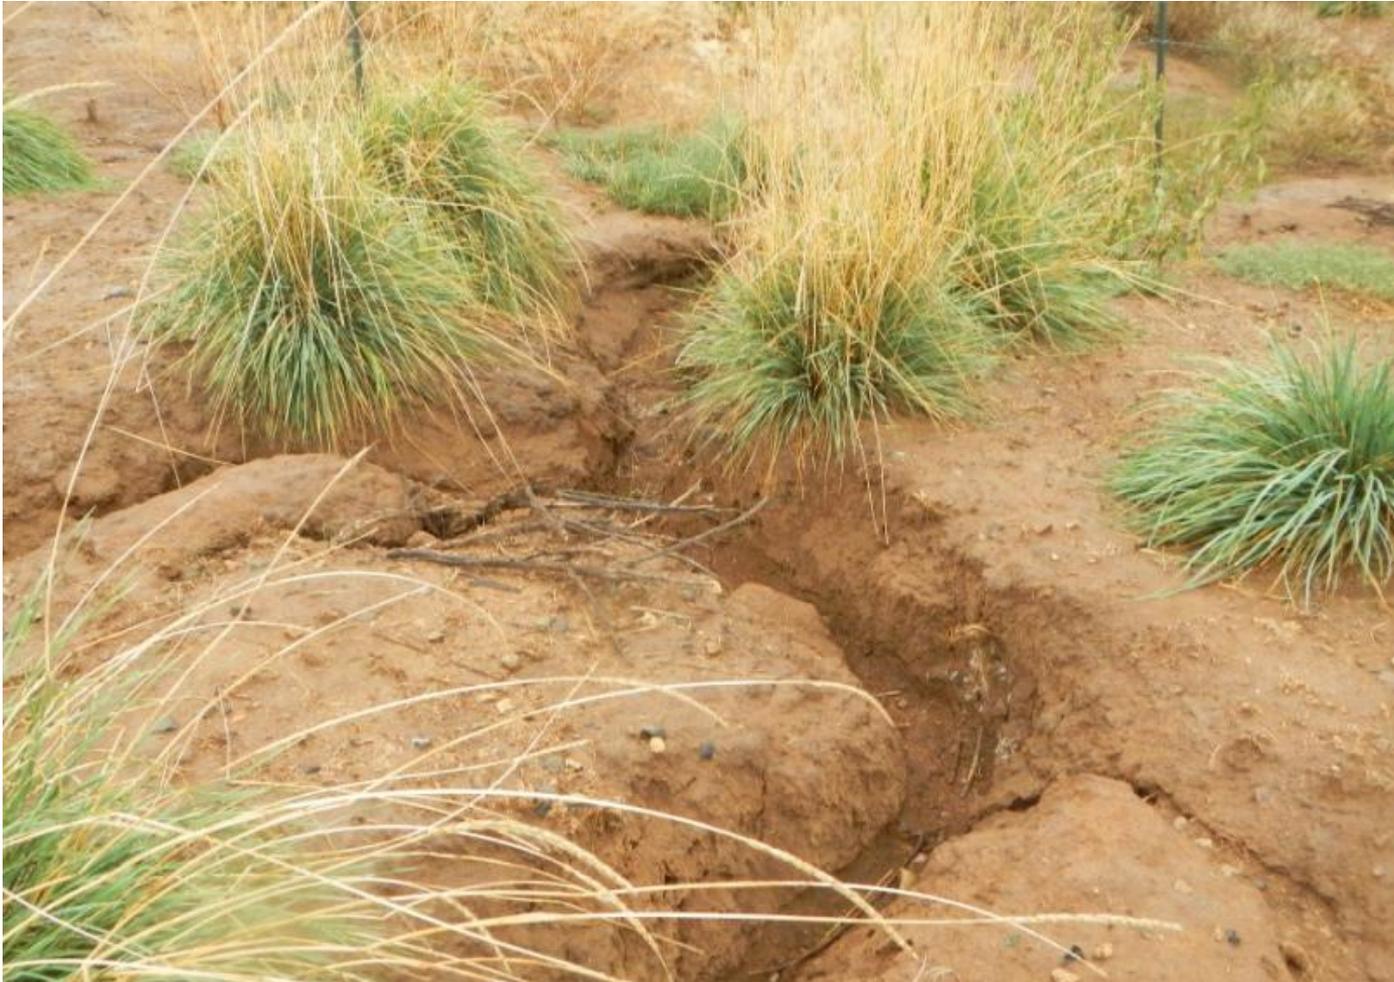
Photo 3. View of erosional channels approximately 18 inches wide and deep formed between vegetation gaps within northern portion of the project area.

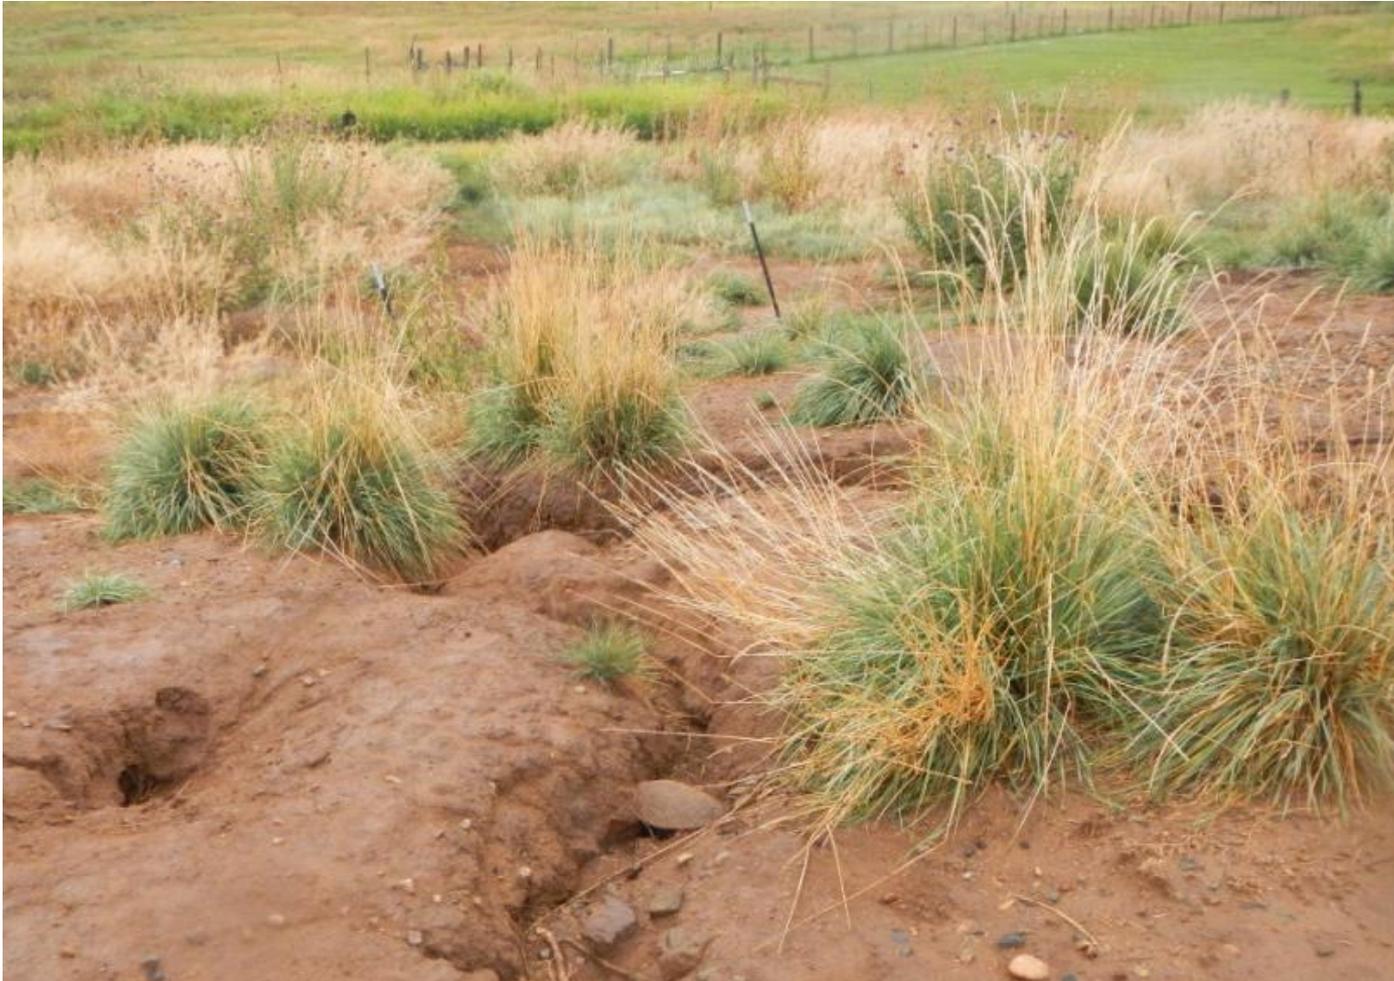
Photo 4. View of erosional channels in northern portion of project area flowing toward irrigation canal in background.
