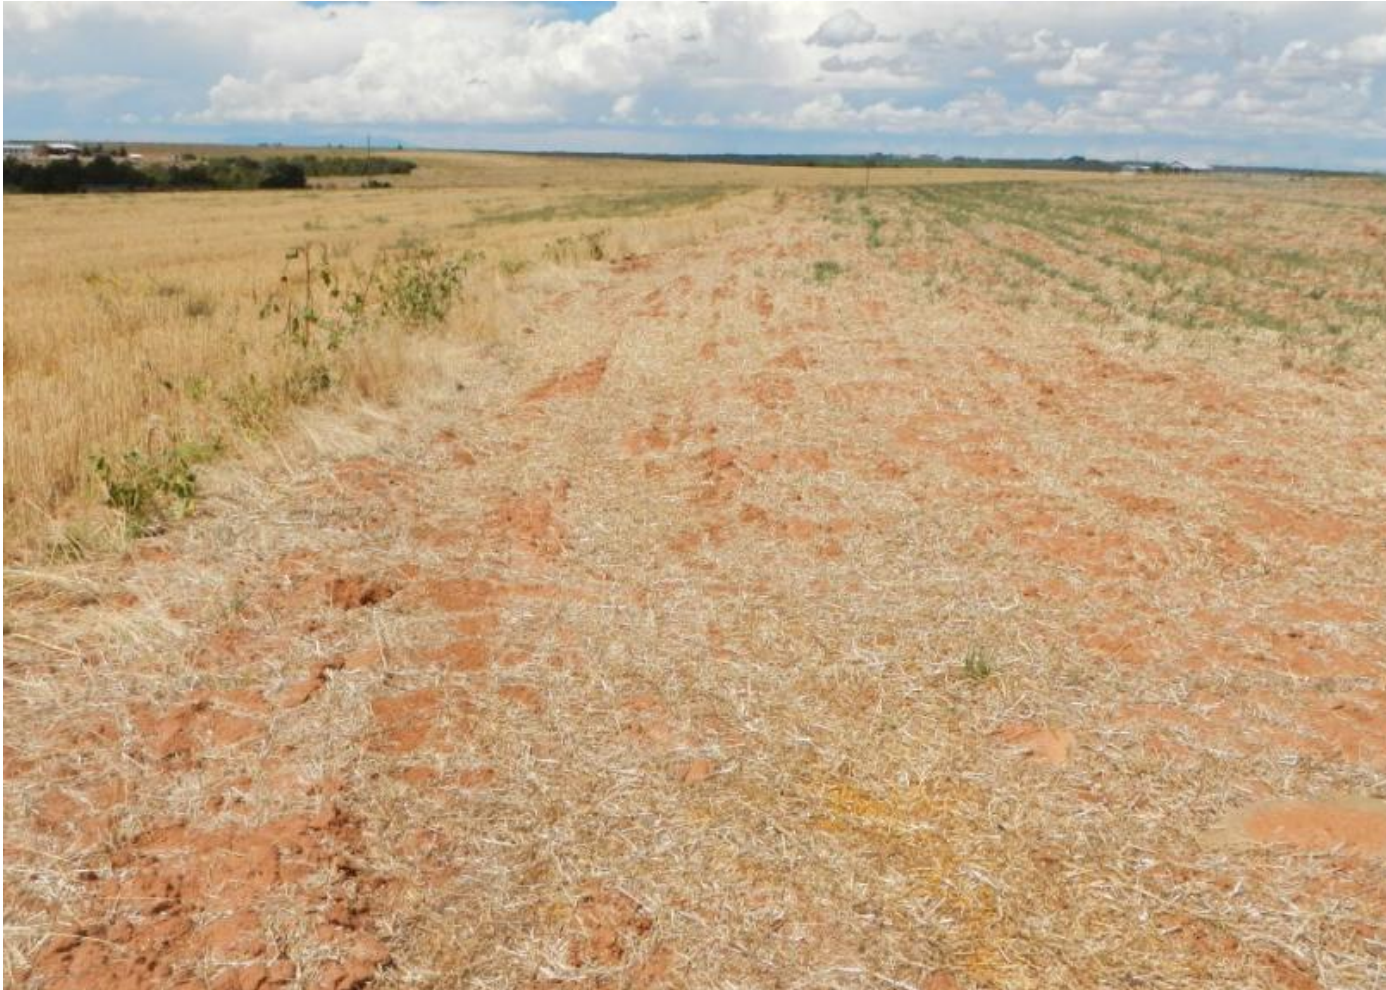
Photo 1. View of western portion of project area from southwestern corner facing northward. Straw mulch and young grass plants are present in this area.

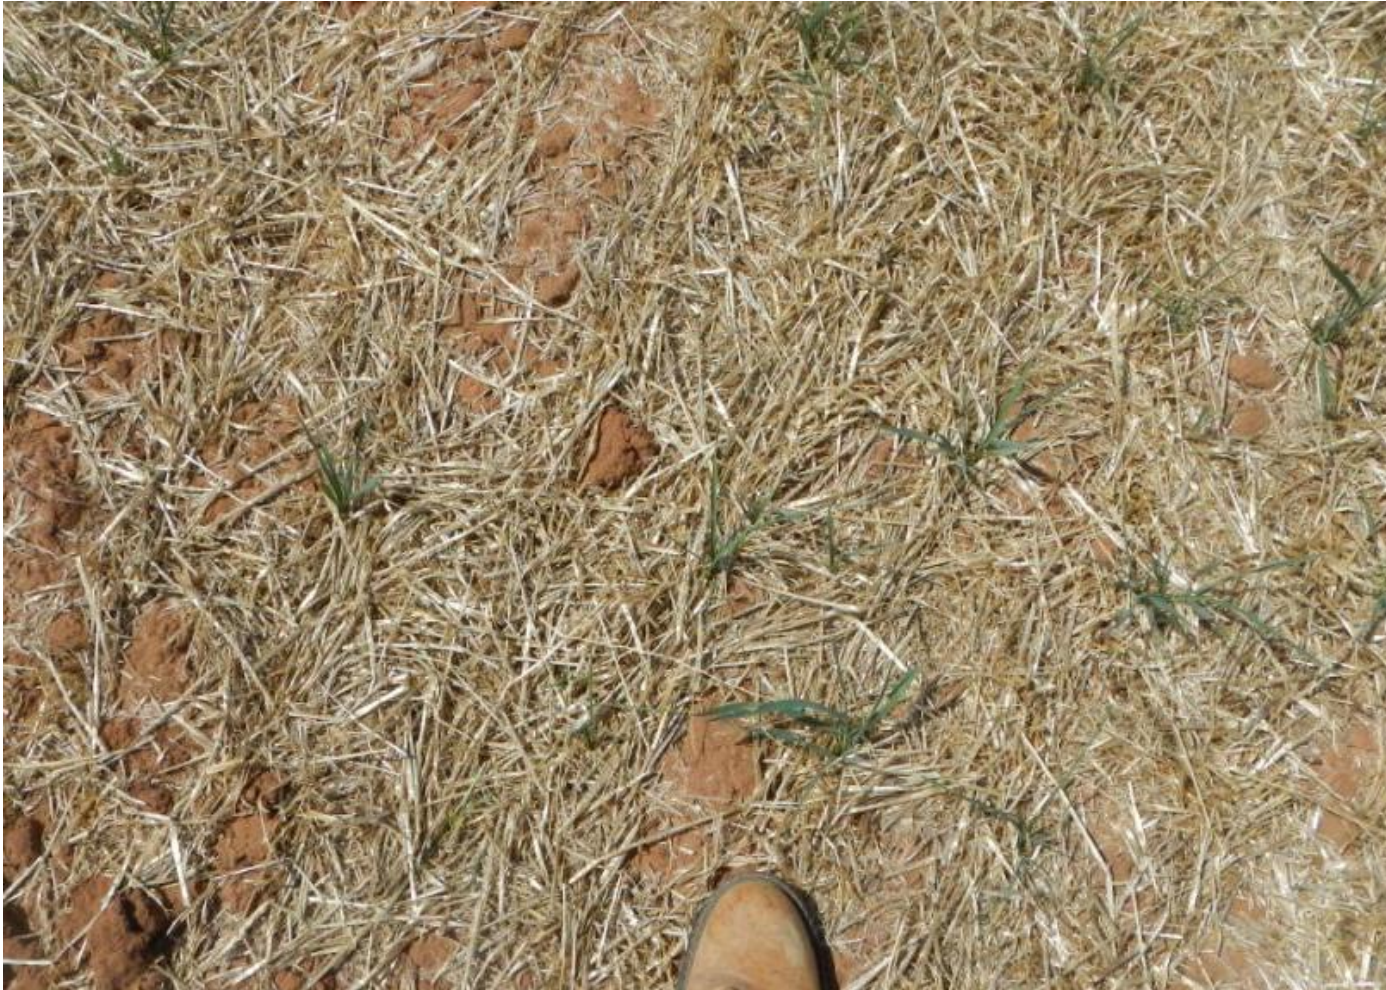
Photo 2. Birdseye view of revegetation within western portion of project area where young grass plants are starting to become established.

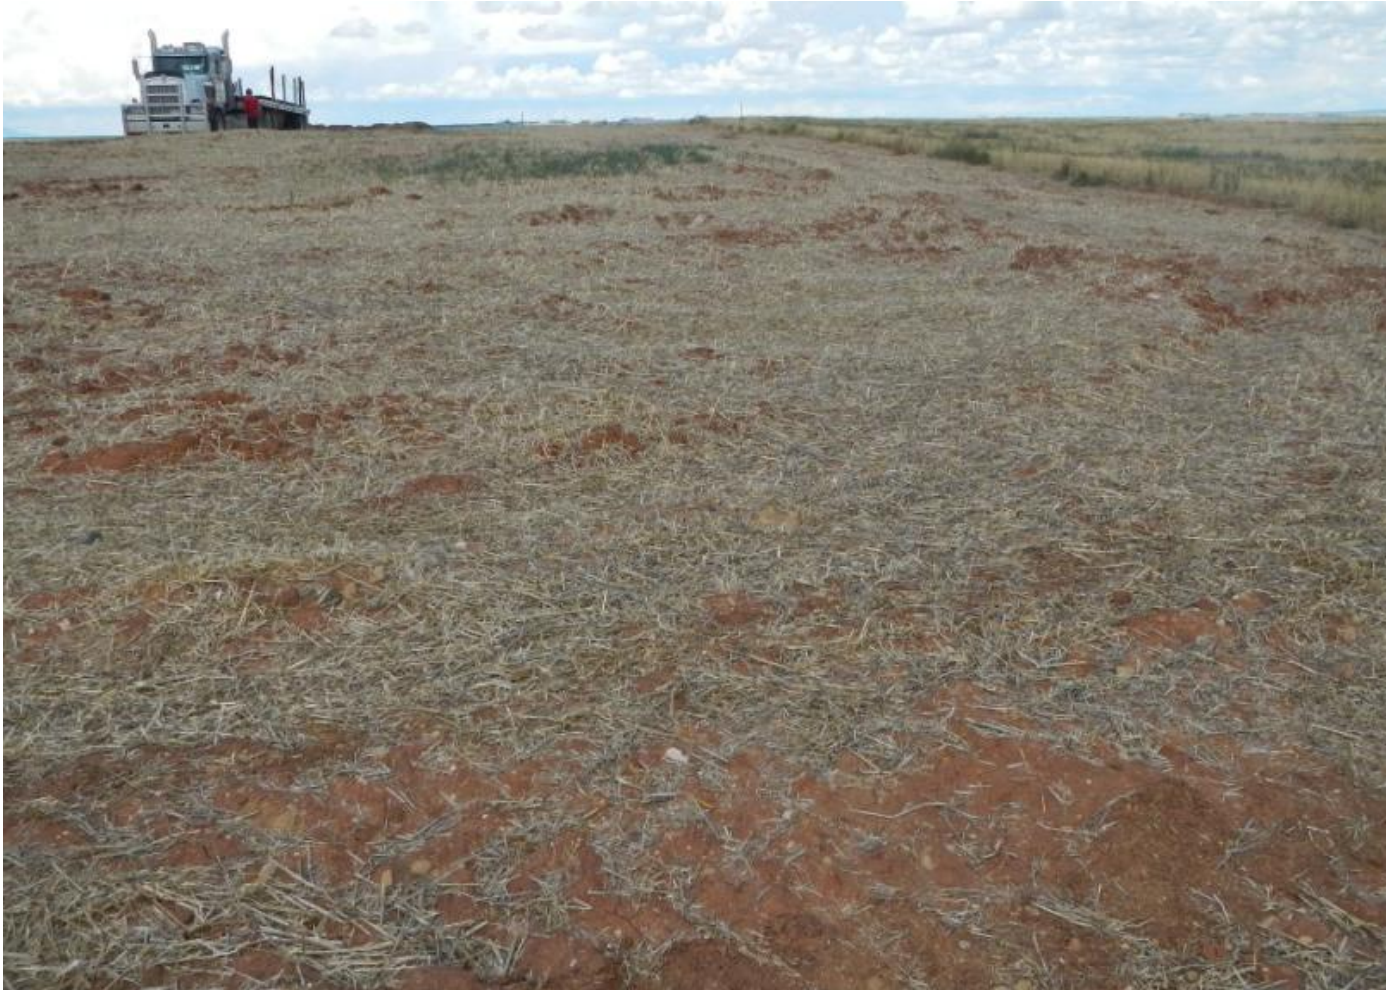
Photo 3. View of eastern portion of project area from southeastern corner facing northward.

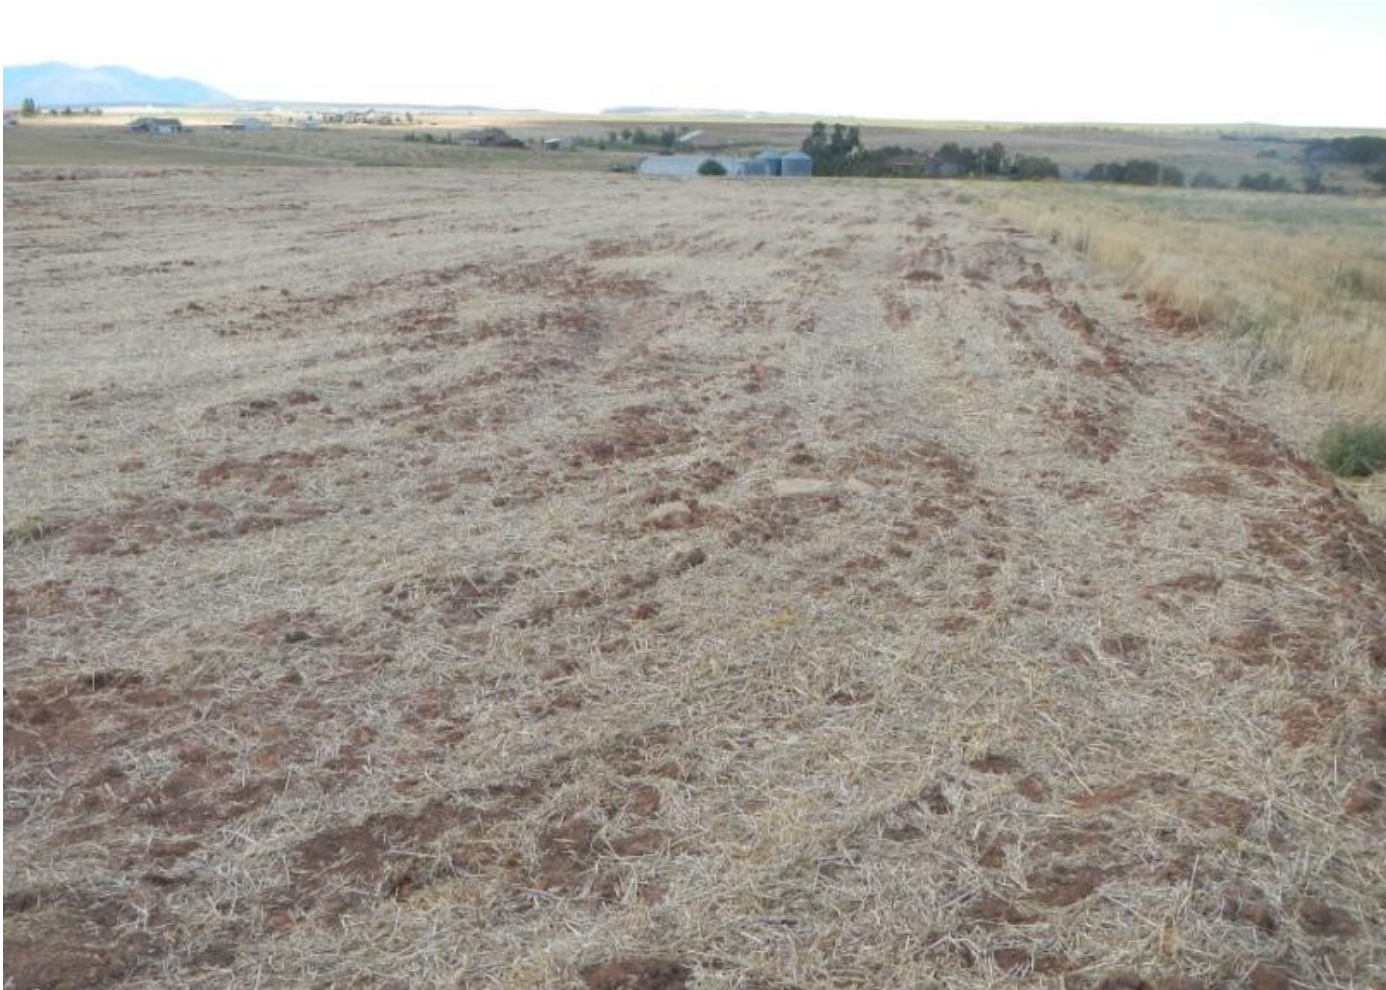
Photo 4. View of northern portion of project area from northeastern corner facing westward. Little successful germination present. This area should be monitored and re-seeded if necessary.
