Reference Area Photographs

Inspection Conducted on August 20, 2015

**Linn Energy (Linn Operating Inc)
SCHOOL POINT OM K15 696 Pad
Location Facility ID # 335991
Pit facility ID #415486**

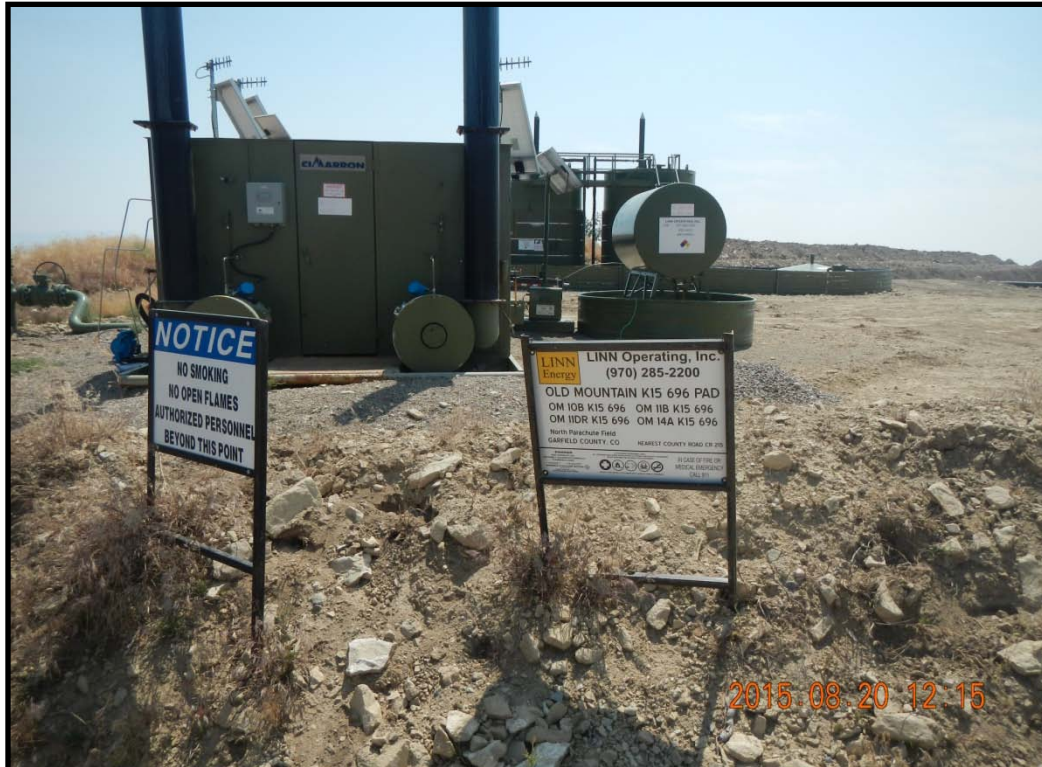
Signs at the entrance. Emergency information and site identification

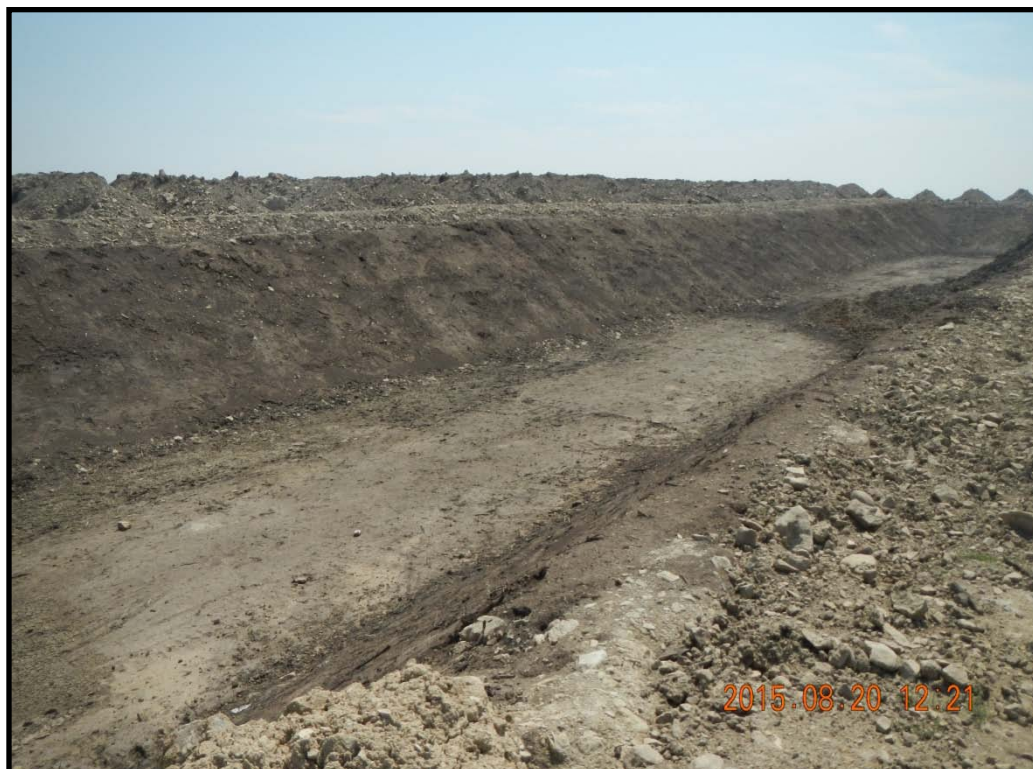
Pit in process of closure. Liner has been removed. No staining was observed at the bottom or on the walls.

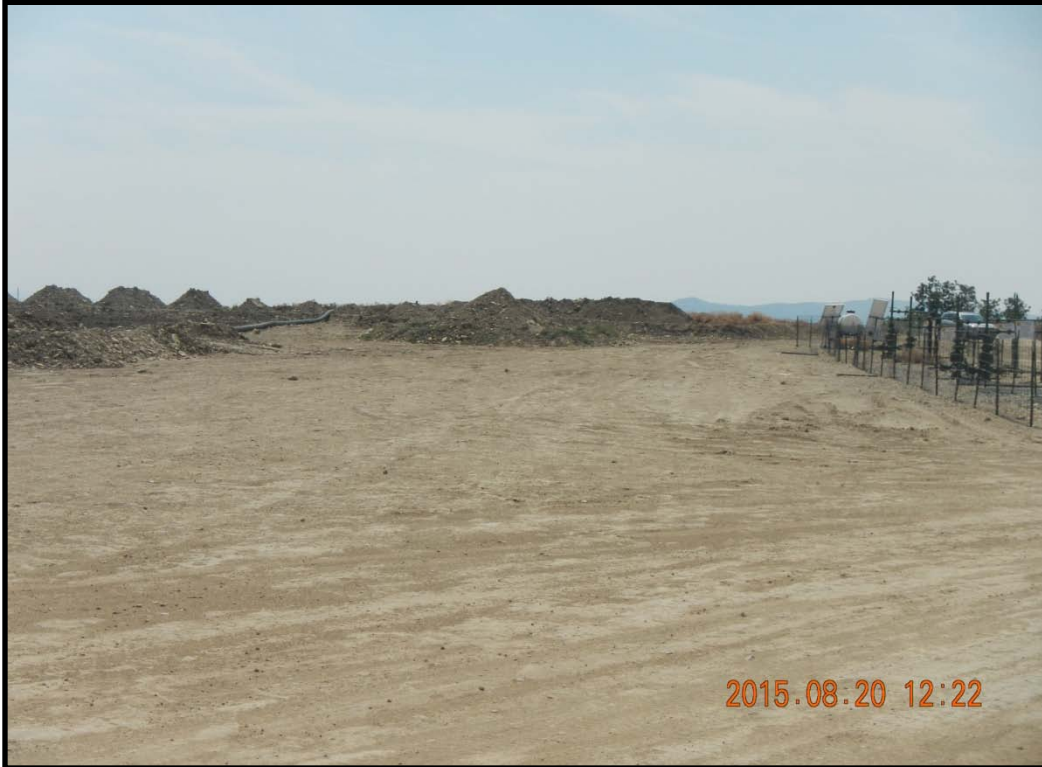
Stockpiles / Land Treatment Cells. Looking west

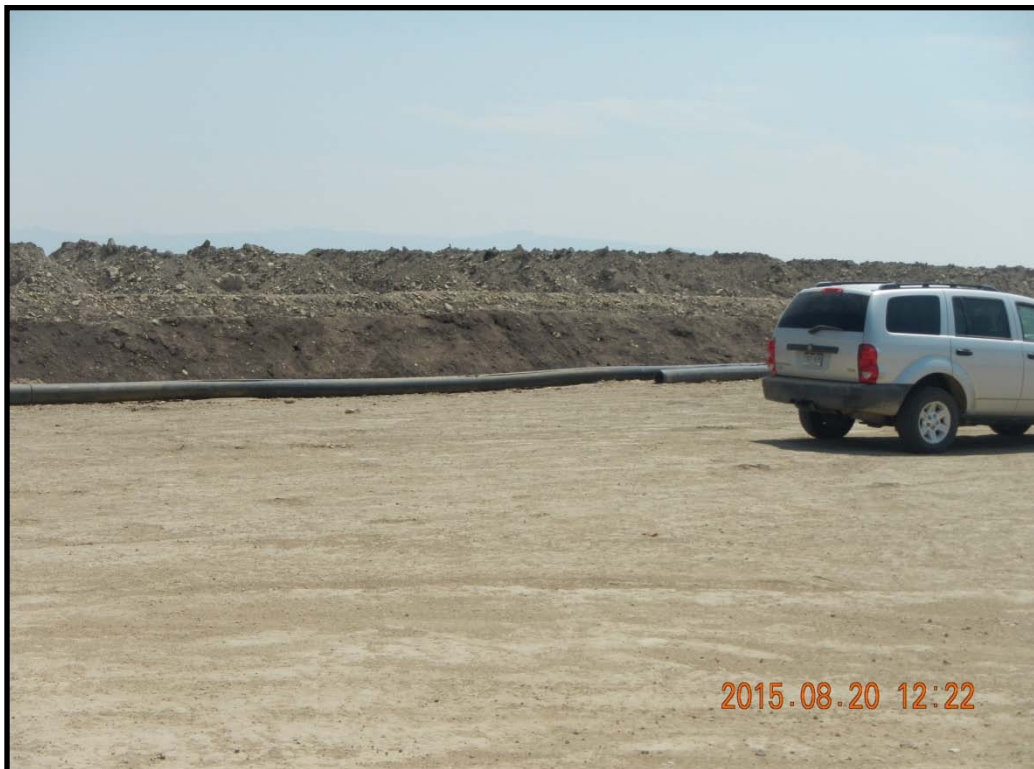
Stockpiles / Land Treatment Cells. Looking north.
Piping that will not be used should be removed.

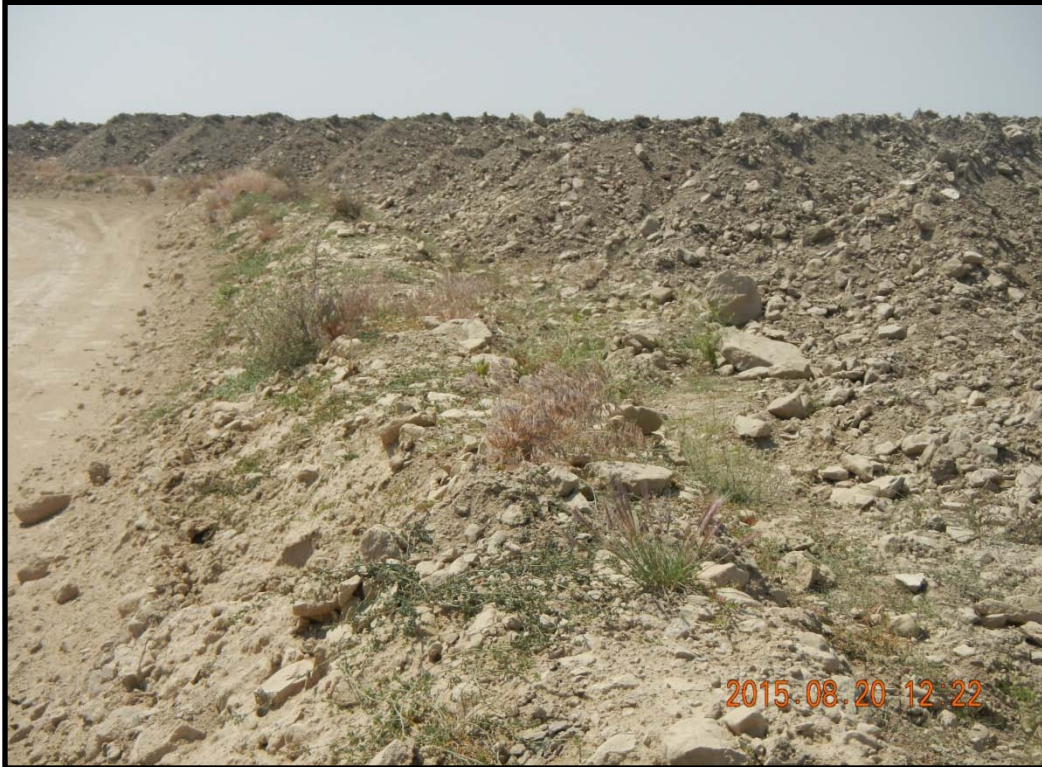
Treatment cells are bermed but not lined.

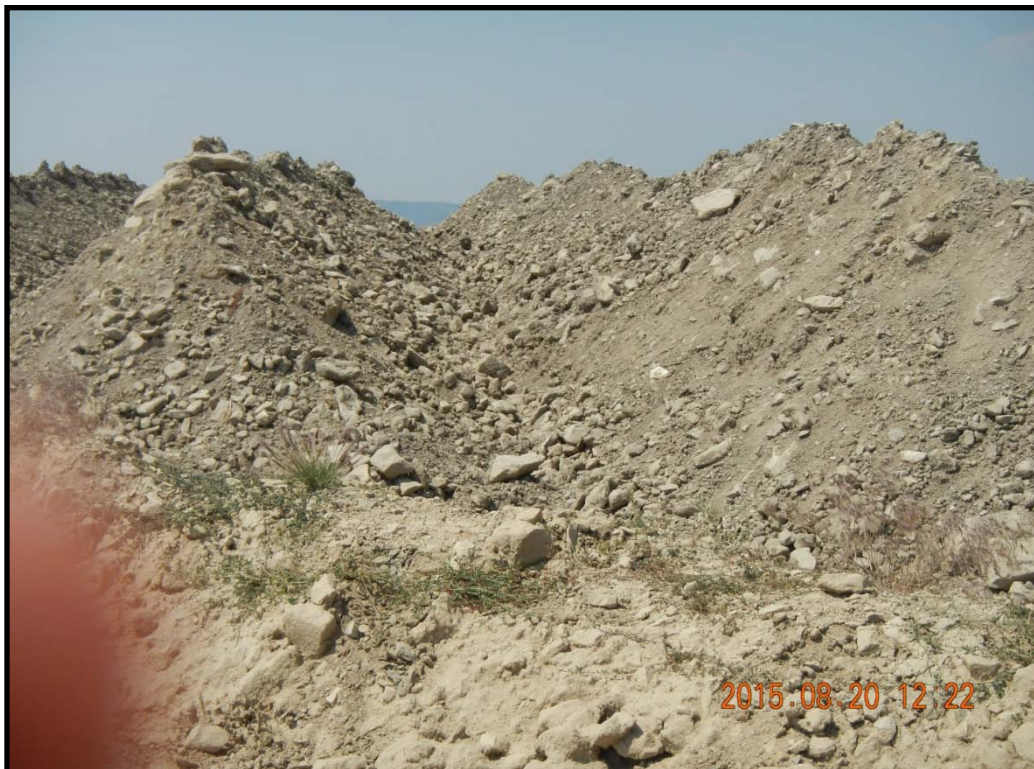
Treated soil in Windrows 6 feet or higher. According to Linn Energy representatives, this soil is moved about twice a year to improve remediation. Fertilized or other additive may be incorporated to the soil.
