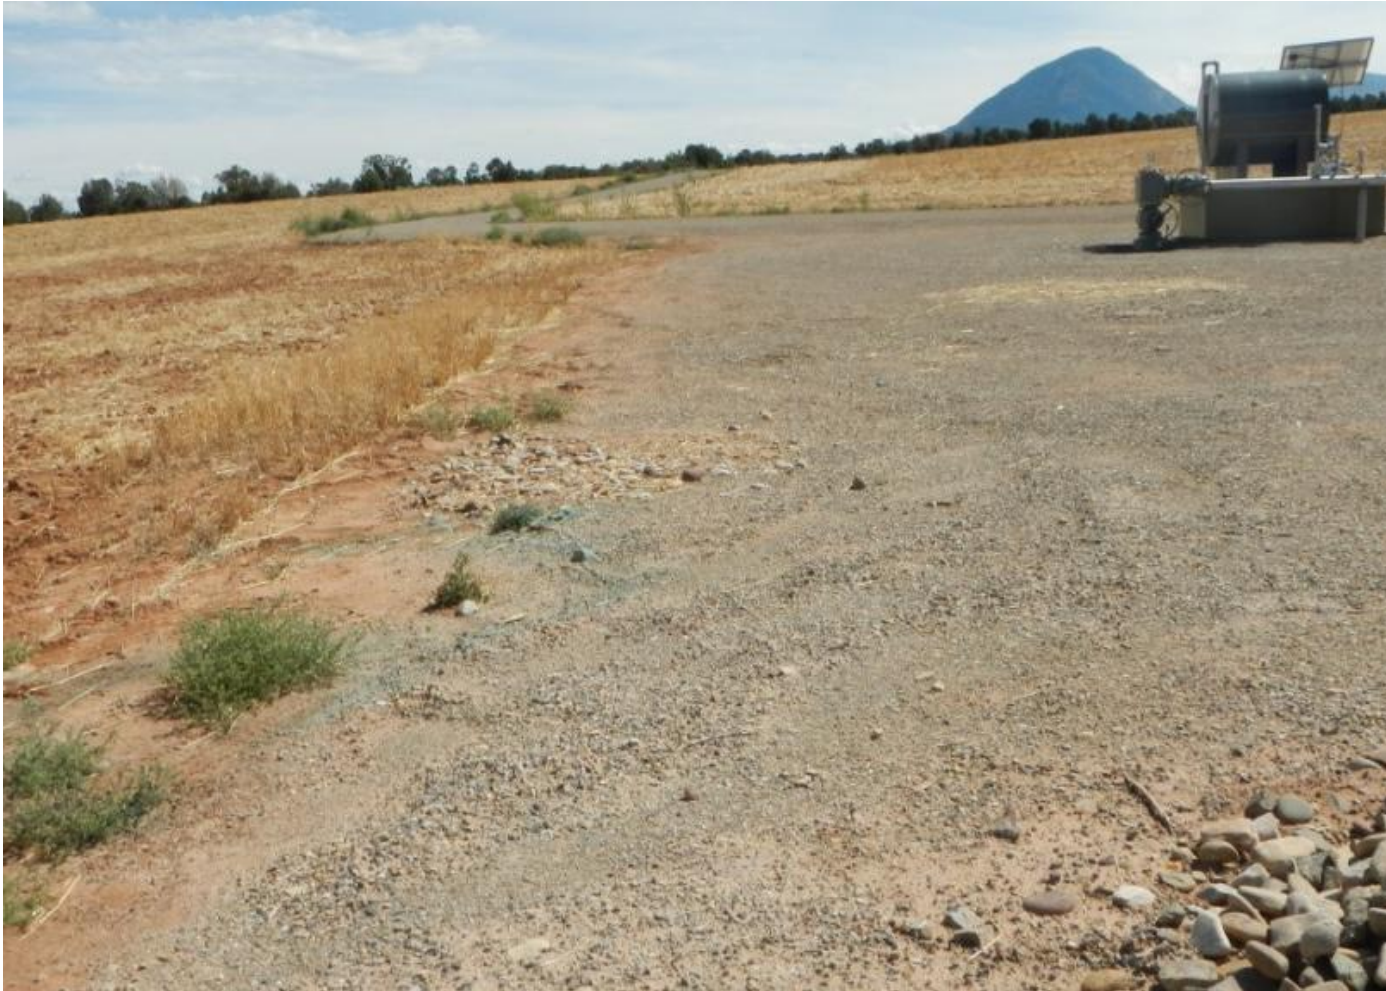
Photo 1. View of eastern portion of project area from northeastern corner facing southward.

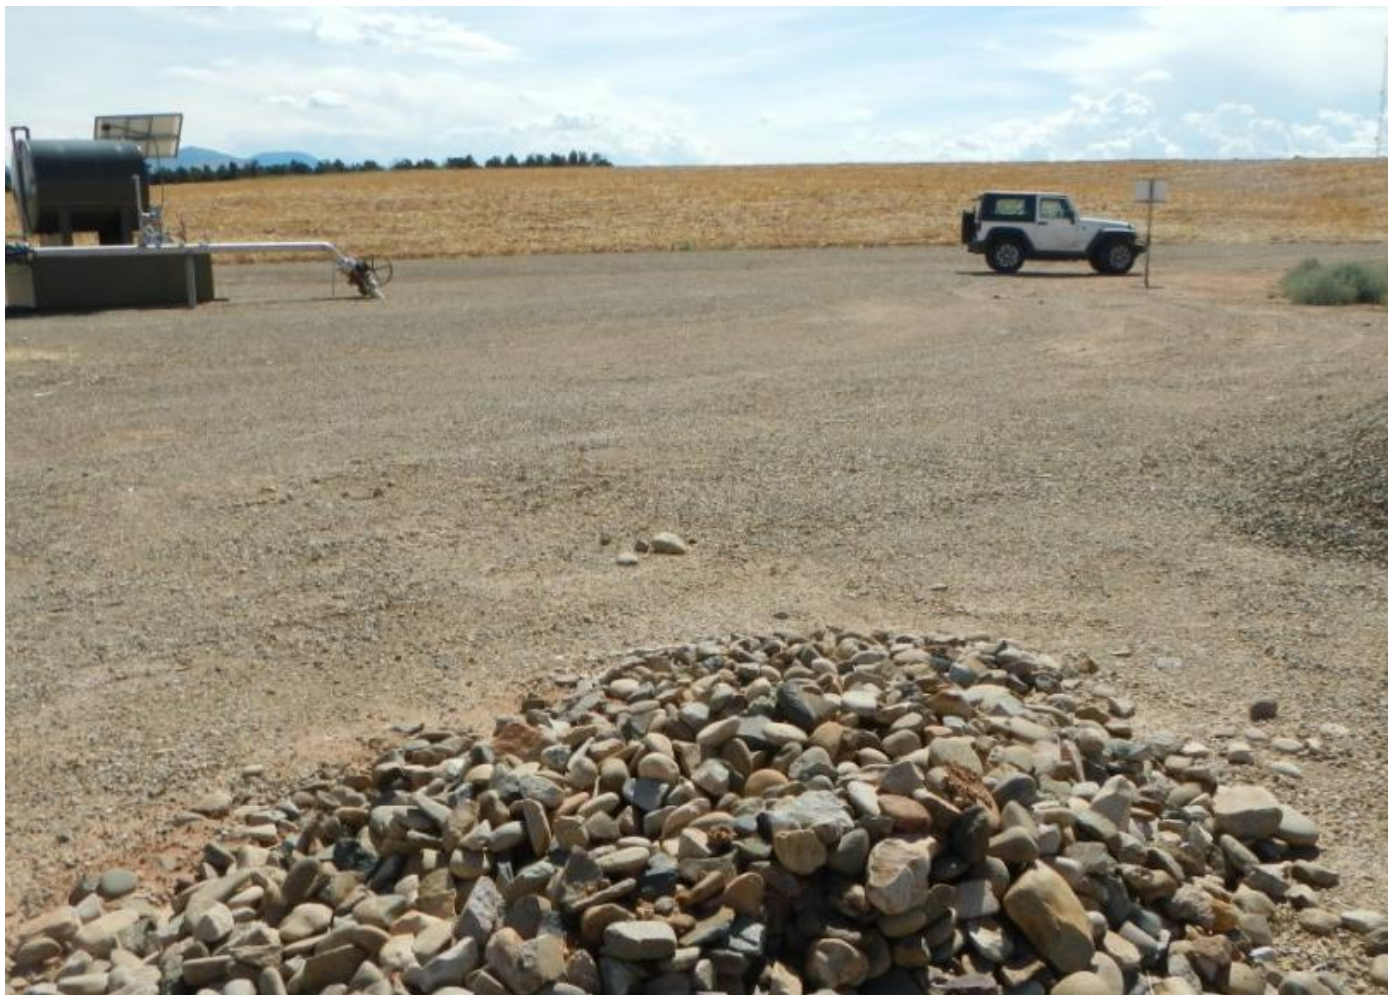
Photo 2. View of well pad from northeastern corner facing center.

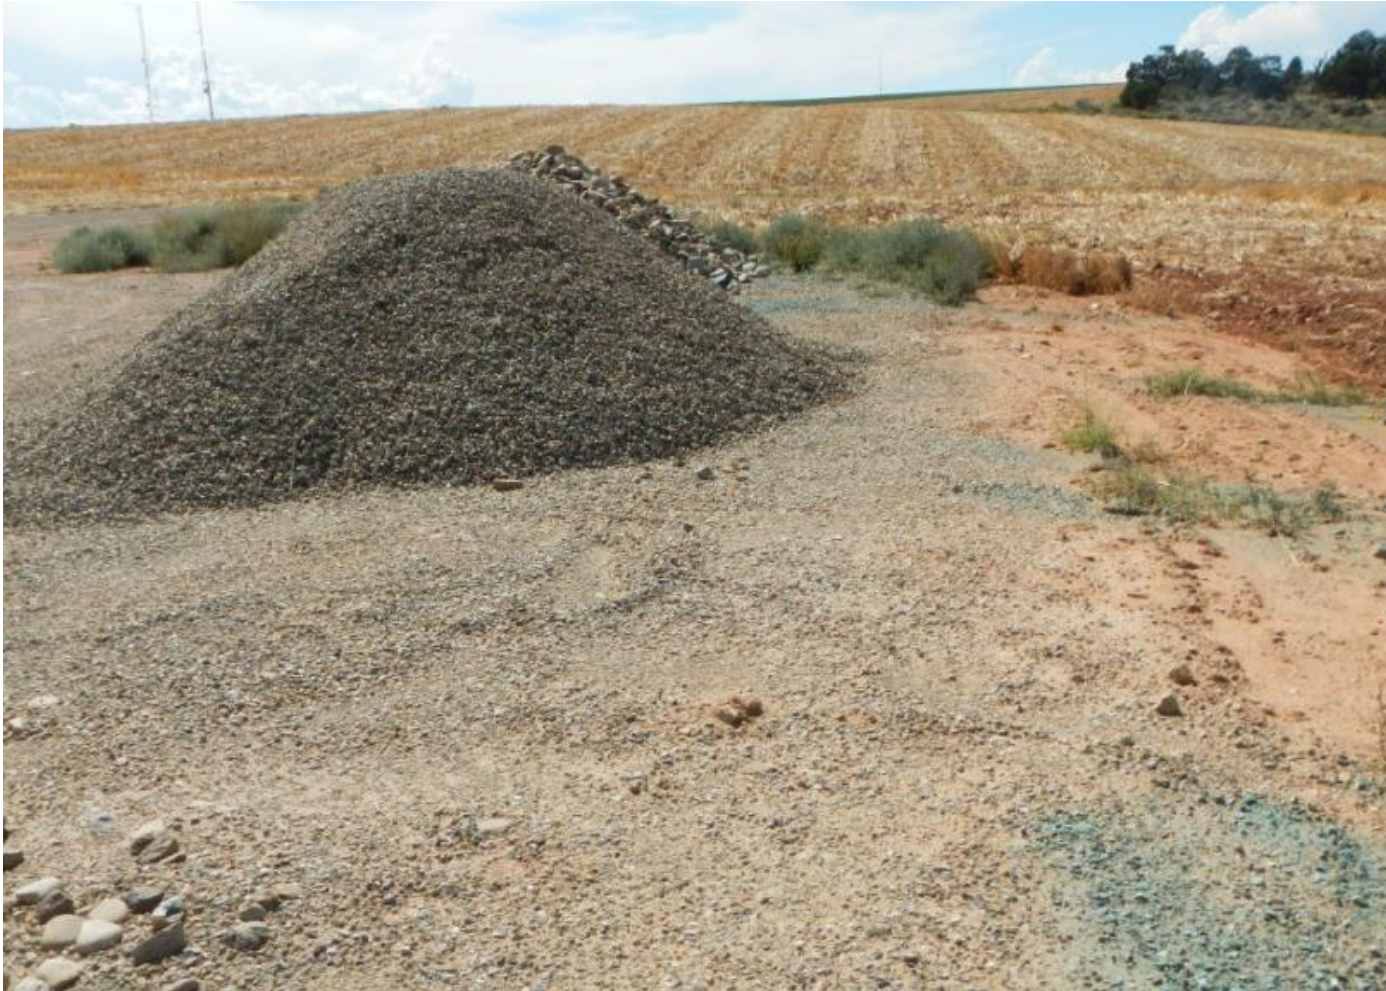
Photo 3. View northern portion of project area with stockpiled construction material facing westward from northeastern corner.

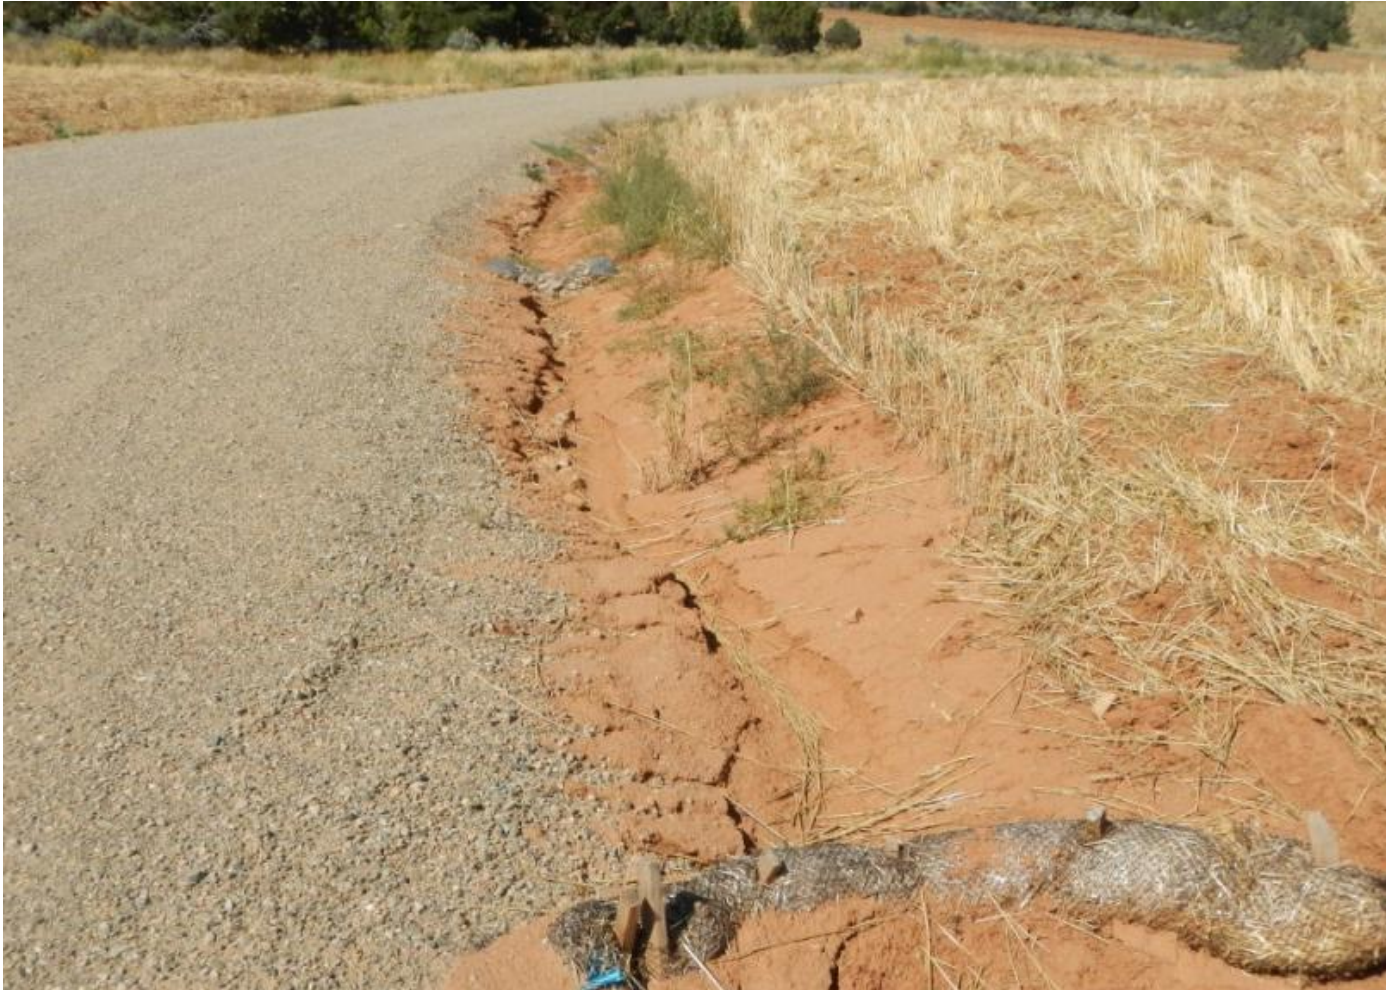
Photo 4. View of erosion occurring along eastern edge of the access road. Incision from high energy flows is observable between wattles and sediment accumulation above and around wattles is apparent in foreground.
