# Gramps Oil Field Site Inspection

REM #73

August 26, 2015

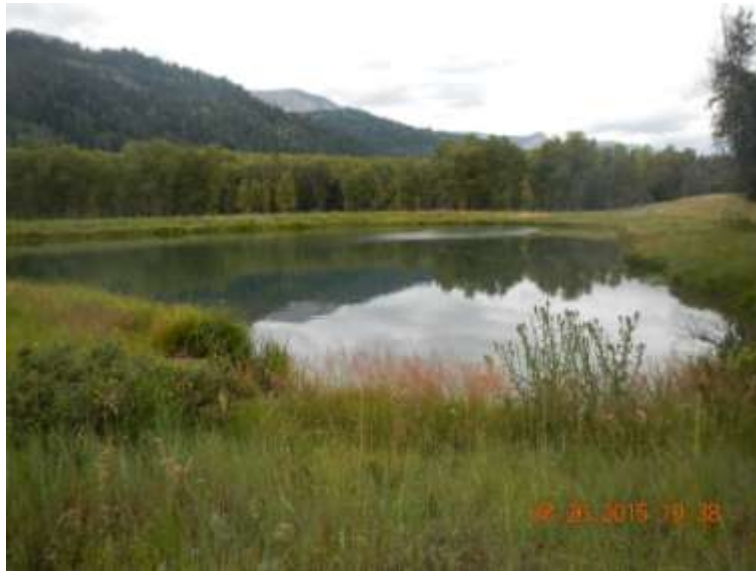
**Pond A** – Former Produced Water Pond. Water was clear with no visual residue or sheen.

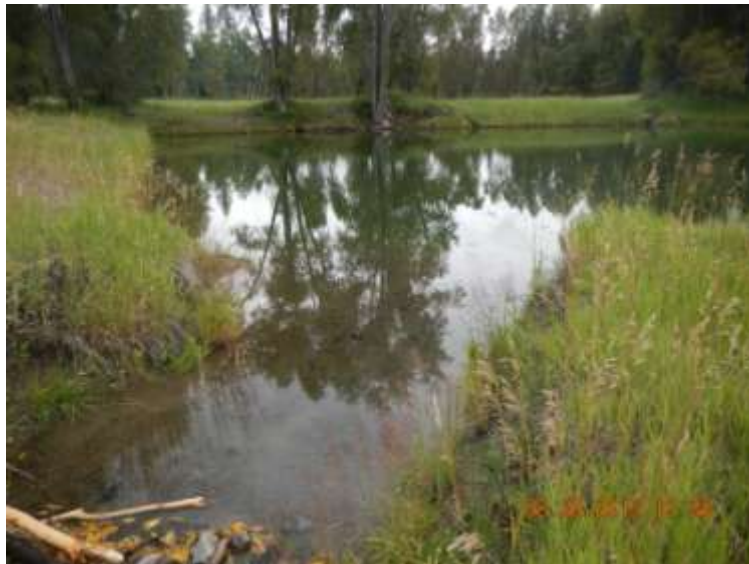
**Pond B** – Former Produced Water Pond. Water was clear with no visible signs of hydrocarbons.

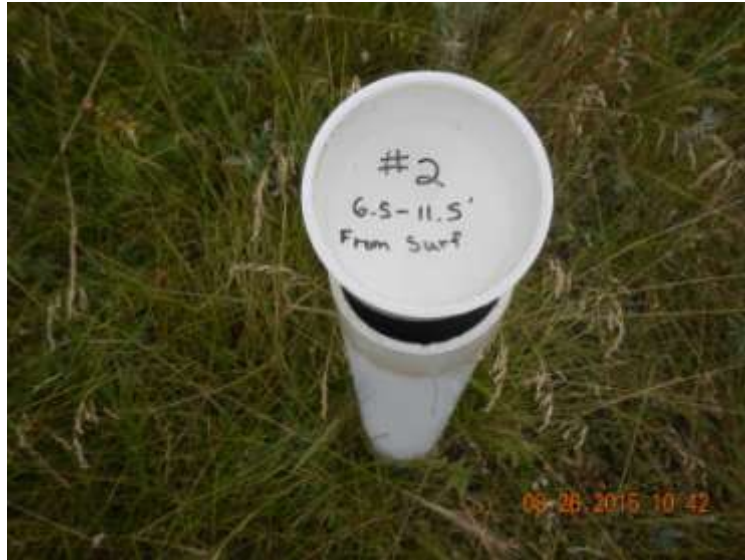
**Monitoring Well (MW) #2** – 4” PVC pipe approximately 2.5’ above ground surface. No hydrocarbon odor.

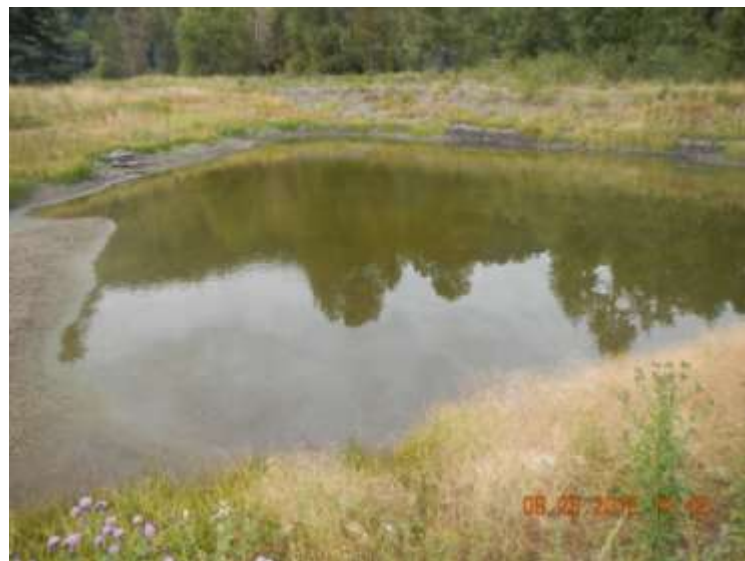
**Pond F** – Former Produced Water Pond. Water was clear with no visible signs of hydrocarbons.

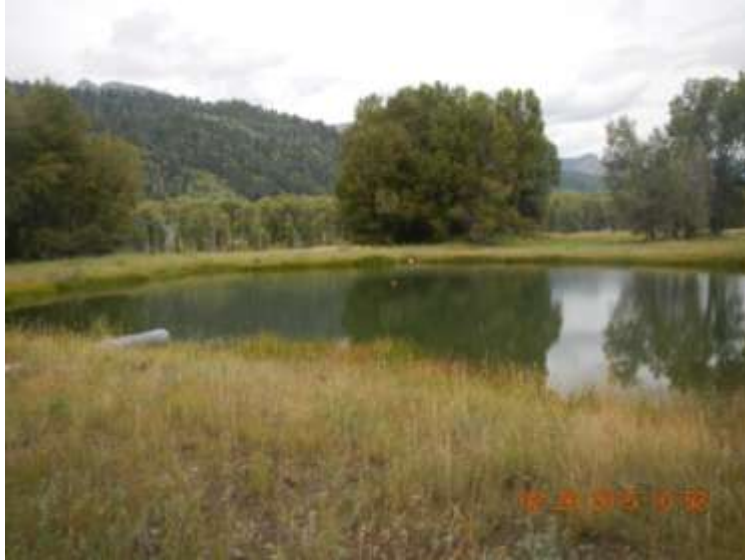
**Pond C** – Surface water diverted into Pond C from stream. Water was clear with no visible impacts.

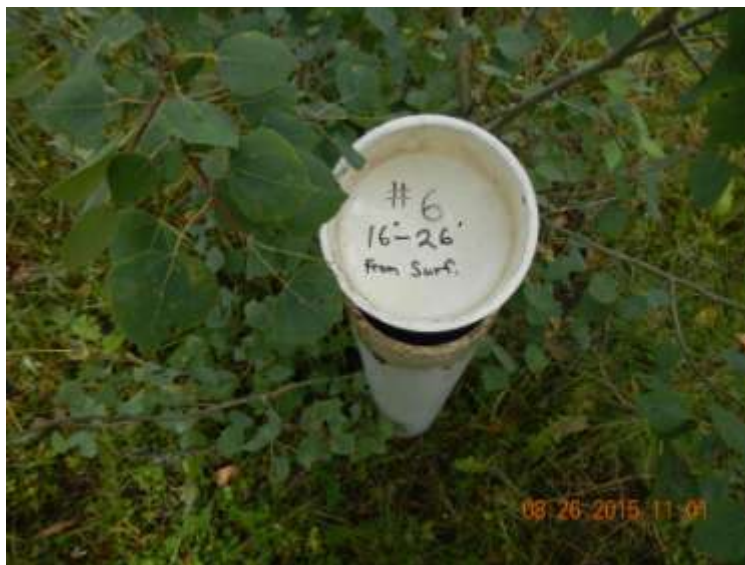
**MW #6** – 4" PVC pipe approximately 2' above ground surface. Hydrocarbon odors present. Surface water located approximately 20' to the south does not appear to be impacted.

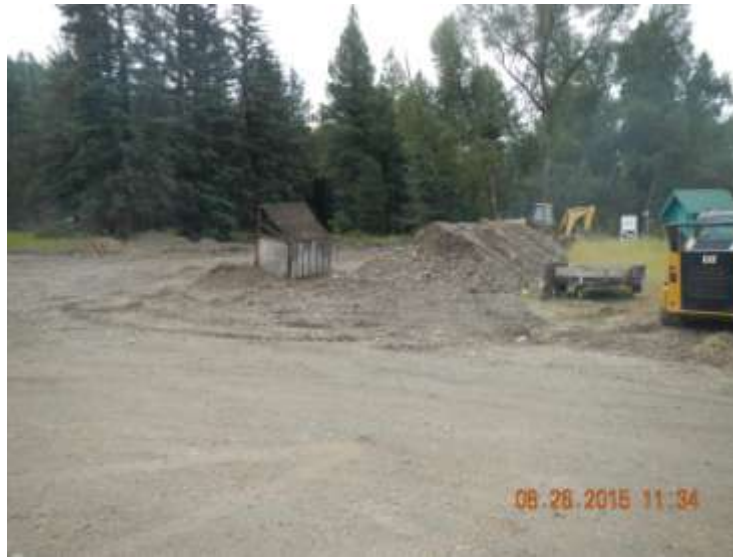
**Hay Barn Construction** – Located southeast of current shop area. No visual evidence of impacted material in excavation.

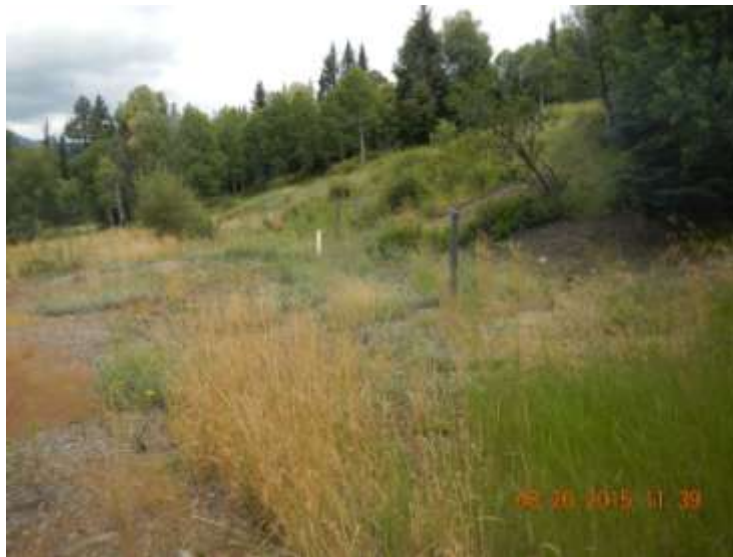
**MW #4** – Location photo of historically impacted monitoring well. Gray PVC risers for treatment cell A can also be seen in this photograph.

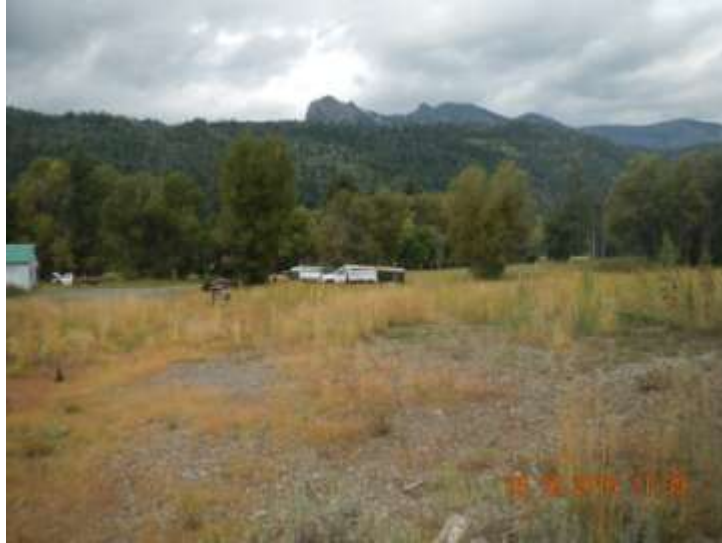
**GCL Treatment Cell** – Location photo to the northwest showing treatment cells C and GCL.

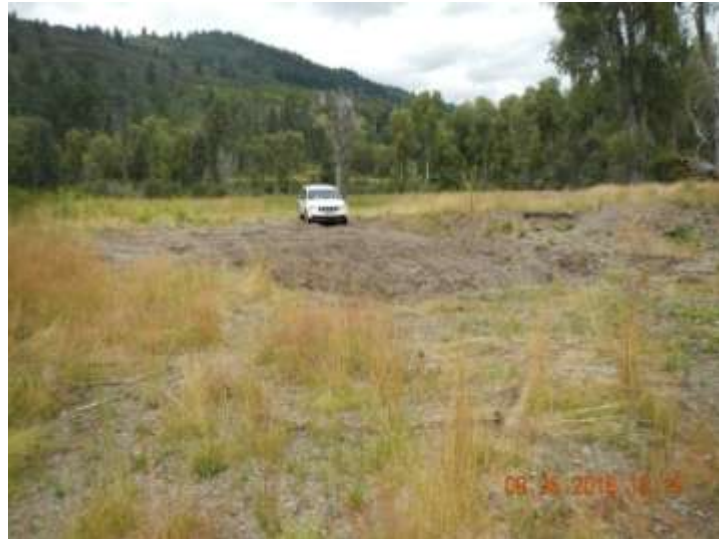
**Gravel Pit** – Approximate area of “low point” in historic pipeline. Slight hydrocarbon odor and what appeared to be stained soils present. A sample was collected from this material for analysis.
