September, 2015 COGCC Environmental field inspection of CM Productions LLC Pit Complex Facility
(Location ID: 324634, Pit Facility IDs 112265, 112266, 112267, 112268, 112269, and 115241)

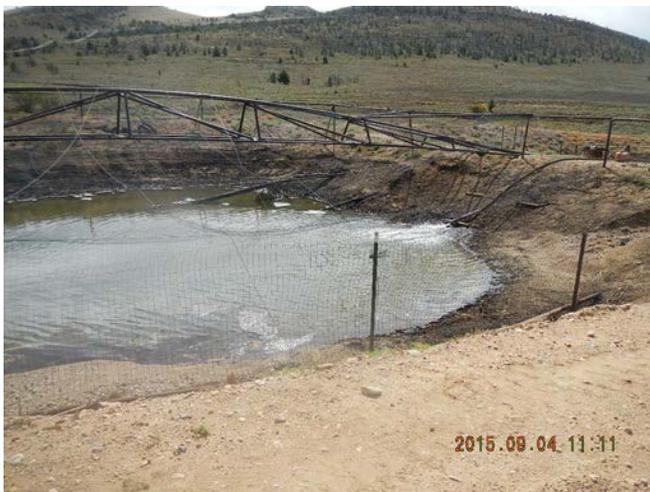
Pit Facility 115241- Pit bottom appeared to be moist with some vegetation growth. Material has sloughed from the sides or upper portion of the pit. Surface water runoff from the main Facility is controlled via a ditch was constructed along the north side of the Pit Complex. Pit not netted.

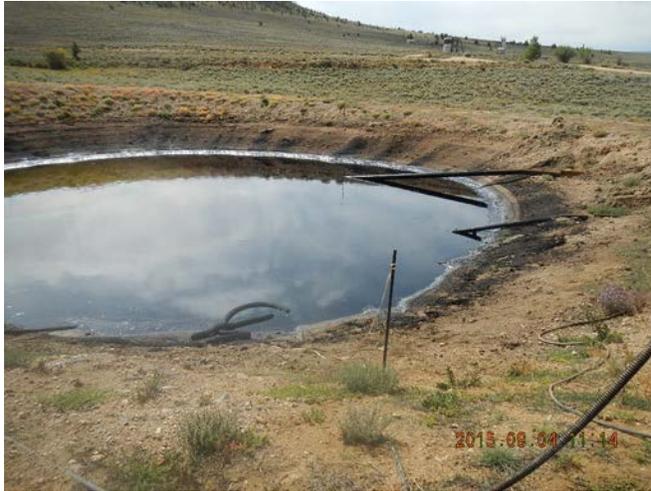
Pit Facility 112265- Fluid in pit app 15-20' below berm. Visual signs of hydrocarbons on fluid surface (10% of surface), netted but compromised with holes, visual staining of hydrocarbons along sides of pit. Used oil absorbent booms along east bank of pit. Fluids from Pit Facility 112266 were being transferred via a pump with 2-inch hose (estimated 60-80 gallons per minute)

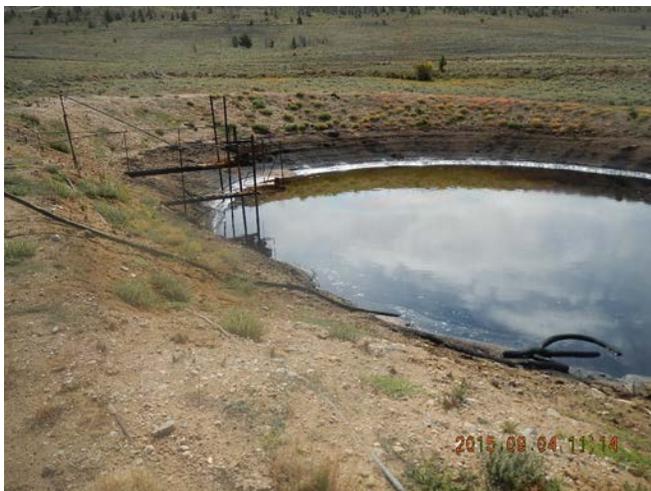
- Pit Facility 112266- Fluid in pit with aerator removed and fluids being transferred to Pit Facility 112256. Visual signs of what appeared to be hydrocarbons covering about 30% of the fluid surface and sheen covering 70%, Visual staining of hydrocarbons noted along sides of pit (12-15'). Pit not netted. Hose and buckets present for skimming apparent oily material from the fluid surface.

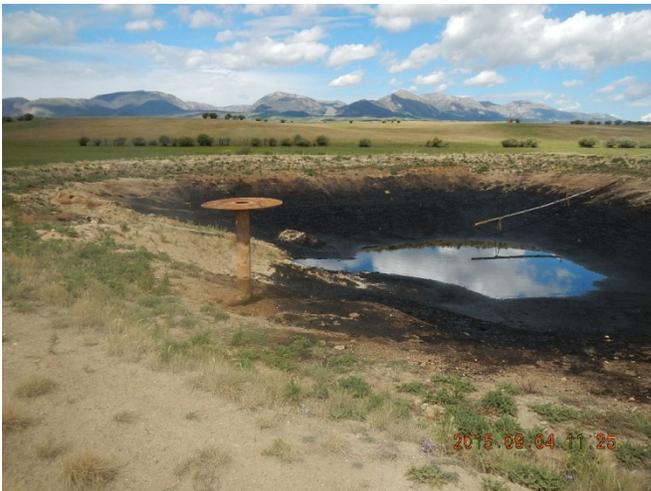
- Pit Facility 112267- An approximate 40' dia area of fluid in bottom of pit visual signs of what appeared to be hydrocarbons covering about 100% of the fluid surface. Visual staining of hydrocarbons along sides of pit (25'). Used oil absorbent booms in fluid along west side of pit. Pit not netted.

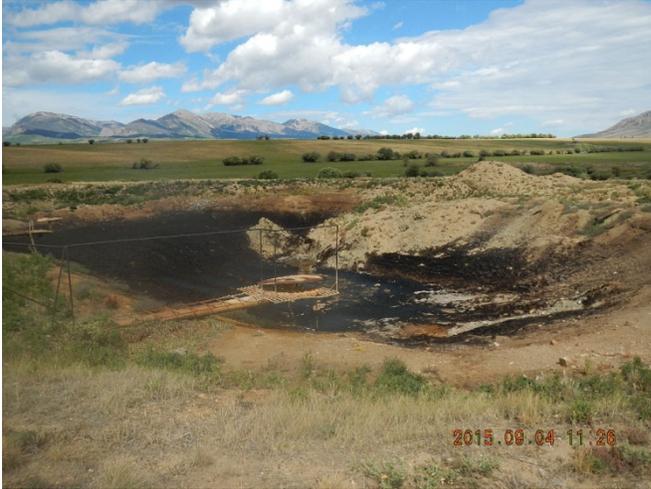
- Pit Facility 112268- An approximate 30'- 40' dia area of fluid in bottom of pit with visual hydrocarbons on fluid surface and visual staining of hydrocarbons along sides of pit (app 25'). Pit not netted.

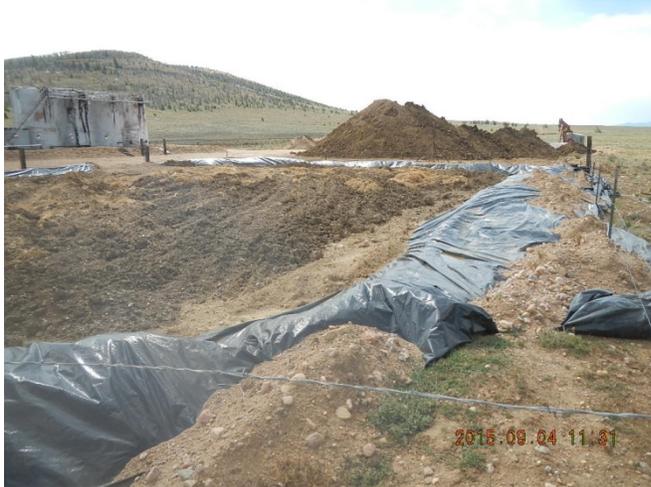
- Pit Facility 112269- An approximate 8' diameter area of fluid in bottom of pit with visual staining on fluid surface and visual staining of hydrocarbons along sides of pit (app 25-30'). Pit not netted.

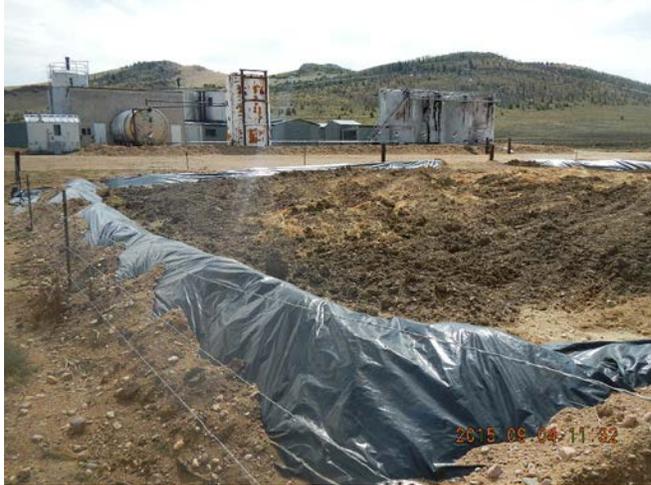
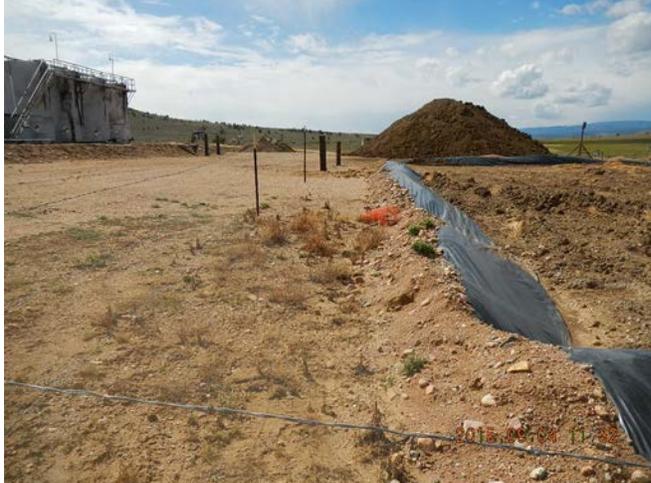
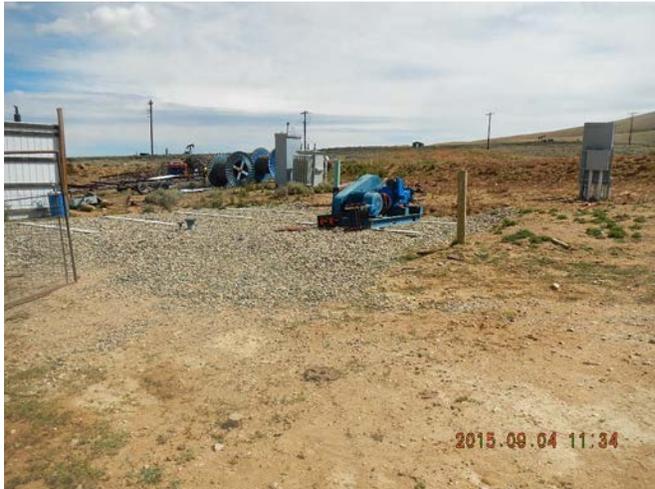
- Landfarm (approximate 100' x 80' area) fenced with 3-strand barbed wire (near the Margaret Spaulding 4-B, API 05-057-06047) with app 3' thick of material that has been leveled with front end loader. Anthony stated that they (CM) work in a 1800 lbs hay bale into the land farmed material. He said that he had worked the material around 2-3 times in the last month. App 20' dia X 5' high liner material on Location from Pit Facility 115241 closure.

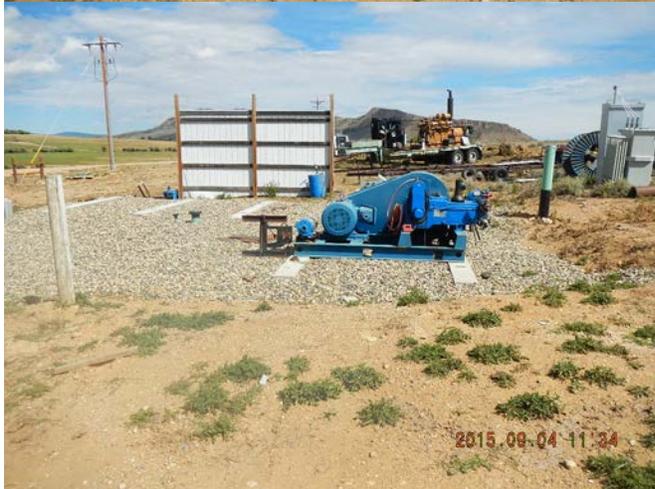
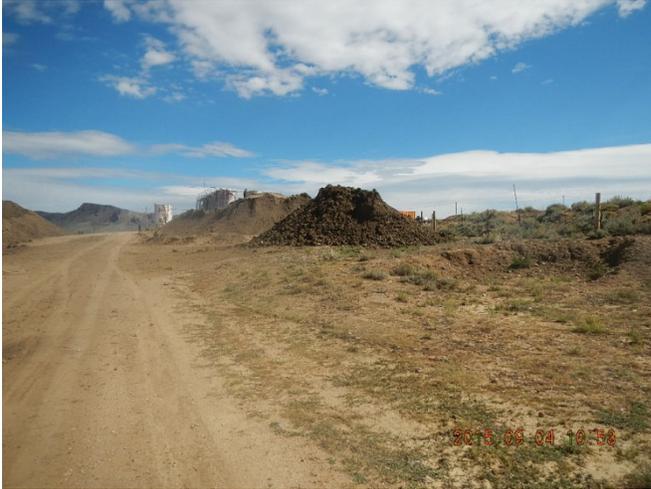
- Injection pump not mechanically connected.

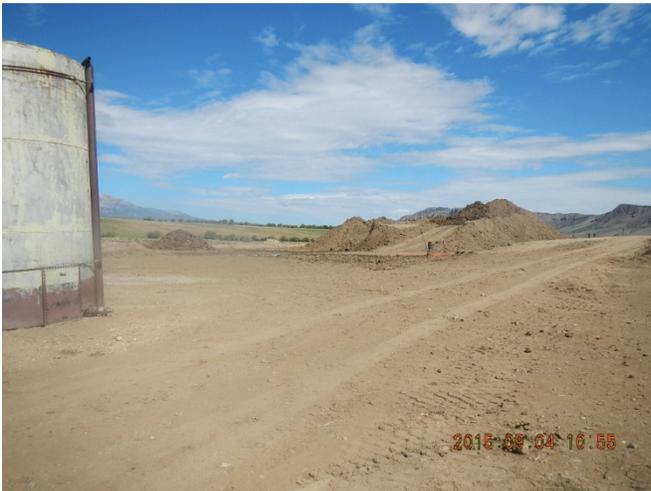
New stock pile (appr 50'x30'x15' in height) of E&P waste (treated soil) near the south west corner of Pit facility 112267. Plastic was noted in the stock pile as well as hydrocarbon odors. Mr. Brick indicated that the material came from the stock pile located south of the Land Application Site.

Stock pile should be bermed to prevent surface water run on and run off.
