BP Produced Water Spill – Spill Release Point ID #443095 NOAV Doc #200437191**COGCC Field Inspection Conducted on 9/14/2015**

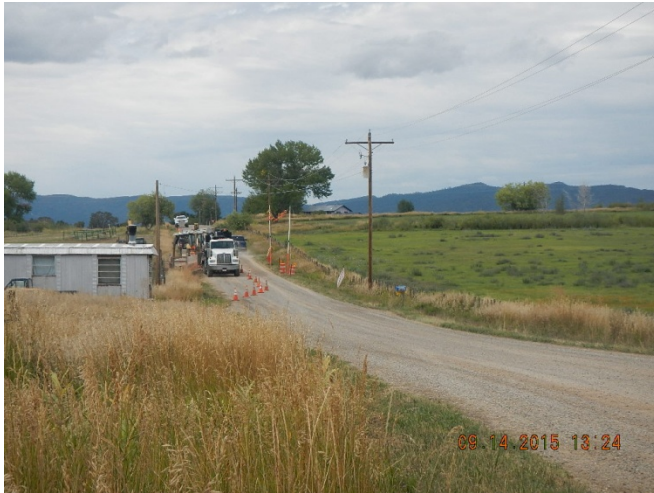
View of project area along La Plata County Road 303 - looking west.

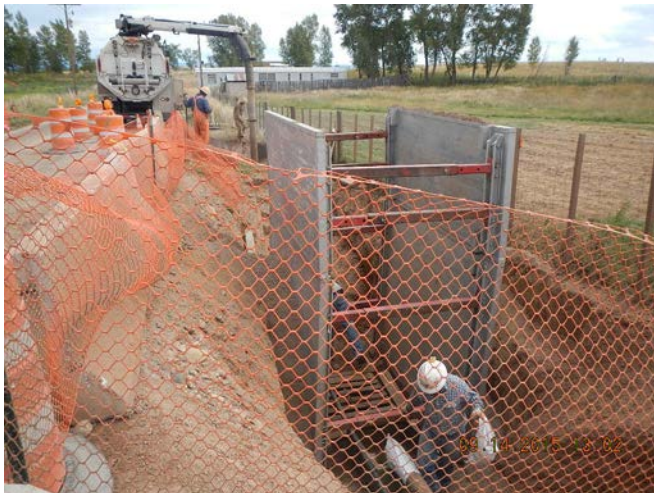
View of flowline excavations looking east; Flowline cutout and second hydro excavation in progress.

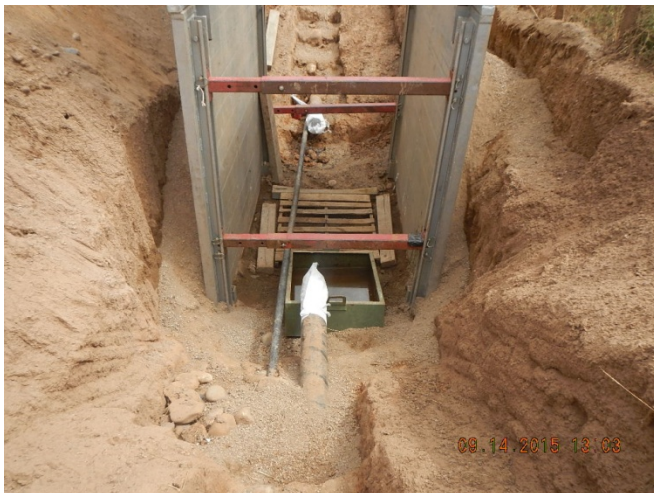
Flowline failure area; Approximate 10' produced water flowline cutout.

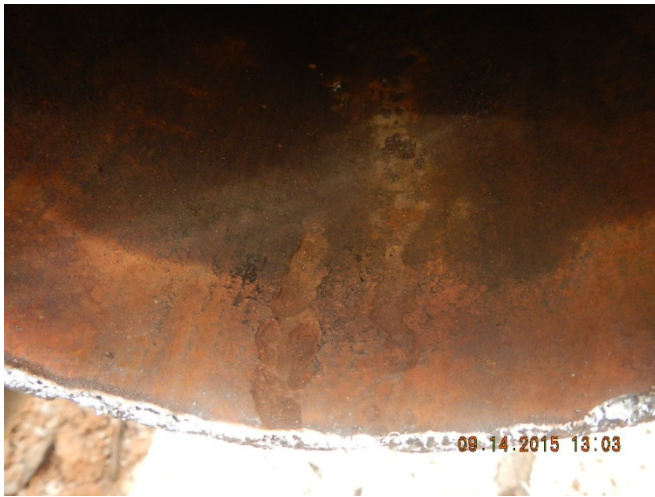
Localized pitting corrosion at 6 o'clock position (flowline heading east/ toward second excavation).

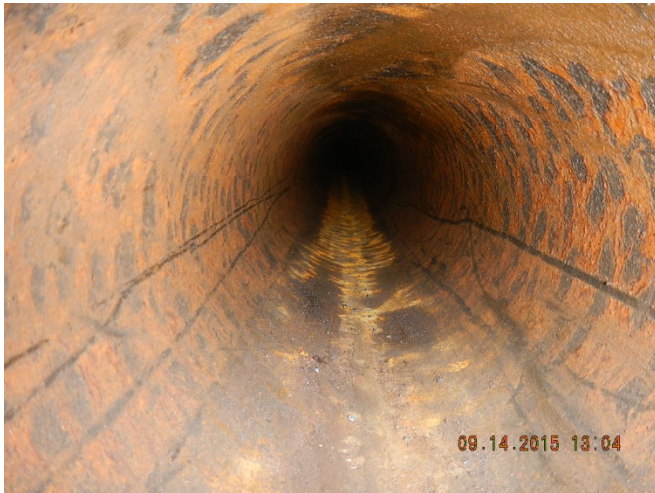
Flowline to east: Pitting corrosion at bottom pipe; Walls of pipe show possible iron deposits.

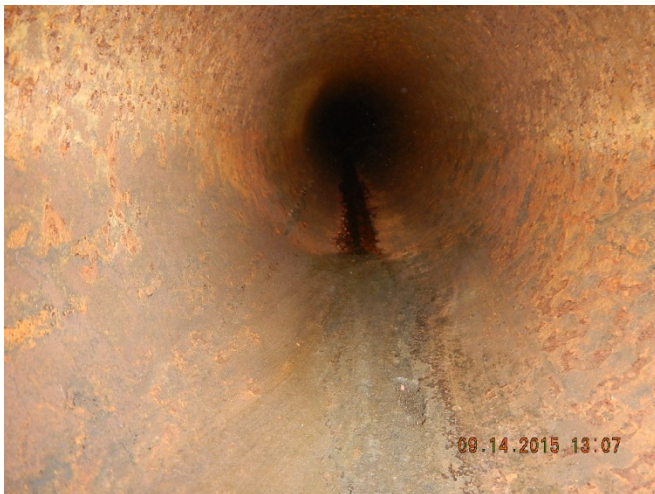
View of flowline to West; Internal corrosion at bottom pipe (appears flow assisted in this area). This section not scheduled to be cut out (as informed/ at this time).

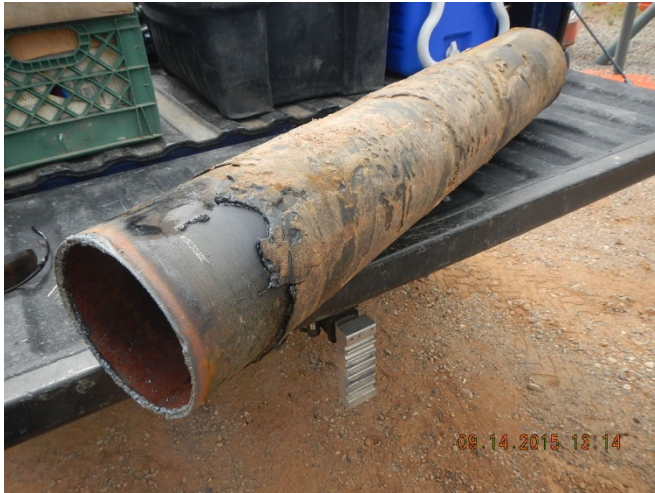
View of flowline cutout section near failure; External coating wear.

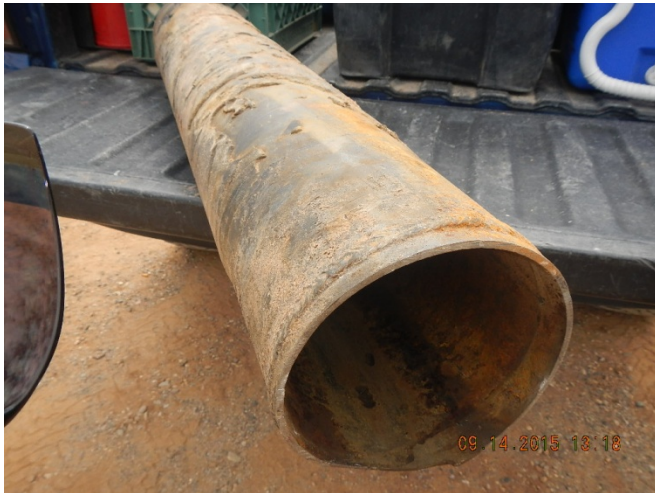
View of cutout near failure; Localized corrosion pitting can be seen at end of pipe.

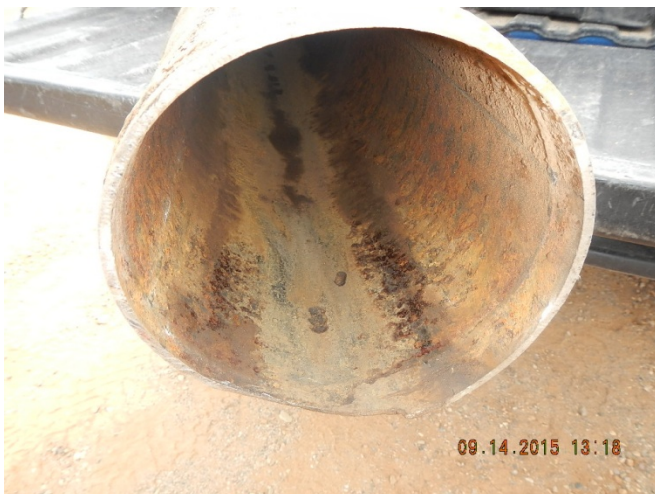
View of cutout near failure; Closer view of internal corrosion pitting in 6" flowline pipe. Dished shaped corrosion pitting.
