COGCC Field Inspection Conducted on 9/14/2015

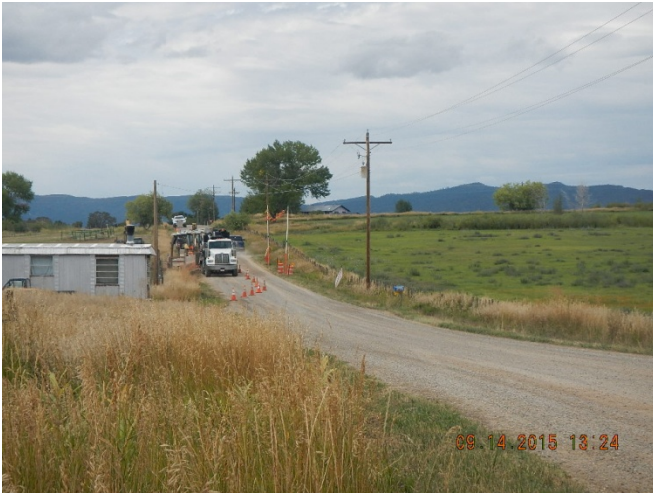
View of project area along La Plata County Road 303 - looking west.

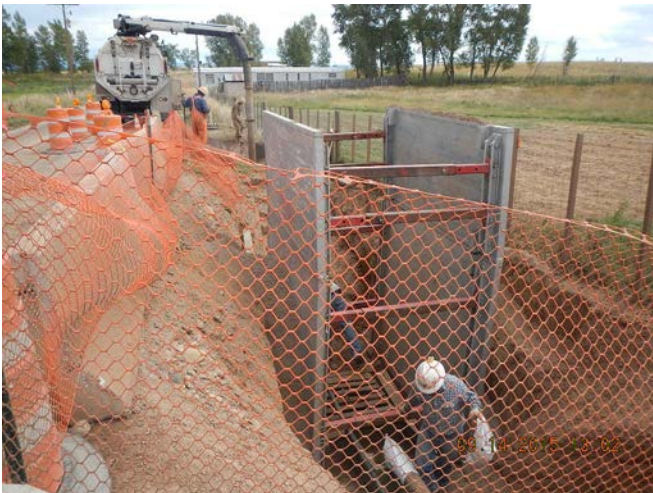
View of flowline excavations looking east; Flowline cutout and second hydro excavation in progress.

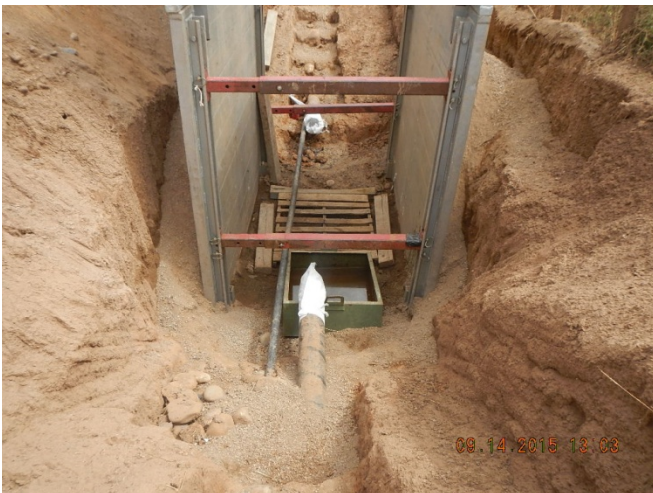
Flowline failure area; Approximate 10' produced water flowline cutout.

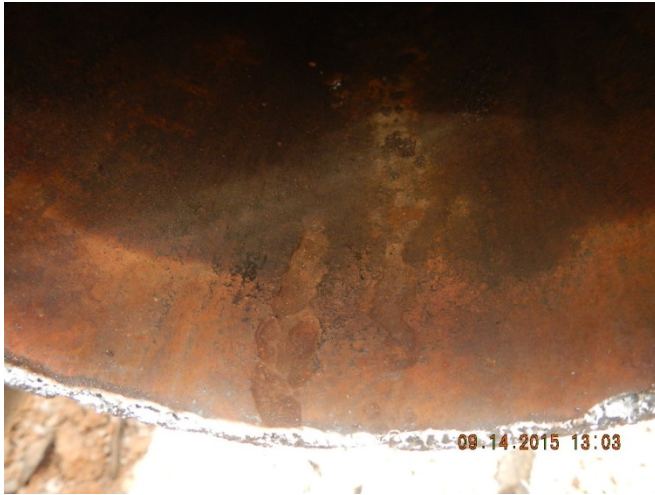
Localized pitting corrosion at 6 o'clock position (flowline heading east/ toward second excavation).
