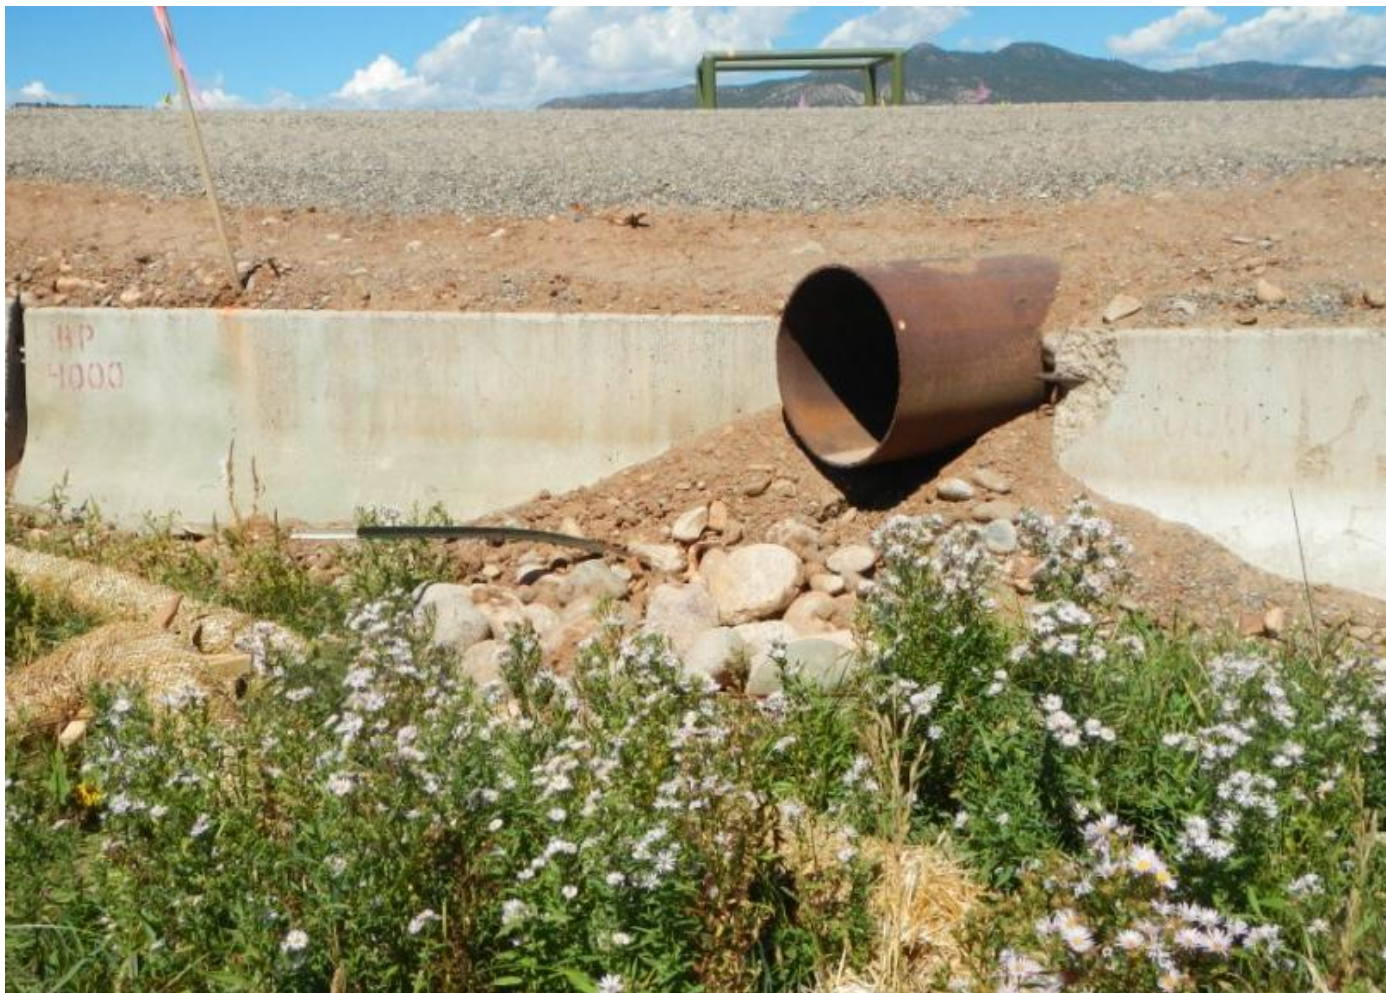
Photo 1. View of culvert outlet downstream of project area. No significant stormwater erosion is occurring here at this time.

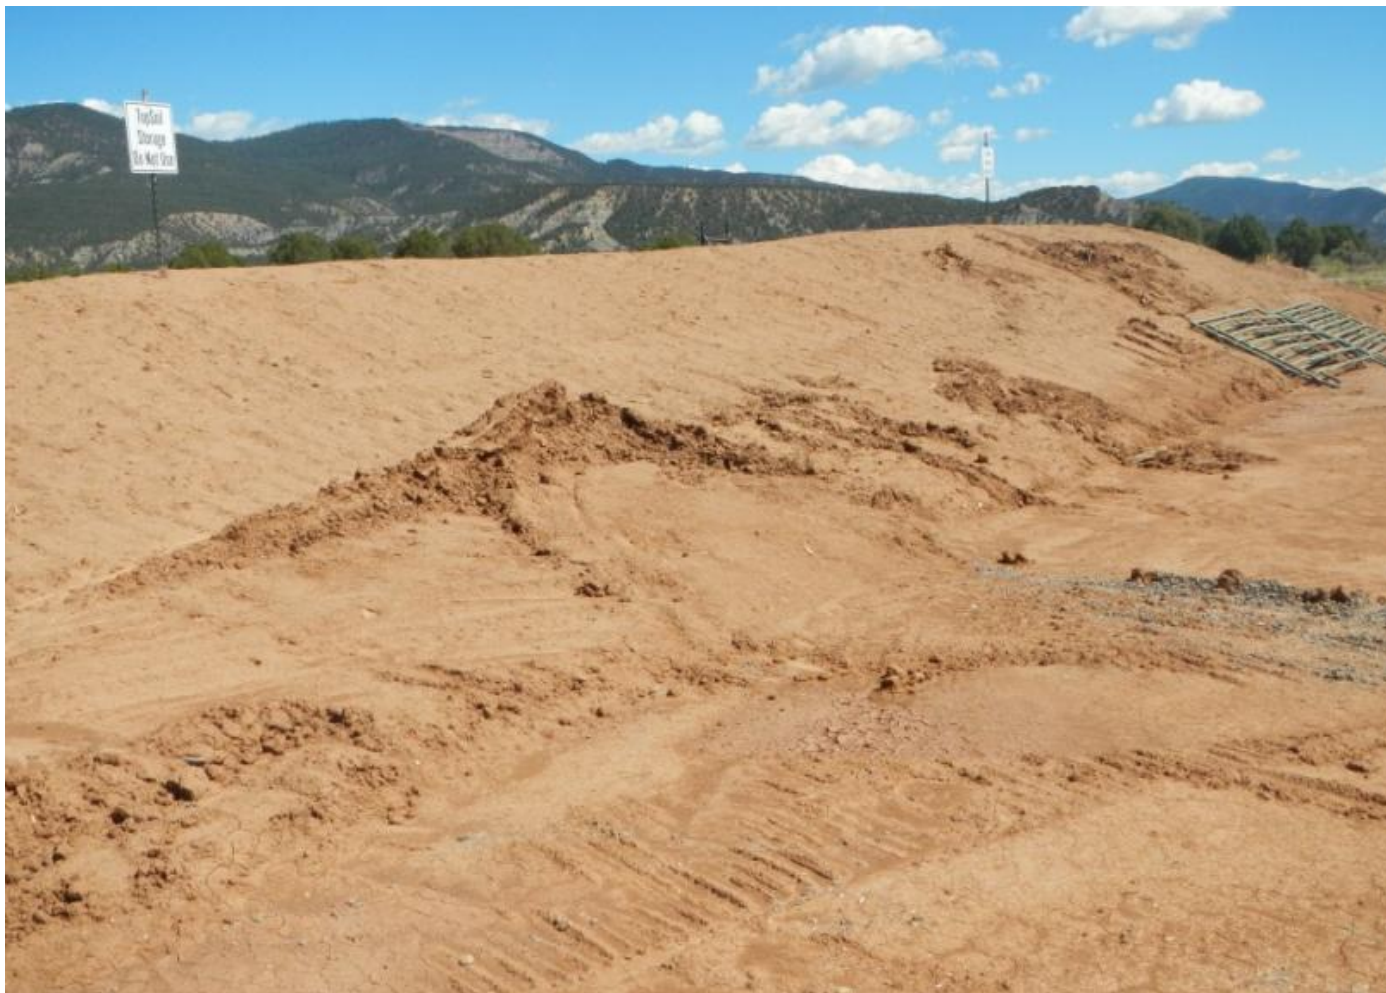
Photo 2. View of topsoil stockpile in northern portion of project area. Straw wattles present along northern edge. No stormwater controls for topsoil on well pad side. If interim reclamation isn't completed within the next month, then the entire topsoil stockpile will need stabilization.

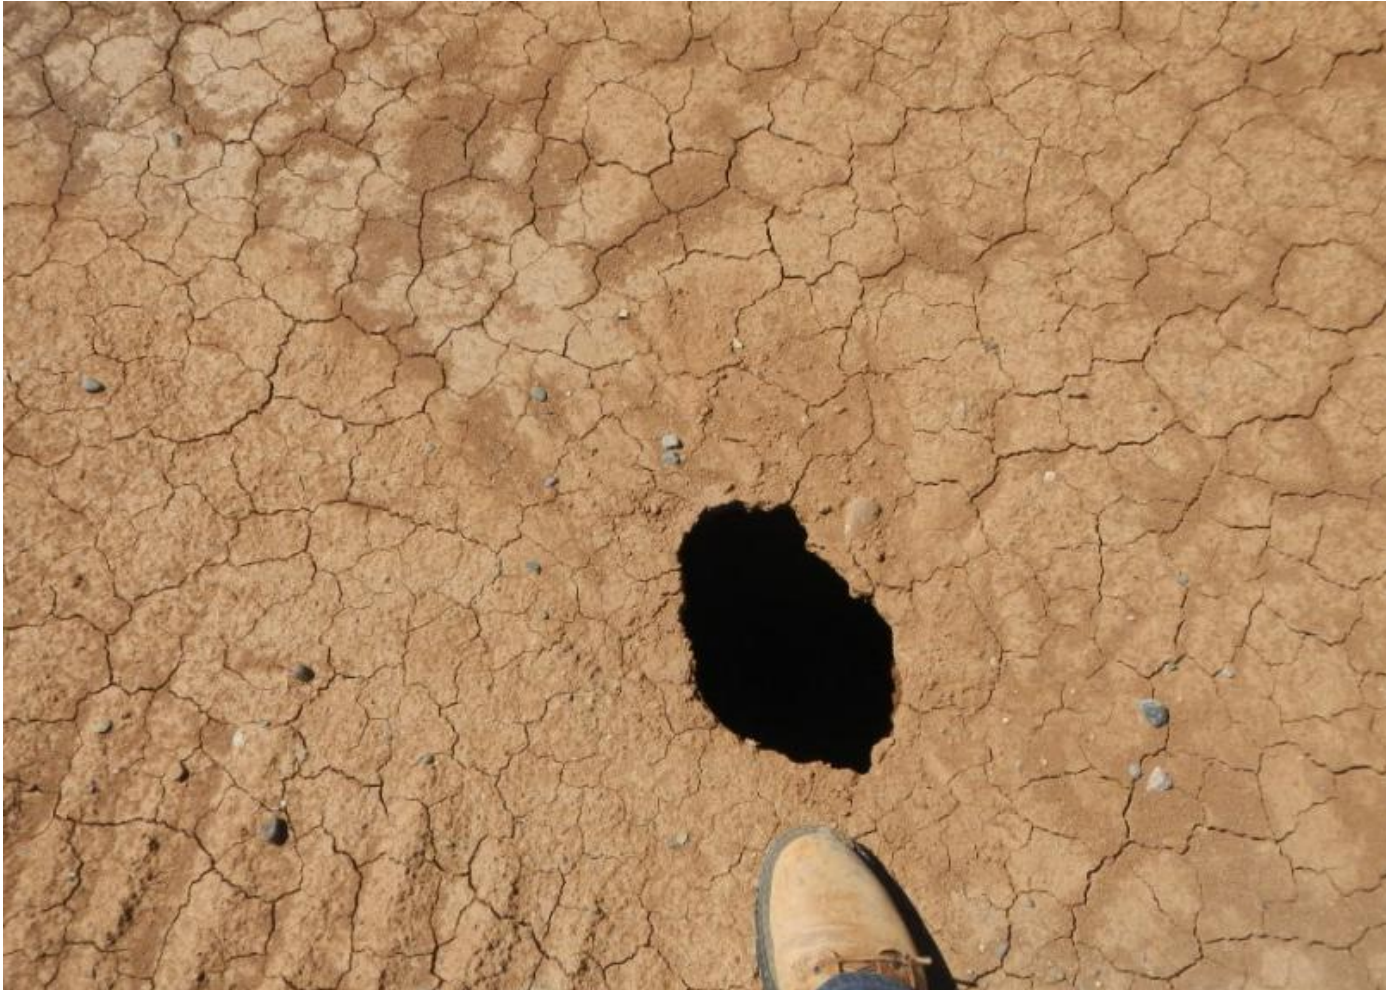
Photo 3. View of hole in well pad surface approximately 8 inches wide and 18 inches deep, that needs repair.
