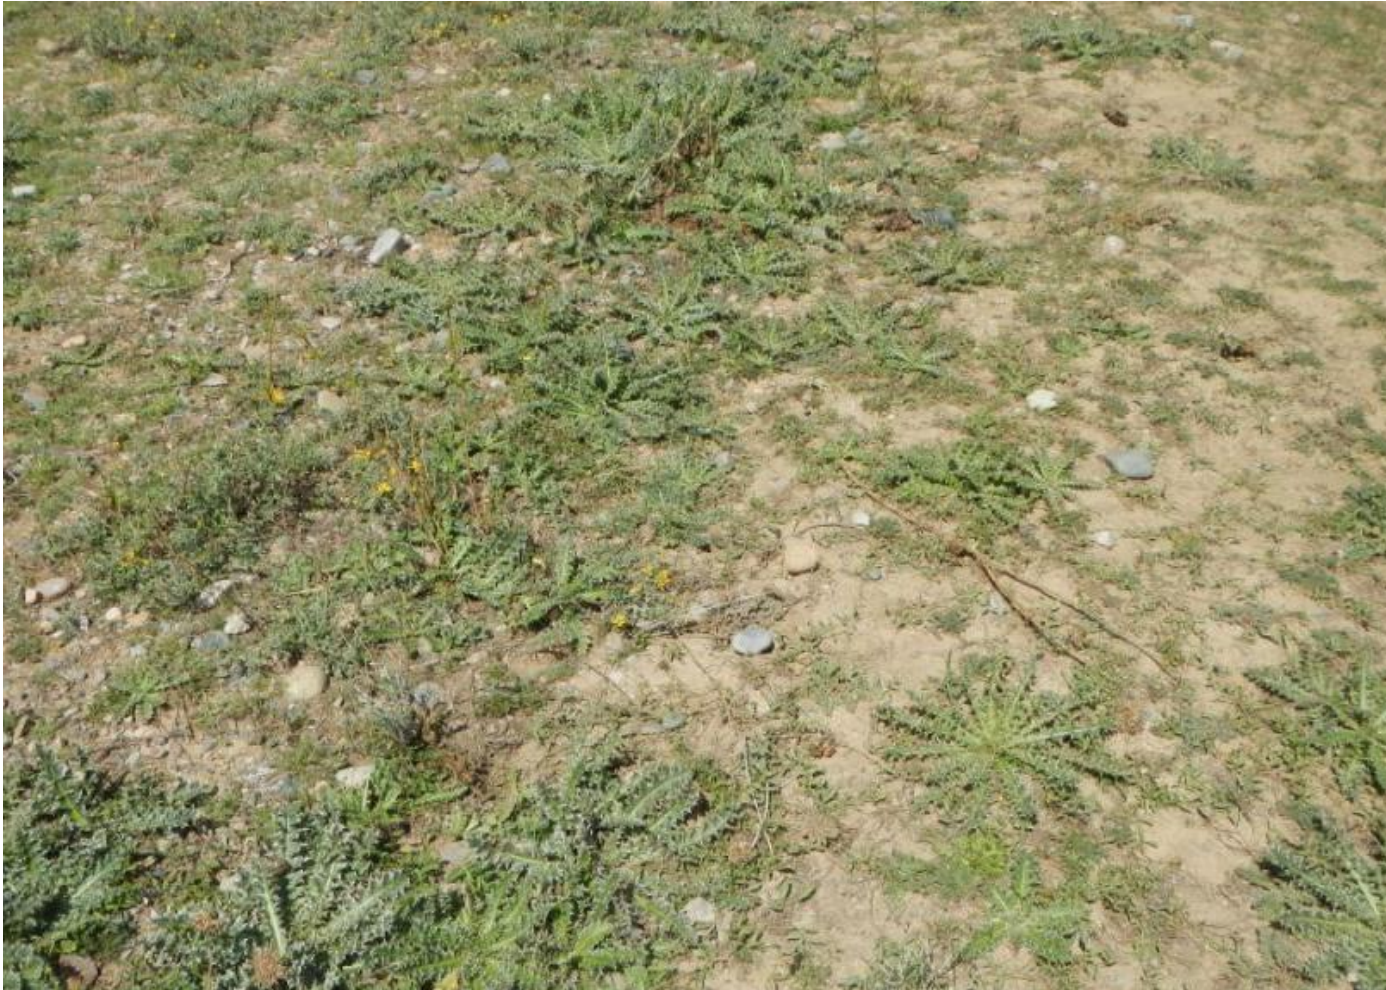
Photo 1. View of dense population of musk thistle (*Carduus nutans*) in eastern portion of project area.

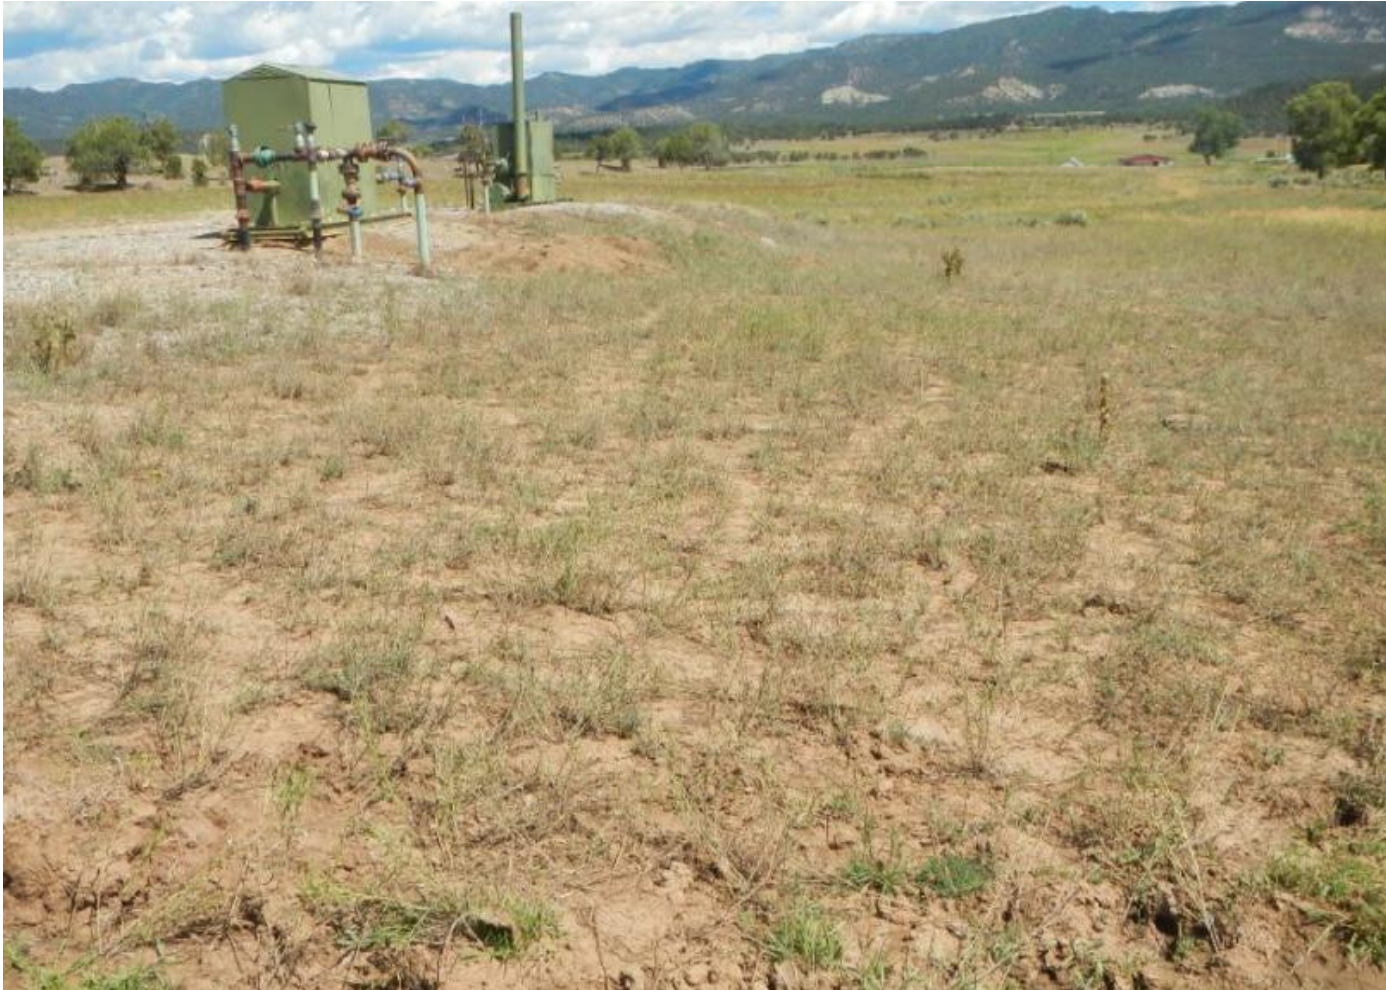
Photo 2. View of southern portion of project area from southwestern corner facing eastward. Vegetation in this area is largely comprised of Russian knapweed (*Acroptilon repens*). It appears that the Russian knapweed was mowed or grazed during the current growing season as few flower heads are present.

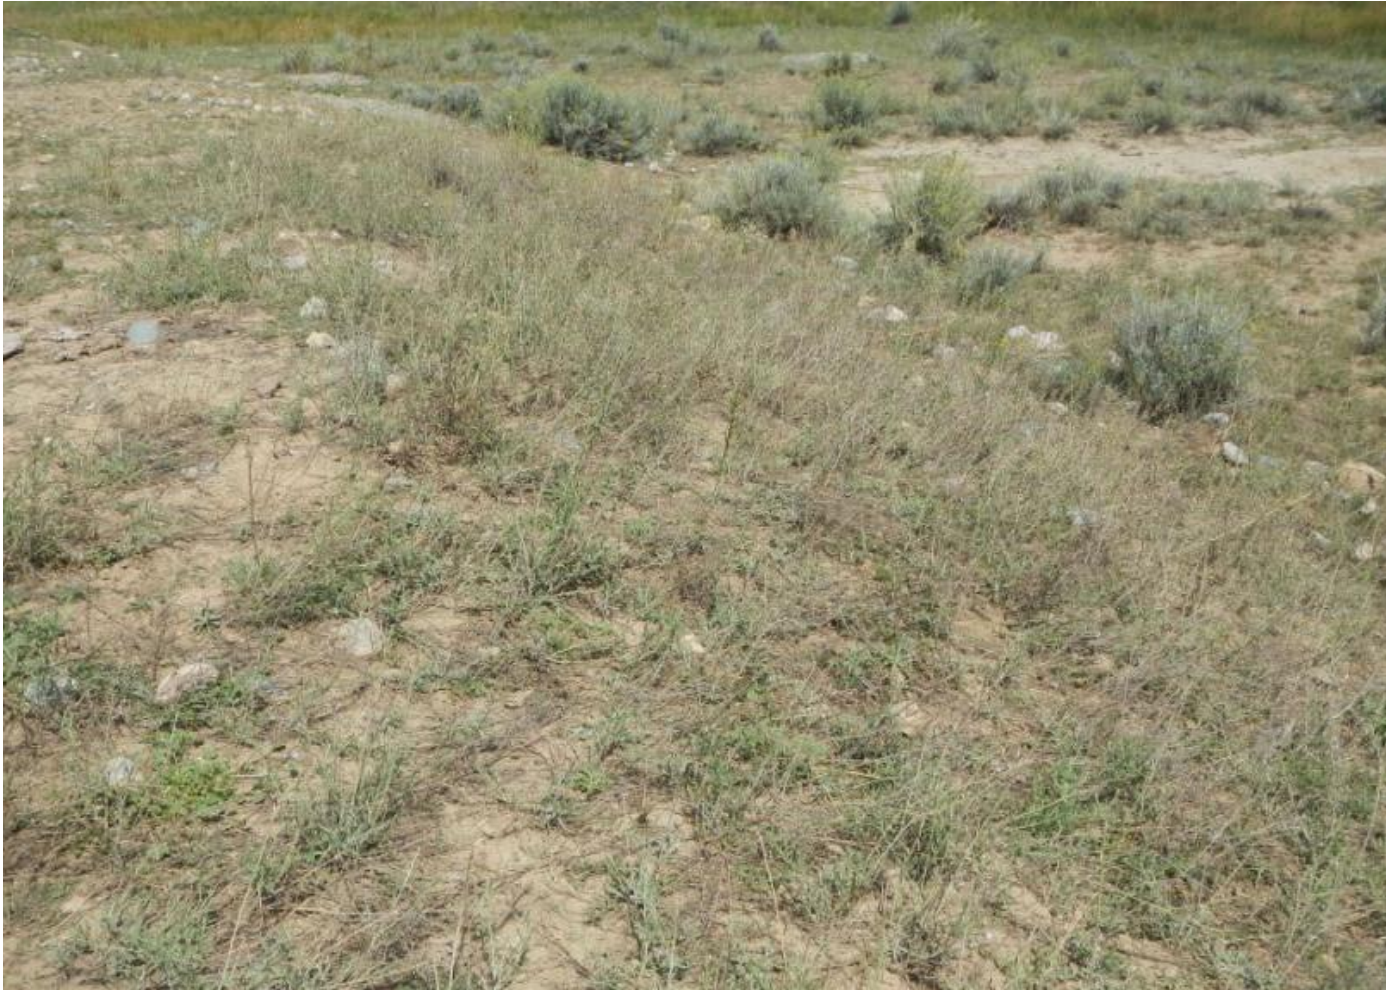
Photo 3. View of Russian knapweed plants growing within the eastern portion of the project area.

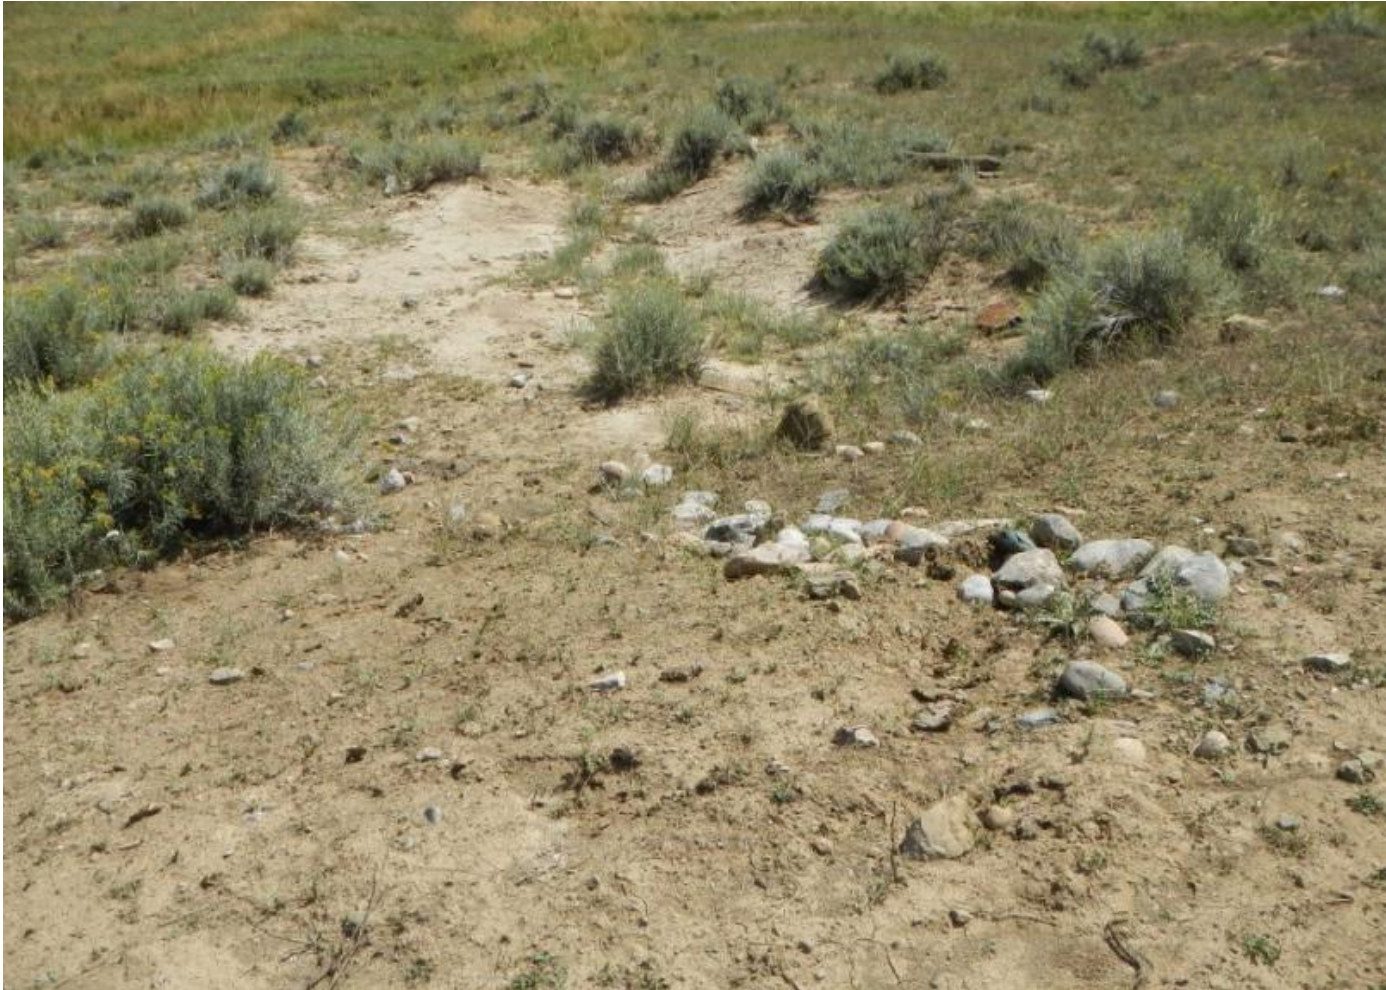
Photo 4. View of erosional channel that appears to be stabilized at this time, within the eastern portion of the project area.

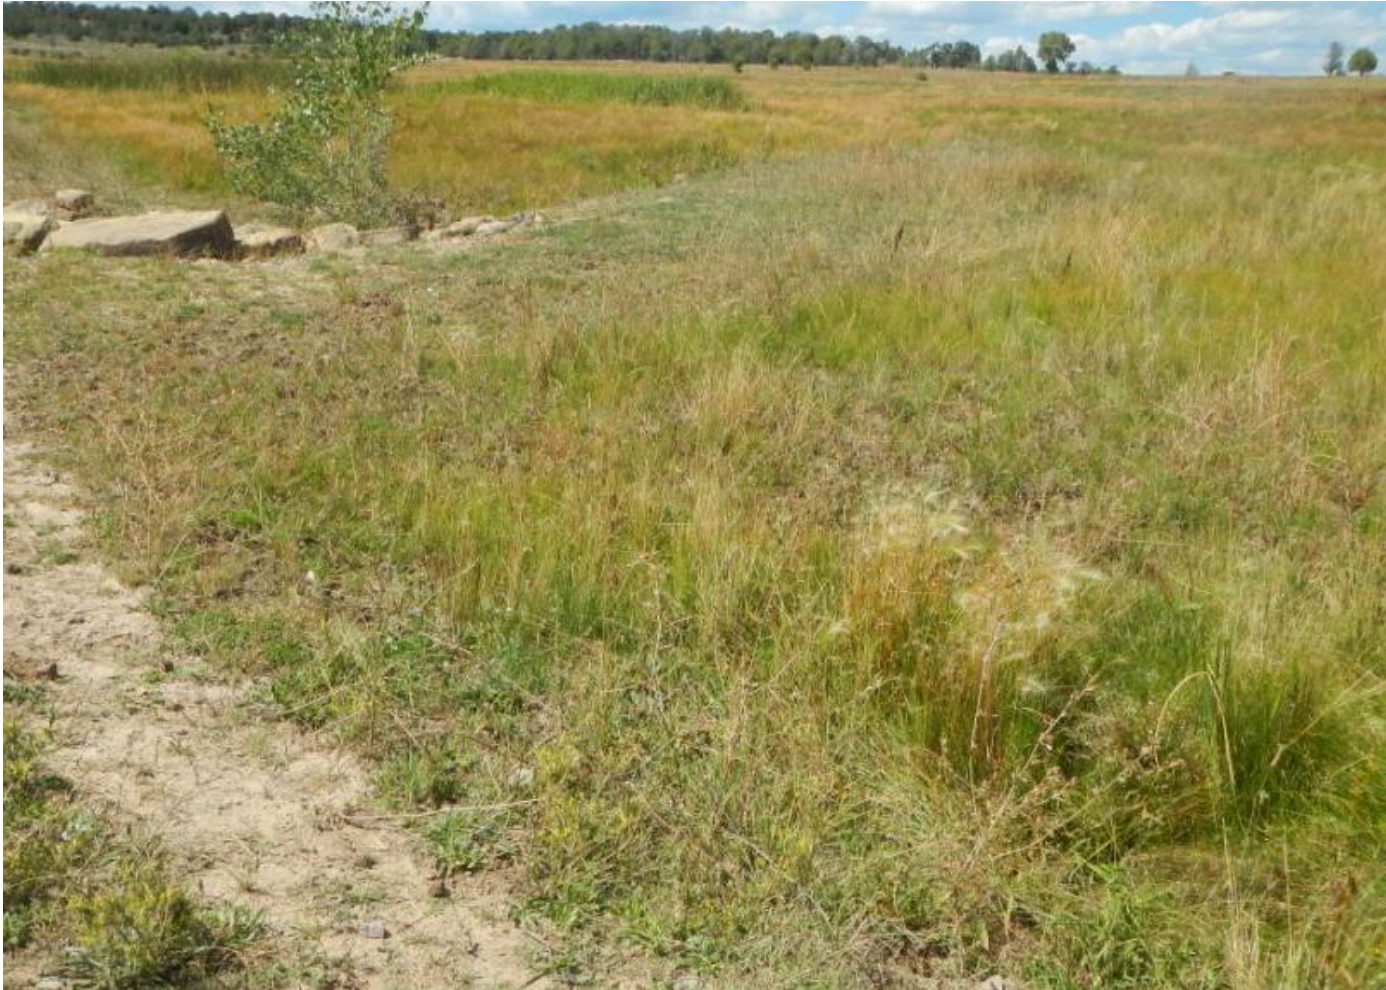
Photo 5. View of northern portion of project area from well pad entrance facing northwestward. A stream (likely irrigation ditch) flows adjacent to northern edge of project area.

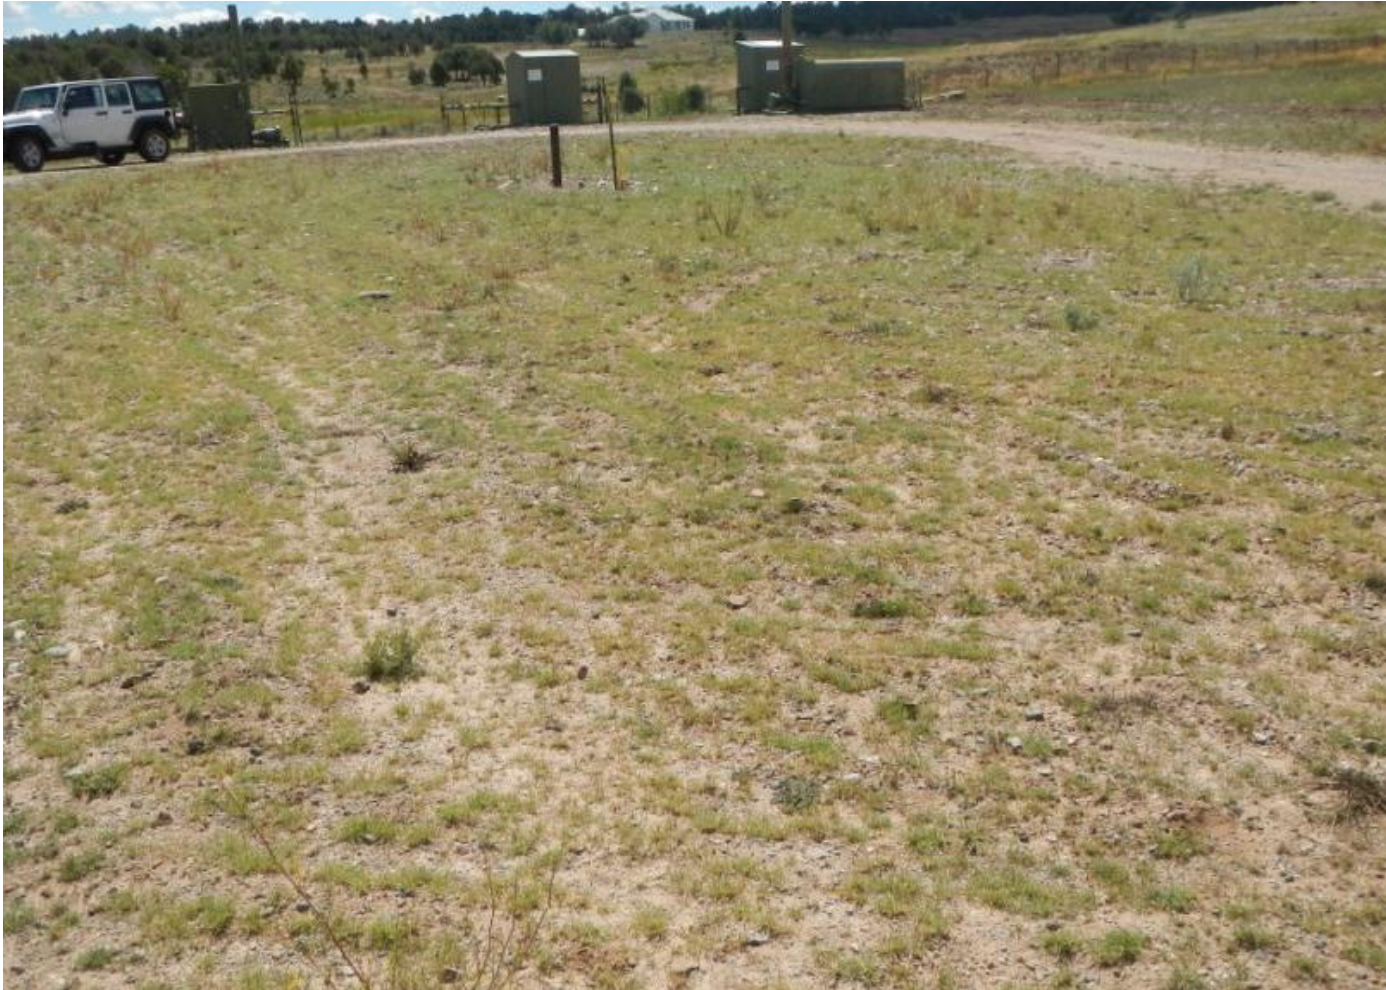
Photo 6. View of revegetation becoming established within the teardrop of the well pad, from the northern portion facing southward.
