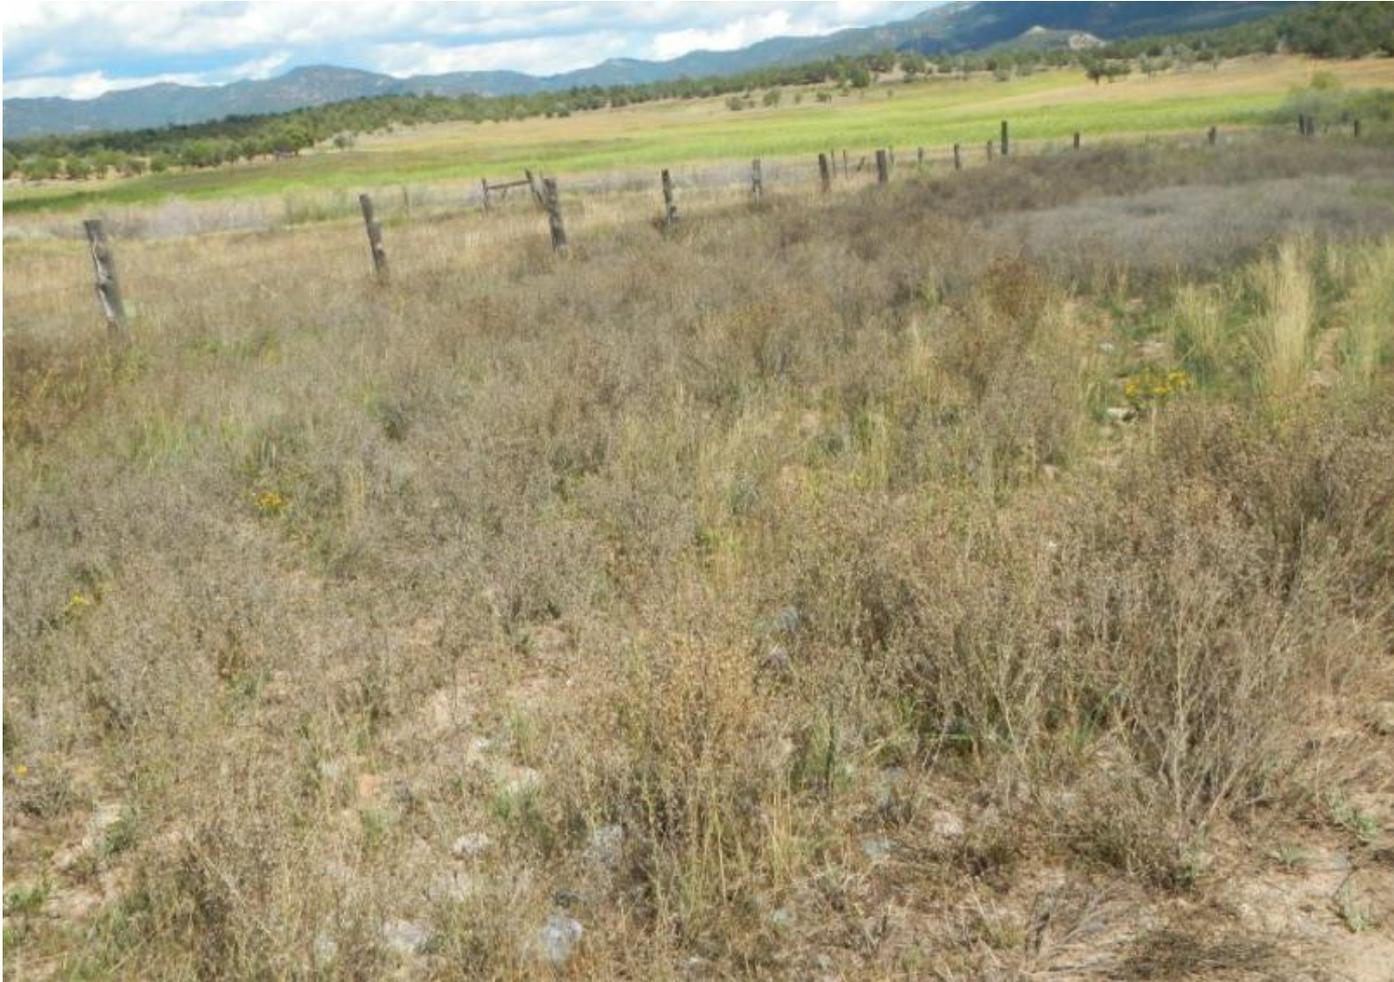
Photo 1. View of Russian knapweed (*Acroptilon repens*) in northern portion of project area from well pad facing northeastward.

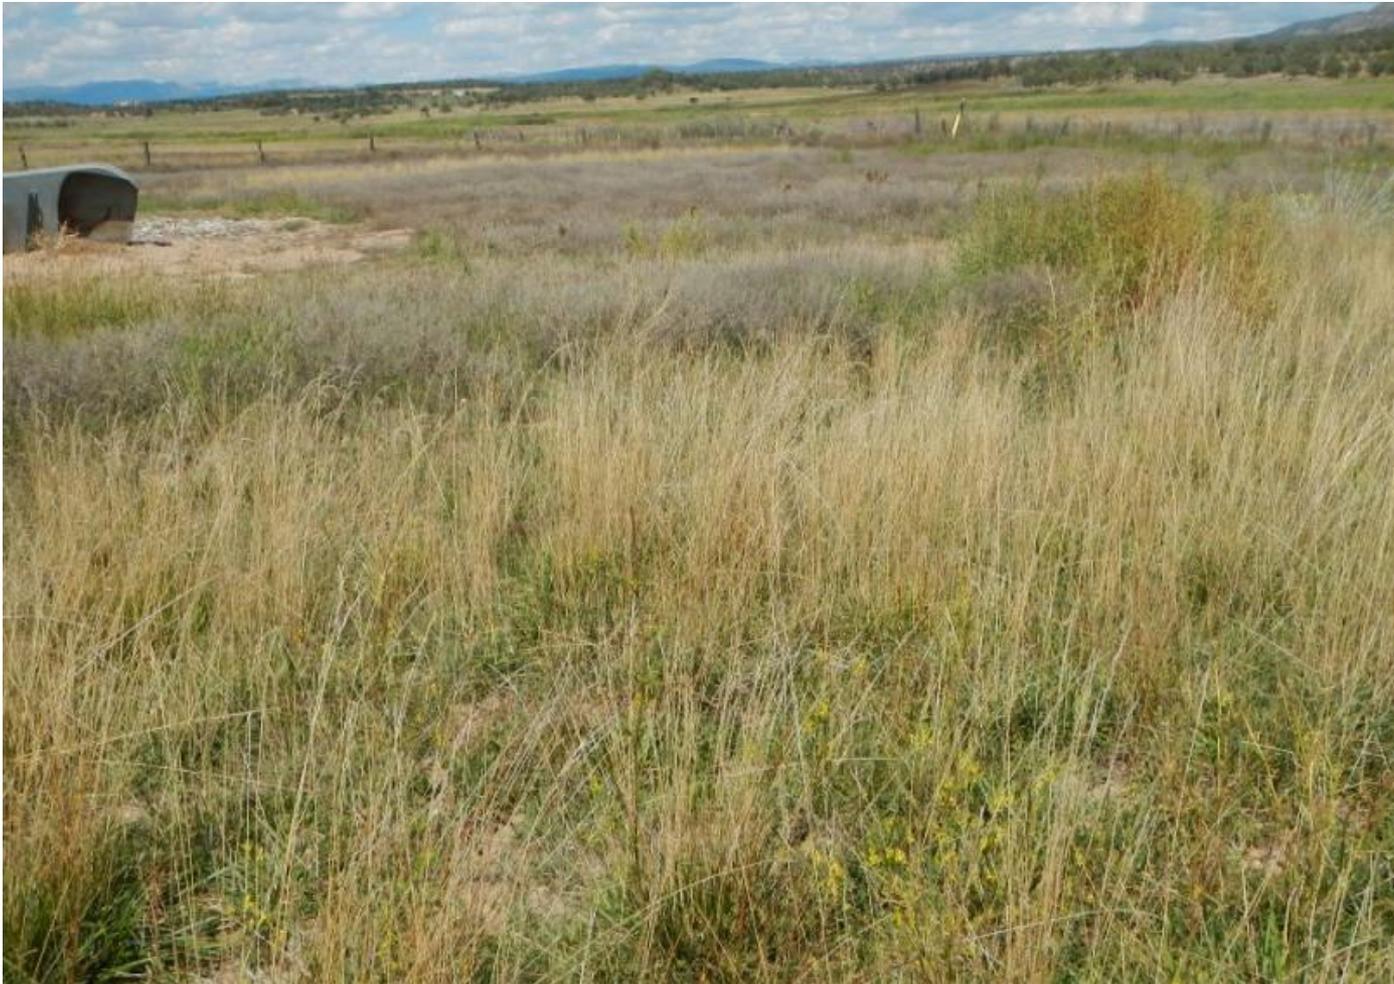
Photo 2. View of eastern portion of project area from southeastern corner facing northward. Vegetation is progressing in the foreground with grasses such as intermediate wheatgrass (*Thinopyrum intermedium*). Russian knapweed infestation in mid-ground and background (grey vegetation) is likely spreading to reclaimed area and threatening revegetation efforts.

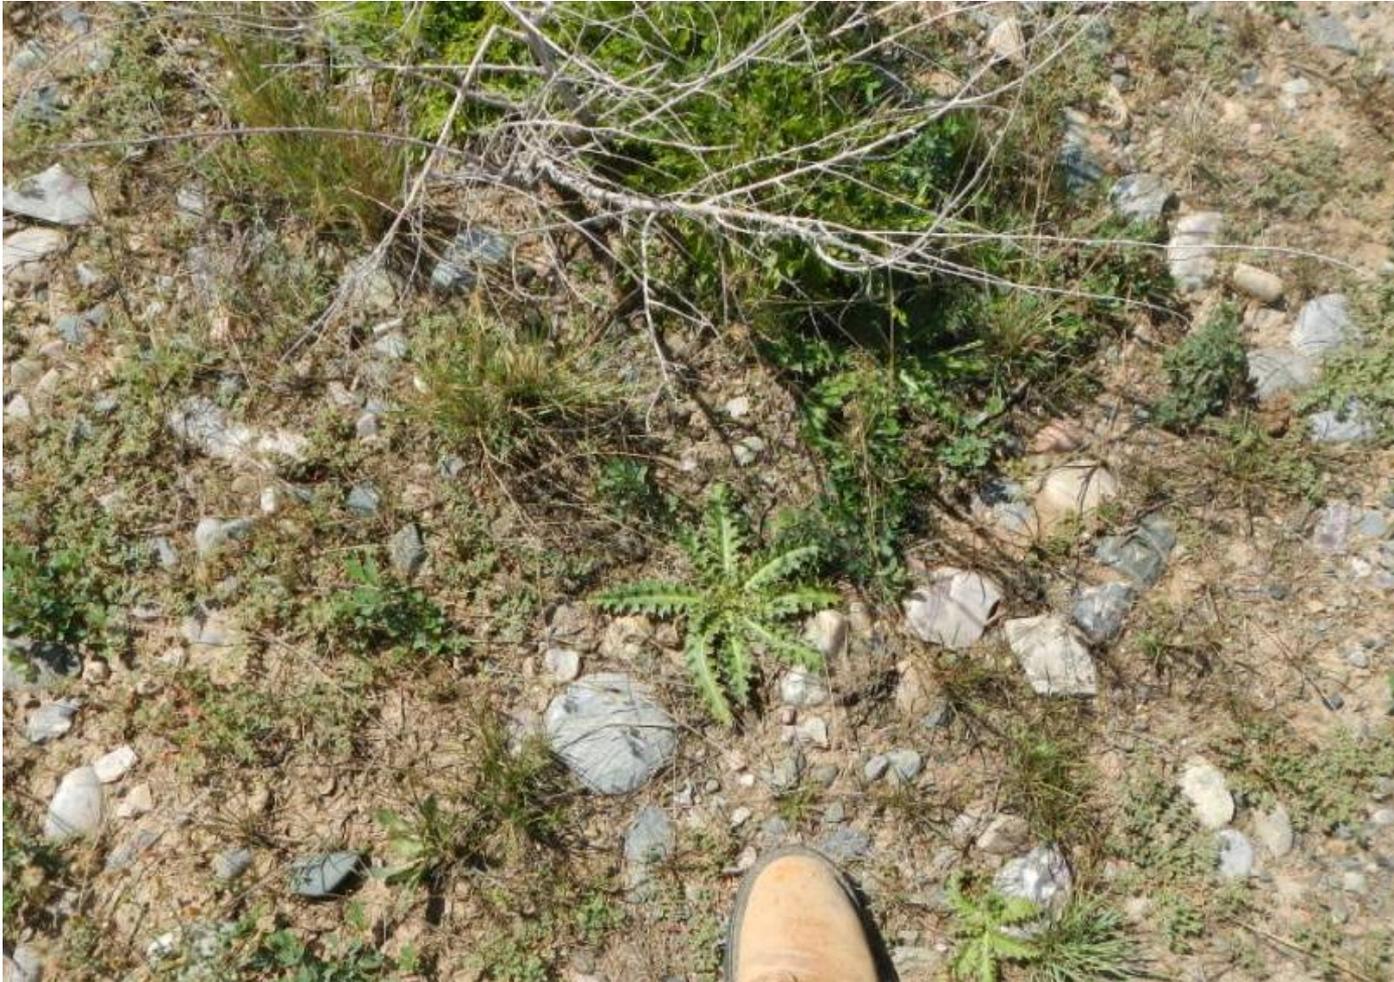
Photo 3. View of young musk thistle (*Carduus nutans*) rosettes within the interim reclamation area.

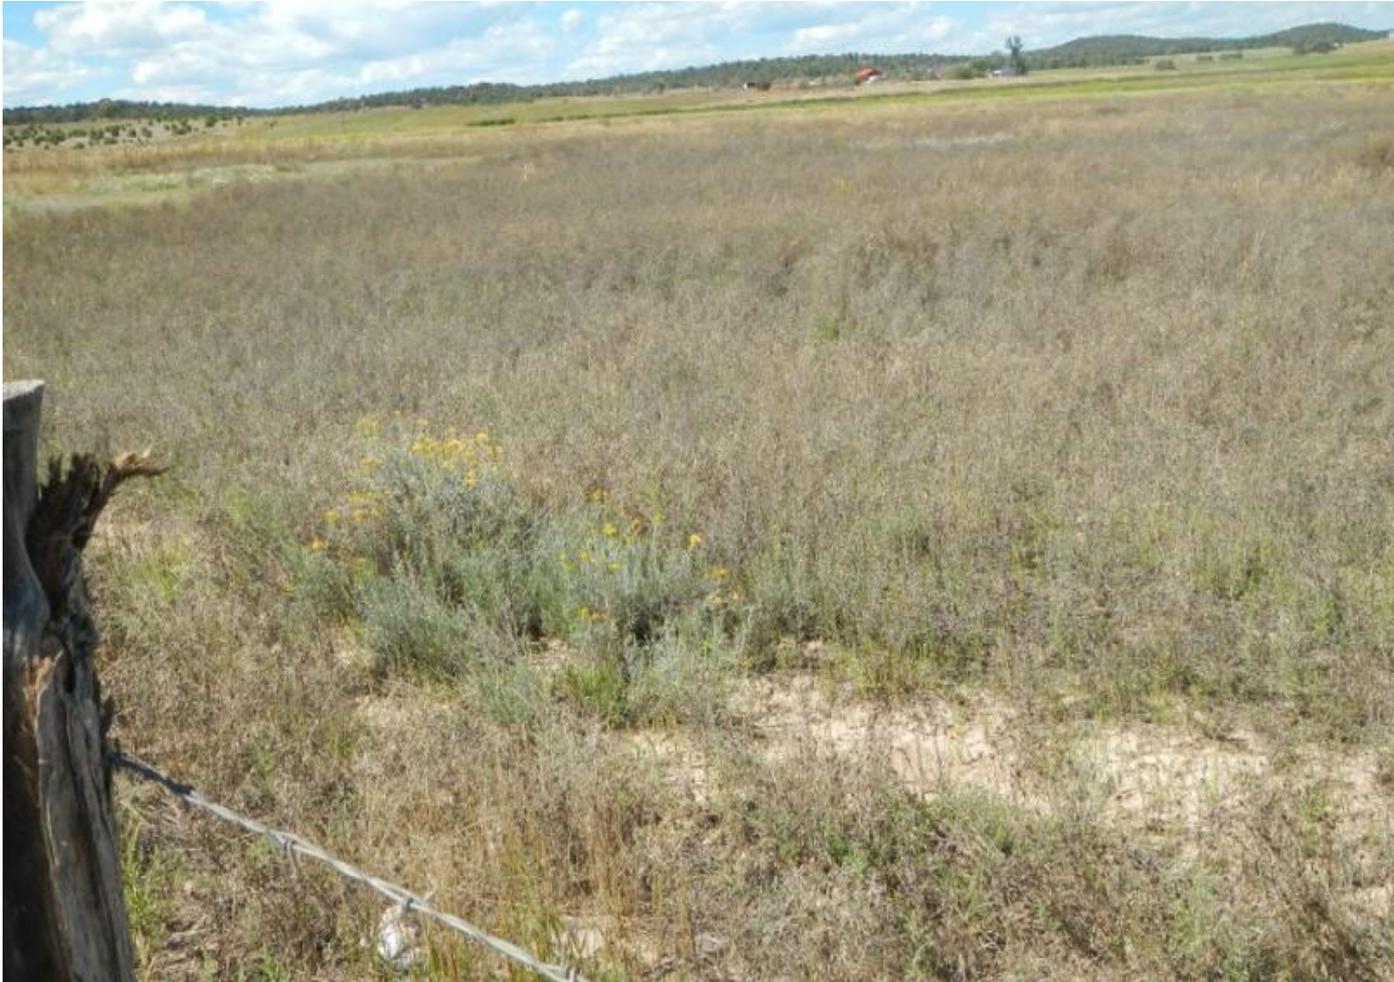
Photo 4. View of Russian knapweed infestation north of the project area.

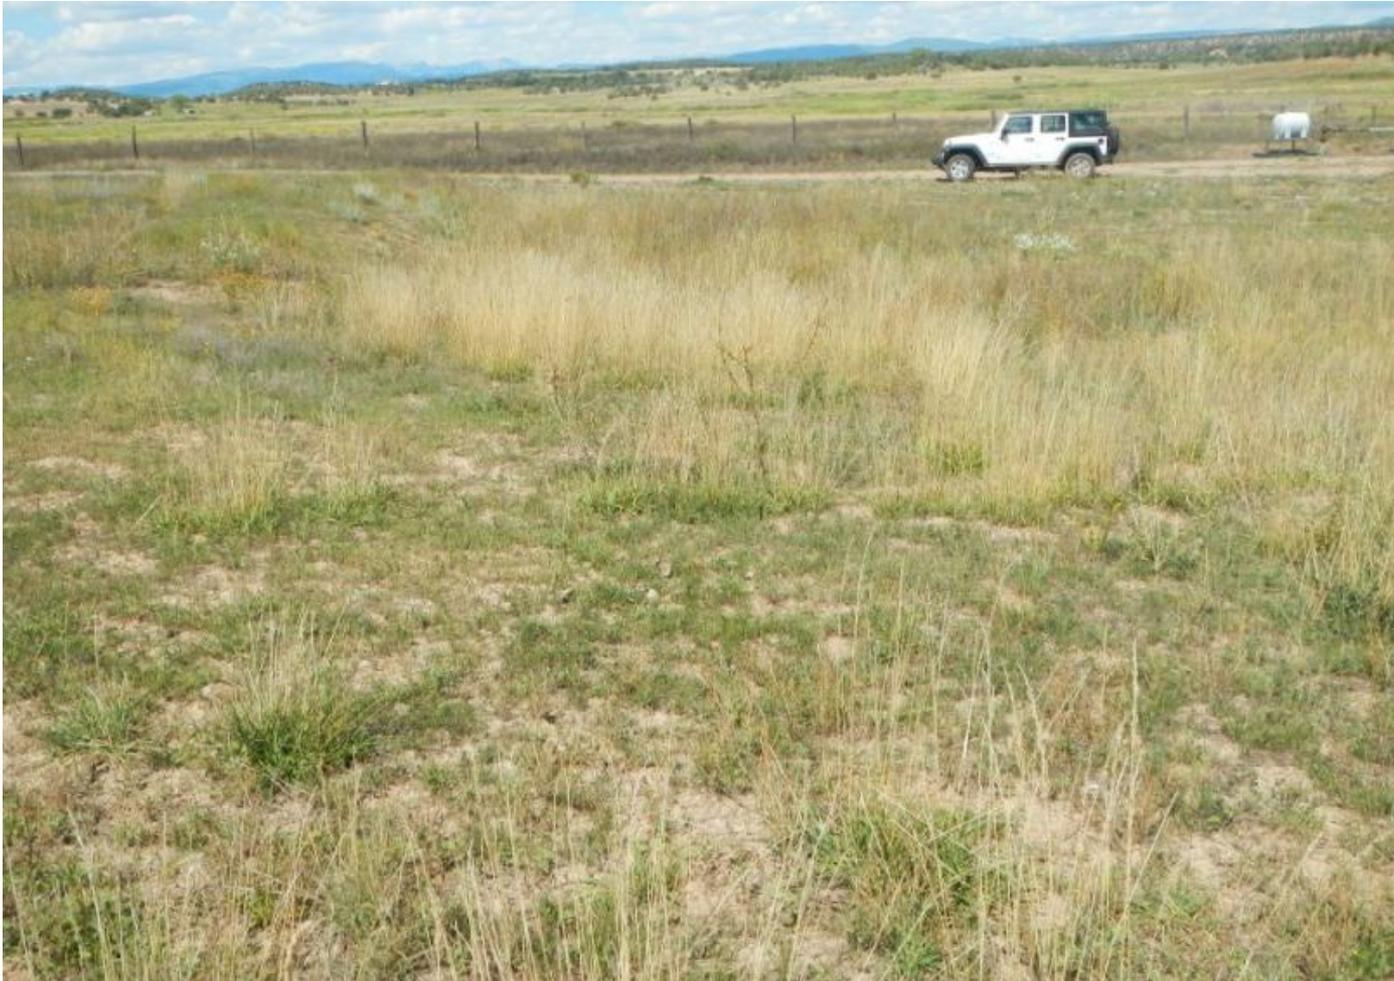
Photo 5. View of western portion of the project area from southwestern corner facing northward. Revegetation in this portion of the project area appears to be progressing.

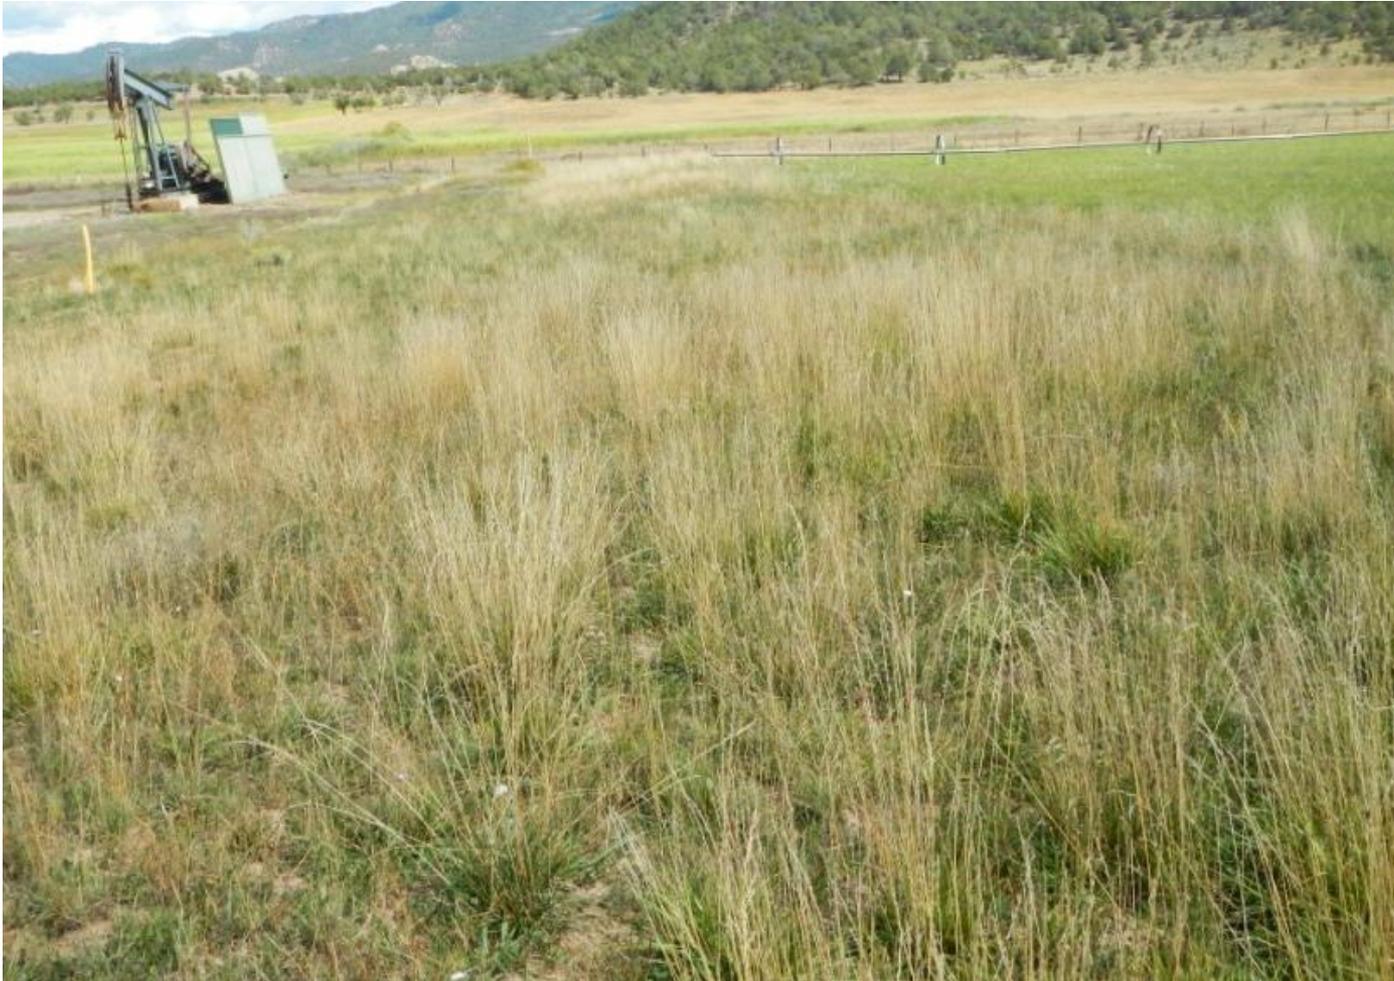
Photo 7. View of southern portion of project area from southwestern corner facing eastward. Irrigated field (on right) does not appear to have knapweed.
