Sonterra Energy 05-103-08096

Federal 1-30

Follow up inspection

September 11, 2015

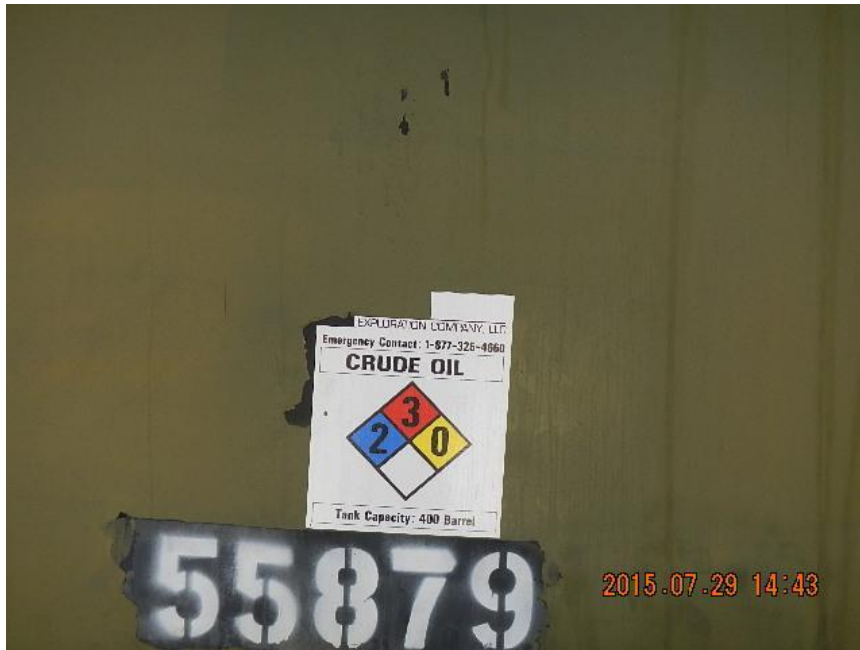
^ - Initial inspection

Tank labels incomplete and emergency contact number not valid.

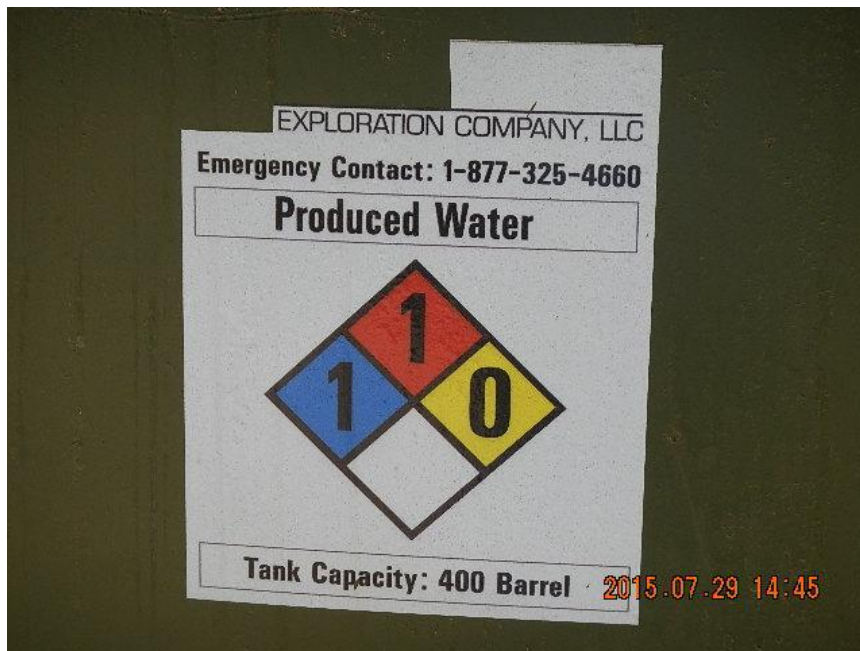
^ - Initial inspection

Tank labels incomplete and emergency contact number not valid.

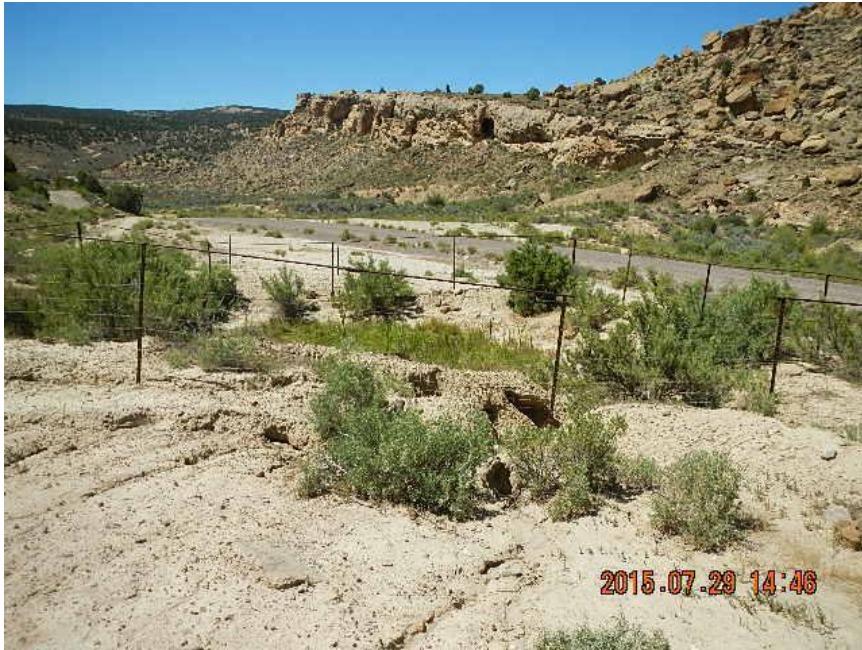
^ - Initial inspection

Brush and weeds inside blowdown pit, fence and stormwater BMP's around pit need maintained.

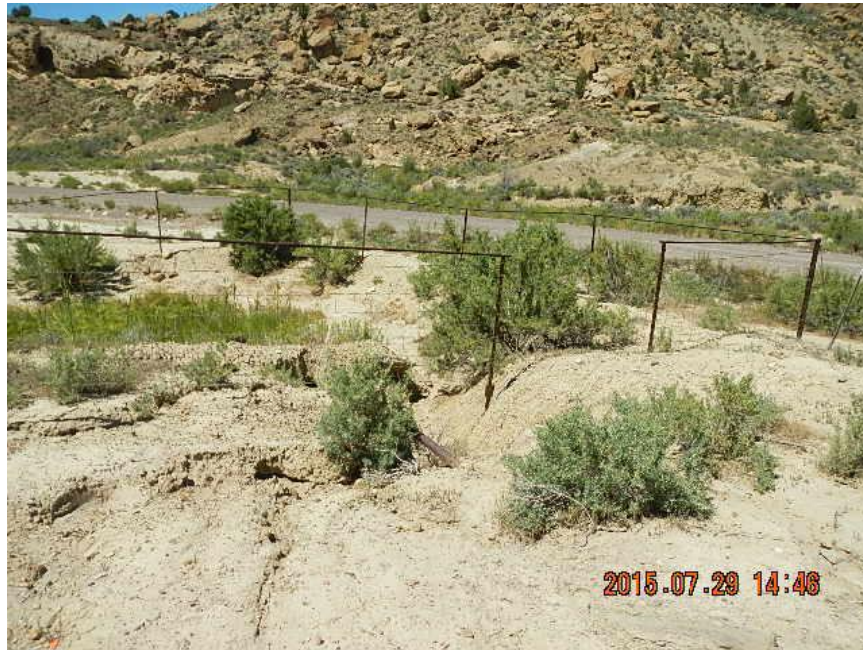
^ - Initial inspection

Brush and weeds inside blowdown pit, fence and stormwater BMP's around pit need maintained.

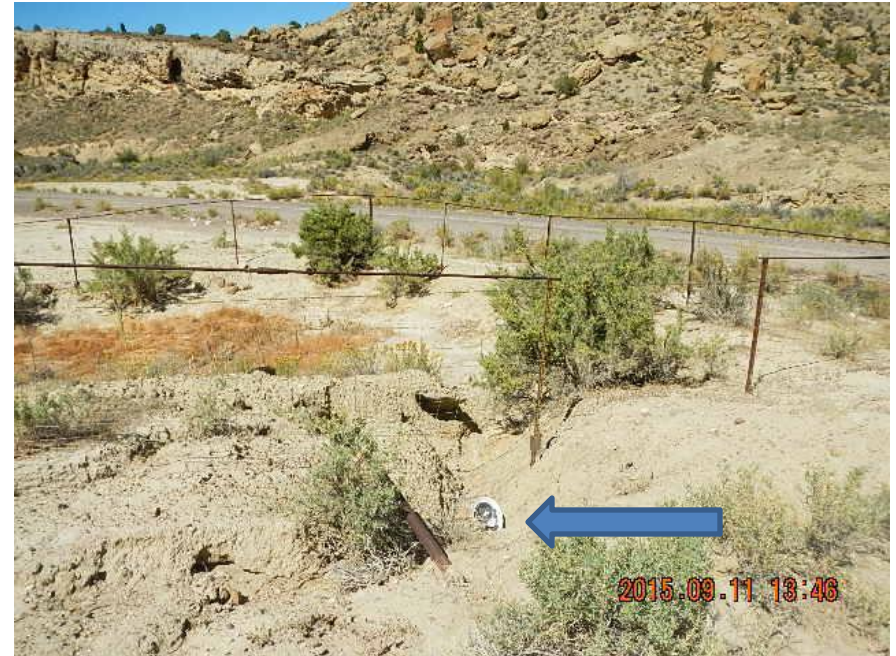
^ - Follow up inspection

*Hard hat for visual reference

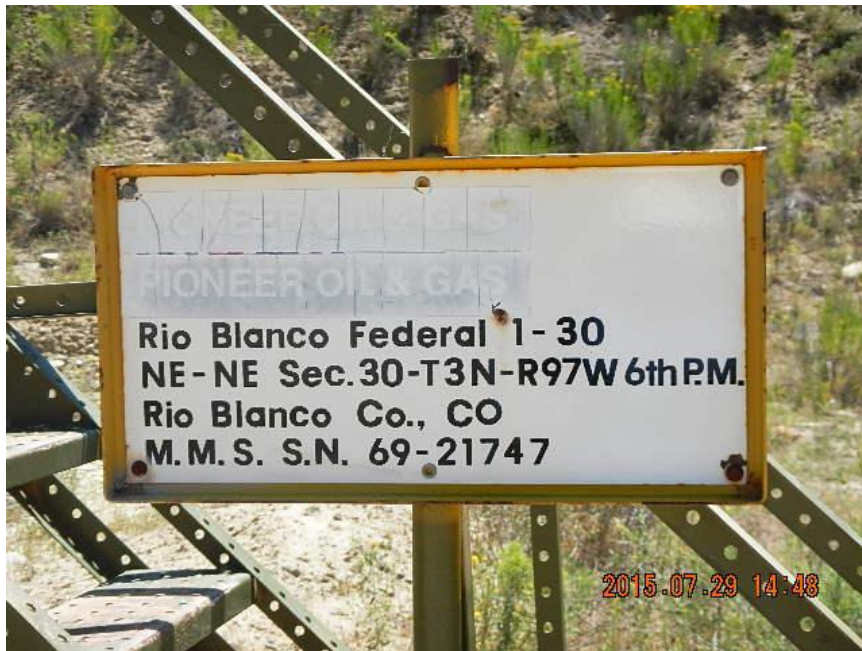
^ - Initial inspection

Tank battery sign – incomplete.

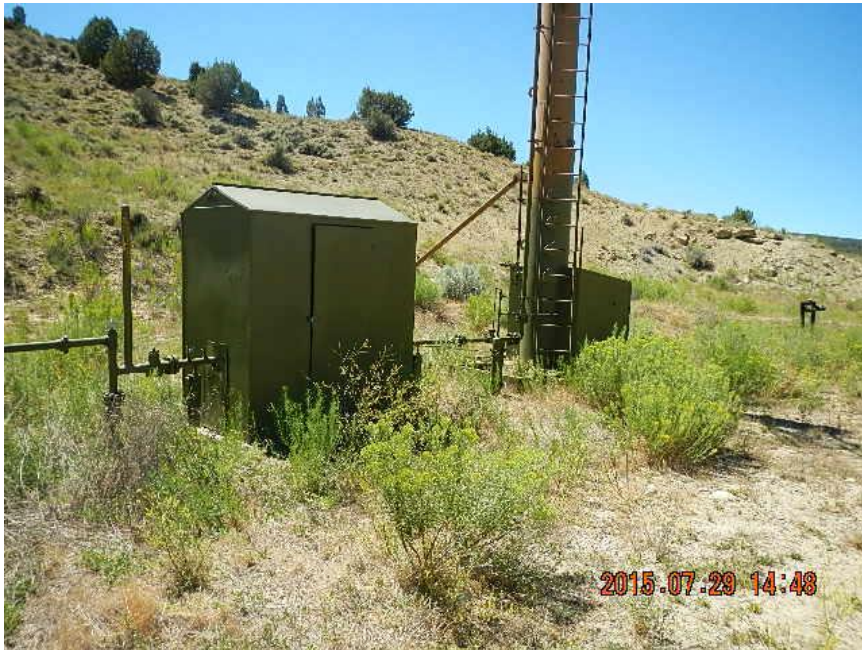
^ - Initial inspection

Weeds/brush within 25' of production equipment.

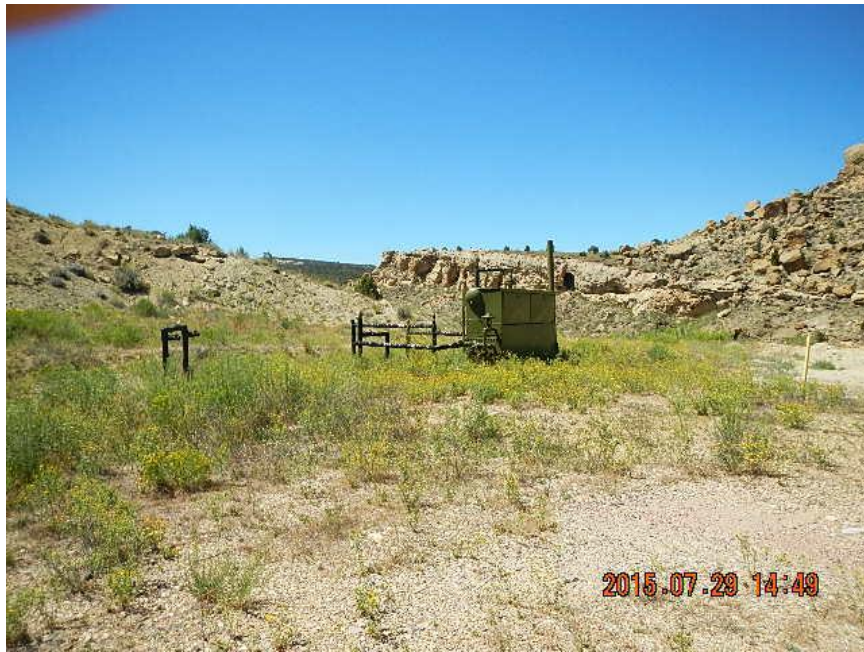
^ - Initial inspection
Brush/weeds within 25' of production equipment.
