September 13, 2013

#5122434

**RE: STATUS REPORT: CACHE SPILL #1 (REM #7786) AND #2 (REM #7787)
MONUMENT GLOBAL RESOURCES, INC. (OPER #10430)
CACHE FIELD, MONTEZUMA COUNTY, COLORADO**

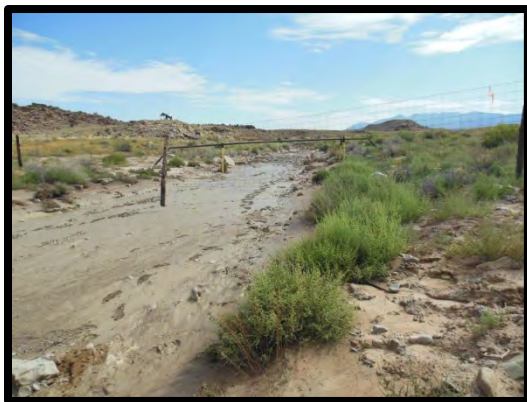
8/29/13: View of spill #1, just below fence near source

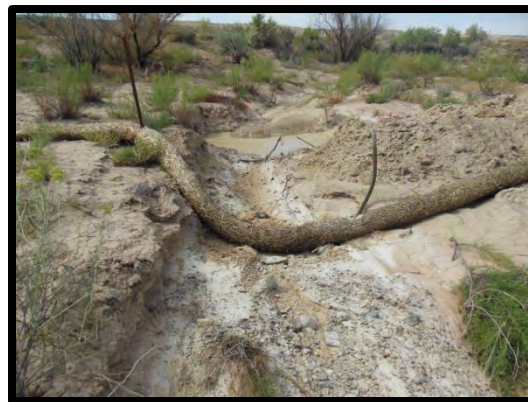
8/29/13: View downstream, near end of spill #1

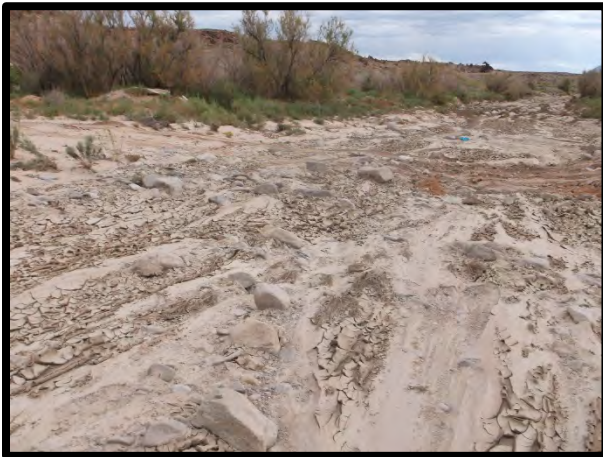
9/3/13: View of spill #1, at intersection w/road

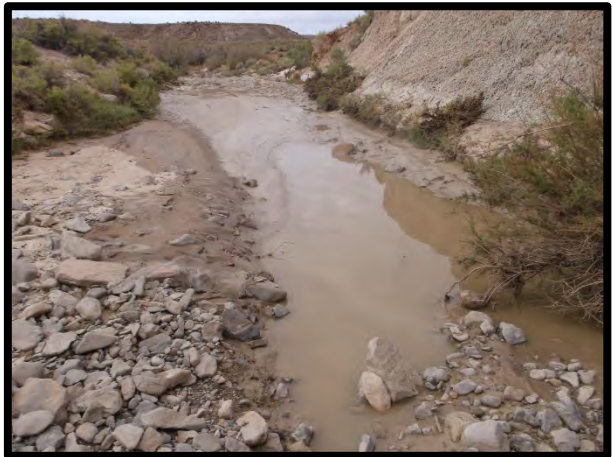
9/3/13: View of standing water in spill #1 area;
no hydrocarbon sheen observed

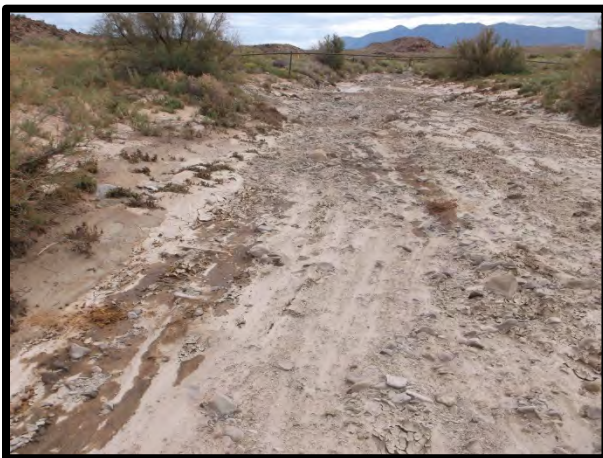
9/3/13: View of stained soil in wash near source of
spill #1

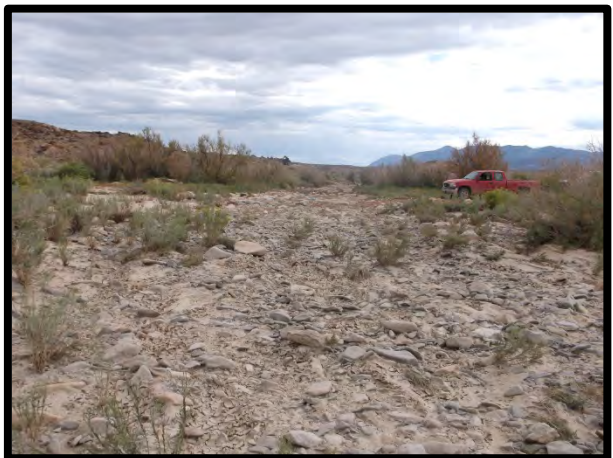
9/3/13: View of spill #1 from below intersection
w/road

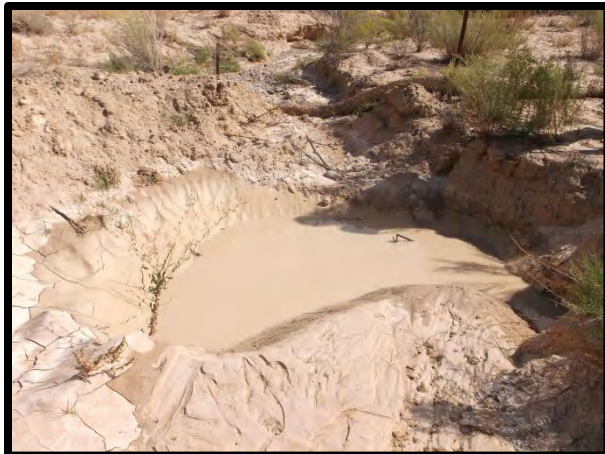
9/3/13: View of excavated sediment trap at end of spill #2; no hydrocarbon staining observed

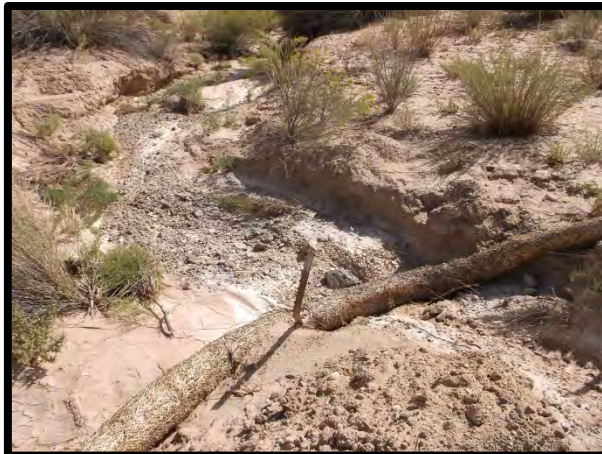
9/3/13: View of erosion log below sediment trap at spill #2; no hydrocarbon sheen observed

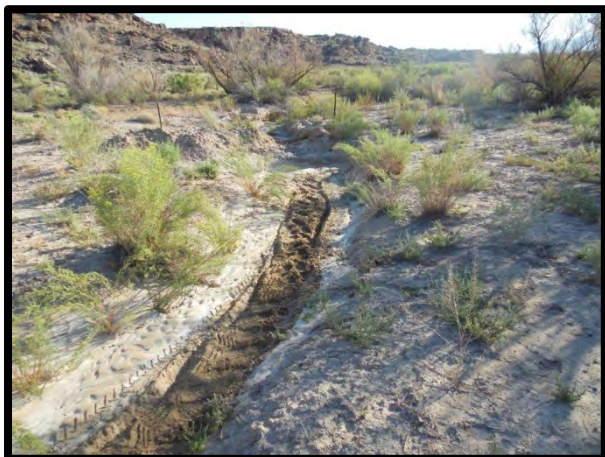
9/6/13: Tilled area near fenceline of spill #2

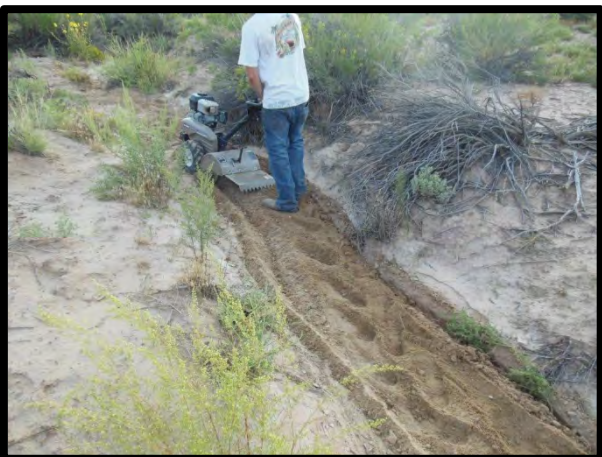
9/6/13: MGRI personnel tilling in spill #2

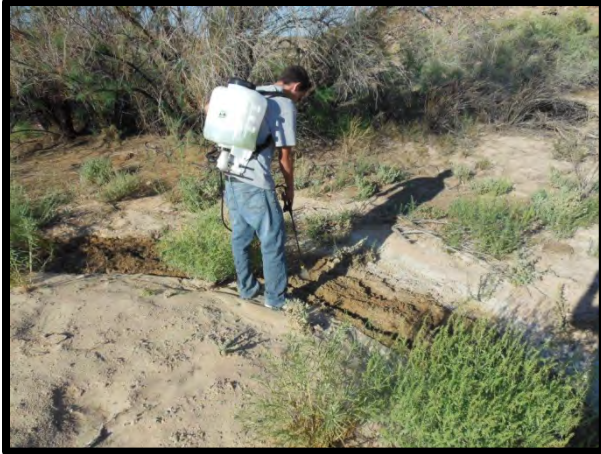
9/6/13: MGRI personnel spraying solution in spill #2

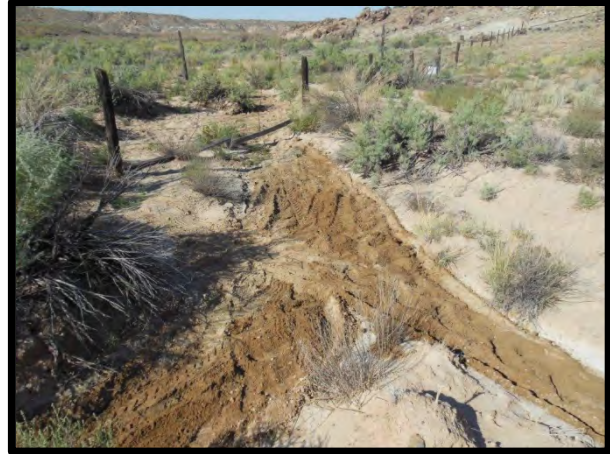
9/6/13: View of spill #2 after tilling and spraying activities

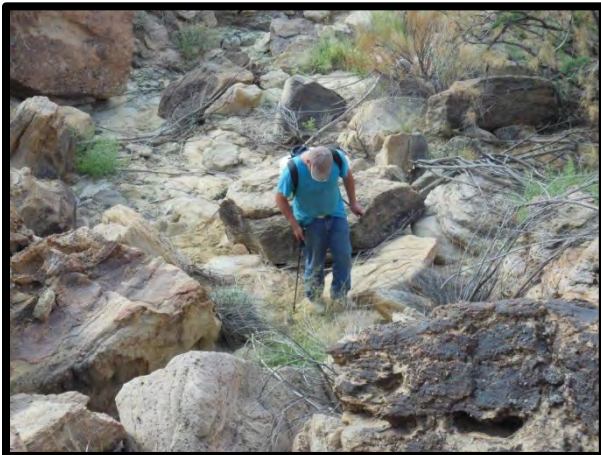
9/7/13: MGRI personnel spraying solution in boulder area of spill #2

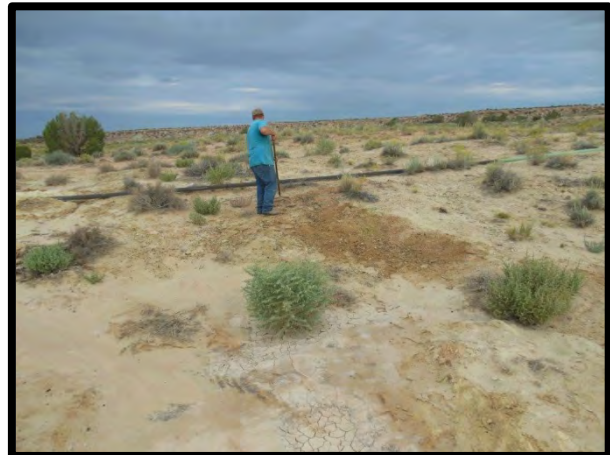
9/7/13: Raking near source area of spill #2

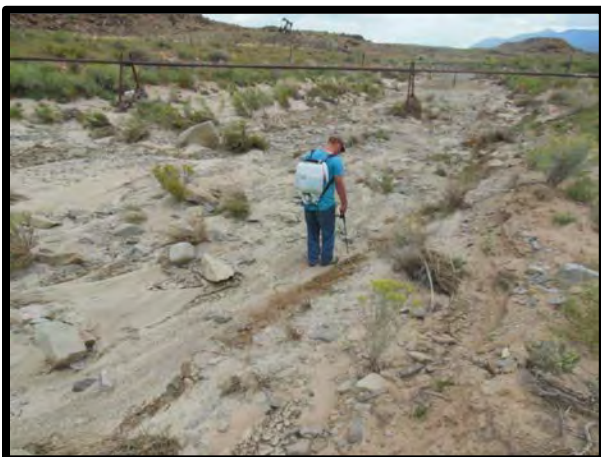
9/8/13: MGRI personnel spraying solution near spill #1

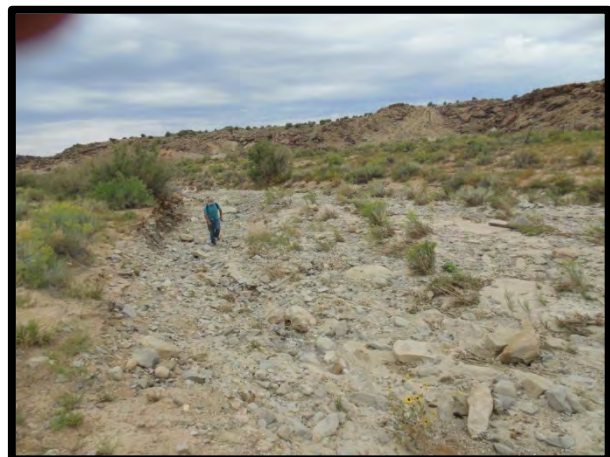
9/8/13: MGRI personnel spraying solution in source of spill #1
