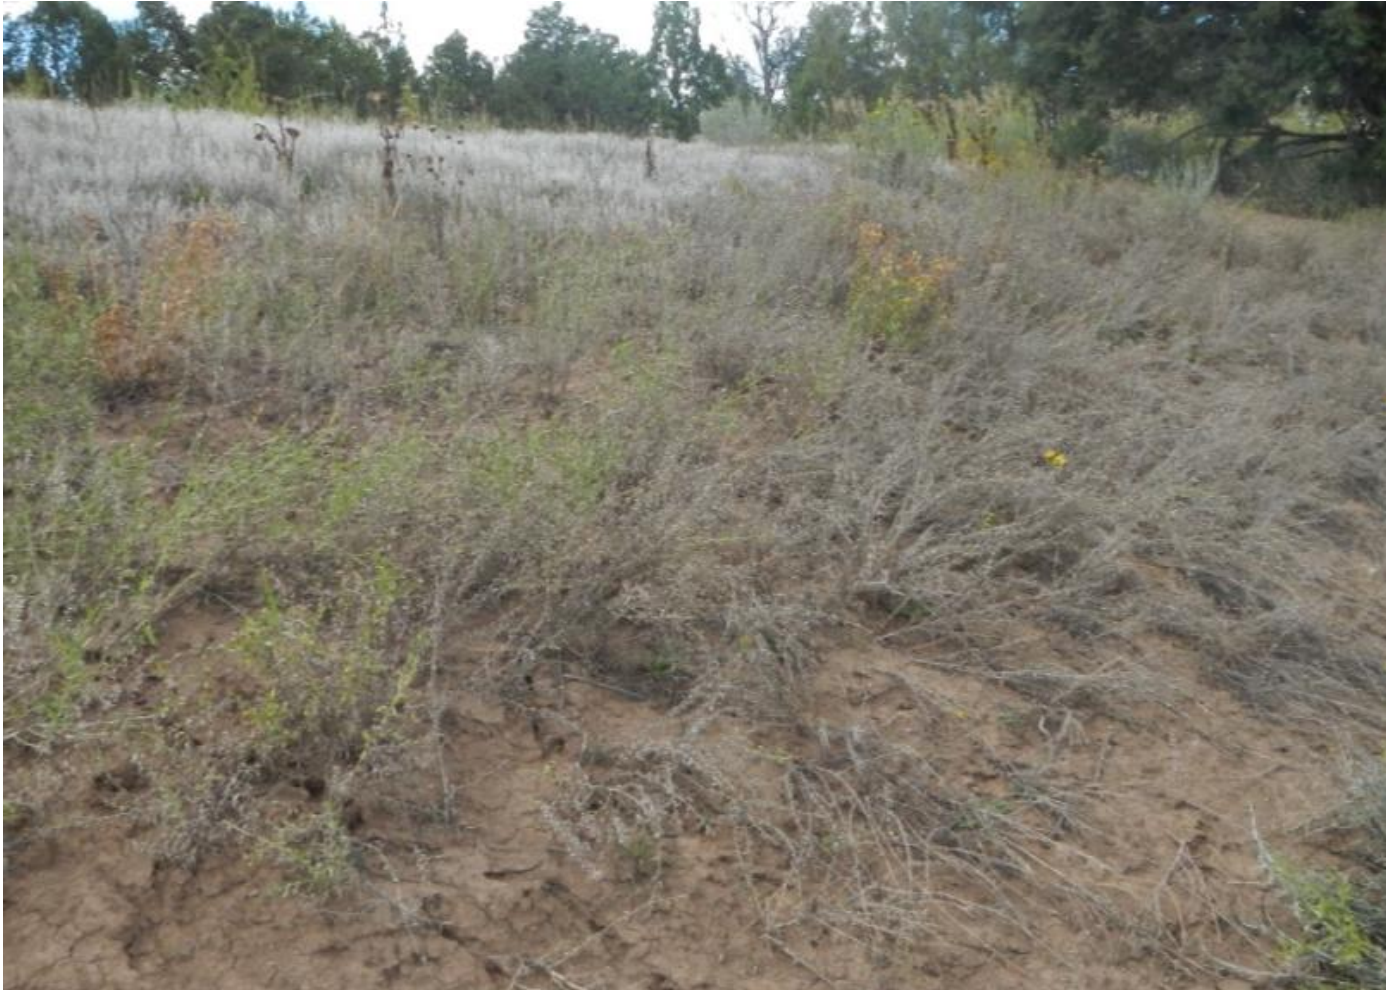
Photo 1. View of Russian knapweed (*Acroptilon repens*) in northwestern portion of project area.

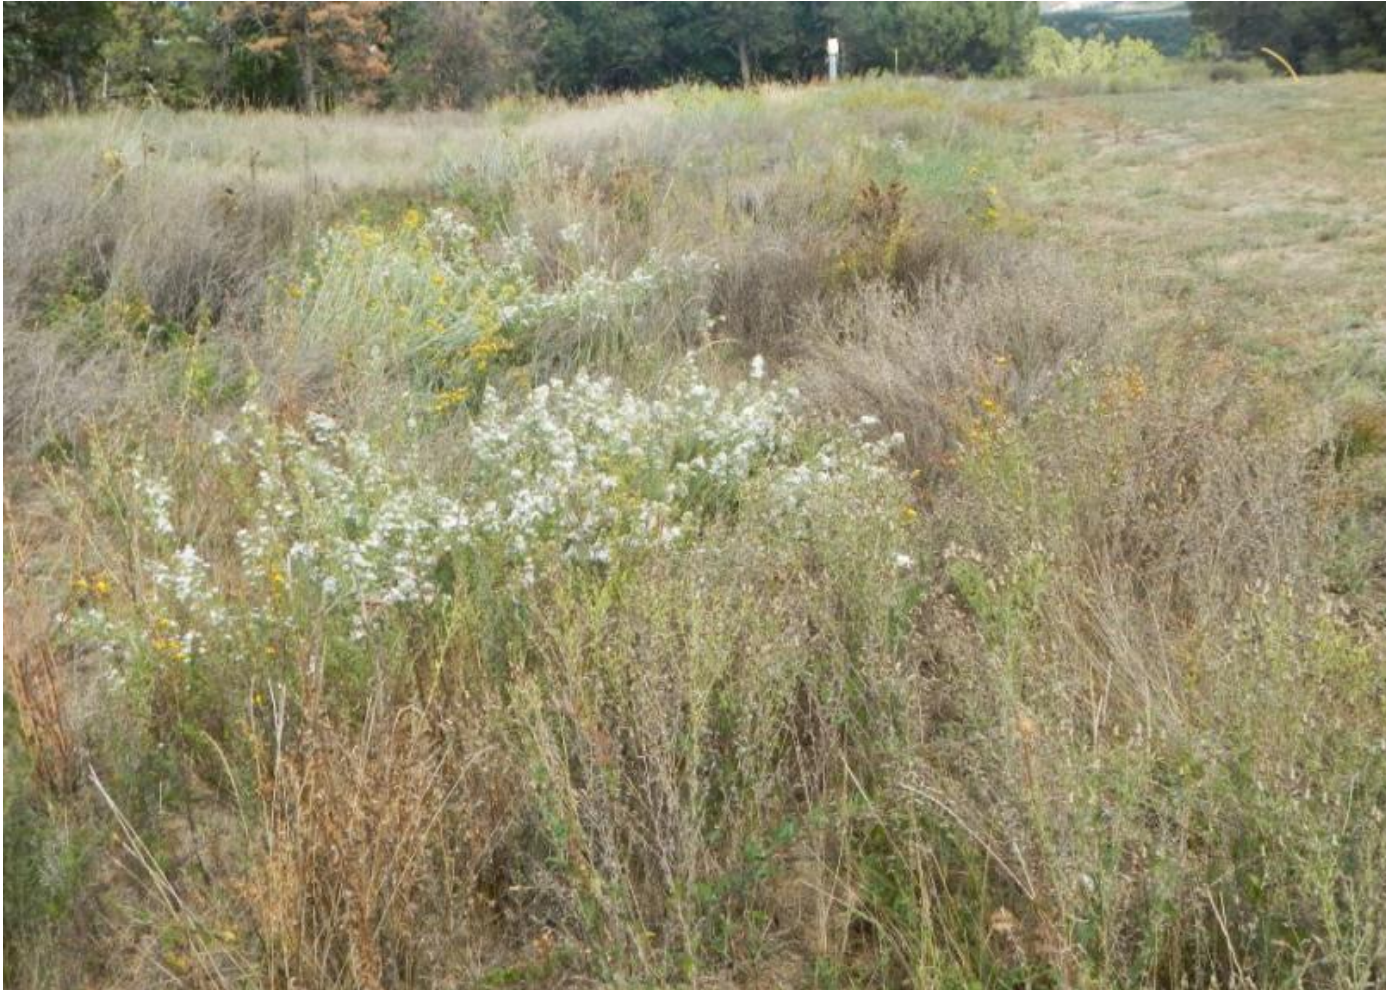
Photo 2. View of northern portion of project area from northwestern corner facing eastward. Revegetation is comprised of a mix of forbs such as fleabane (*Erigeron* sp.) and shrubs such as rubber rabbitbrush (*Chrysothamnus nauseosus*). Hundreds of Russian knapweed plants are growing throughout this portion of the project area.

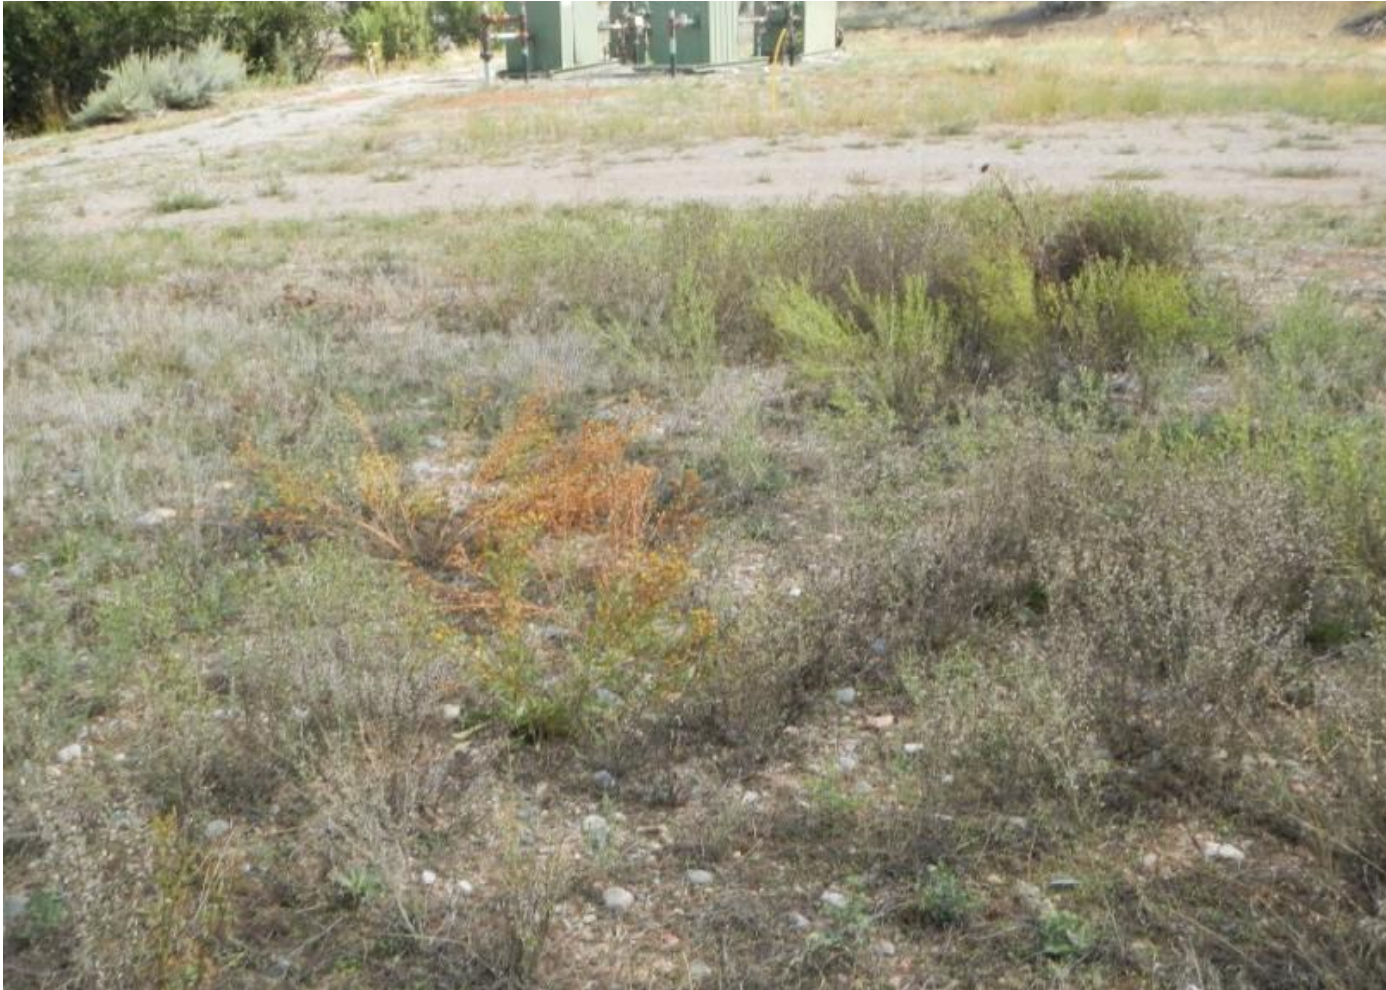
Photo 3. View eastern portion of the project area facing westward from northeastern corner. The majority of the vegetation here is Russian knapweed.

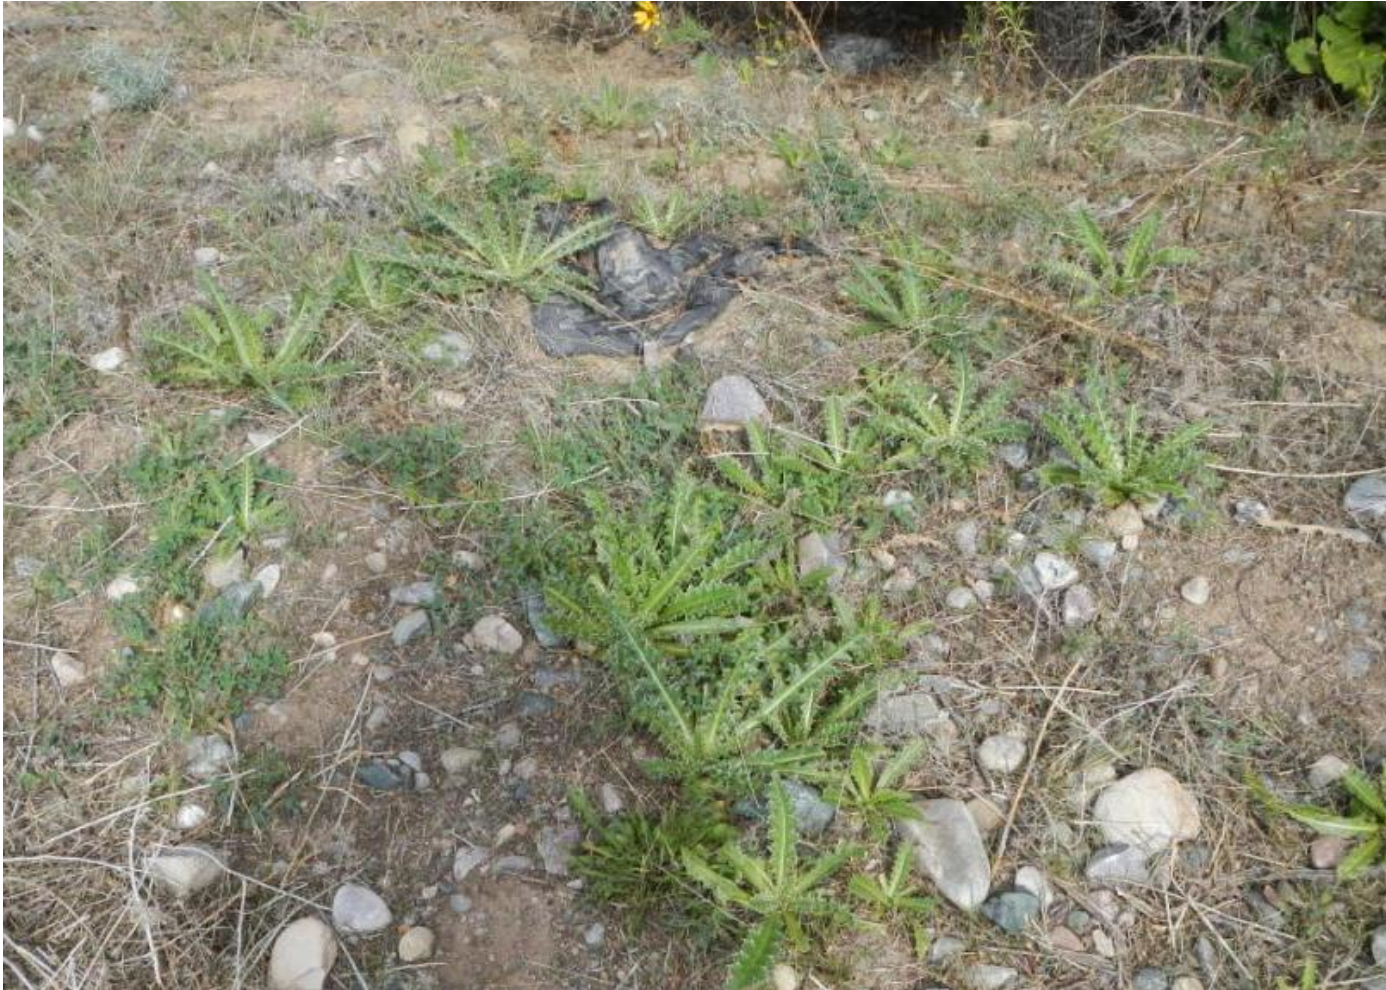
Photo 4. View of numerous musk thistle (*Carduus nutans*) rosettes within the interim reclamation area.

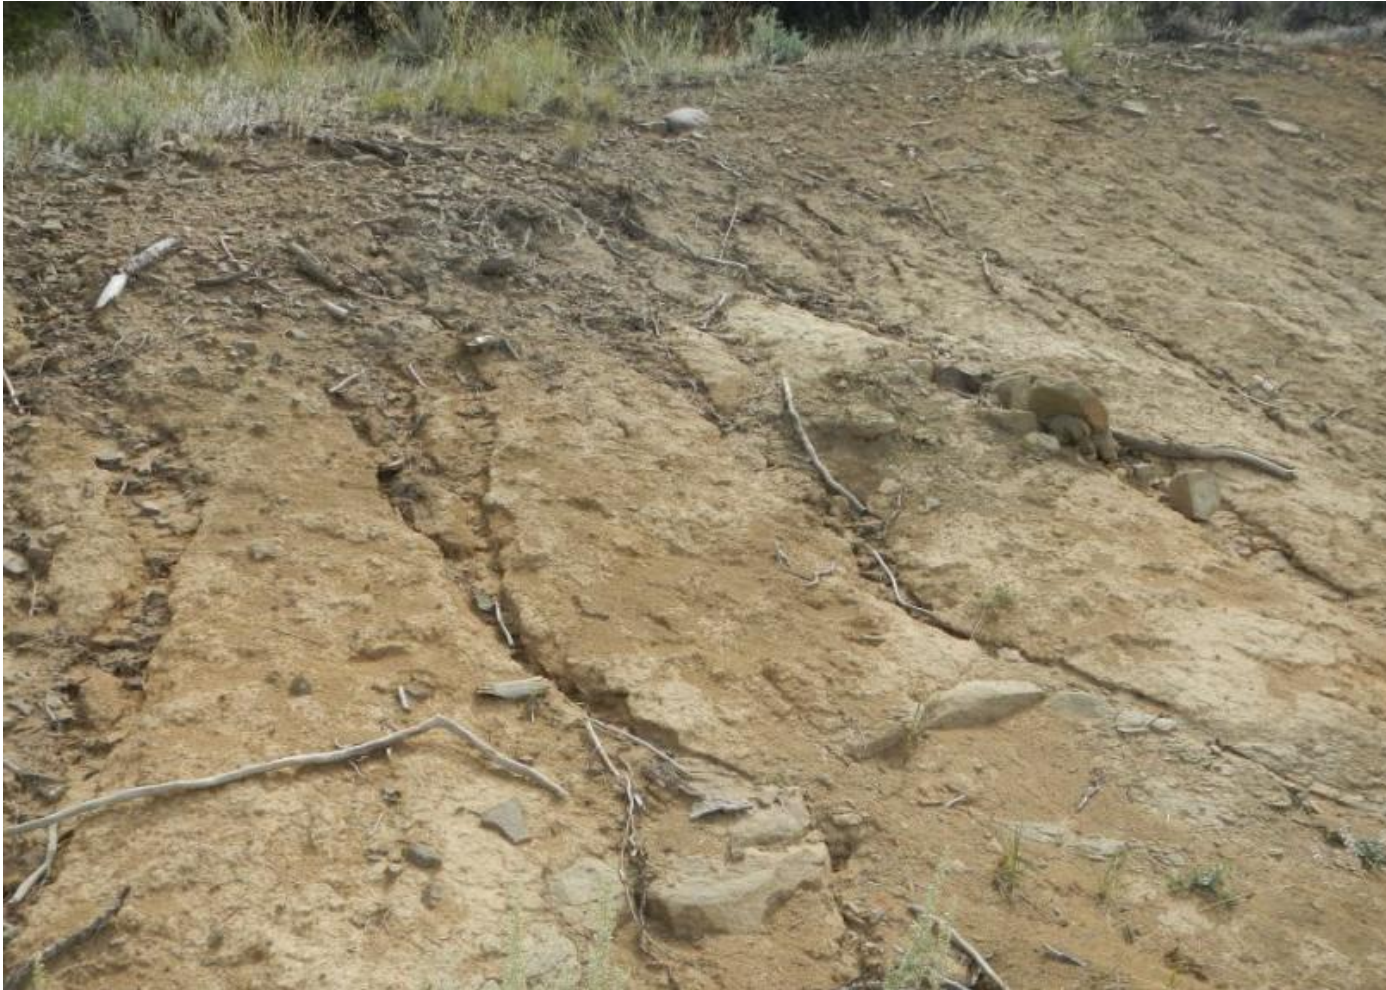
Photo 5. View of rill erosion occurring on largely barren cut slope within southeastern portion of the project area.

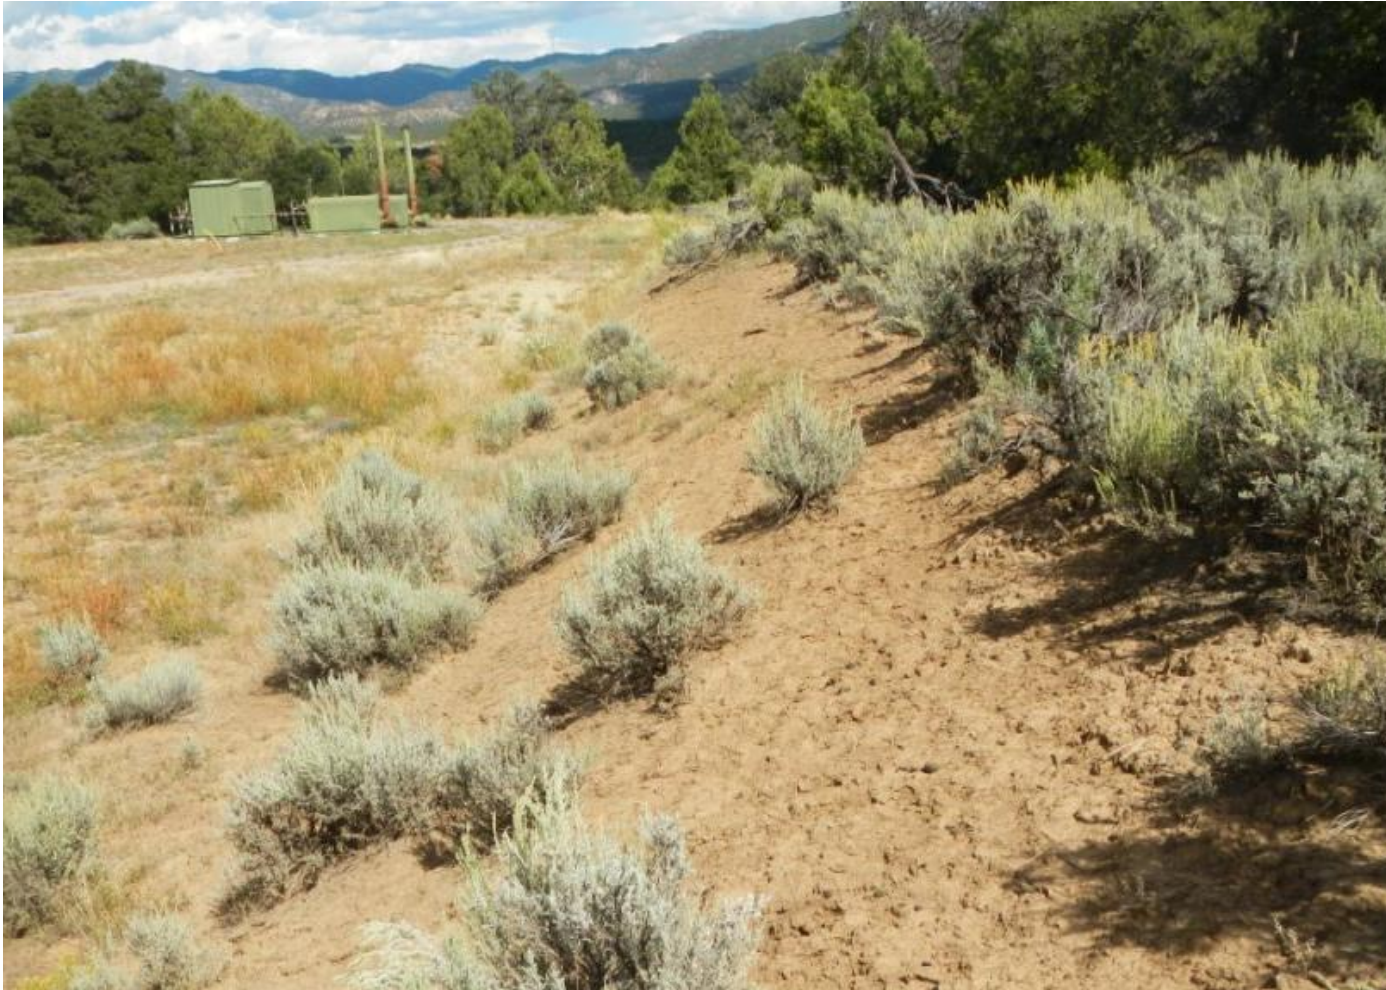
Photo 6. View from southwestern corner of project area facing eastward. Sparse revegetation of sagebrush along cut slope in this area.
