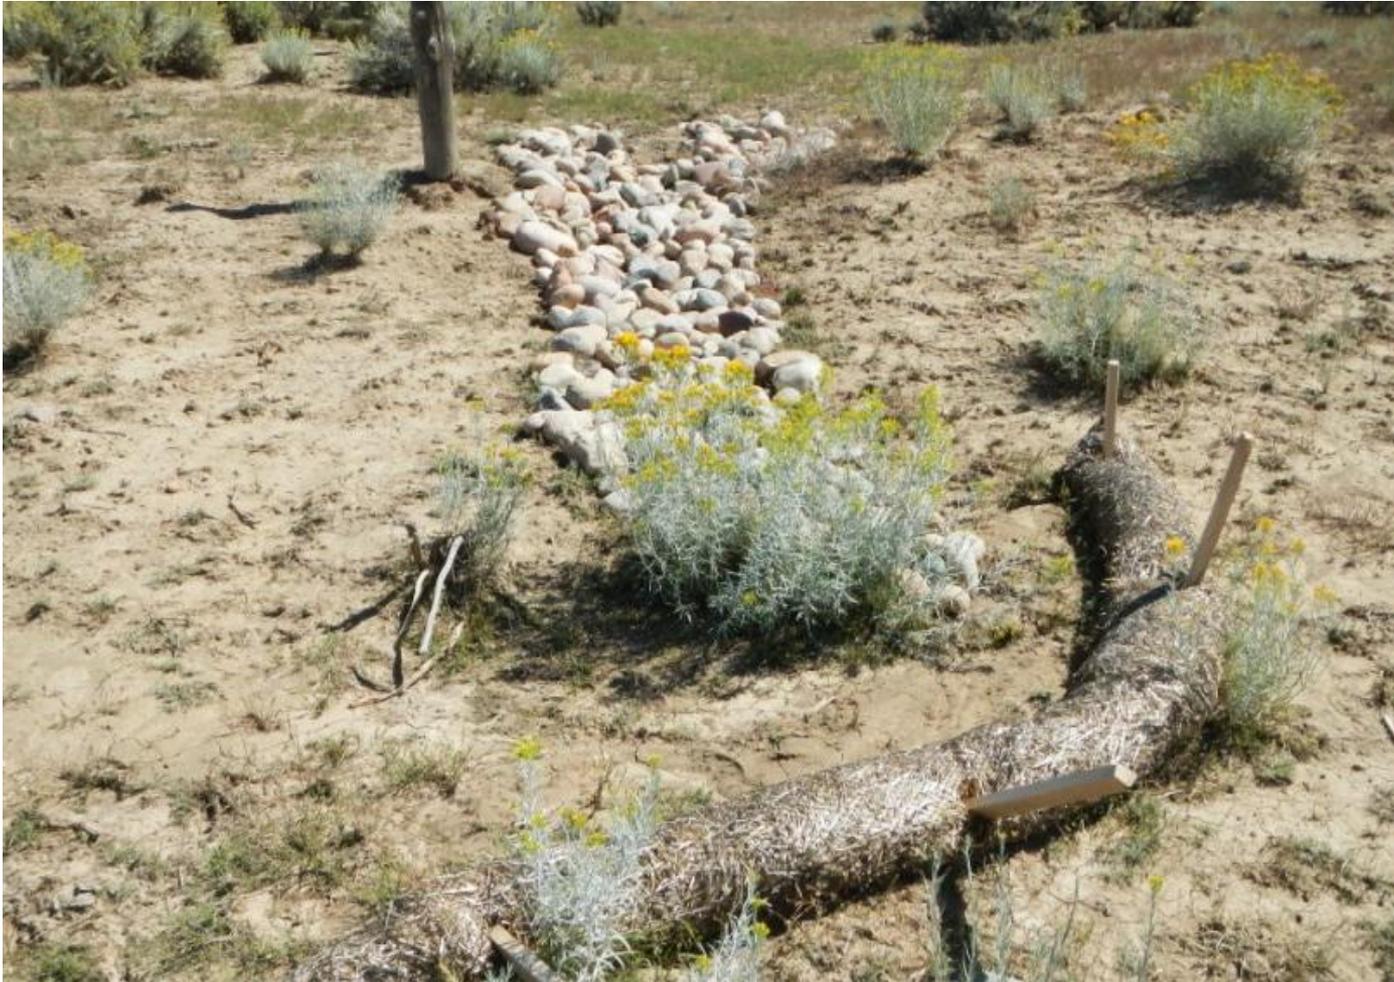
Photo 1. View of new cobble armoring and straw wattle in eastern portion of project area from well pad facing upstream.

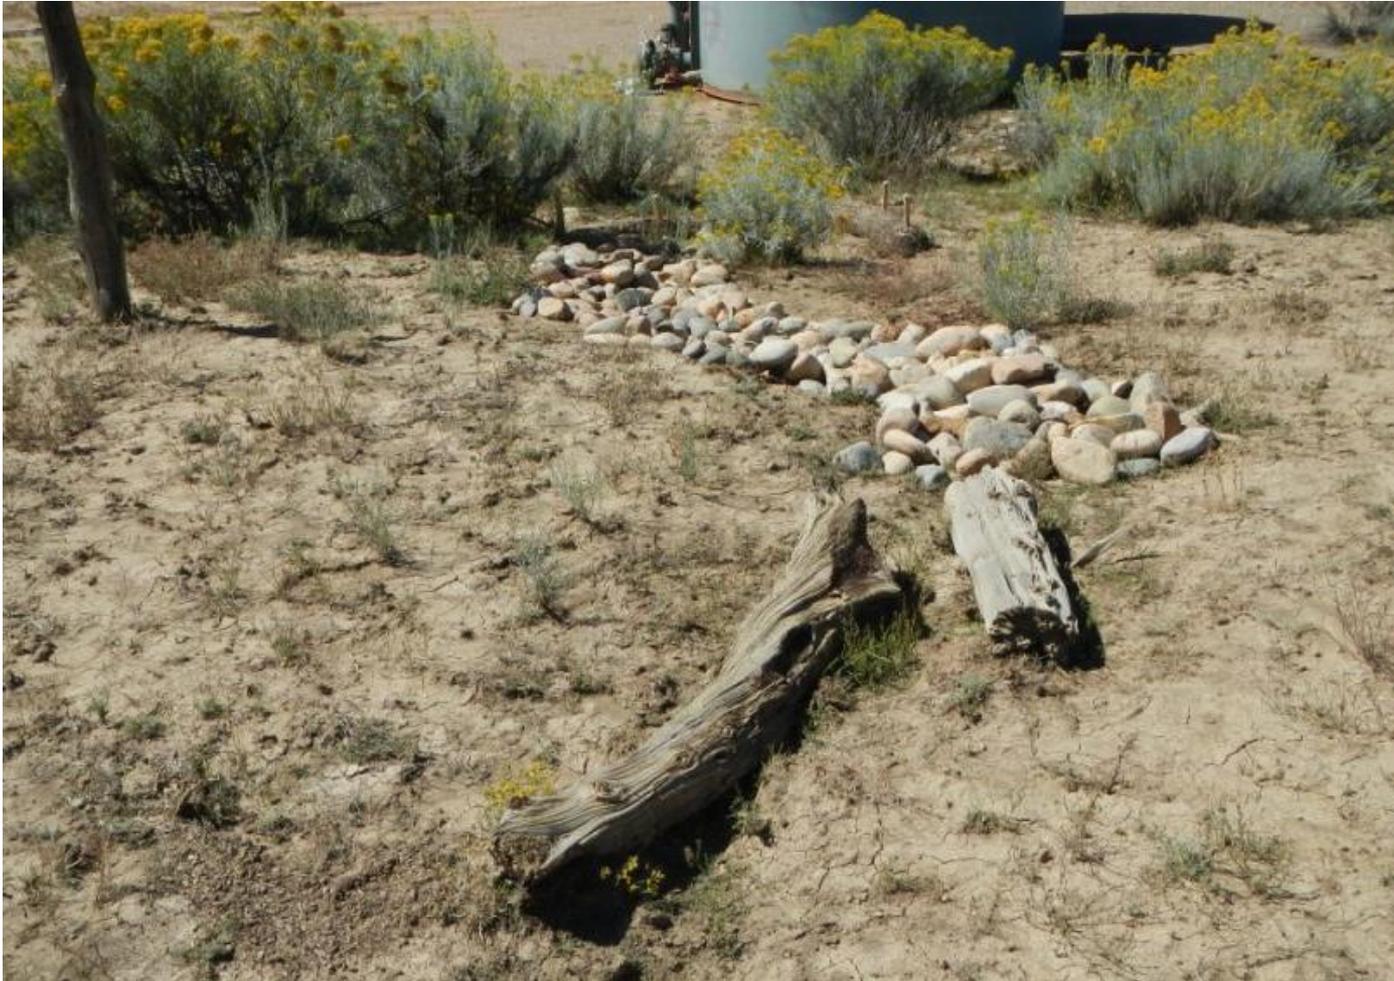
Photo 2. View of upper portion of new cobble armoring within erosional channel from eastern edge of project area facing downstream (toward well pad).

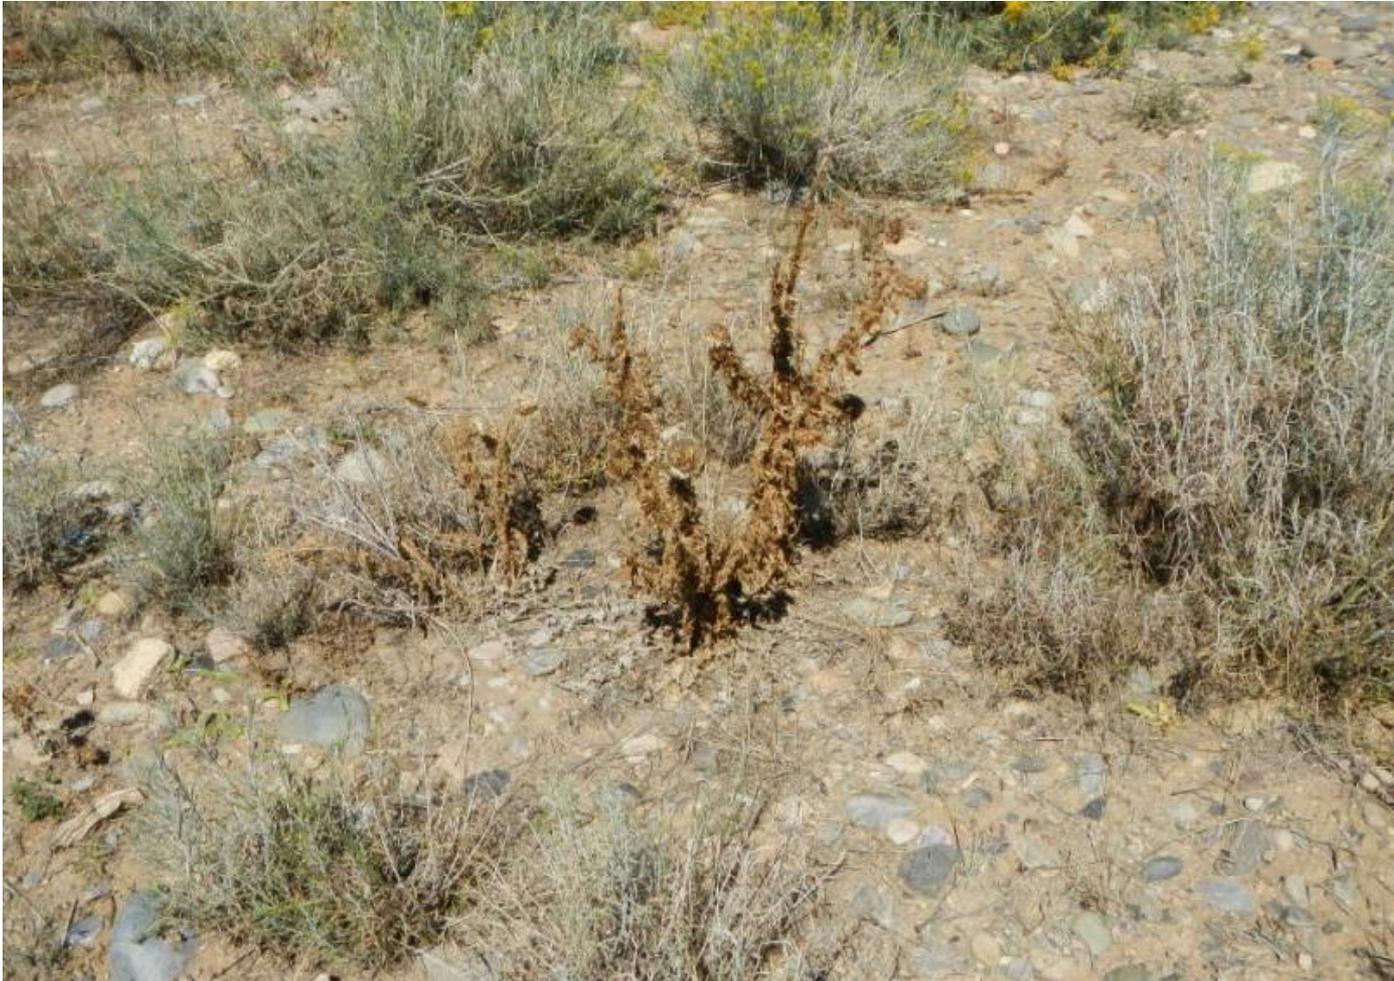
Photo 3. View of musk thistle (*Carduus nutans*) within the project area that appears to have been treated.

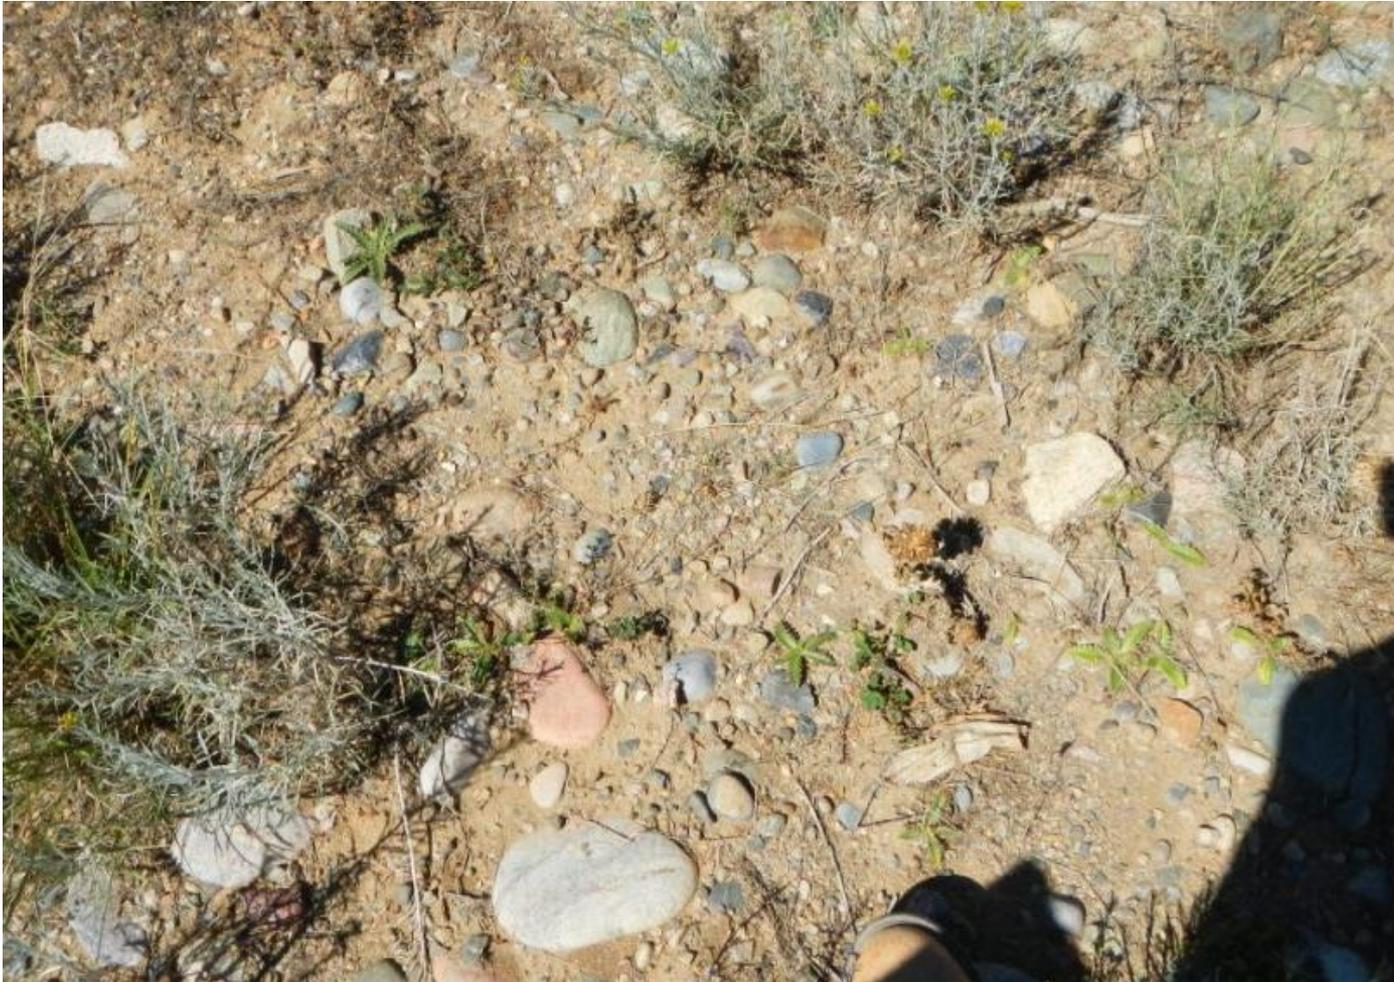
Photo 4. View of numerous small musk thistle rosettes within the southern portion of the project area.
