## Bower Environmental and Sustainable Technologies LLC

### Status Report.

**MGRI Cache Unit, Spill #2, REM #7787, SWSW Section 35, T35N, R20W, N PM.**

Monument Global Resources, Inc.,  
Operator#10430.  
Cache Unit, Montezuma County, Colorado.

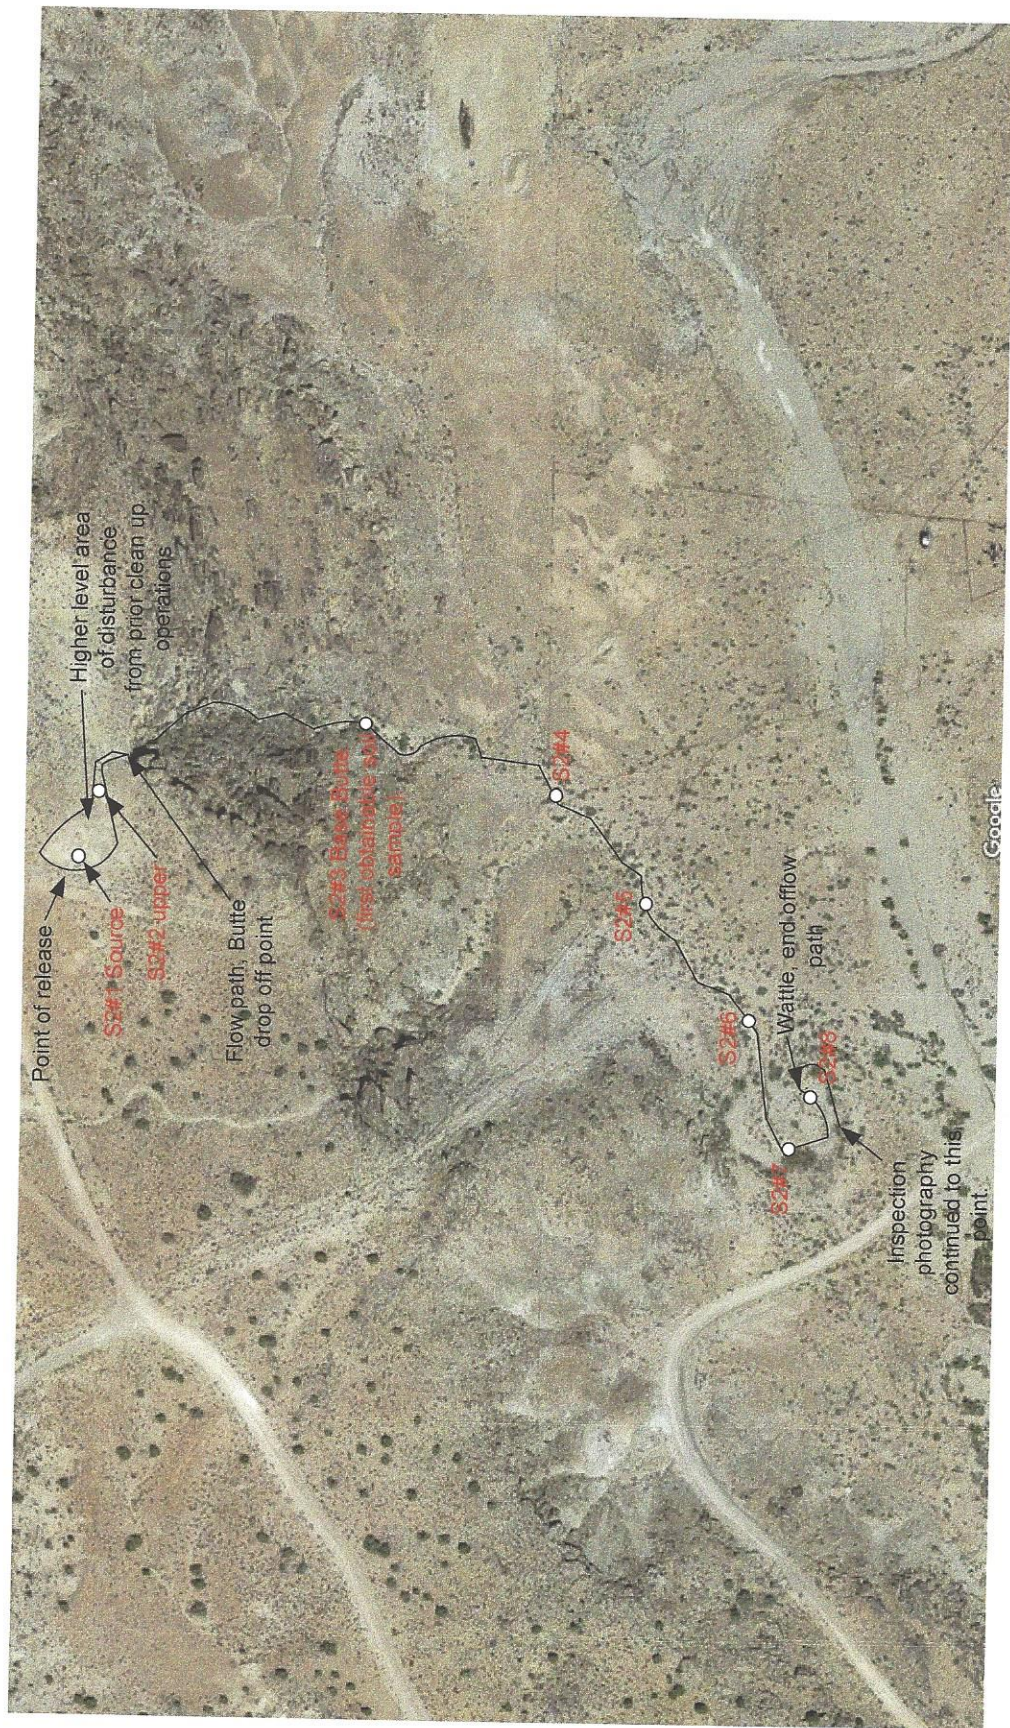
Spill Location #2 REM 7787 . Sample Locations

Soil Sample results demonstrates that further remediation works be completed in certain areas along the spill path. Sample for S2#2 upper shows elevated TPH and Arsenic.

Samples S2#3 Base Butte, S2#4 and S2#5 also have elevated TPH and As.

Within the Rocky area from the Butte drop off point to S2#3 base Butte was visually inspected around the rocks and underlying flow path where accessible, no surface soil was obtainable due to the bedrock being at surface, the path reveals no visible residual surface hydrocarbons or odors.

It is recommended that the area around sample point S2#2 Upper in a 10ft radius and east towards the Butte drop of point be scarified, sprayed with a mix of Simple green and High nitrogen fertilizer (as previous remediation method) and secondarily scarified to ensure good mixing.

The Area from the Base of the Butte (Sample point S2#3 Base Butte) for 600ft to S2#5 Sample point be treated as above and both area subsequently retested for residual hydrocarbons.

It is therefore not recommended to proceed with any works with the rocky area as access limited and safety of operatives would be a major concern. The area was previously sprayed with the previously proposed method as that appears to have removed any hydrocarbon issues in that area.

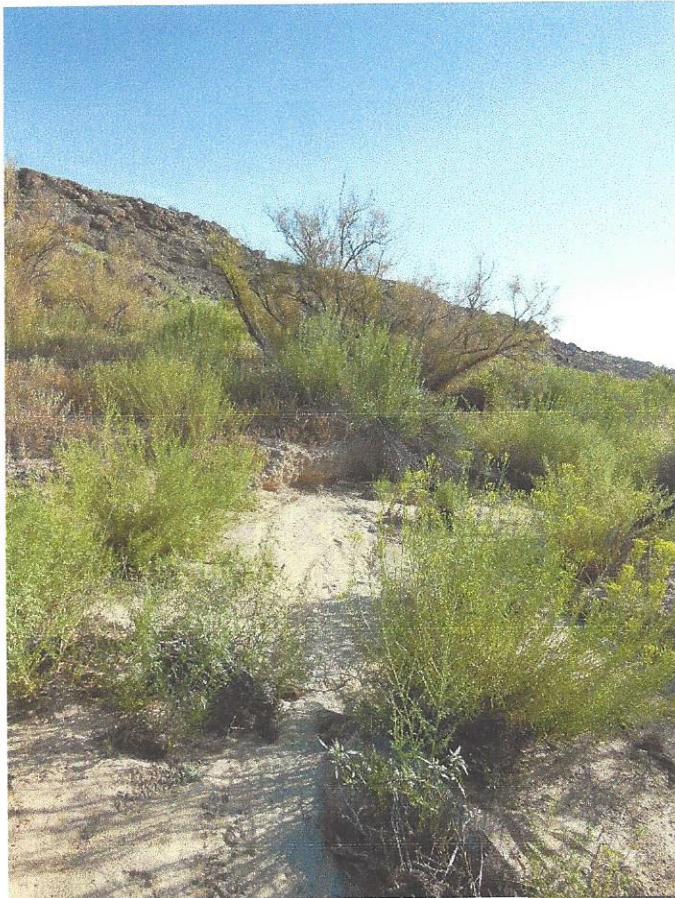
Easterly along flow path +1200ft. At wattle end of spill, continued pic file beyond spill as reported distance longer on original form 27.
