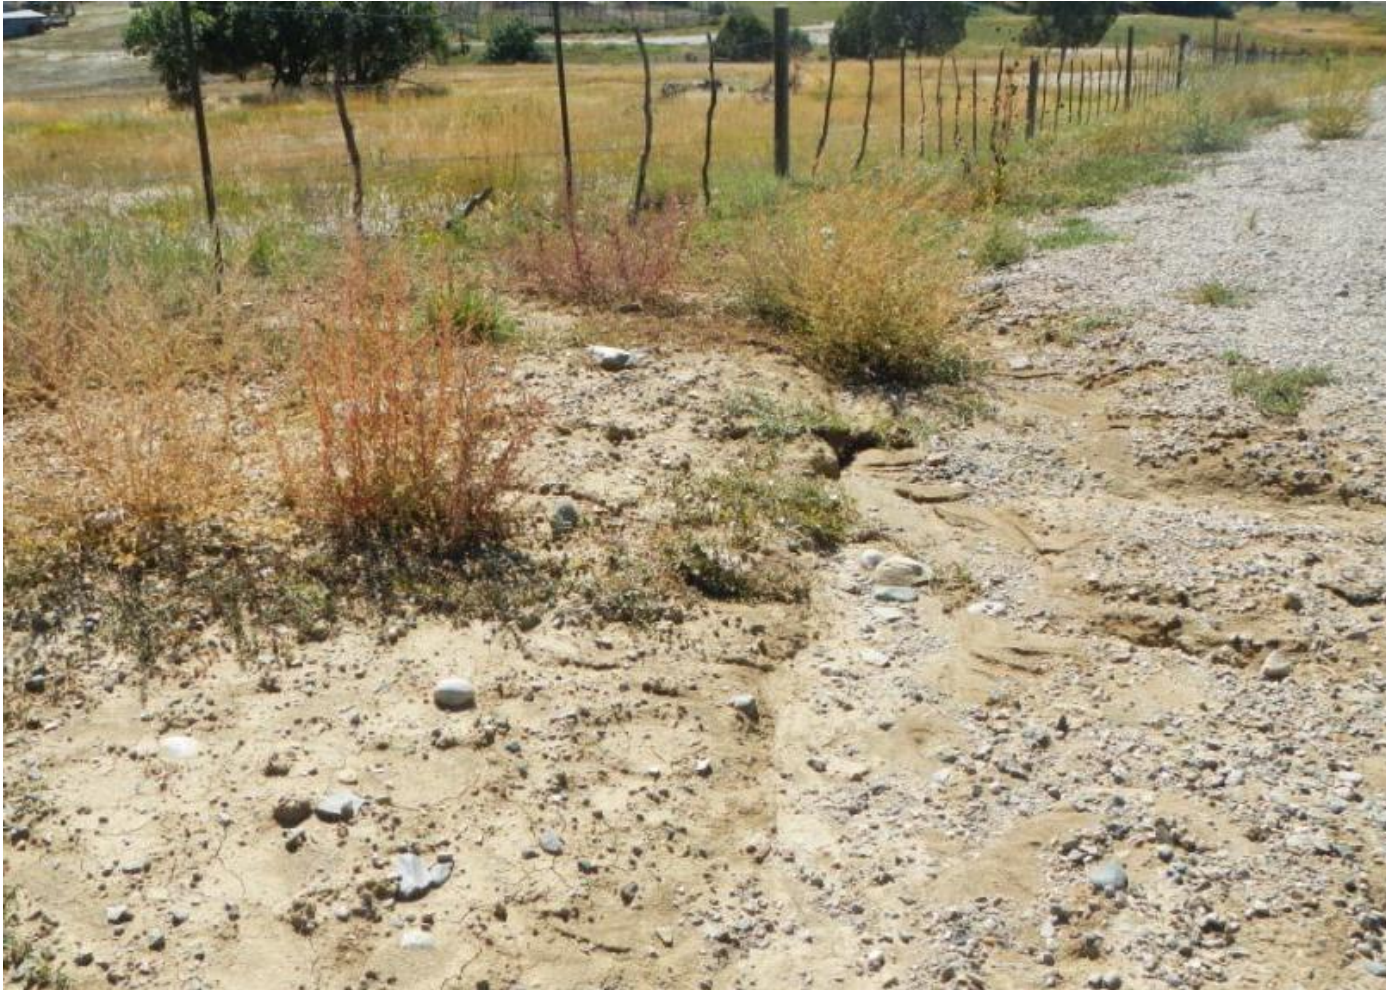
Photo 1. View of location in southern portion of well pad where concentrated stormwater flows appear to exit the well pad and flow into an erosional channel, from southern edge of well pad facing southwestward.

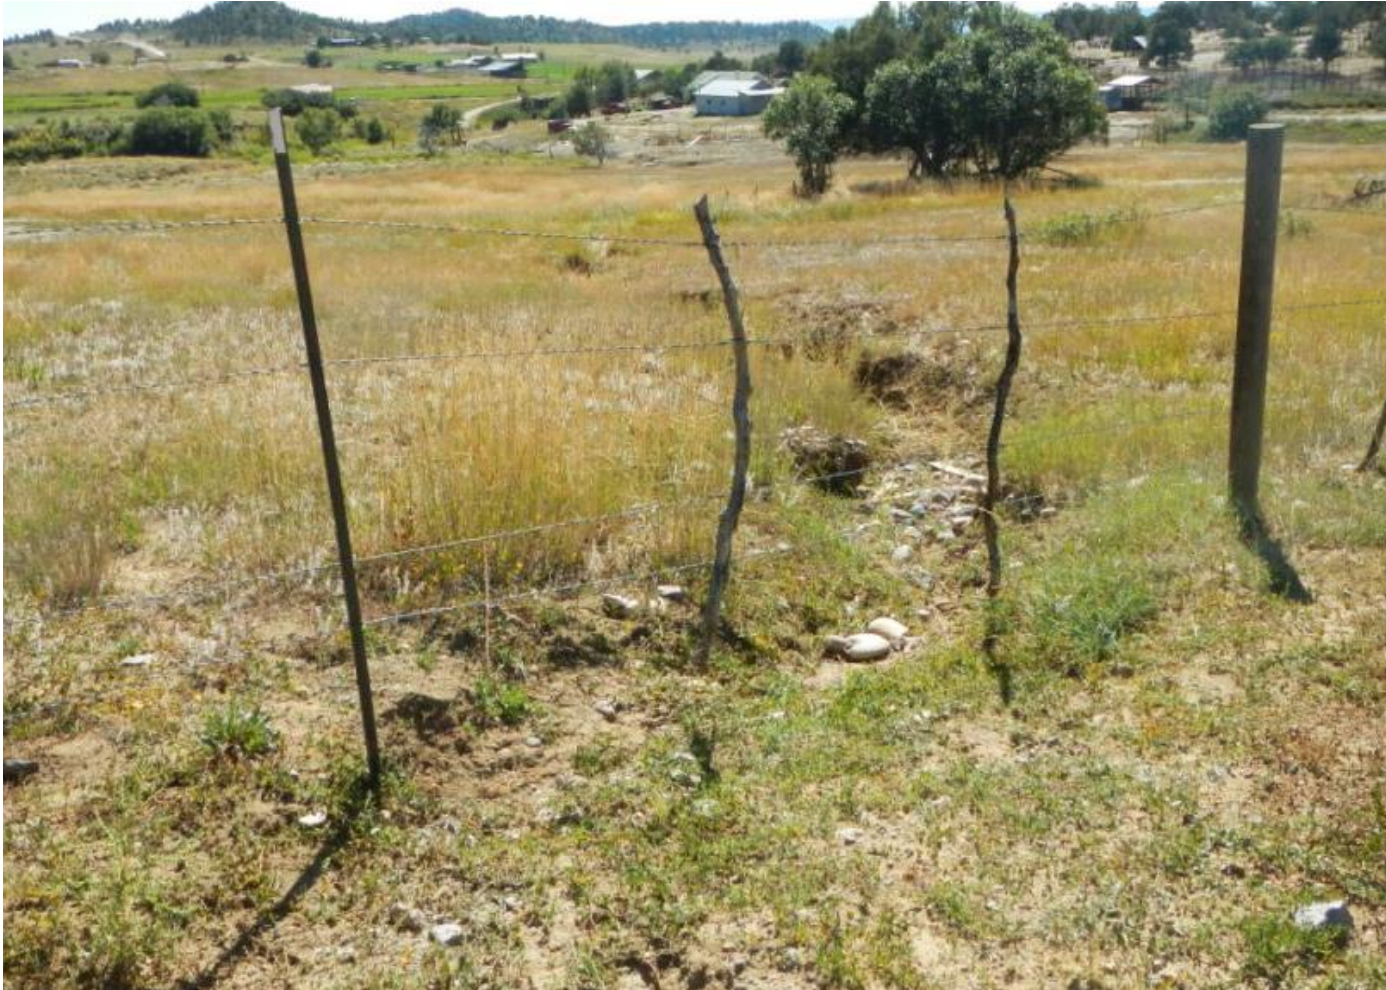
Photo 2. View of erosional channel (approximately 2-3 feet wide and 2 feet deep) that appears to have formed from concentrated stormwater flows exiting the southern edge of the well pad, from southern edge of well pad facing southward.

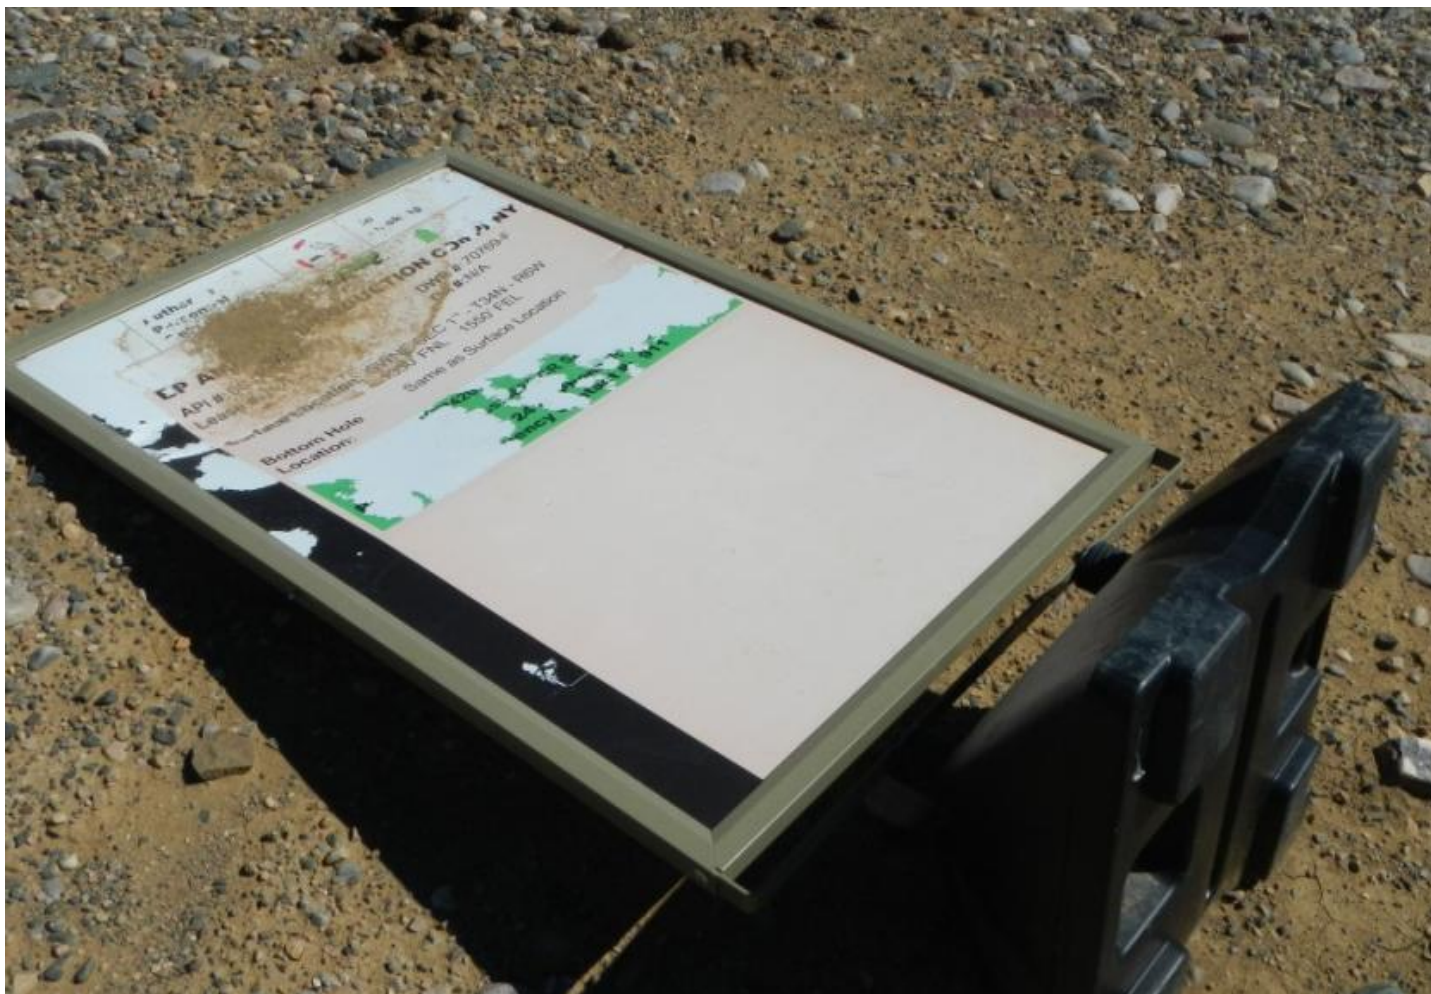
Photo 3. View of sign tipped over and partially illegible near well pad entrance.

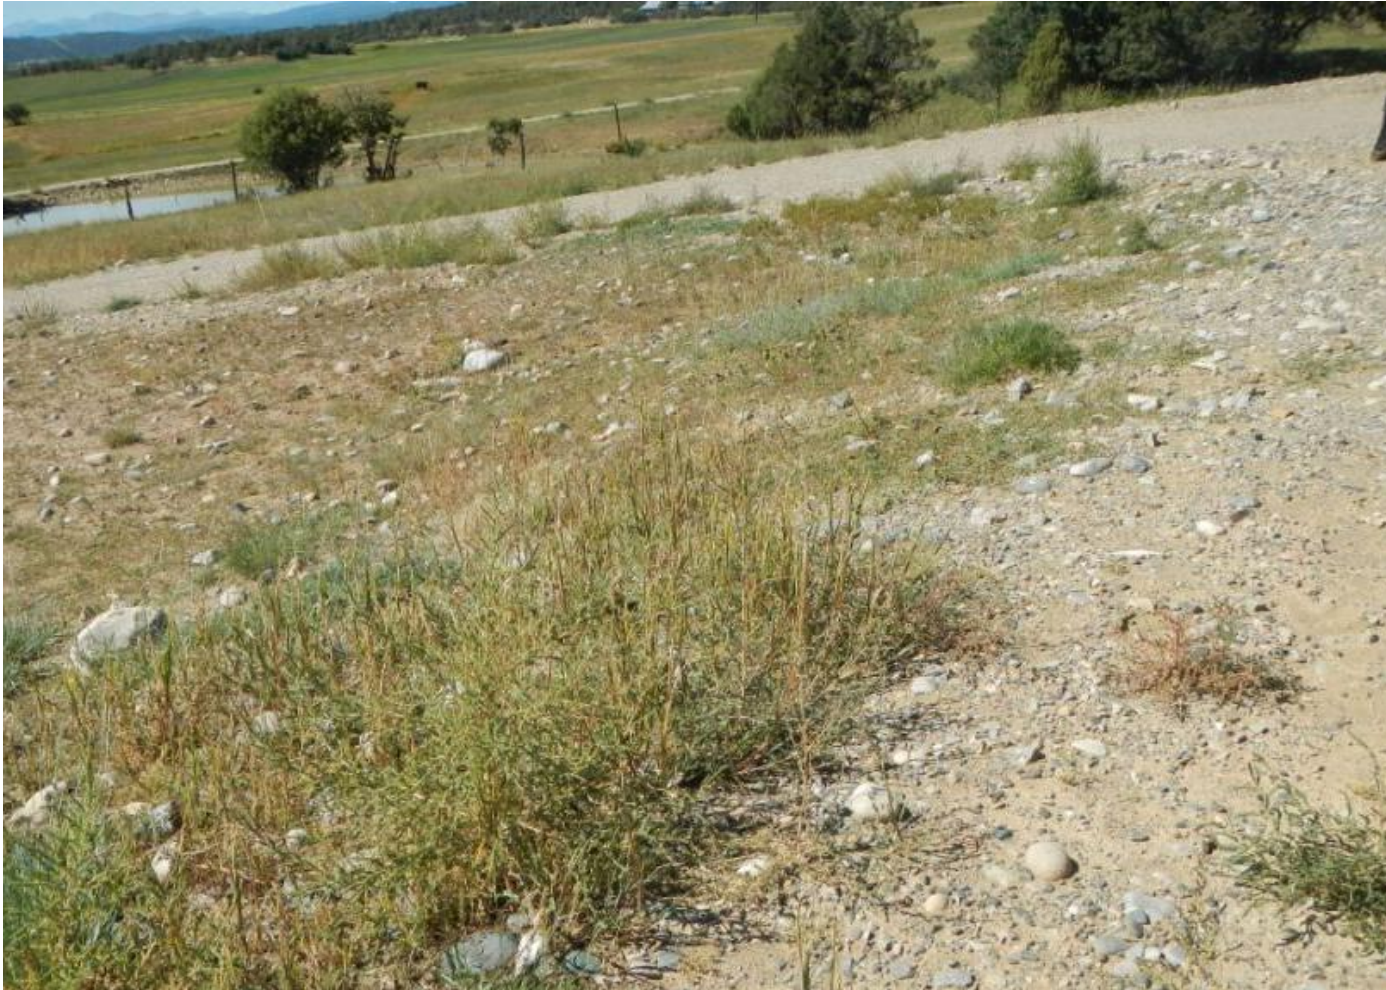
Photo 4. View of western portion of project area from southwestern corner facing northwestward. Vegetation here is largely comprised of weeds such as kochia (*Kochia scoparia*) and field bindweed (*Convolvulus arvensis*) as well as false buffalograss (*Munroa squarrosa*) and scattered western wheatgrass (*Pascopyrum smithii*).

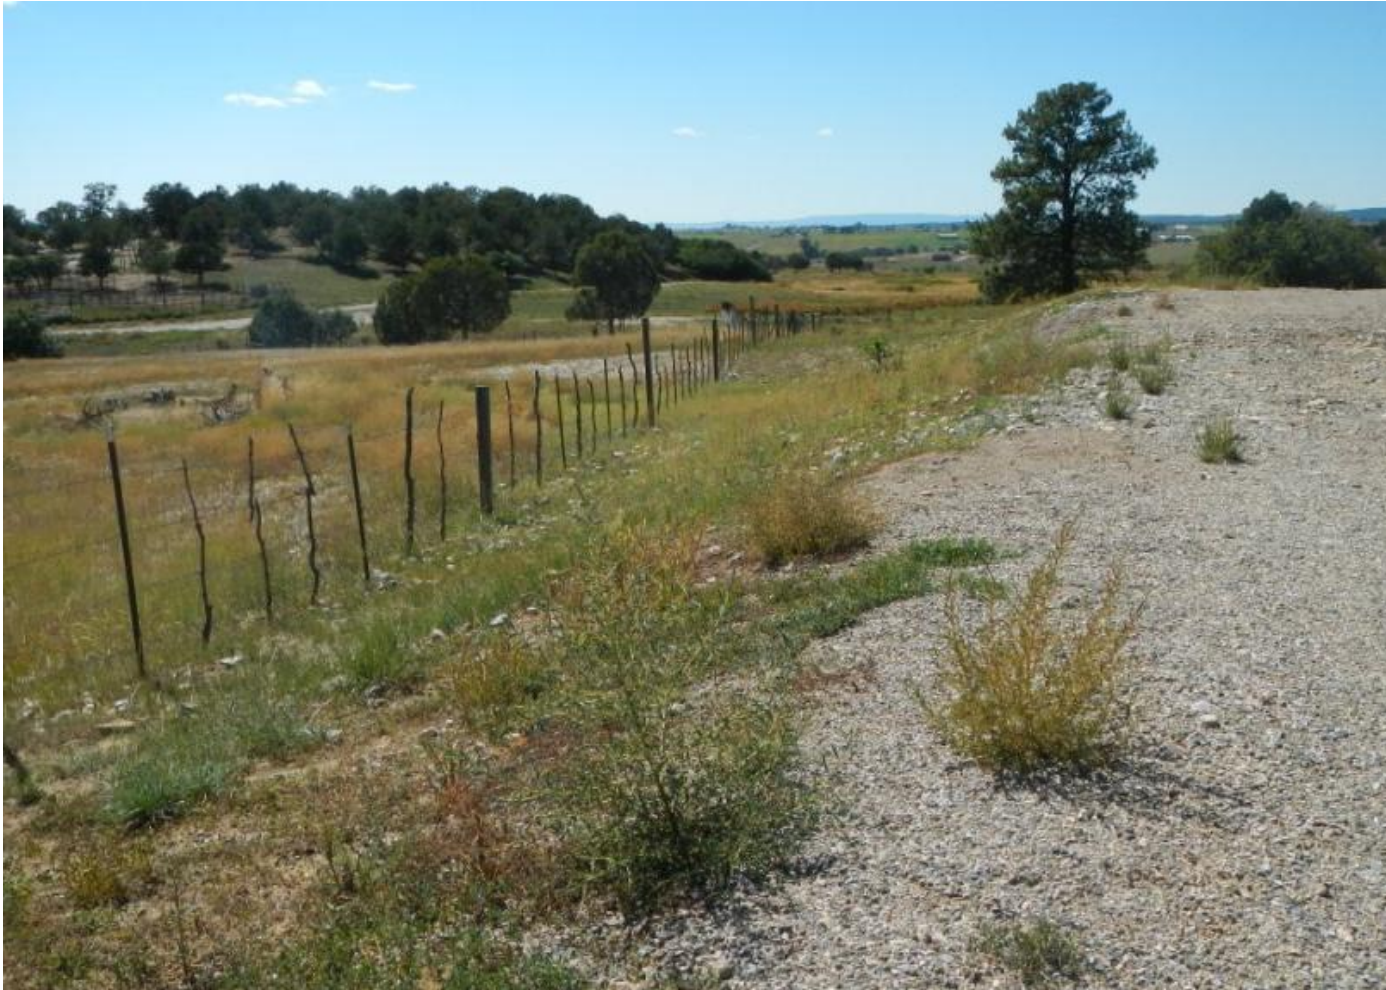
Photo 5. View of southern edge of well pad from southeastern edge facing westward, vegetation is consistent with what is described in Photo 4.

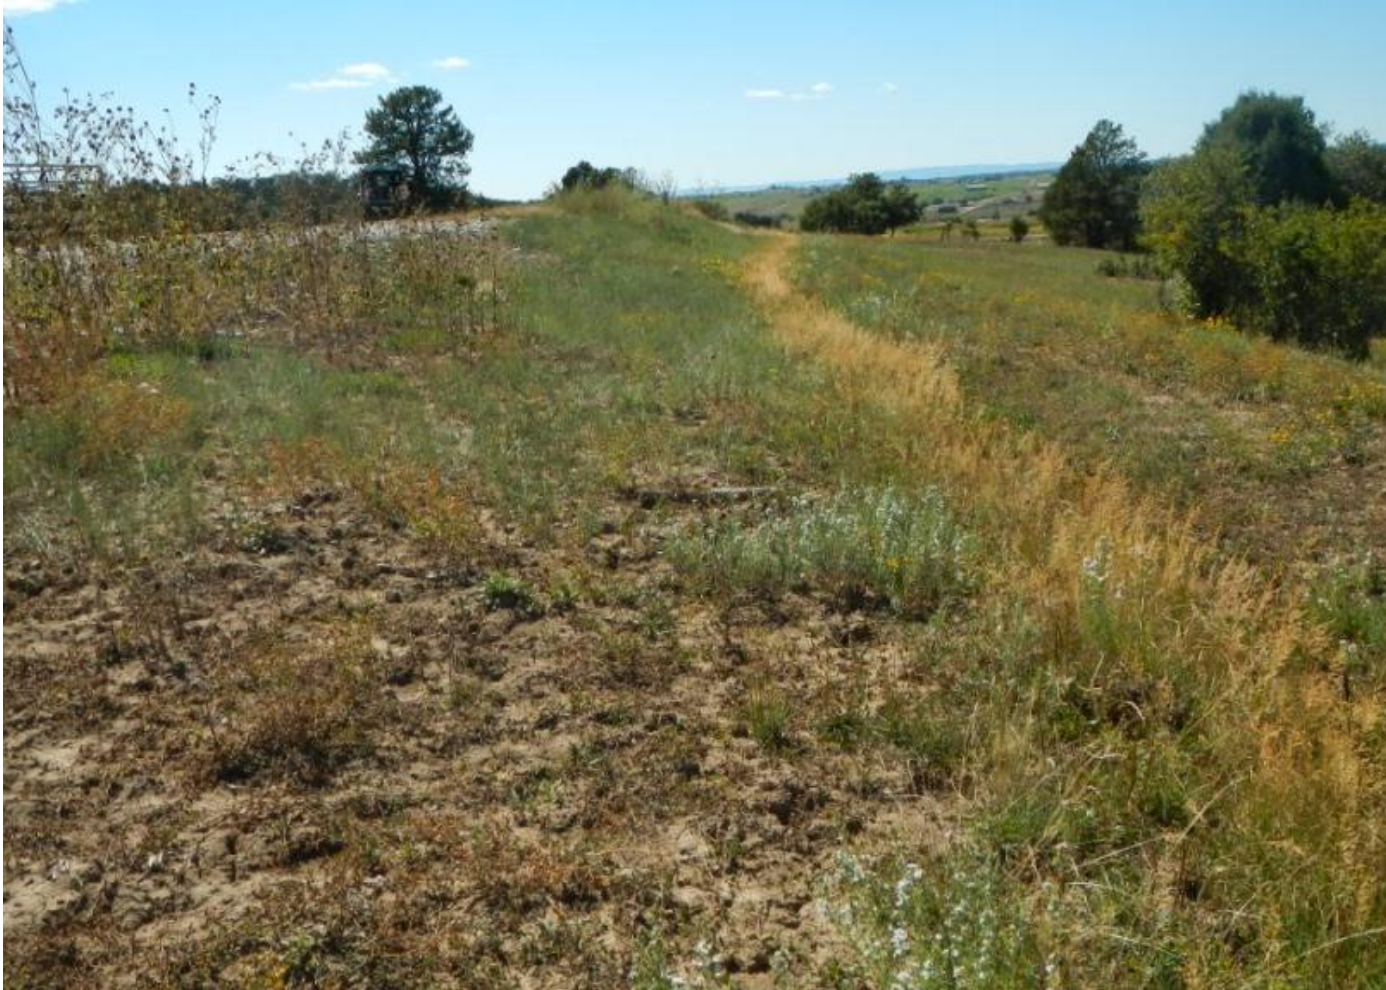
Photo 6. View of northern portion of project area from northeastern portion facing westward. Vegetation is largely comprised of western wheatgrass (*Pascopyrum smithii*), red fescue (*Festuca rubra*), and fleabane (*Erigeron* sp.). A shallow diversion channel can be seen where there is a line of golden, grassy flower heads.

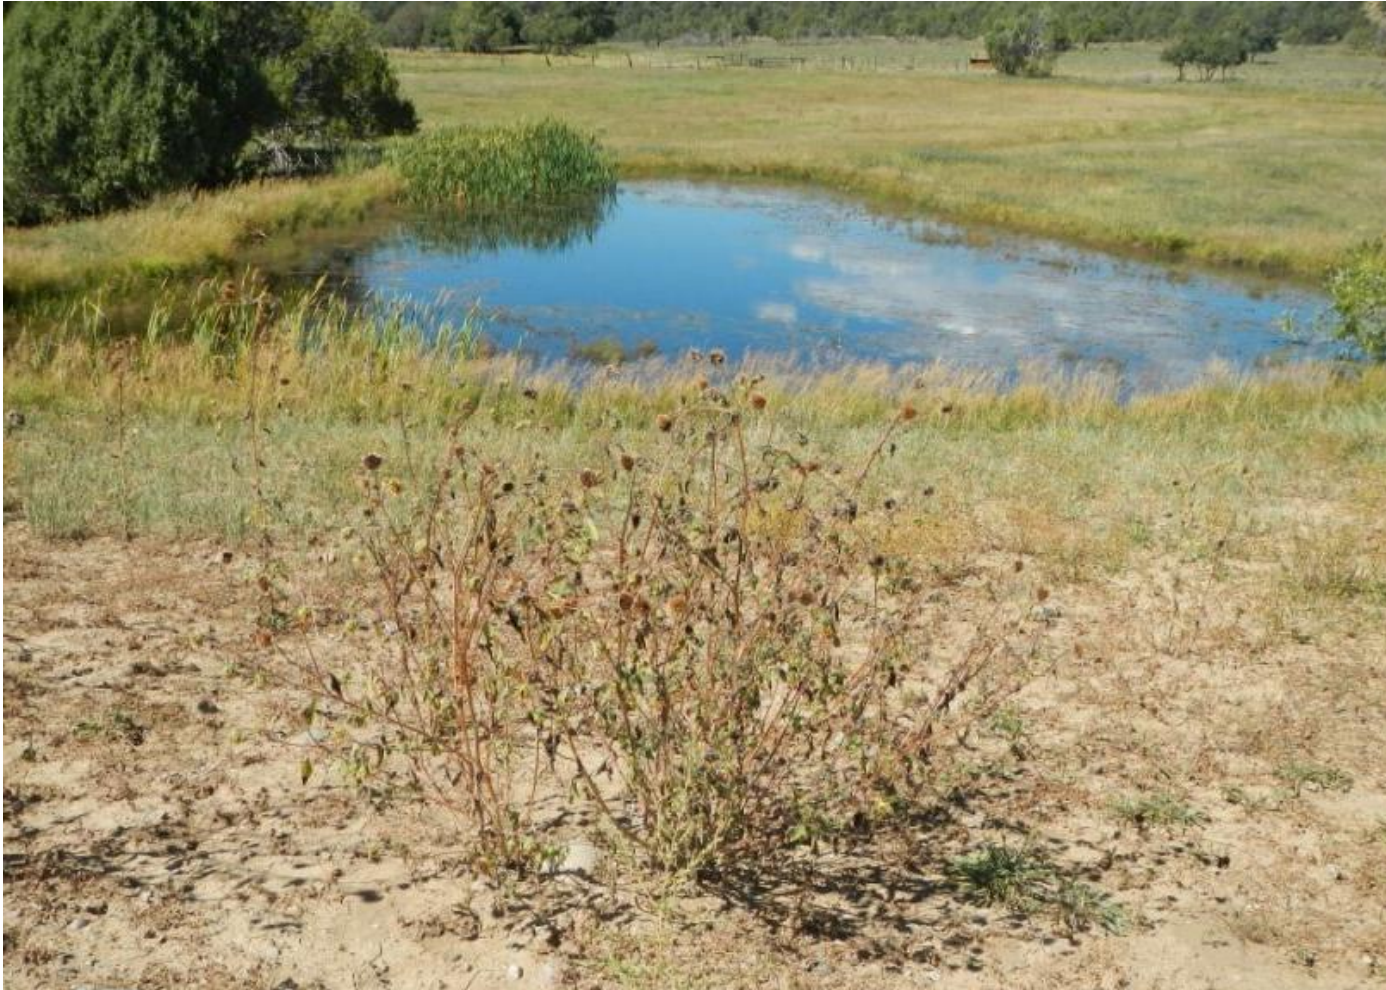
Photo 7. View of open water adjacent to northeastern portion of project area.
