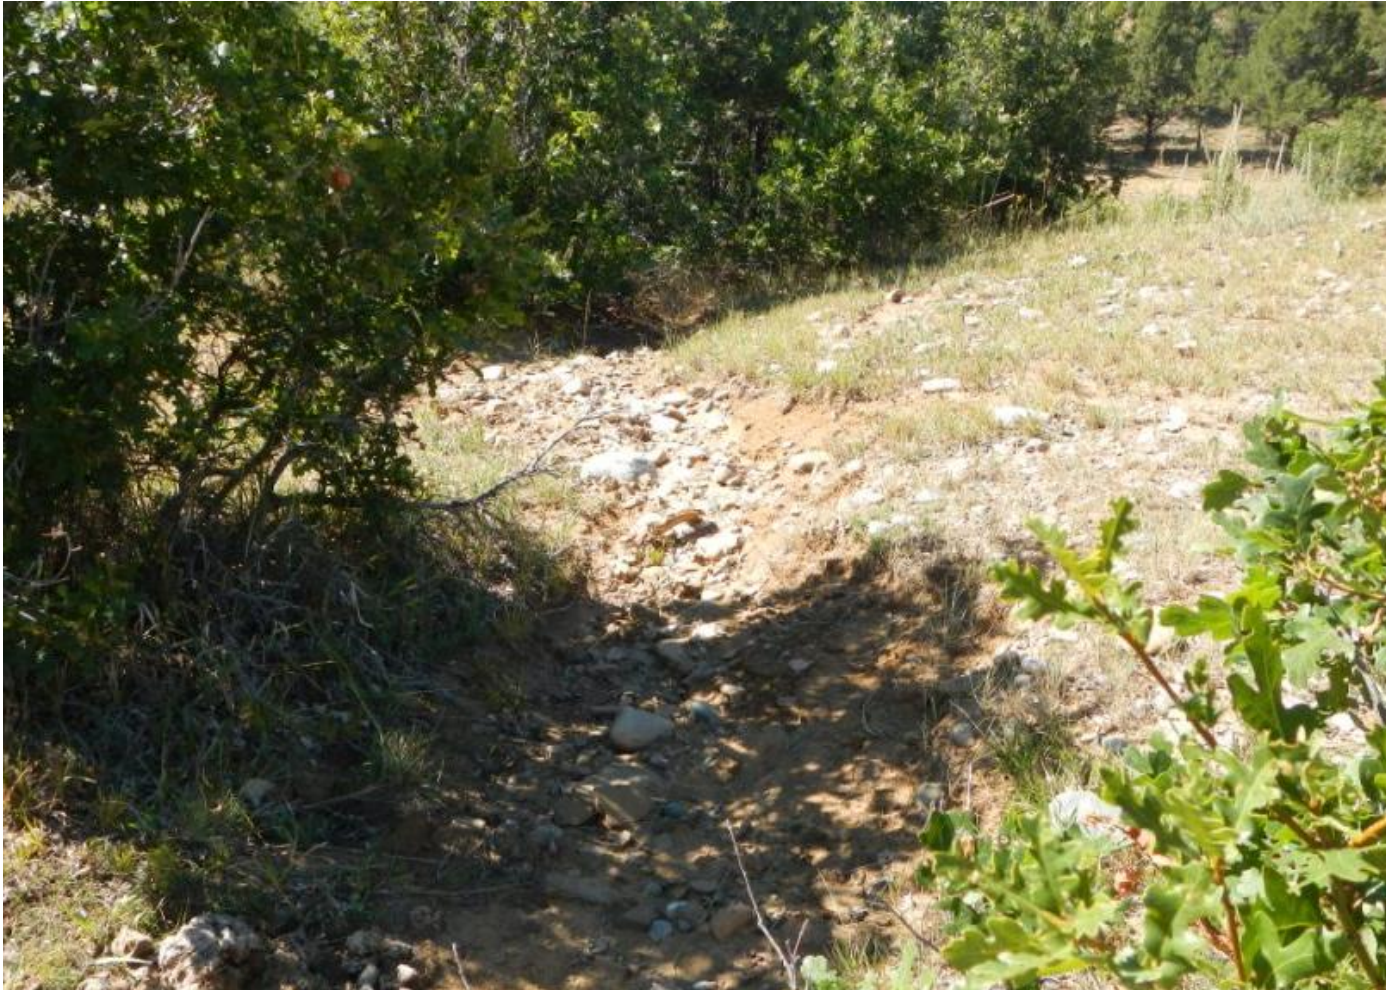
Photo 1. View of diversion channel in southern portion of project area, from southern edge of well pad facing westward. This should be monitored and BMPs applied if down-cutting worsens.

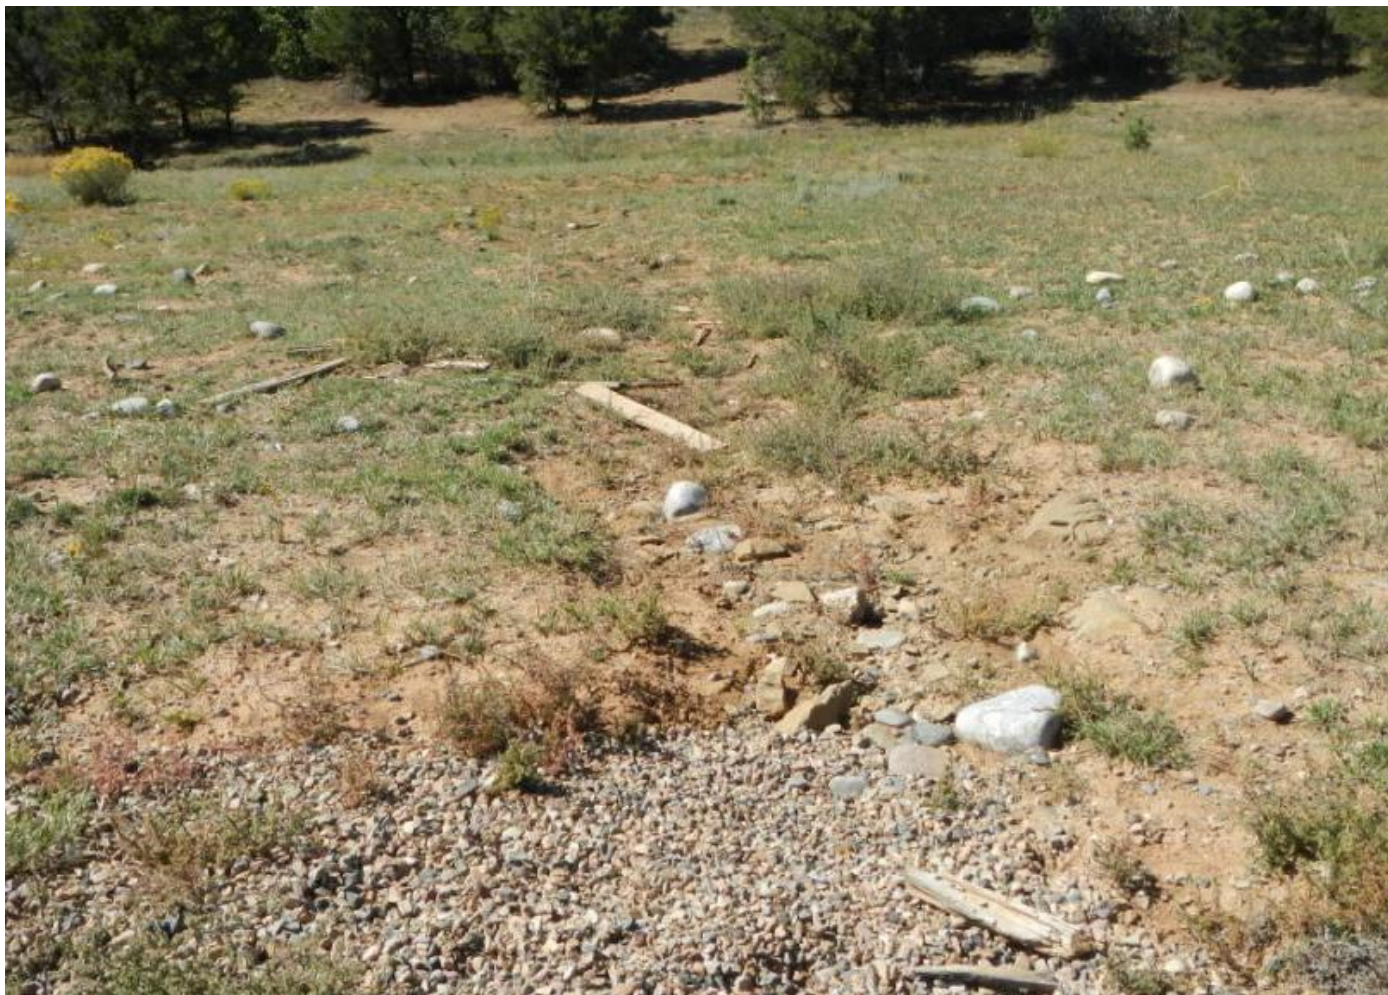
Photo 2. View of shallow erosional feature within western portion of project area. Small gravel/cobble has been placed here. This needs monitoring to make sure it does not worsen.

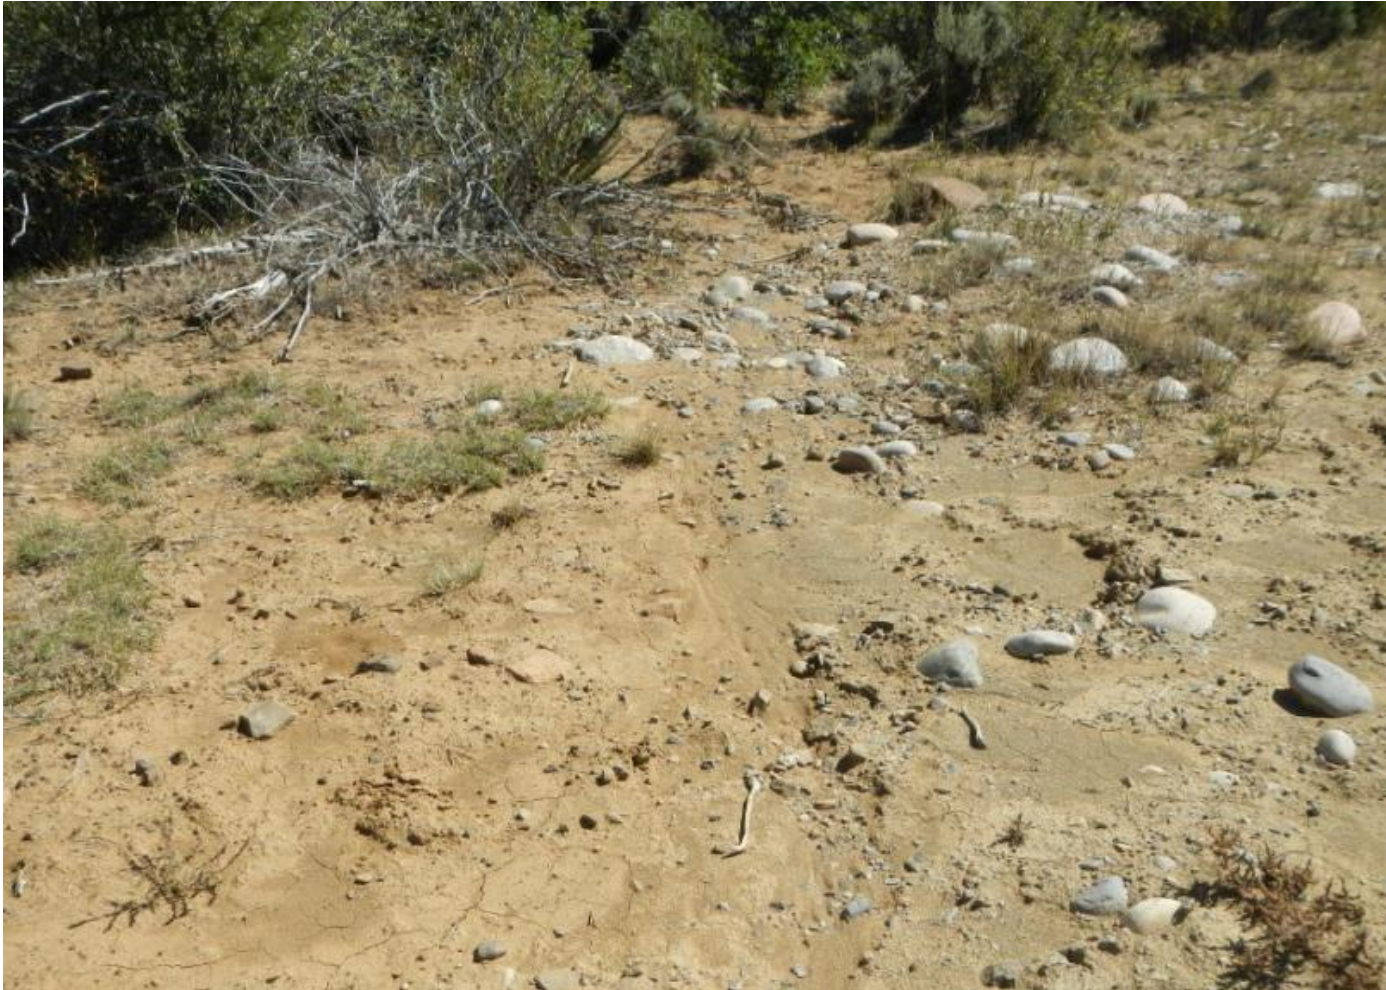
Photo 3. View of shallow erosional feature within eastern portion of the project area.

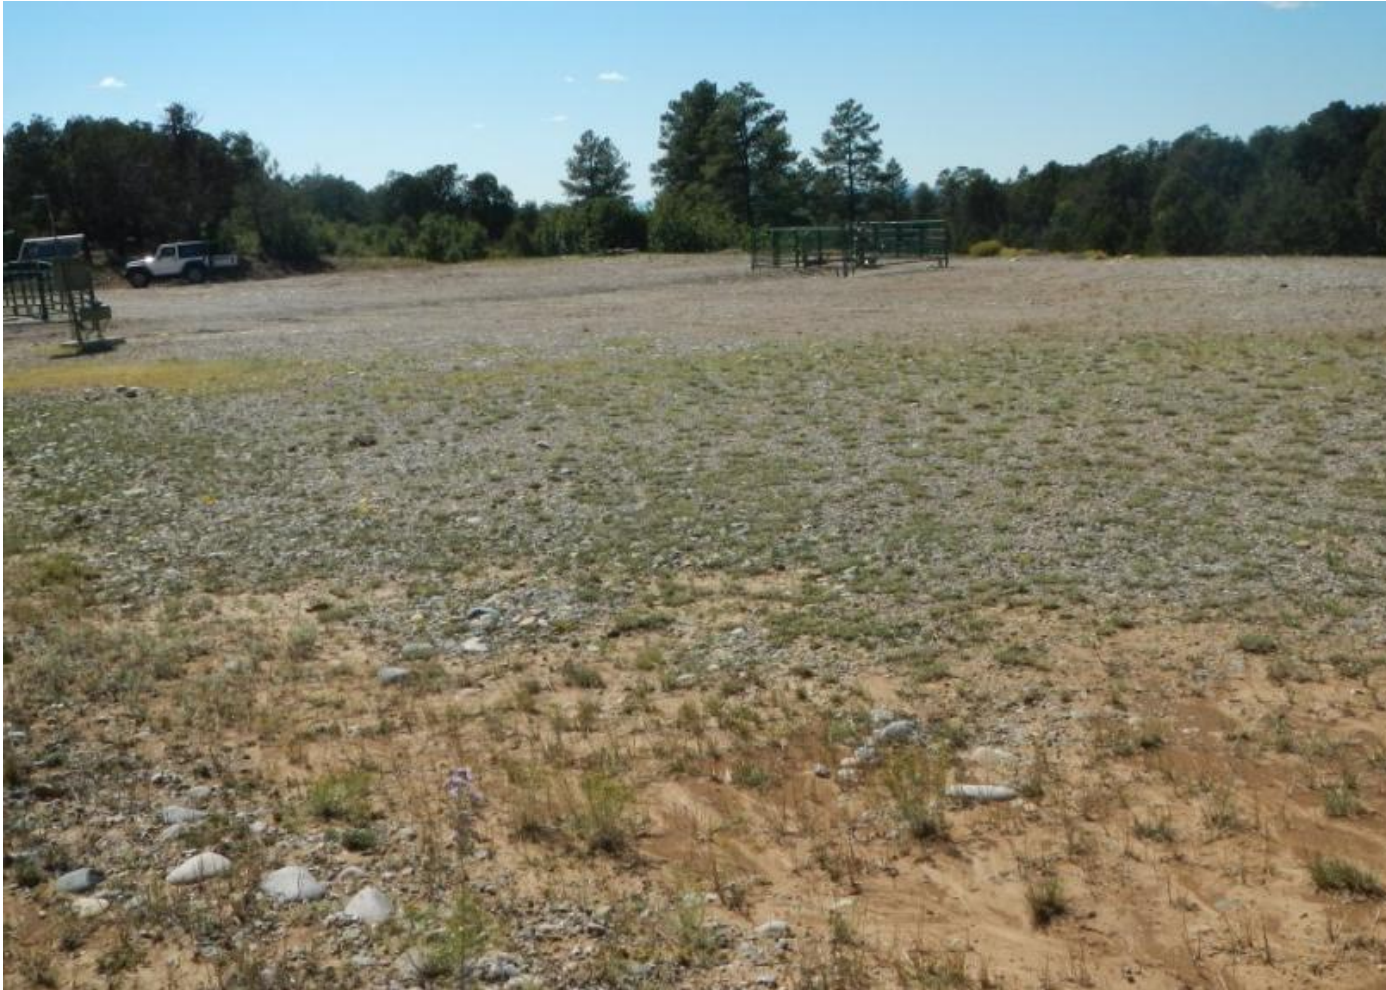
Photo 4. View of project area from eastern corner facing center. Short grasses such as smooth brome (*Bromus inermis*) and dropseed (*Sporobolus* sp.) are growing in the foreground.
