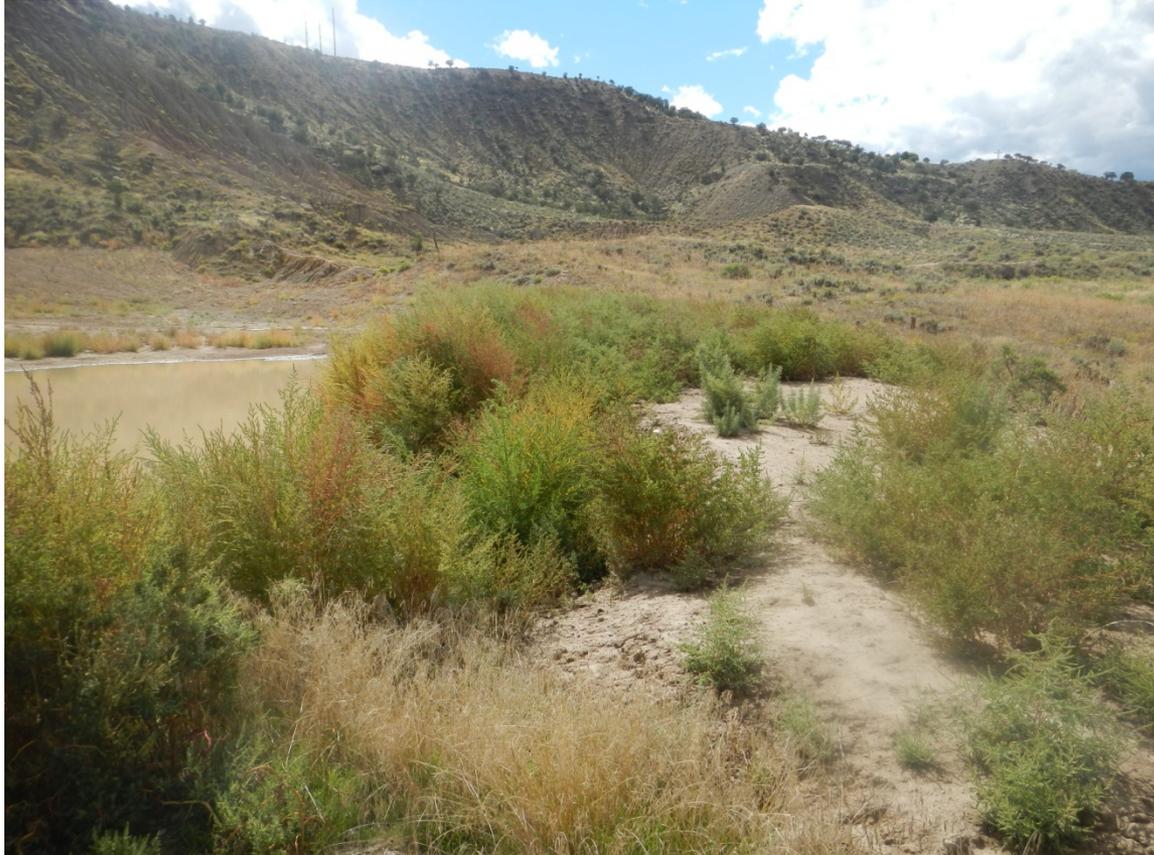
Photo#1: View of location to SW corner ; close up depicted in next photo. Visible Ponding water

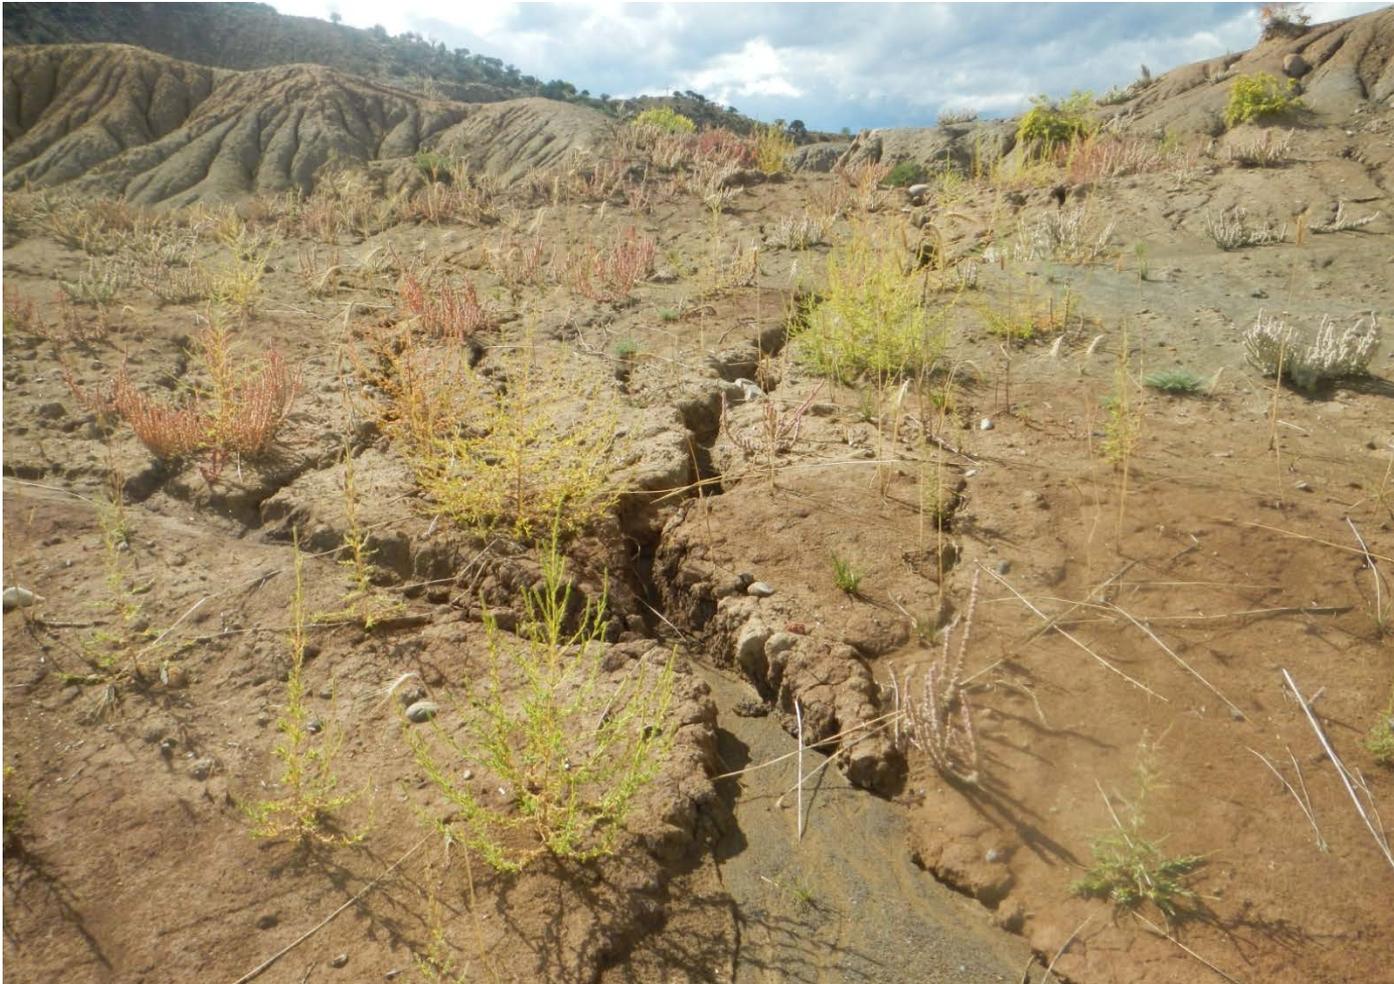
Photo#2: SW corner of location, erosion and reclamation failure evident

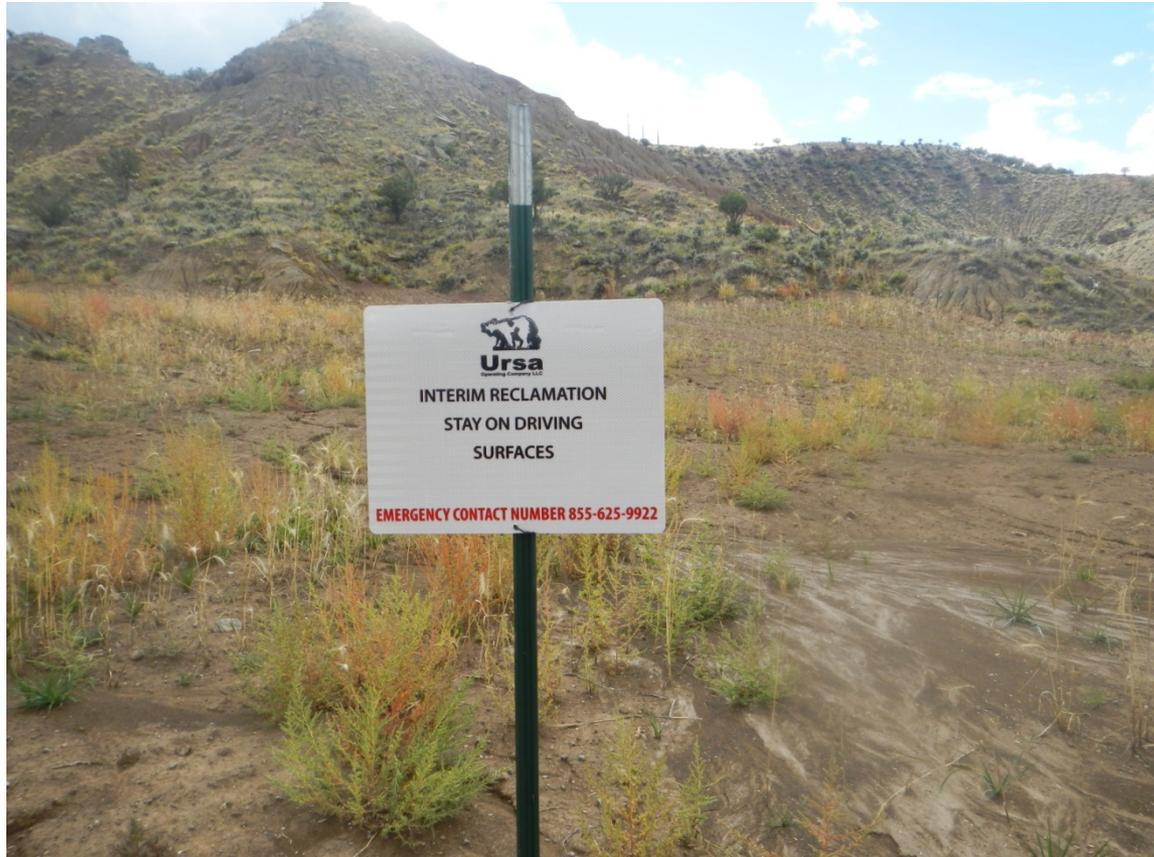
Photo#3: South side of Location; sign defining reclamation area in following photos. Obvious Stormwater run-on.

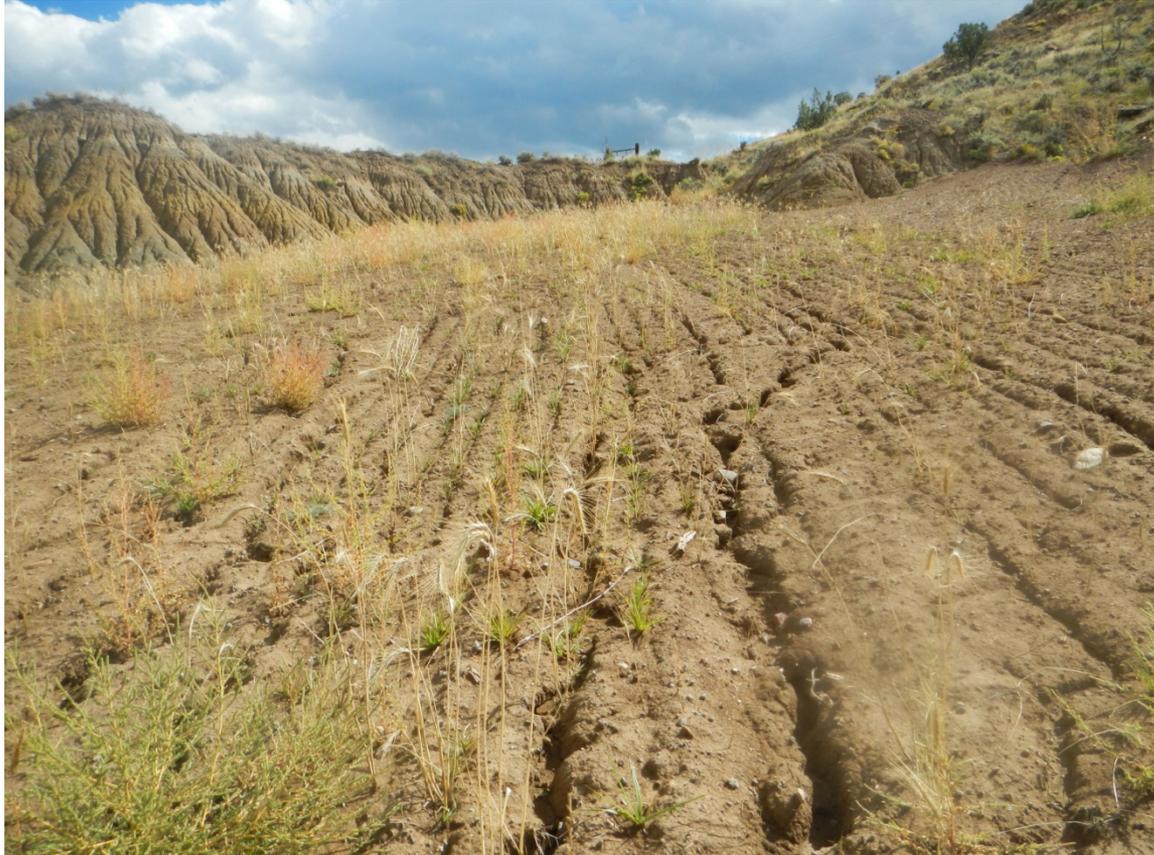
Photo#4: Interim Reclamation; It appears that Last seeding/reclamation activity was not completed along the slope contour. This shows lack of BMPs being utilized, potentially increasing erosion issues.

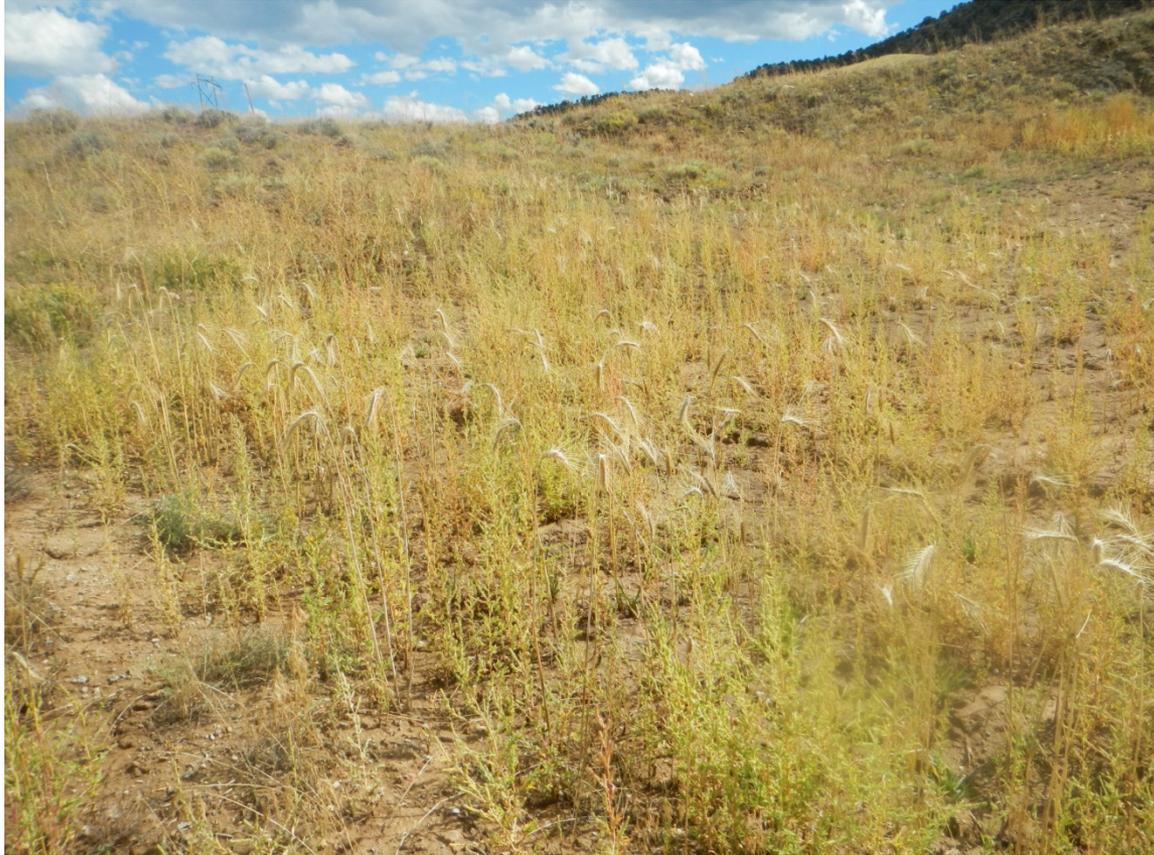
Photo#5: Kochia establishment in Interim Reclamation area east of Photo #4. No evidence of the required perennial vegetation establishment.

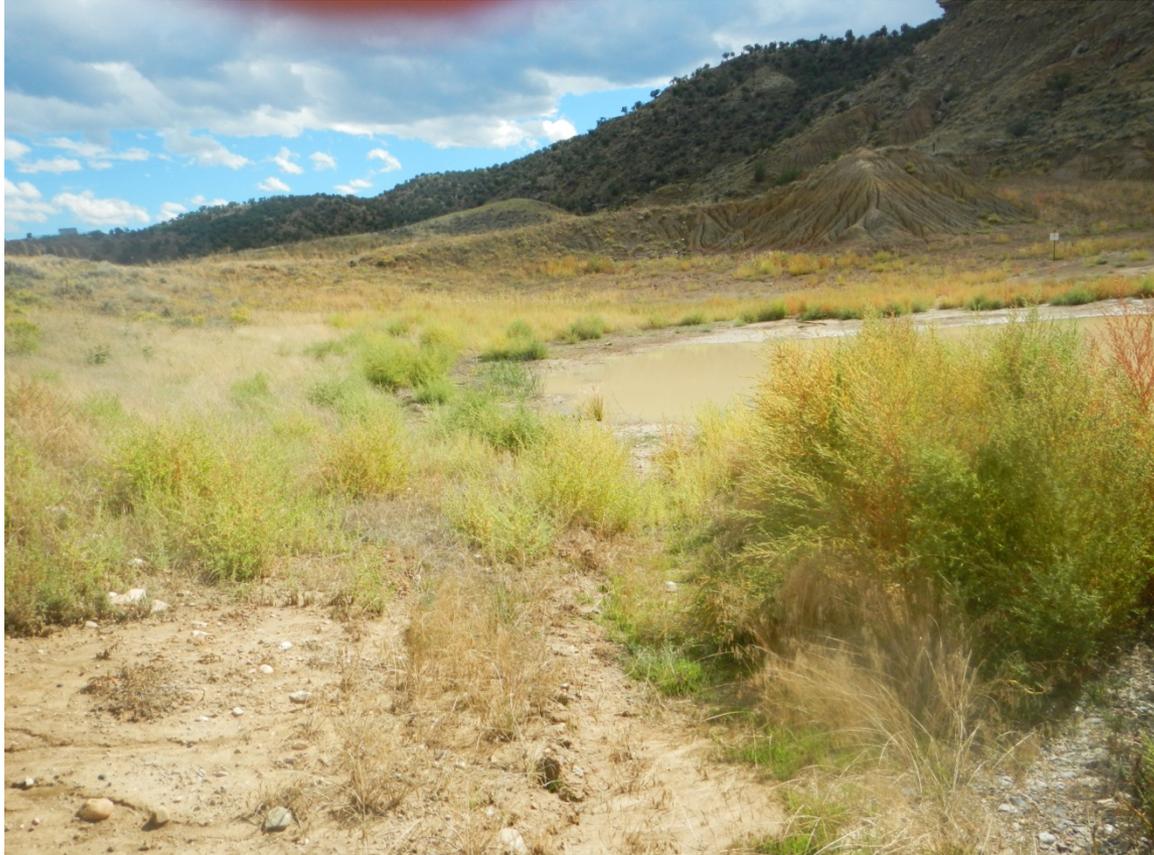
Photo#6: View from NE corner , South to close up in following photo. Obvious ponding and erosion run-on.

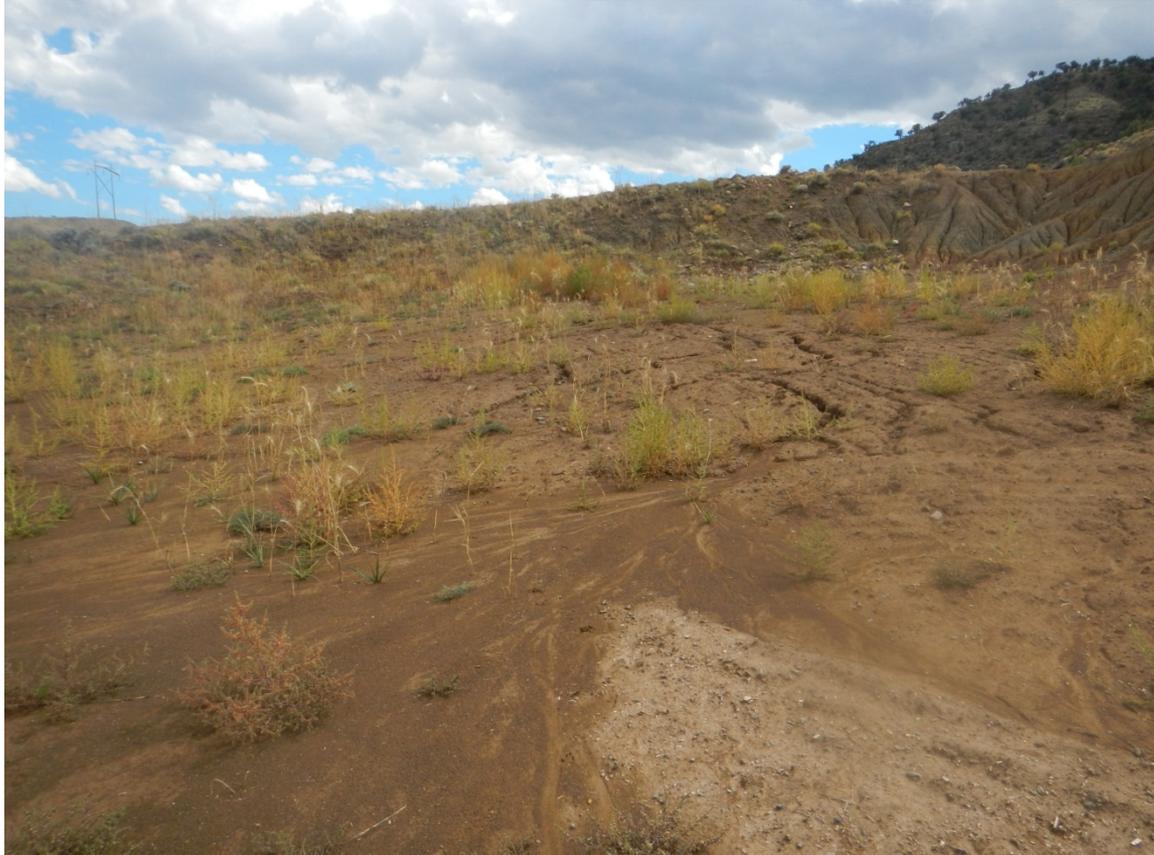
Photo#7: SE corner of Location, failure of vegetation and erosion evident.

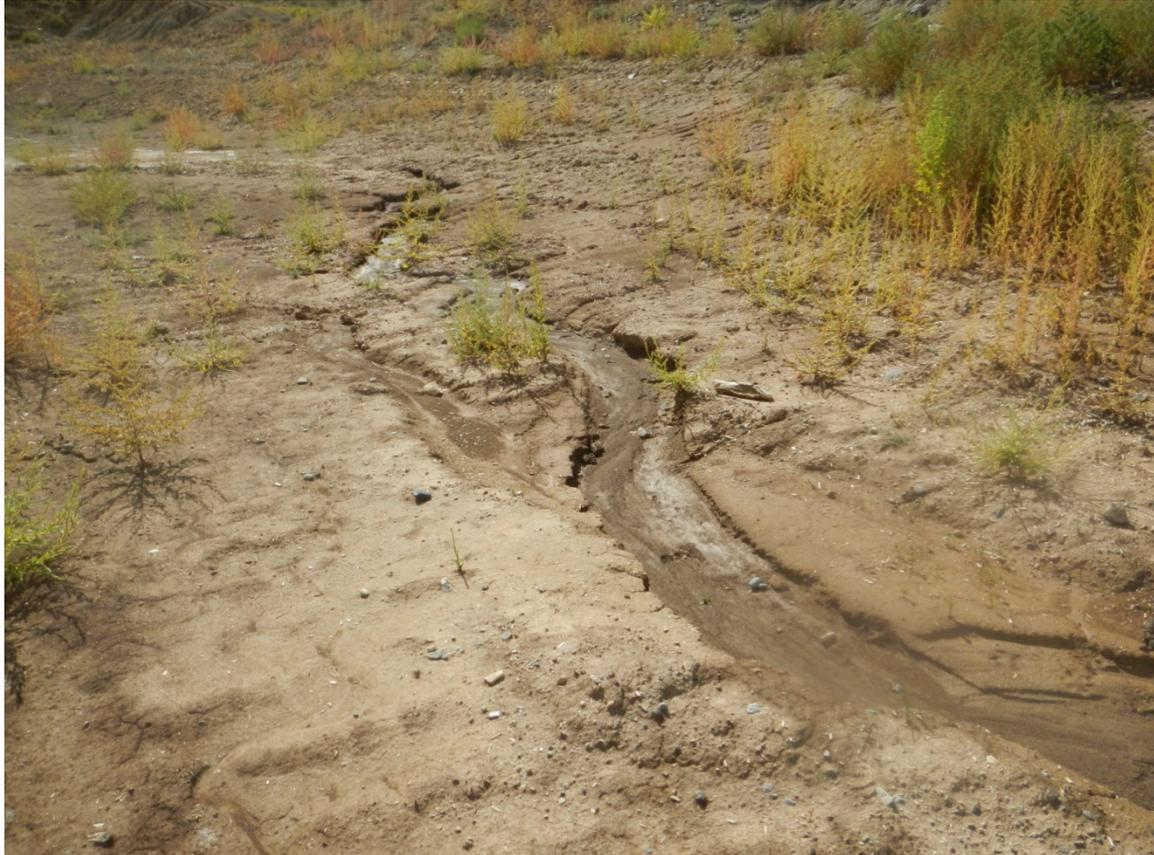
Photo#8: Channel erosion from NW corner of Location to center ponded area.

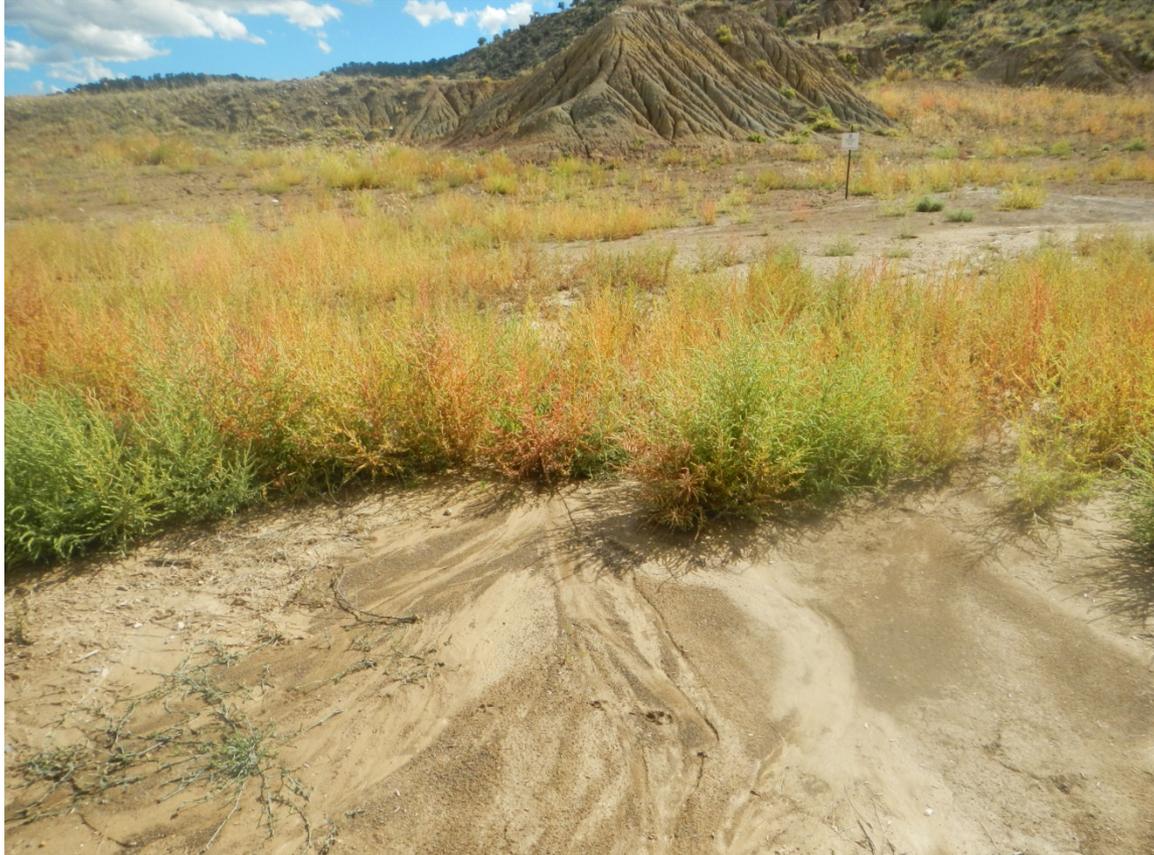
Photo#9: Erosion/Soil migration from NE corner to center ponding area. No perennial stabilizing vegetation.
