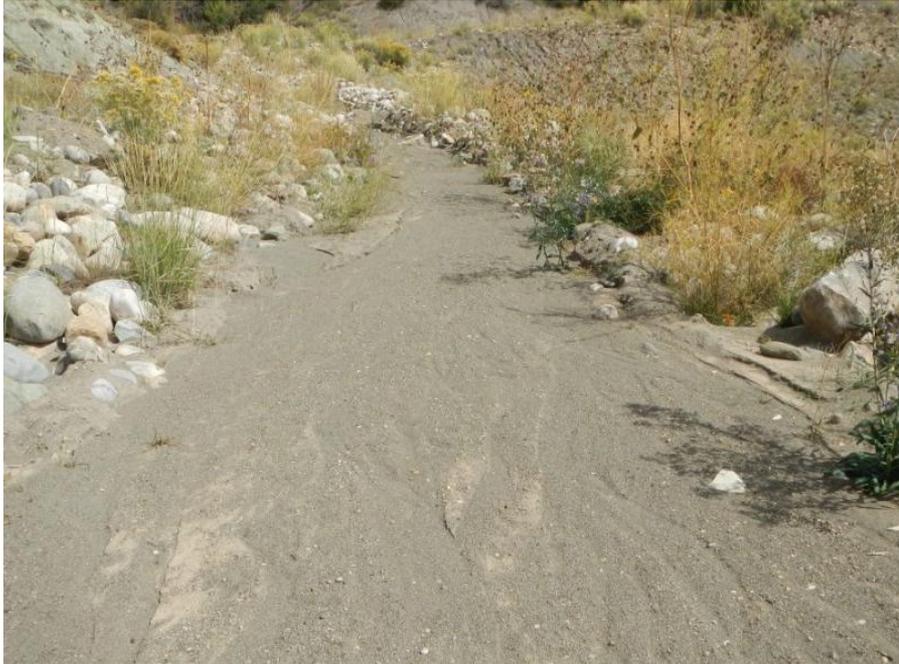
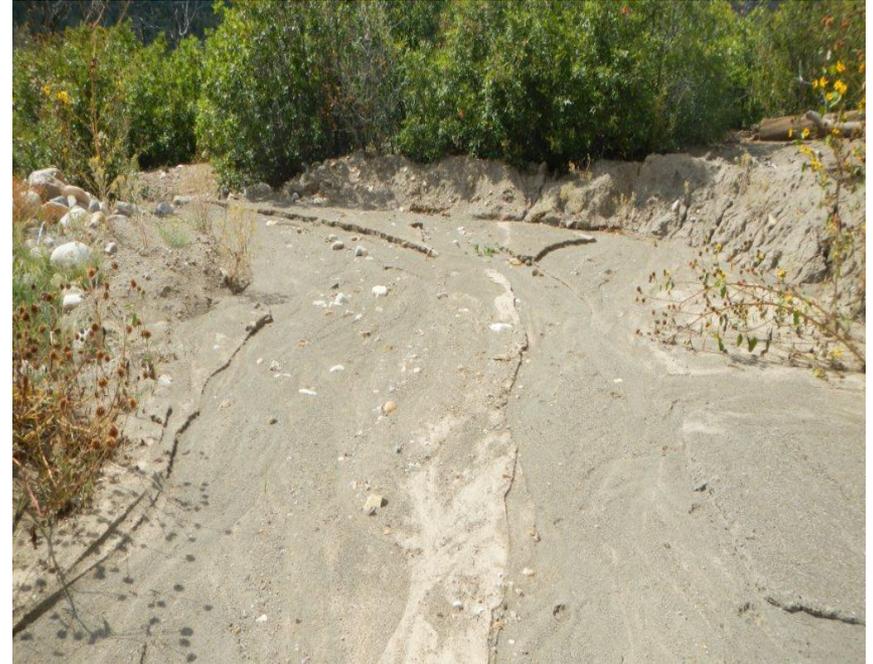
Photos 1 and 2. View of western portion of stormwater diversion channel that is full of sediment facing upstream (on left) and facing downstream (on right).

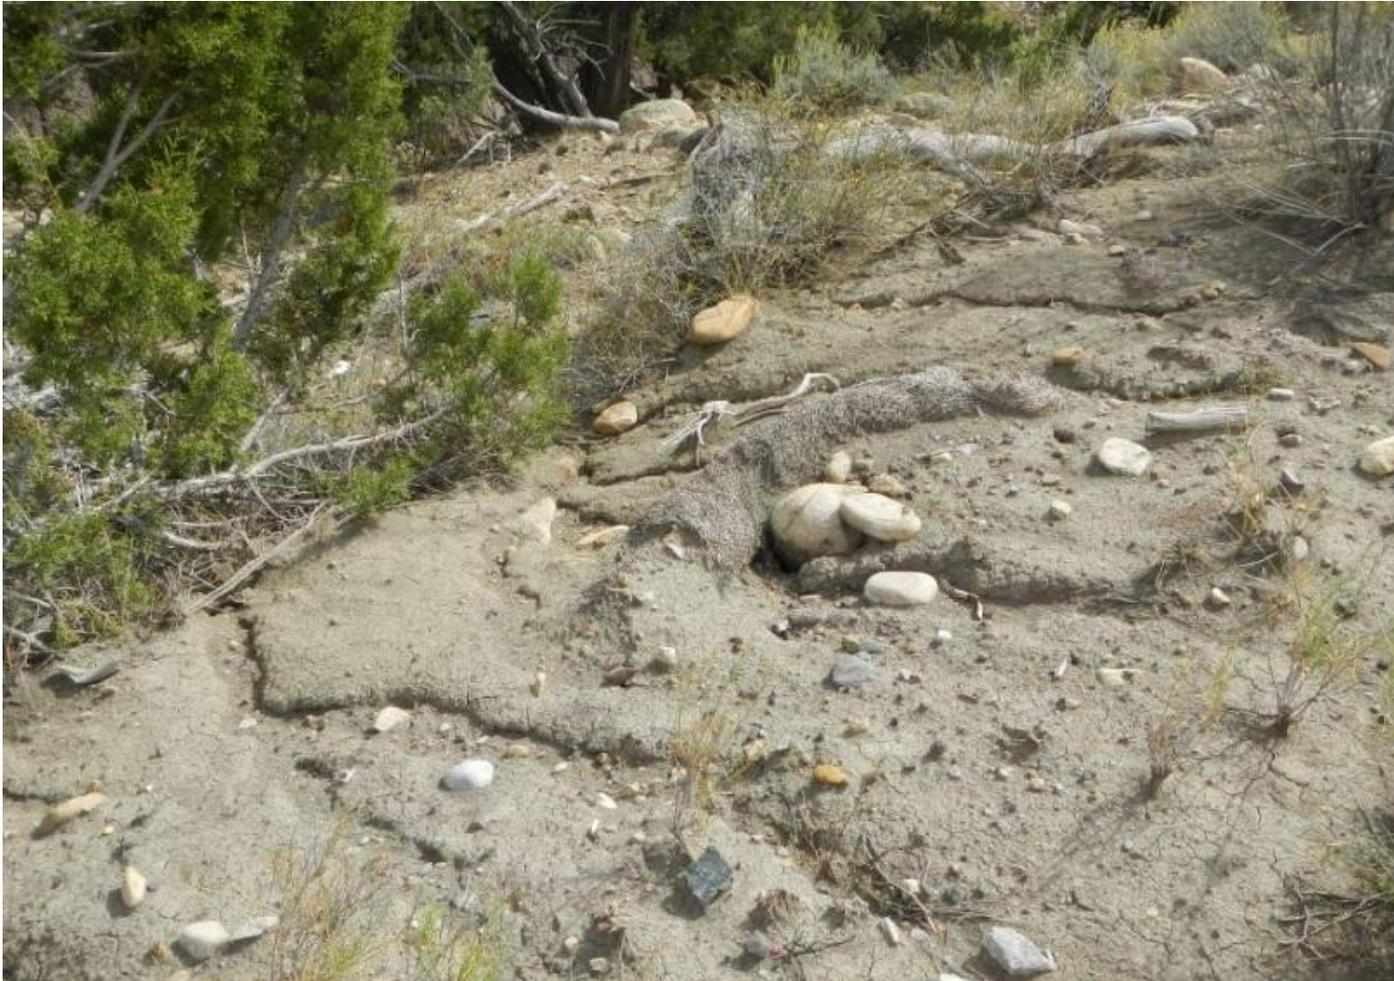
Photo 3. View of rills (approximate 5 to 8 inches deep) degraded straw wattle along eastern edge of project area.

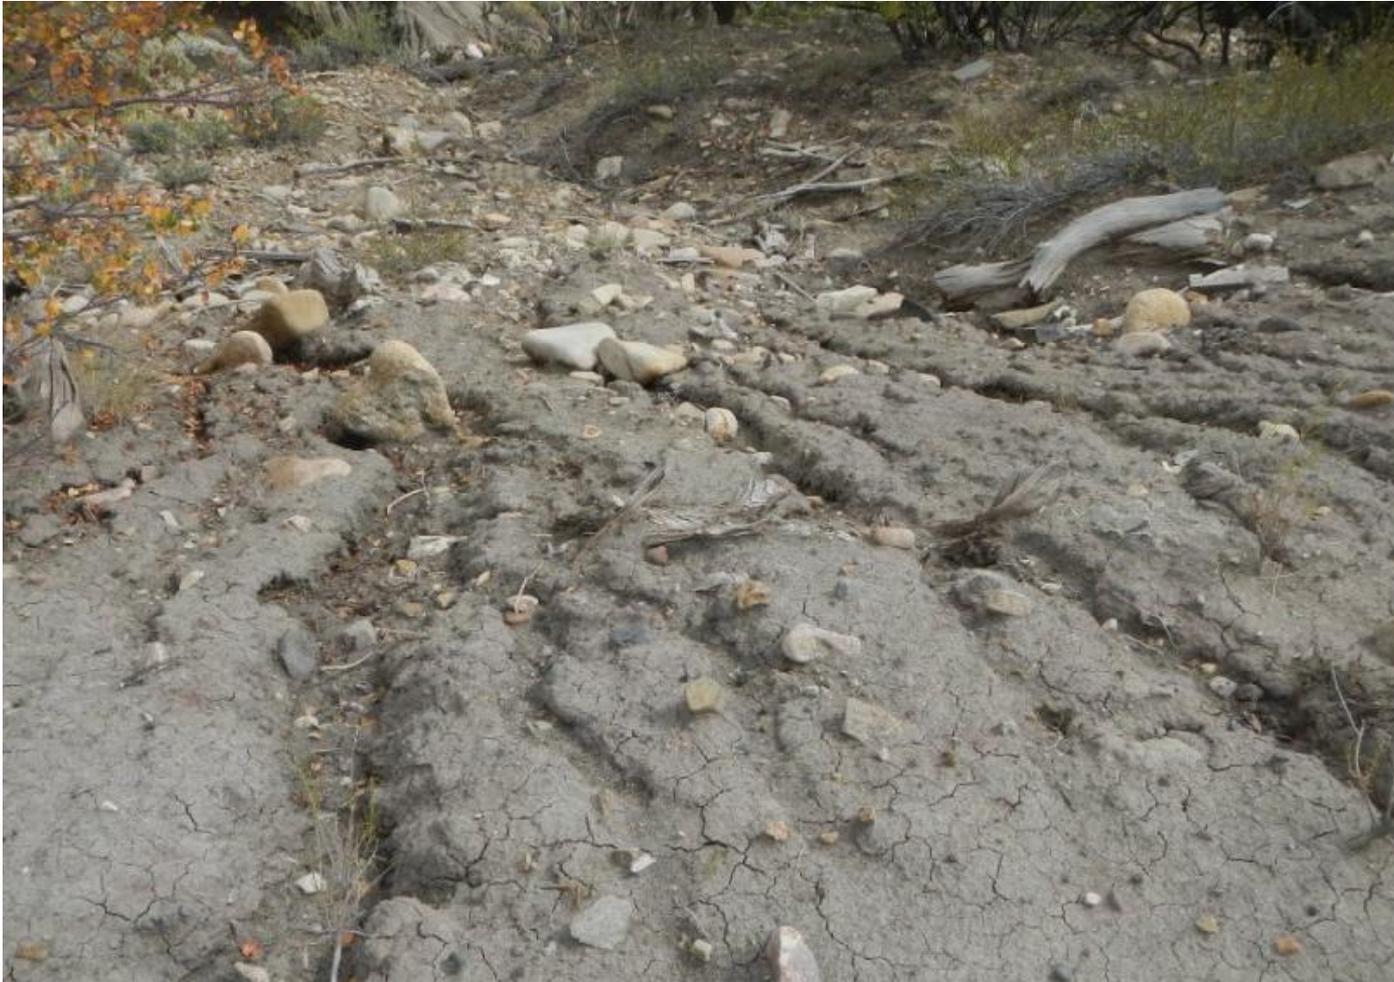
Photo 4. View of more rills, up to 10 inches deep along western edge of project area.

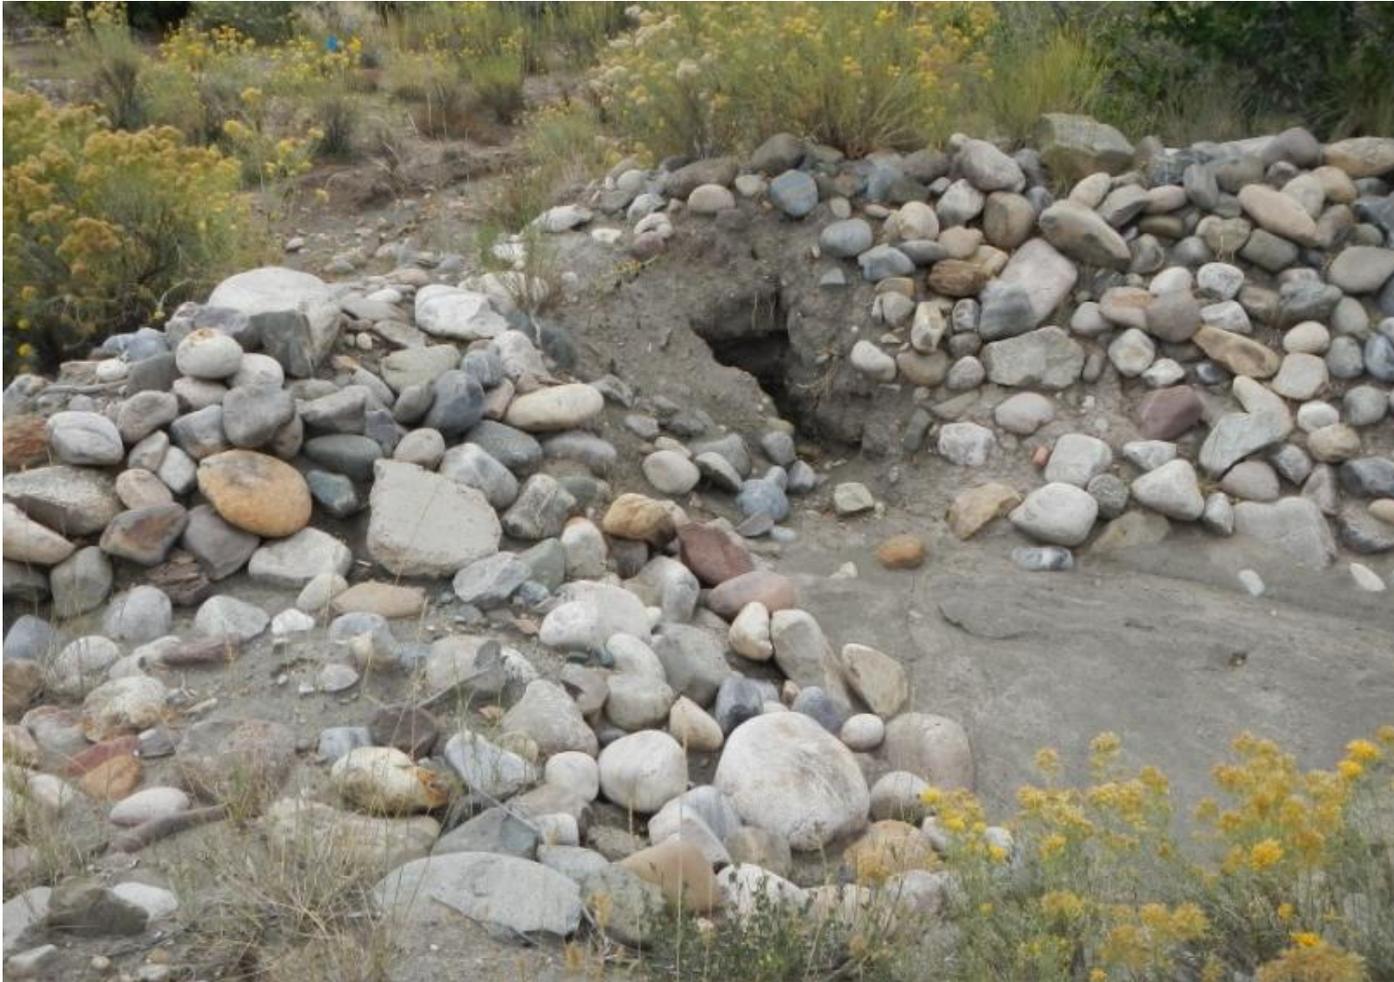
Photo 5. View of hole in silt trap where it appears stormwater and sediment flows during storm events. Located in the southern portion of the project area.

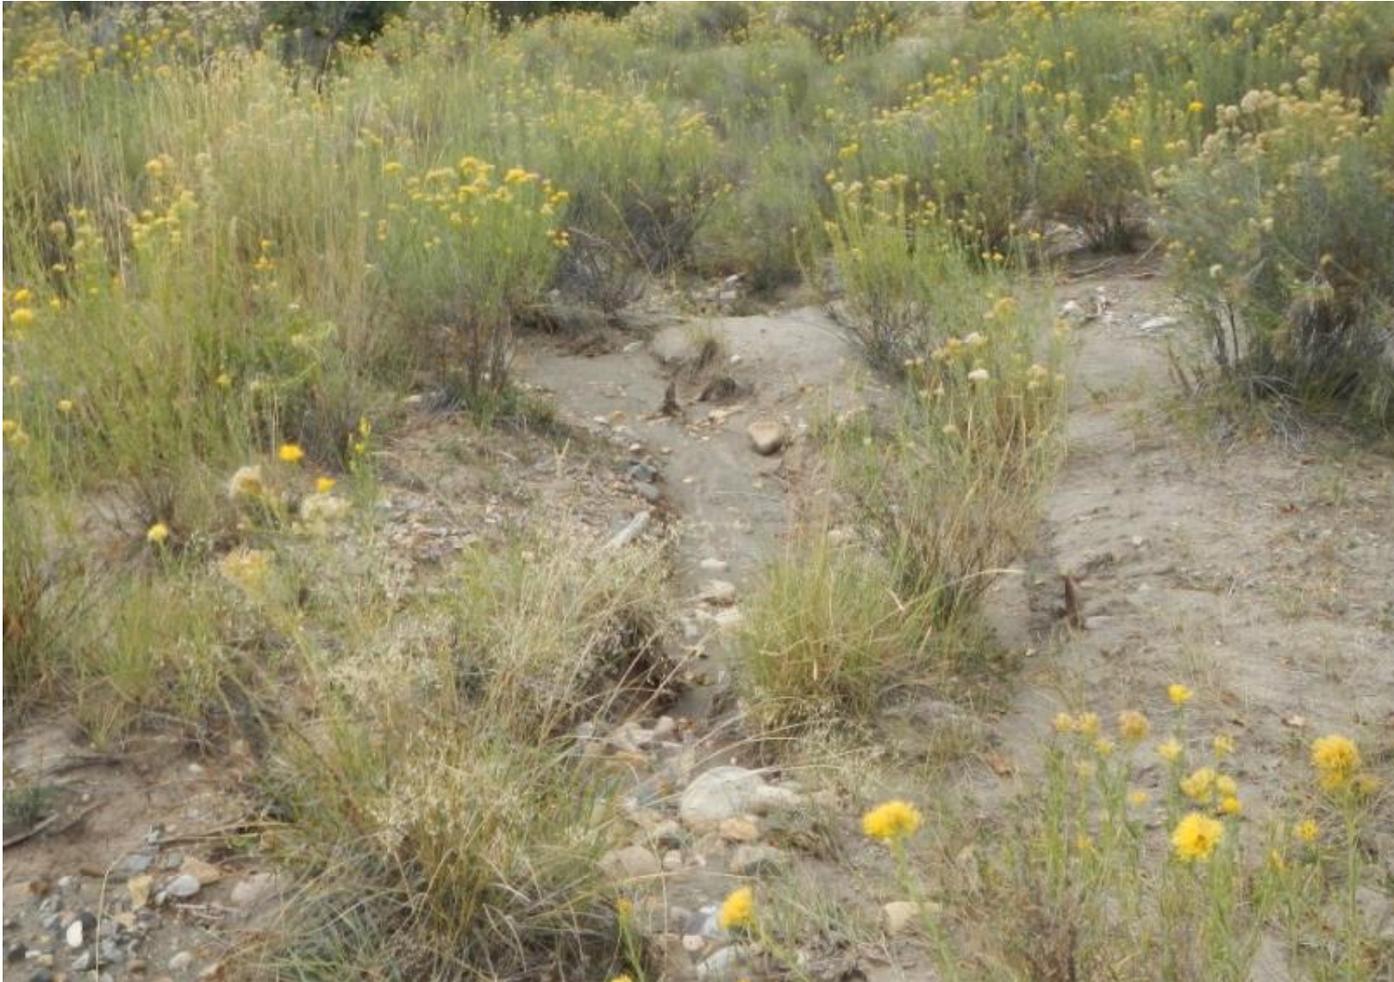
Photo 6. View of erosional channel downstream of eroded silt trap shown in Photo 5, facing downstream. Erosional channel is approximately 2 to 3 feet wide and 1 foot deep.

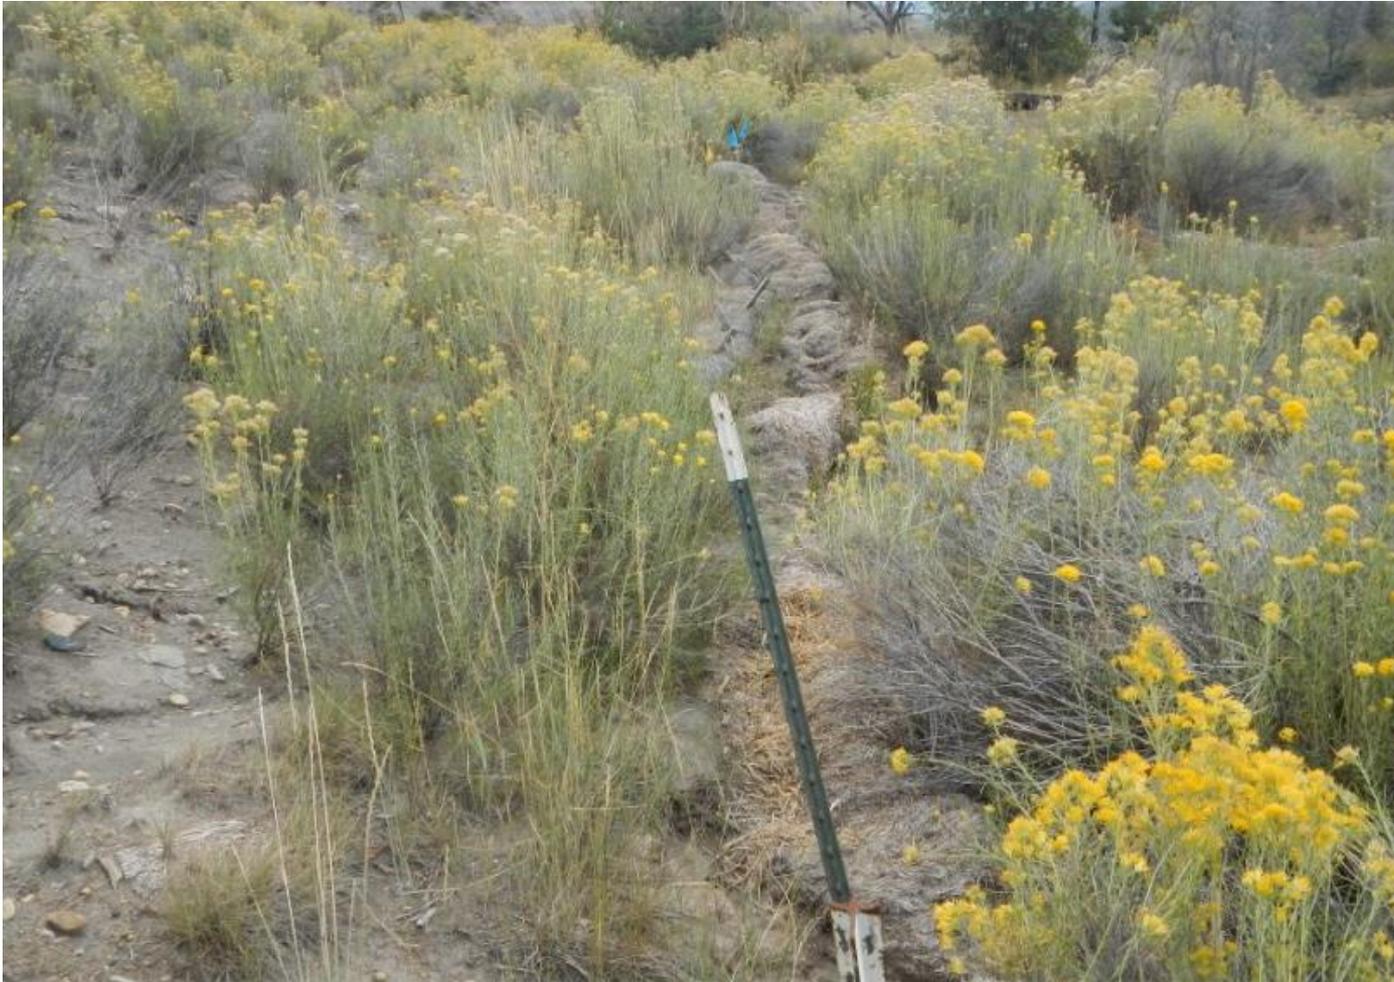
Photo 7. View of degraded straw bales and wattles in southern portion of project area.

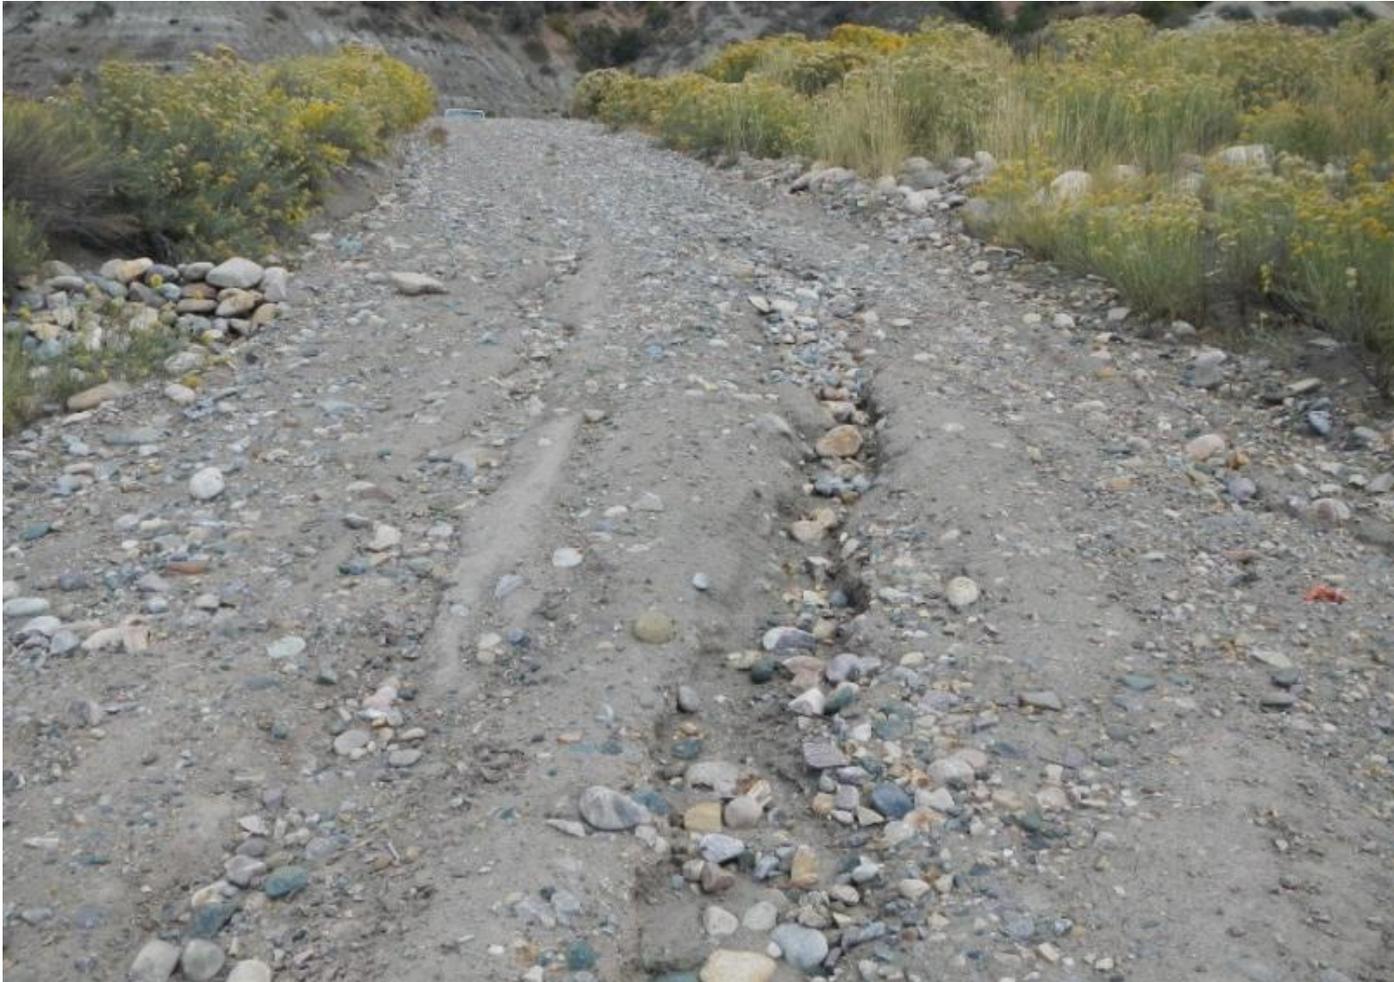
Photo 8. View of erosional channel on access road facing upslope toward well pad (northward).

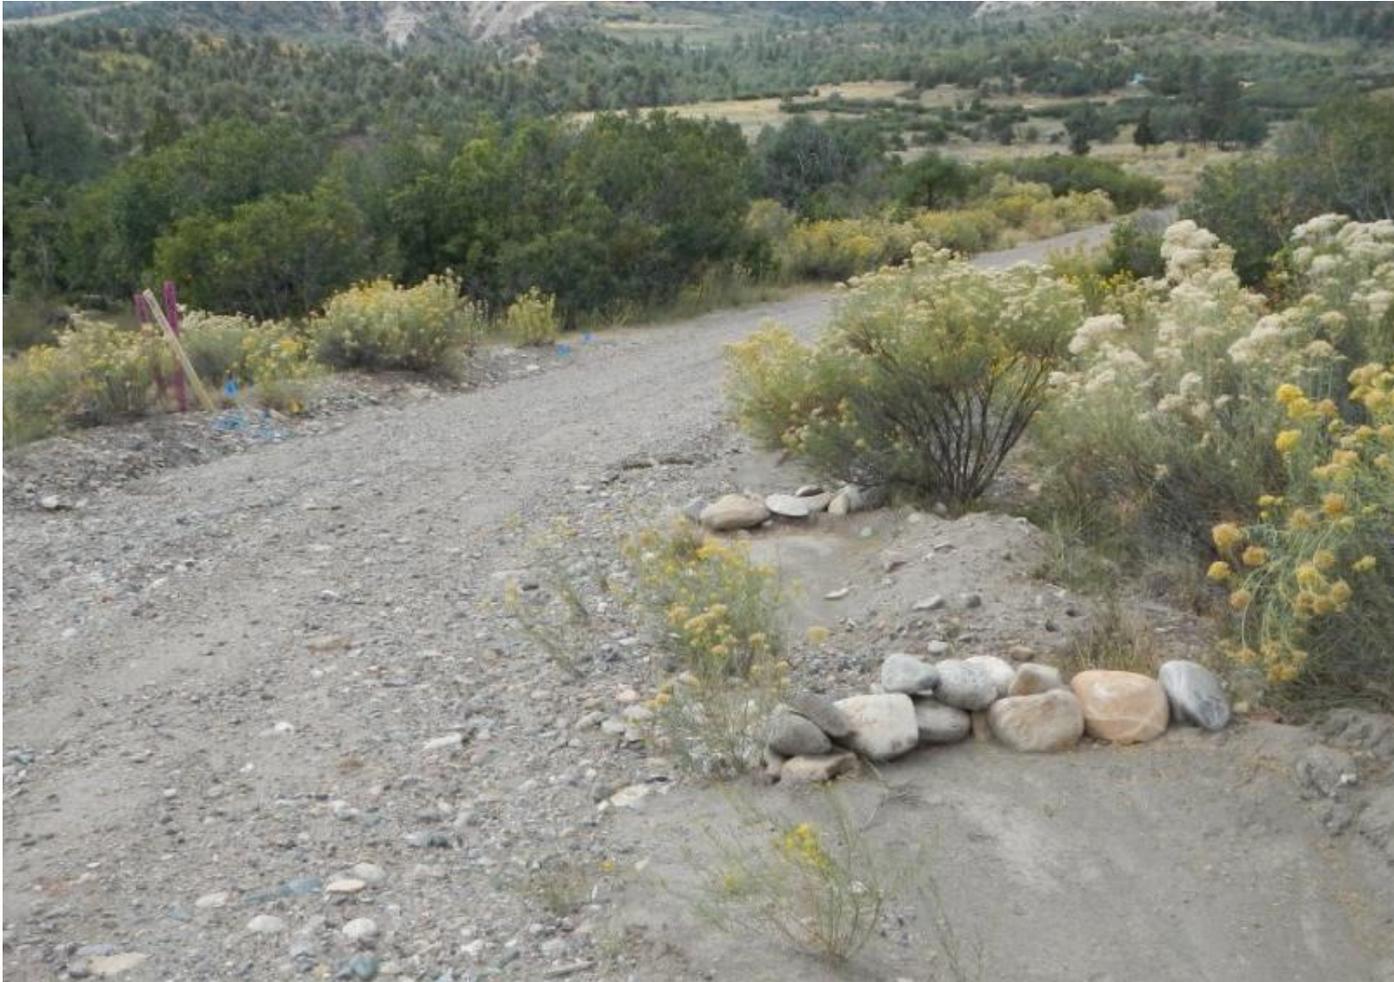
Photo 9. View of cobble filter dams along the access road that are filled with sediment, facing downslope (southward).
