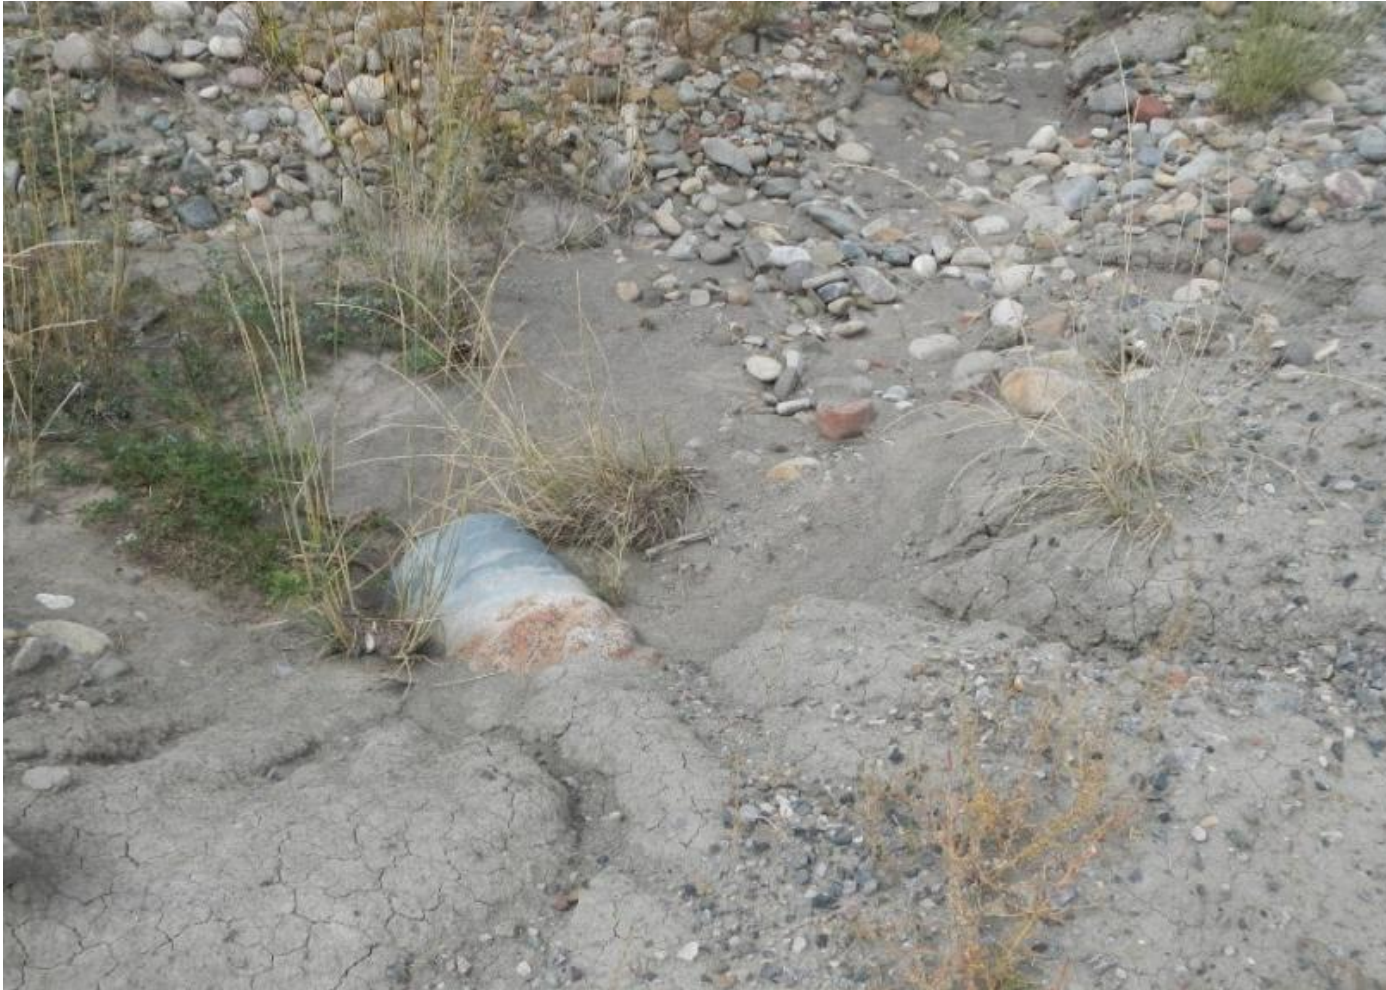
Photo 1. View of culvert inlet at entrance to well pad. Culvert is largely full of sediment, and erosion is occurring around the culvert.

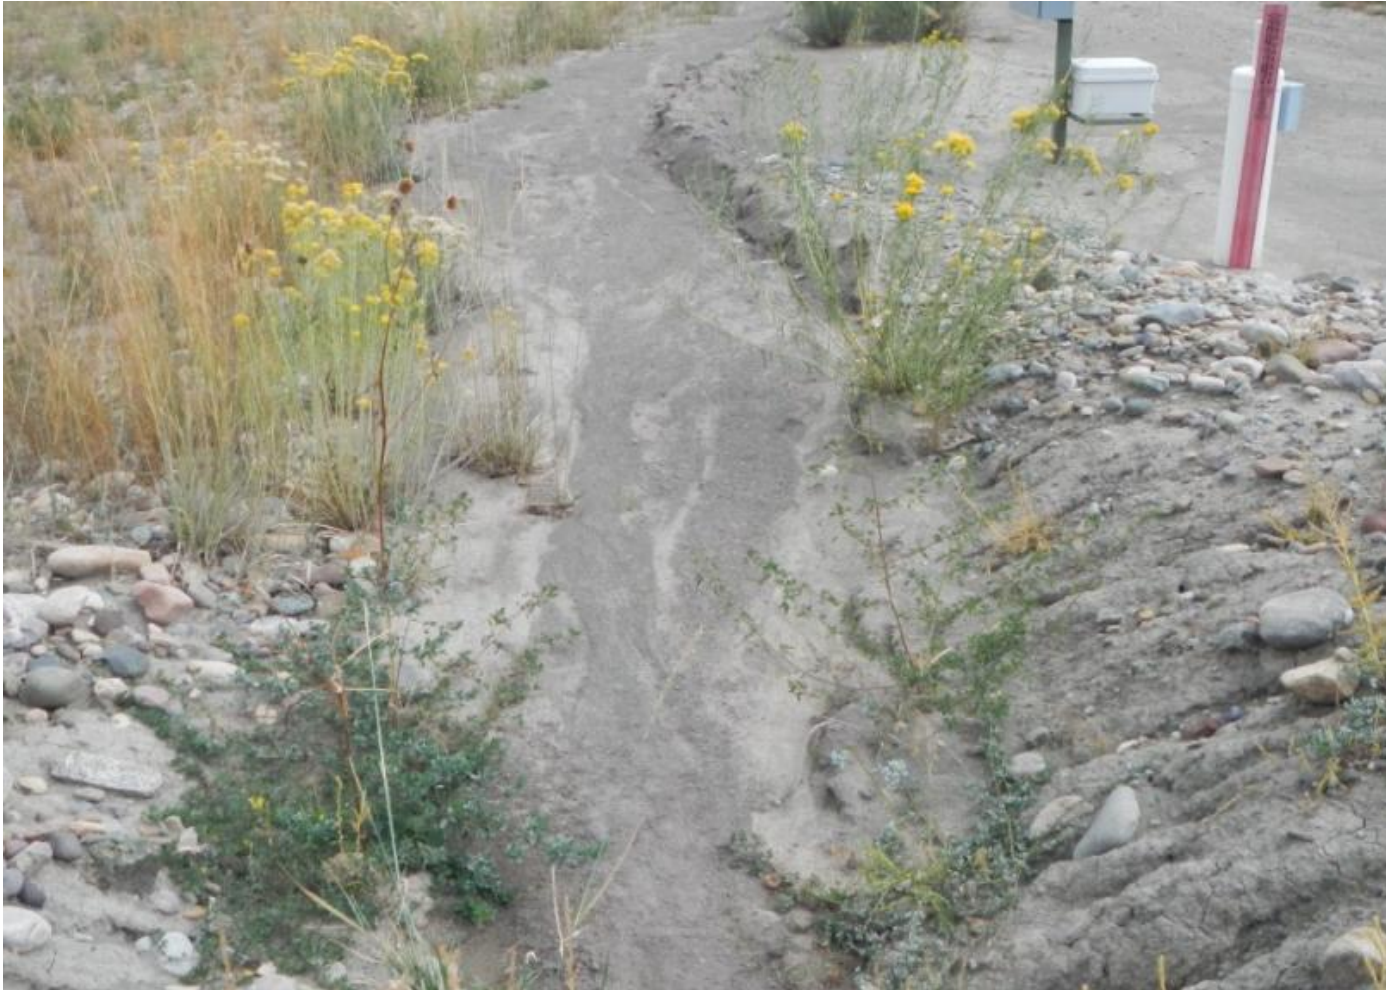
Photo 2. View of sediment filled diversion ditch on western and northern edges of the working area.

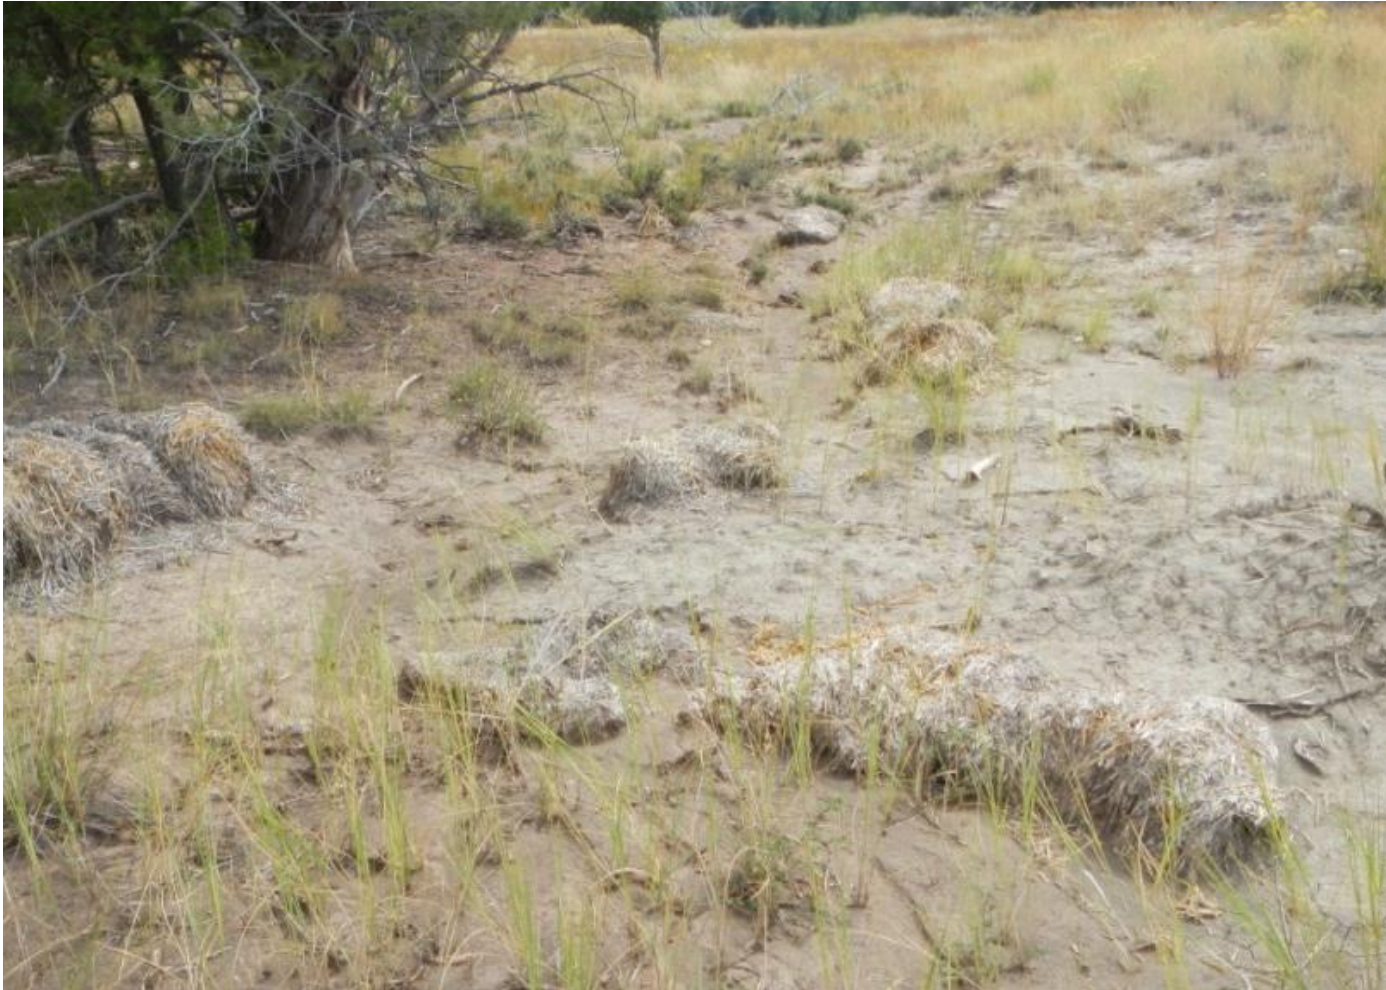
Photo 3. View of straw bales and wattles that are deteriorated along northern edge of project area.

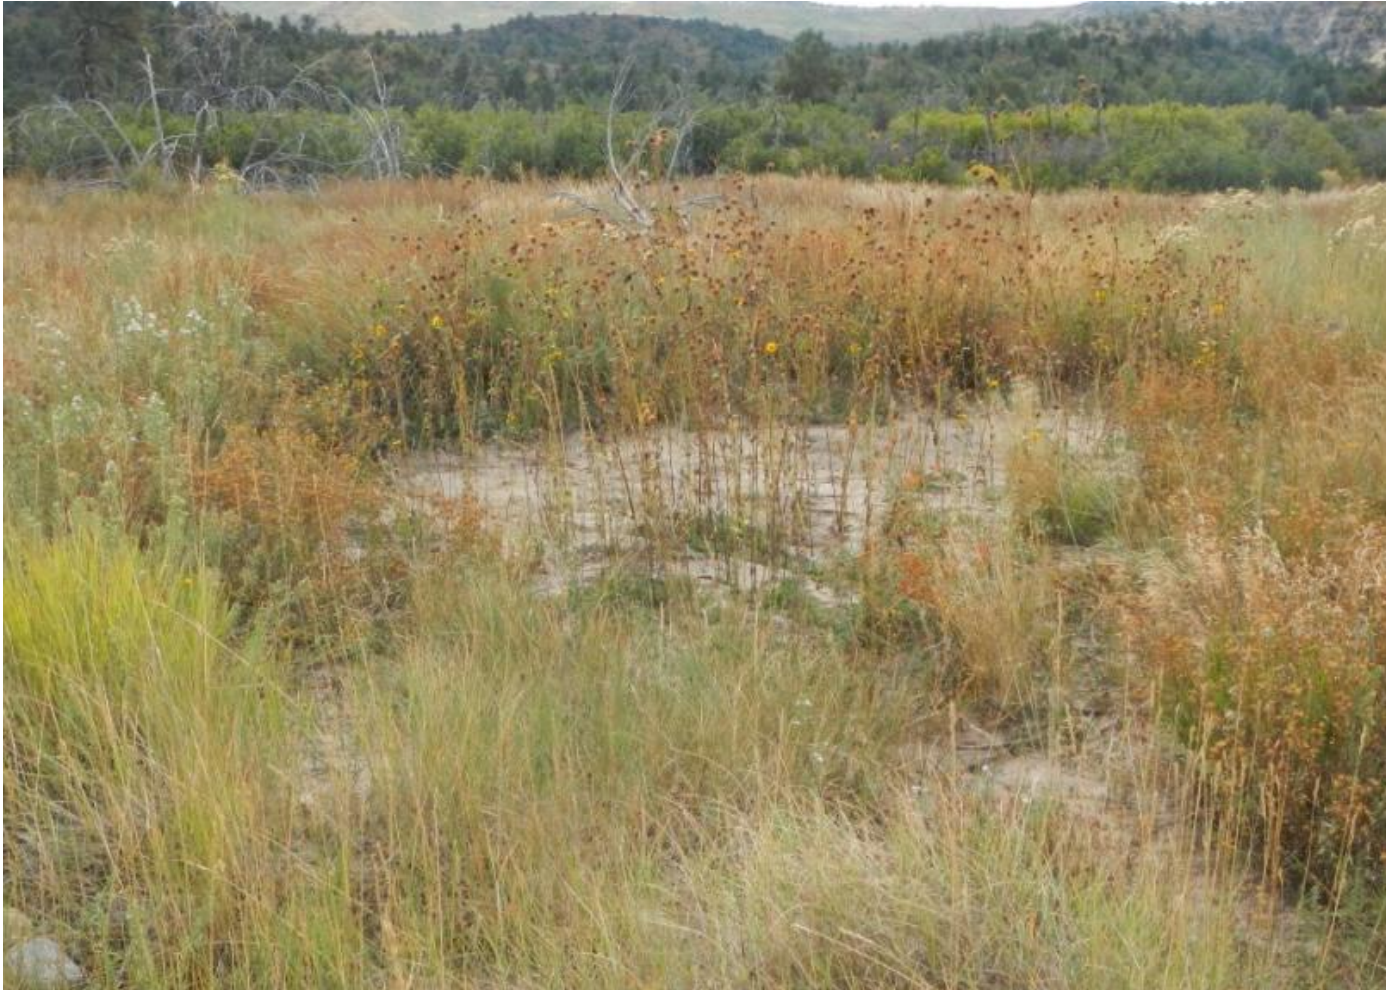
Photo 4. View of silt trap in eastern portion of project area. Silt trap is largely full of sediment and has breached an approximately 1.5 foot wide and deep channel in the supporting berm. Photo facing eastward from well pad.

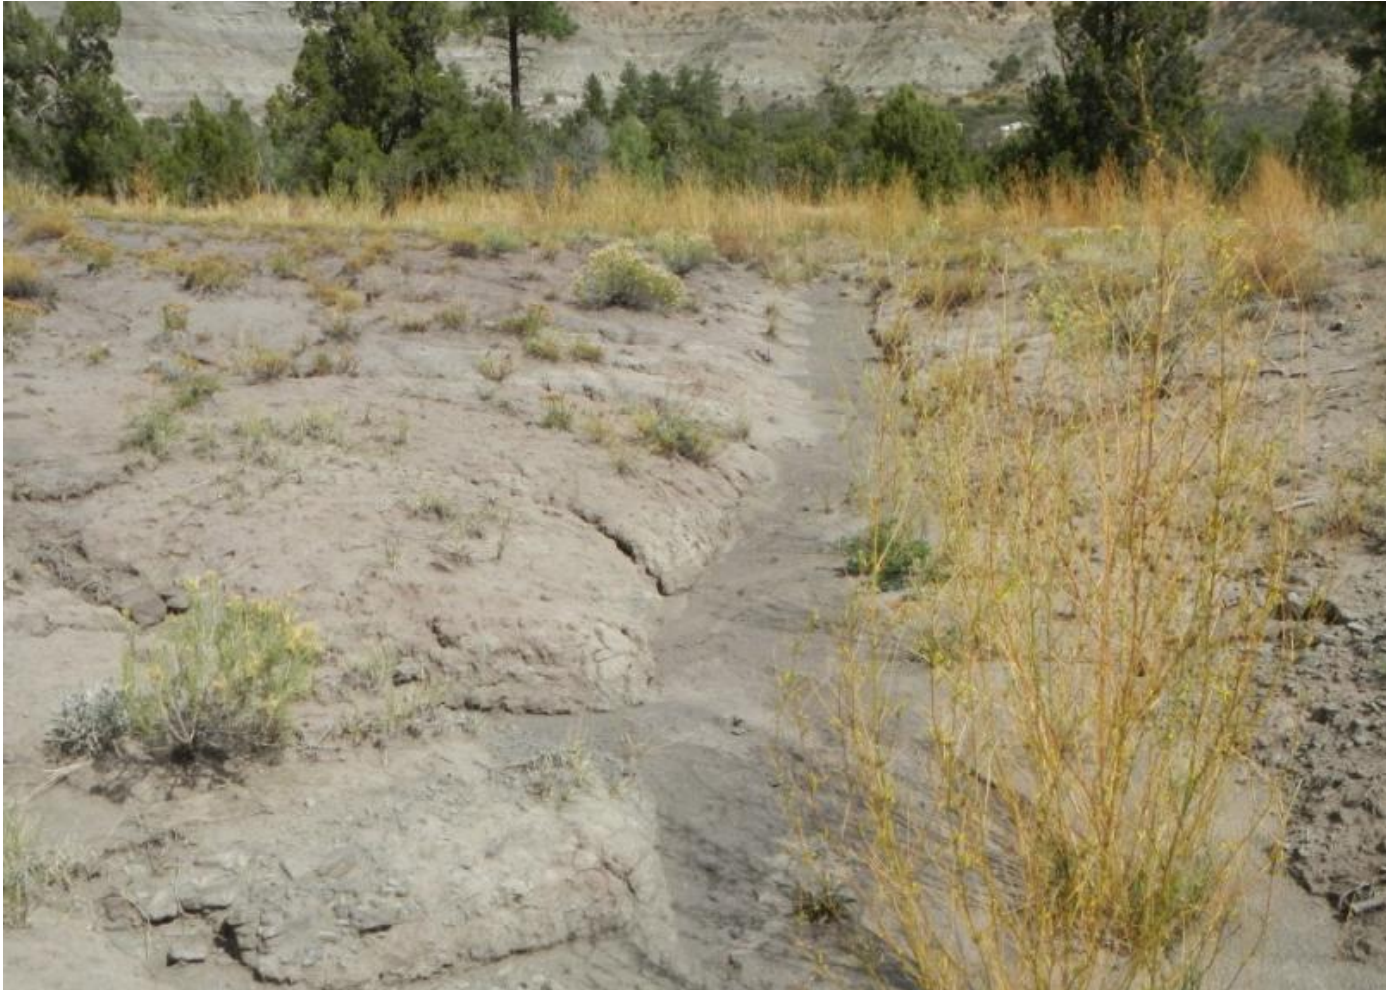
Photo 5. View of bar ditch along access road filled with sediment facing upstream toward the access road (northward).

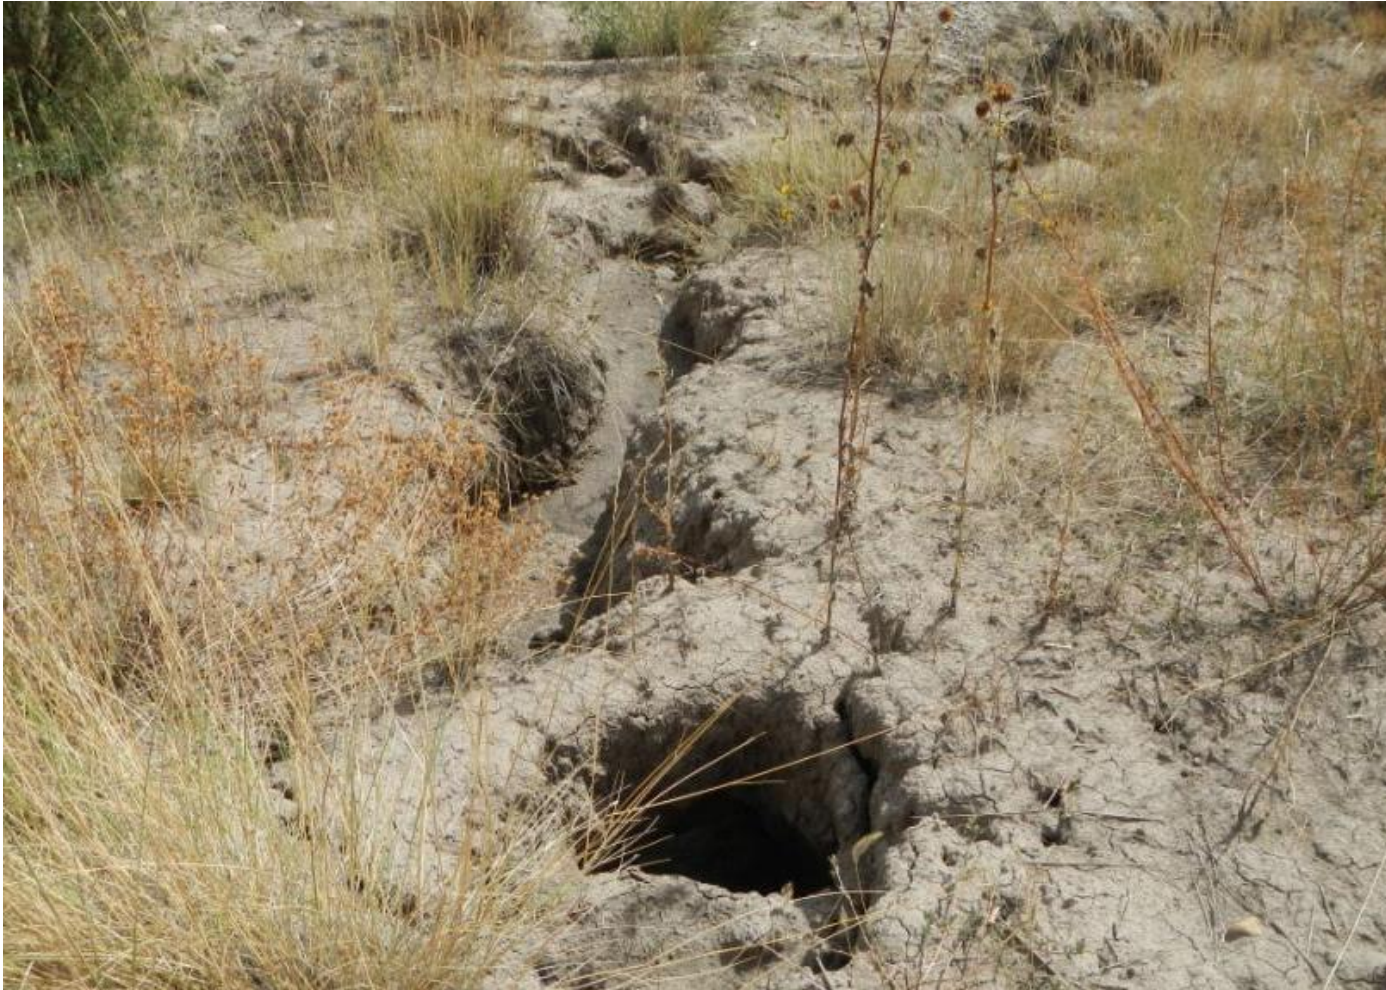
Photo 6. View of erosional channel and tunnelling in cut-slope along access , where it appears stormwater flows from the bar ditch have changed course and eroded through the fill slope. Photo facing downslope from top of hill.
