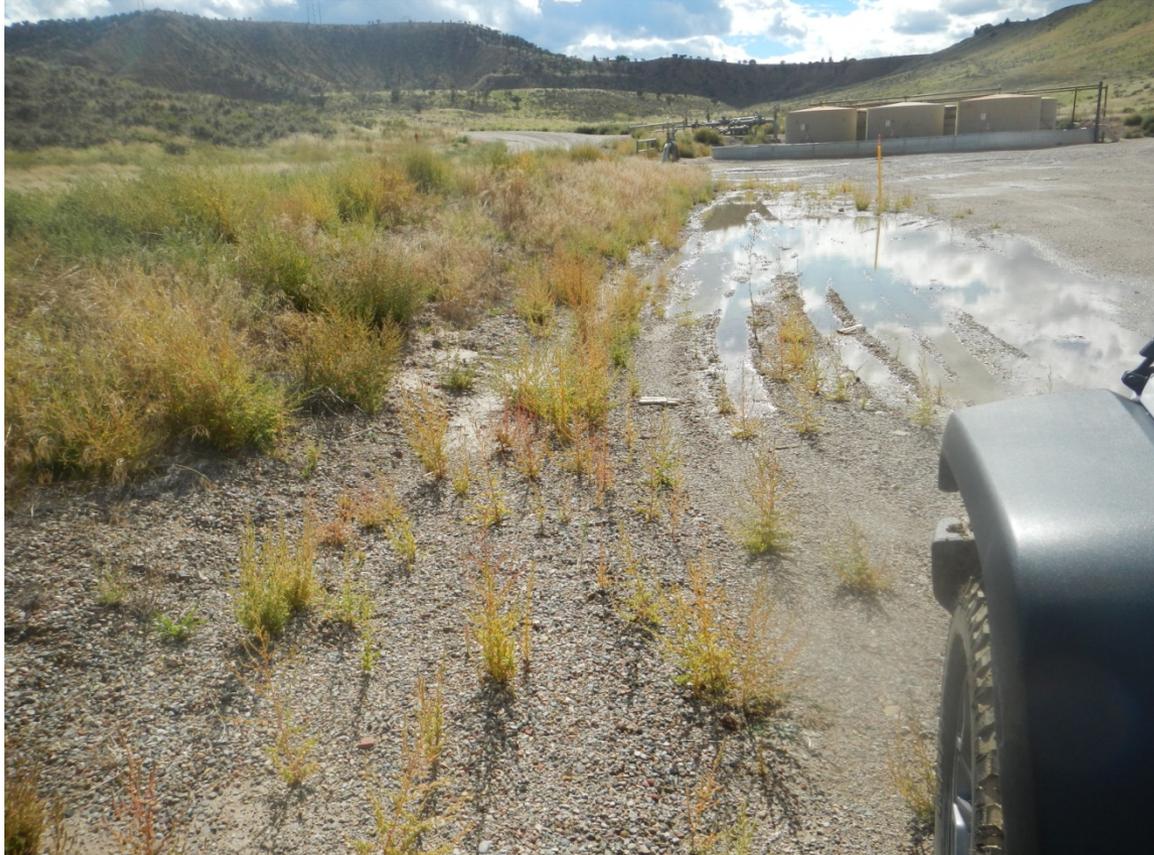
Photo#1: Entering Location, facing West.

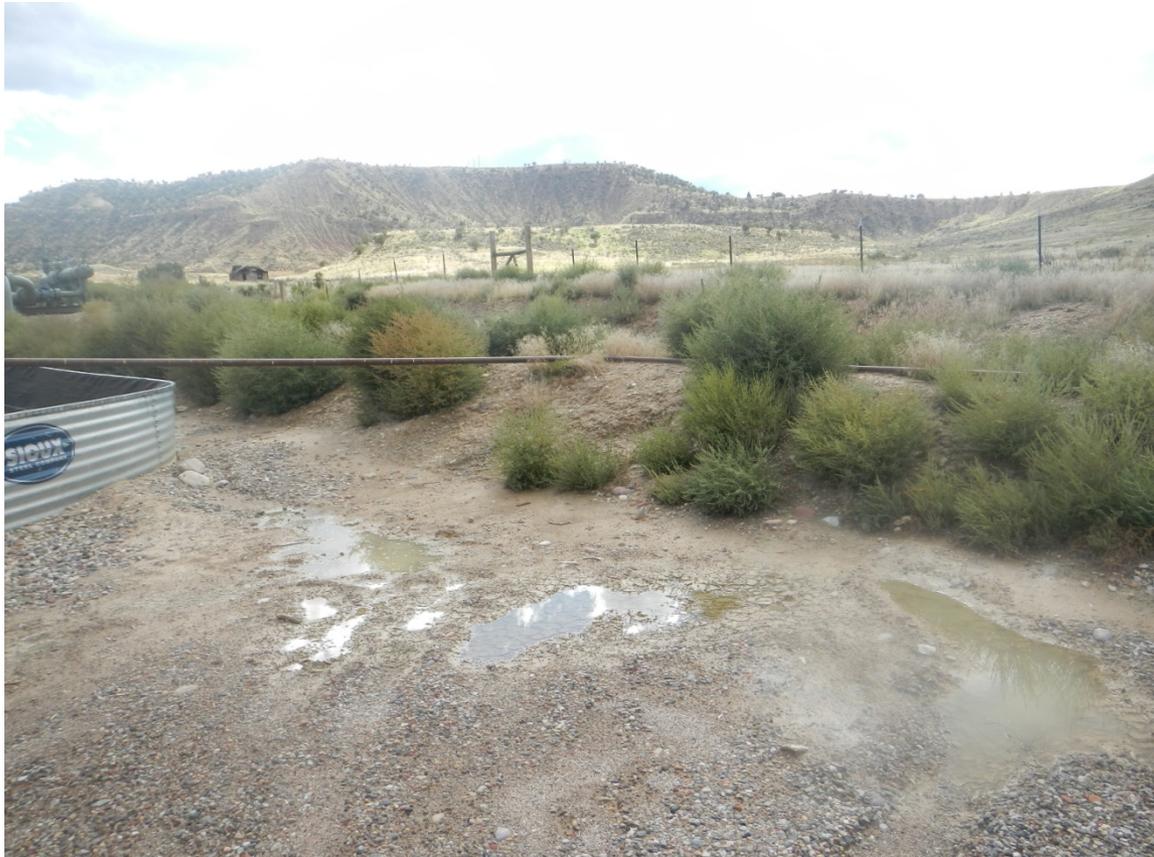
Photo#2: View of Location berms facing SW.

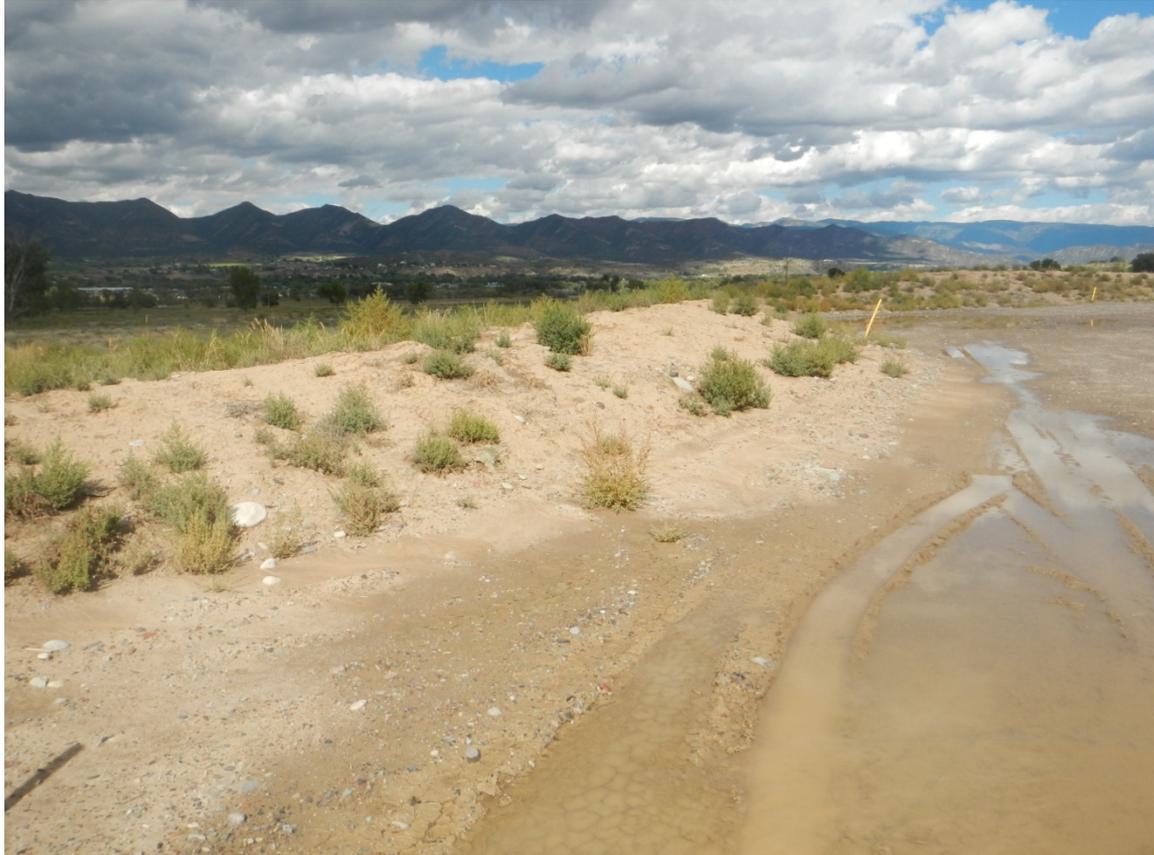
Photo#3: View of berms on North side of location, looking East.

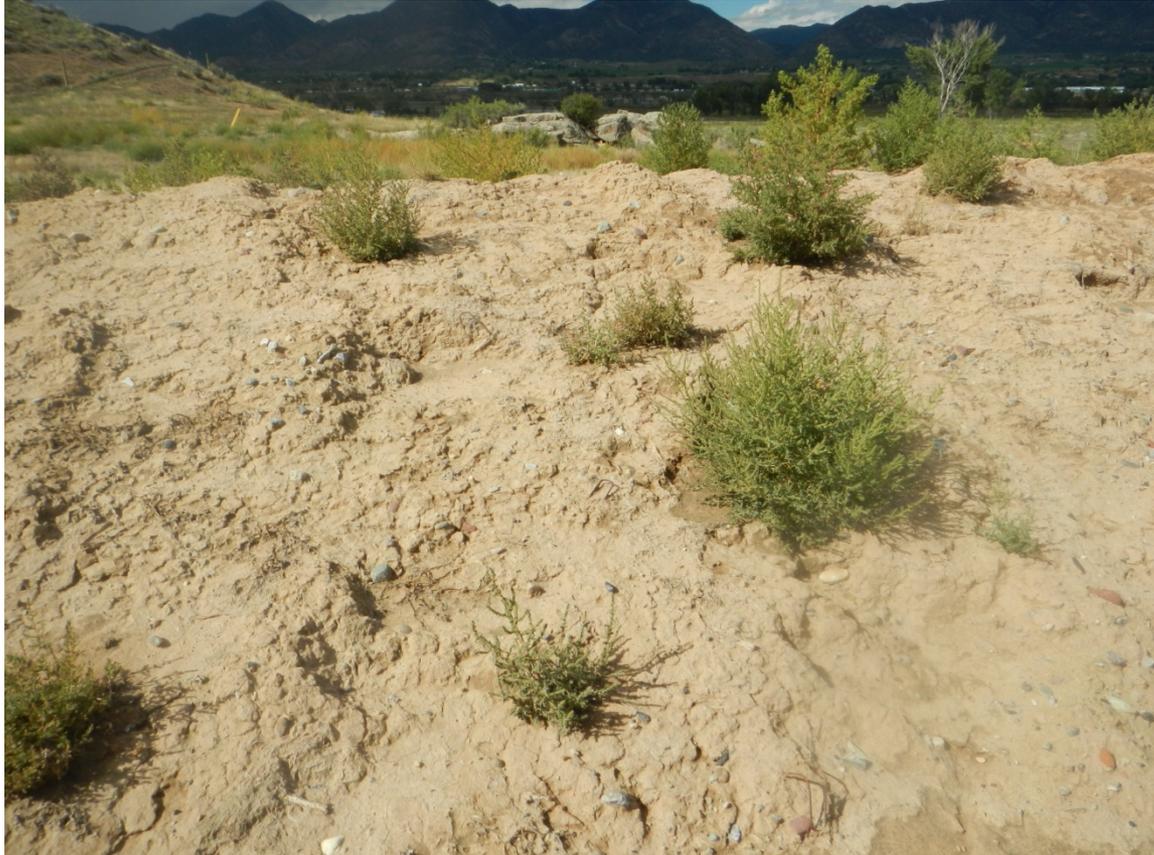
Photo#4: Close up of failed establishment of perennial vegetation.

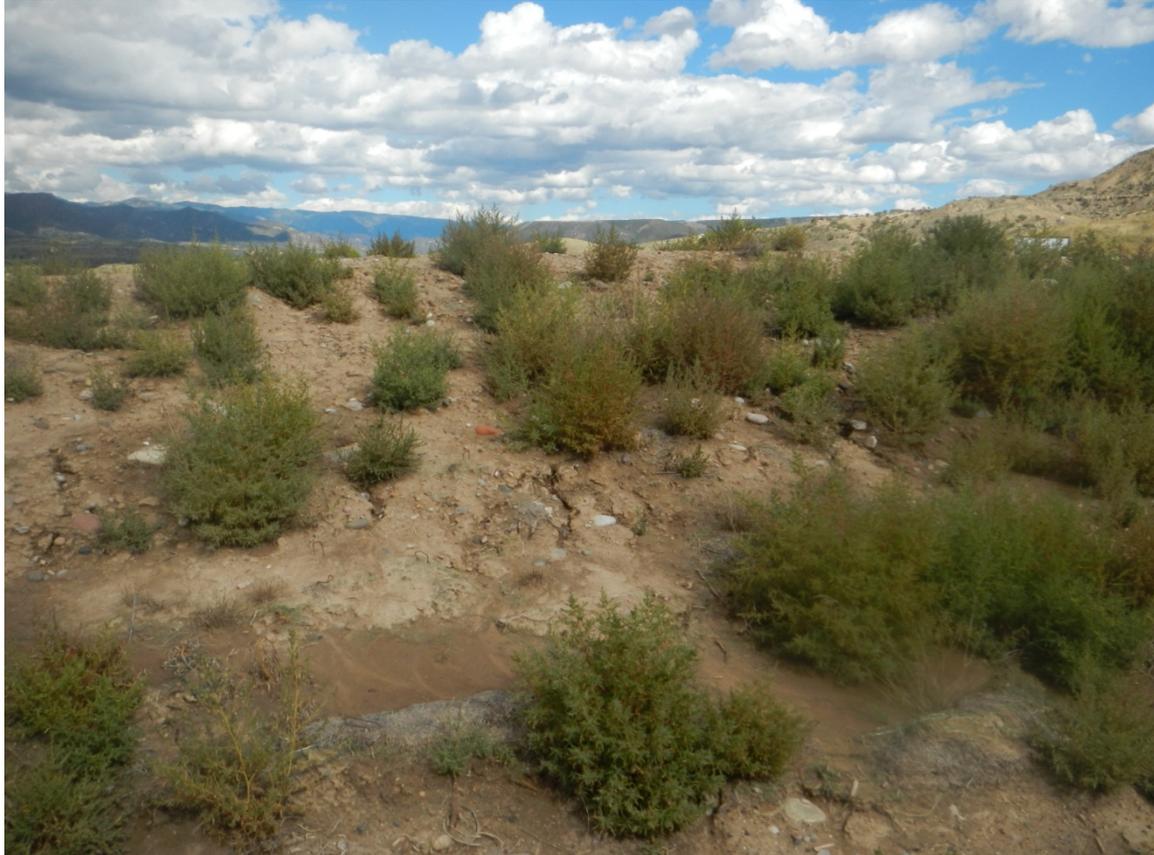
Photo#5: Erosion on unstabilized berms.
