**Federal 6-25**

Inspection# 673402474

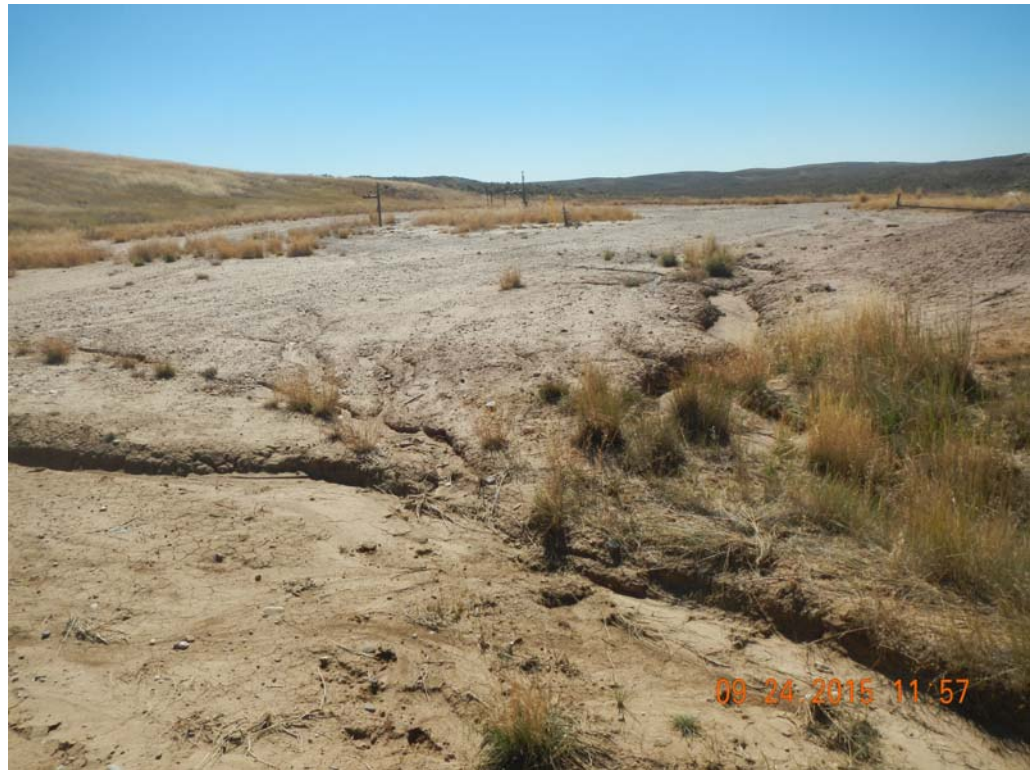
Inspection 673402474  
9/24/2015

Rills leaving location.

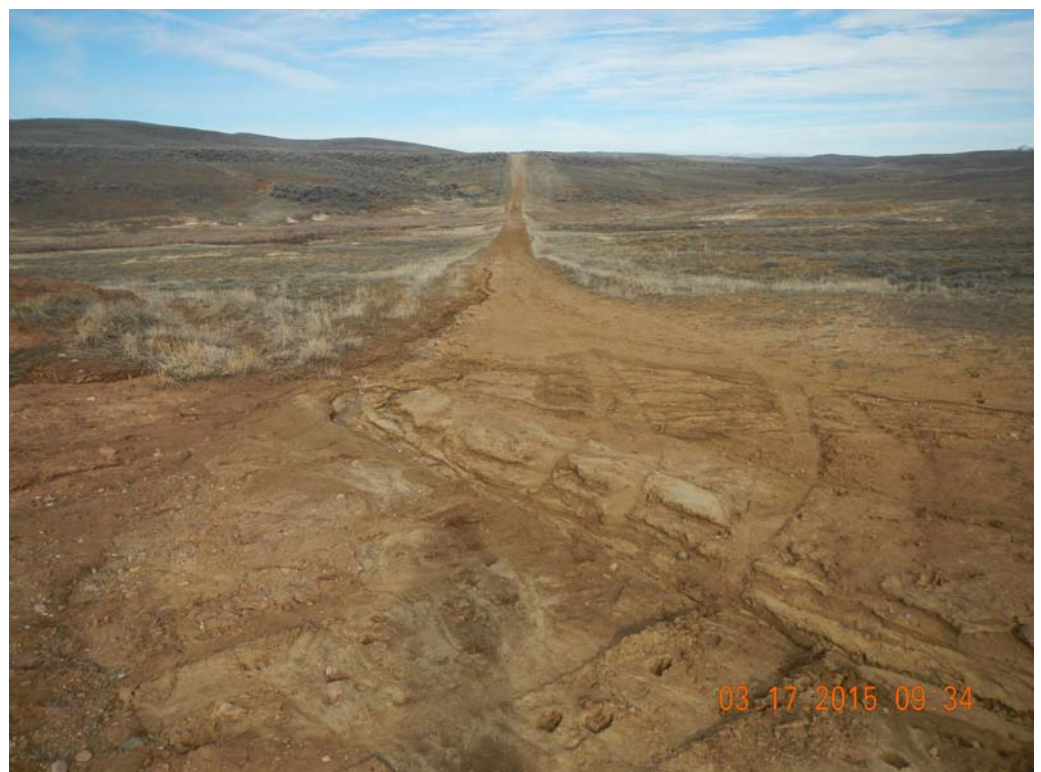
Inspection 673401912  
3/17/2015

Rills leaving location.

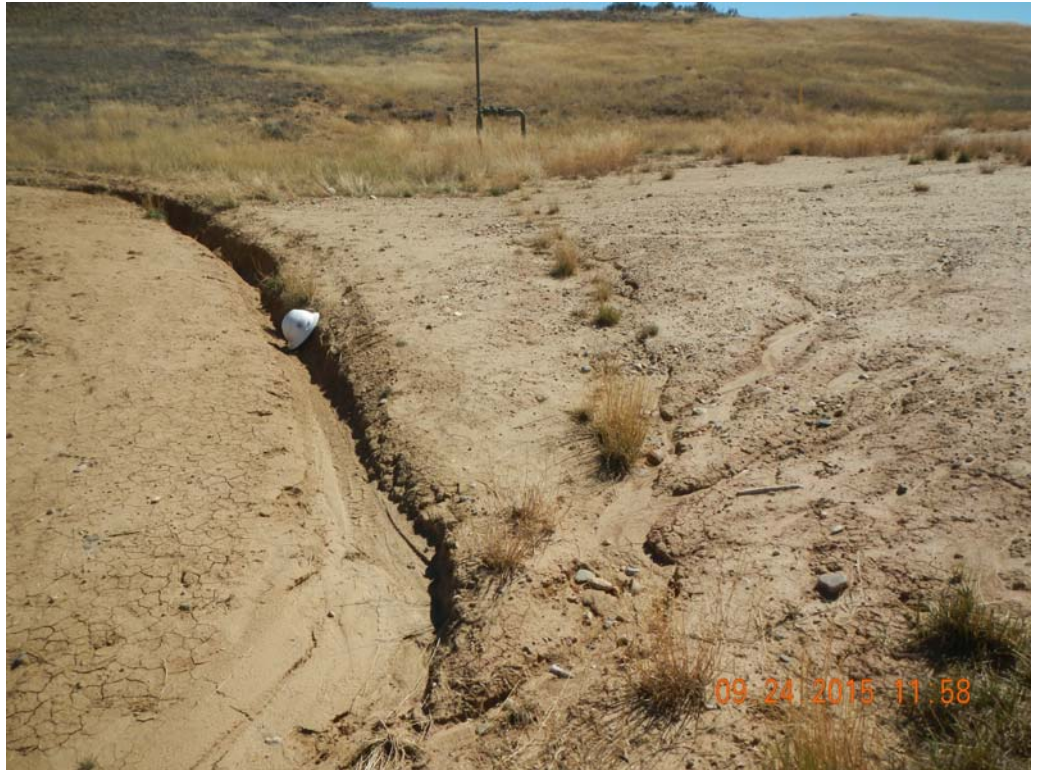
Inspection 673402474  
9/24/2015

Rills leaving location.

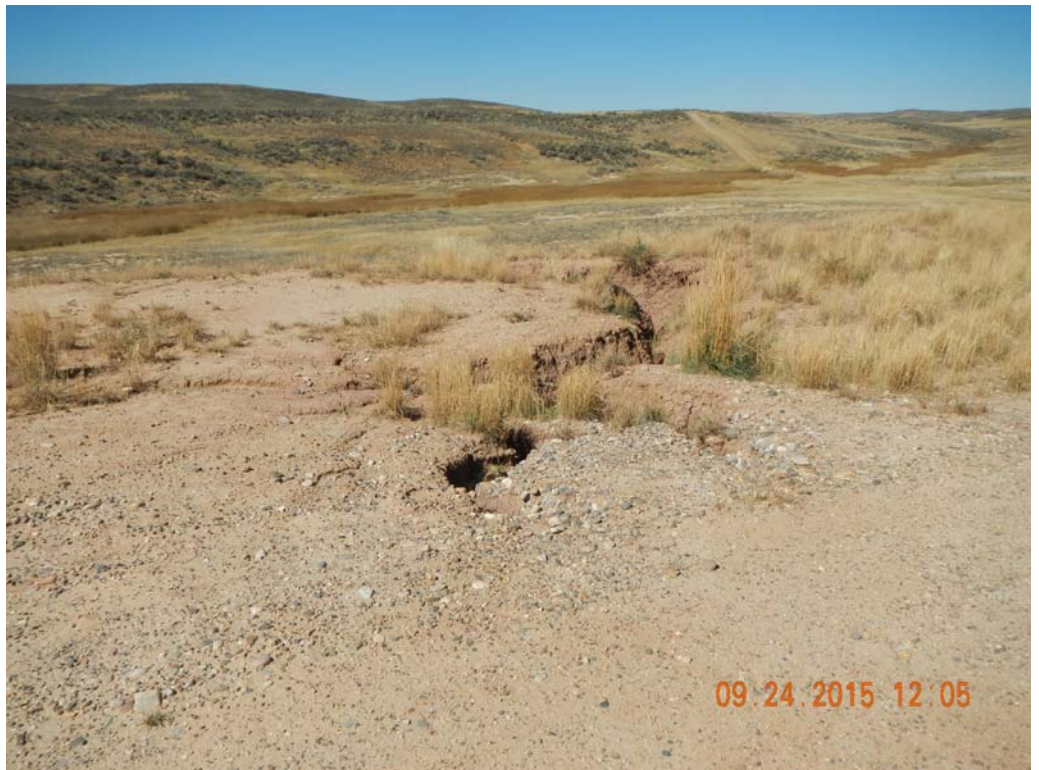
Inspection 673402474  
9/24/2015

Erosion gully on west  
side of location.

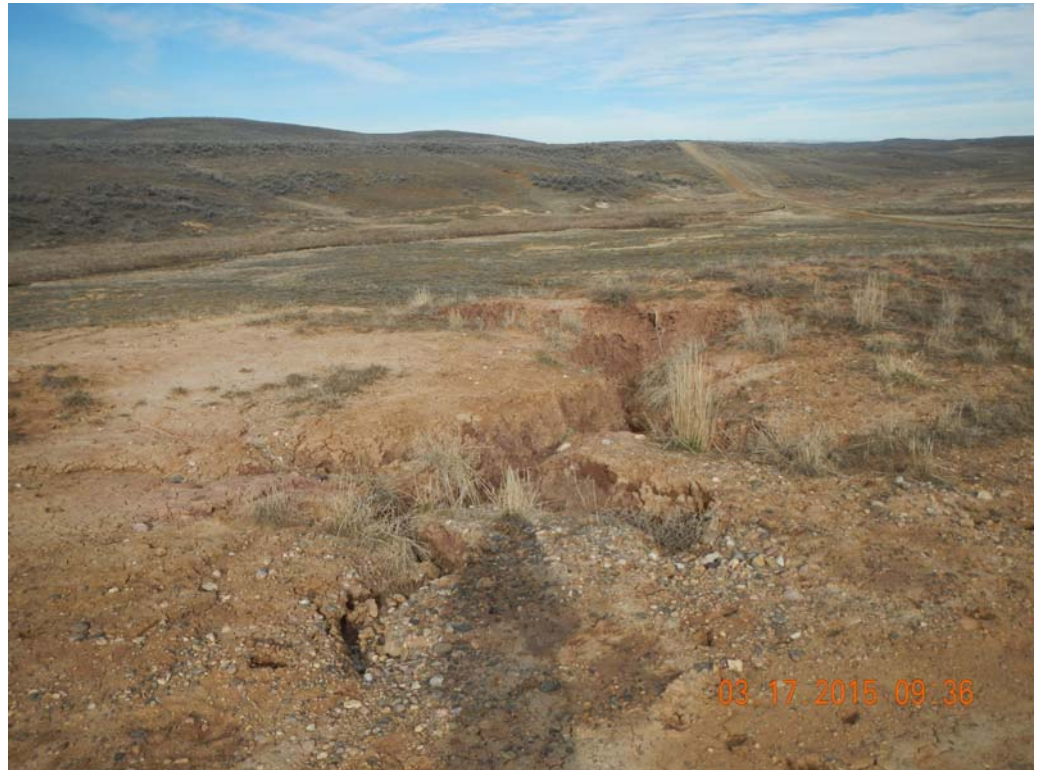
Inspection 673401912  
3/17/2015

Erosion gully on west side  
of location.

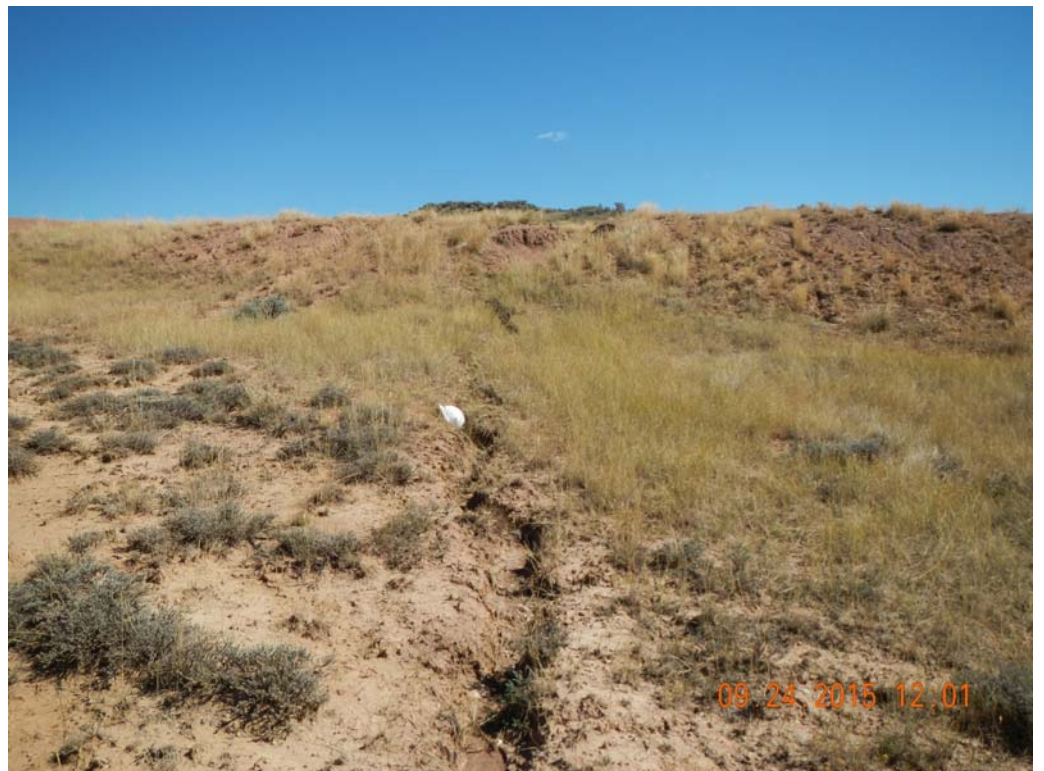
Inspection 673402474  
9/24/2015

Erosion gully on west side  
of location. Hard hat for  
scale.

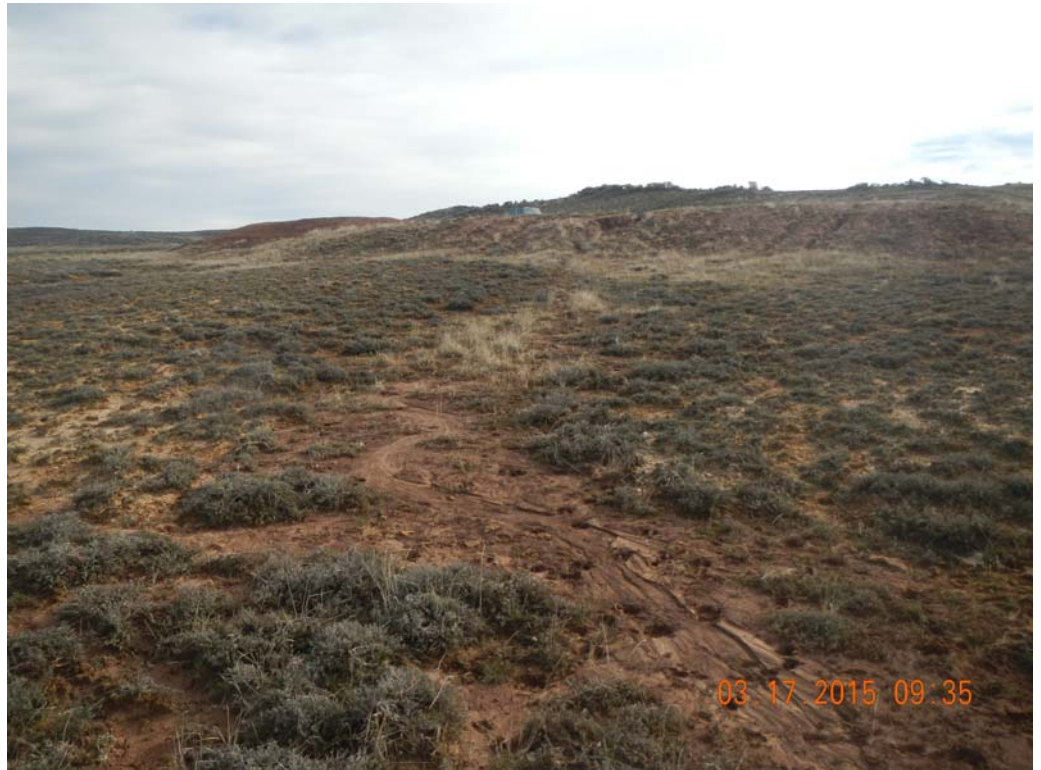
Inspection 673401912  
3/17/2015

Erosion gully on west side  
of location. Evidence of  
sediment migration.

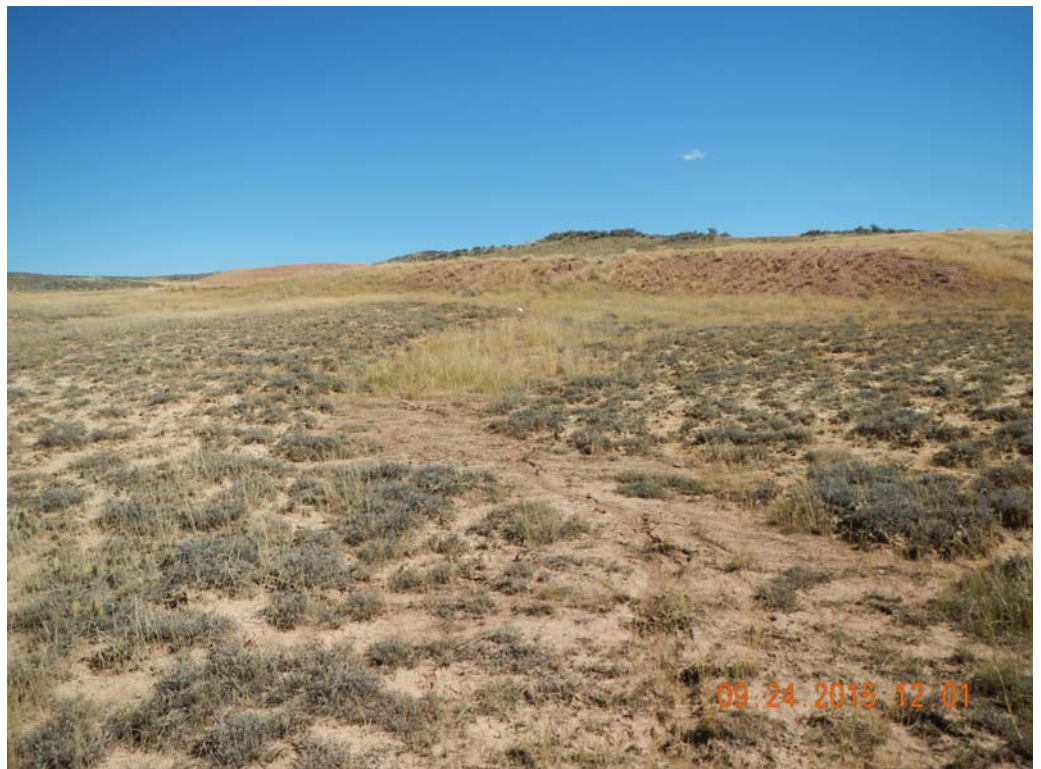
Inspection 673402474  
9/24/2015

Erosion gully on west side  
of location. Evidence of  
sediment migration.

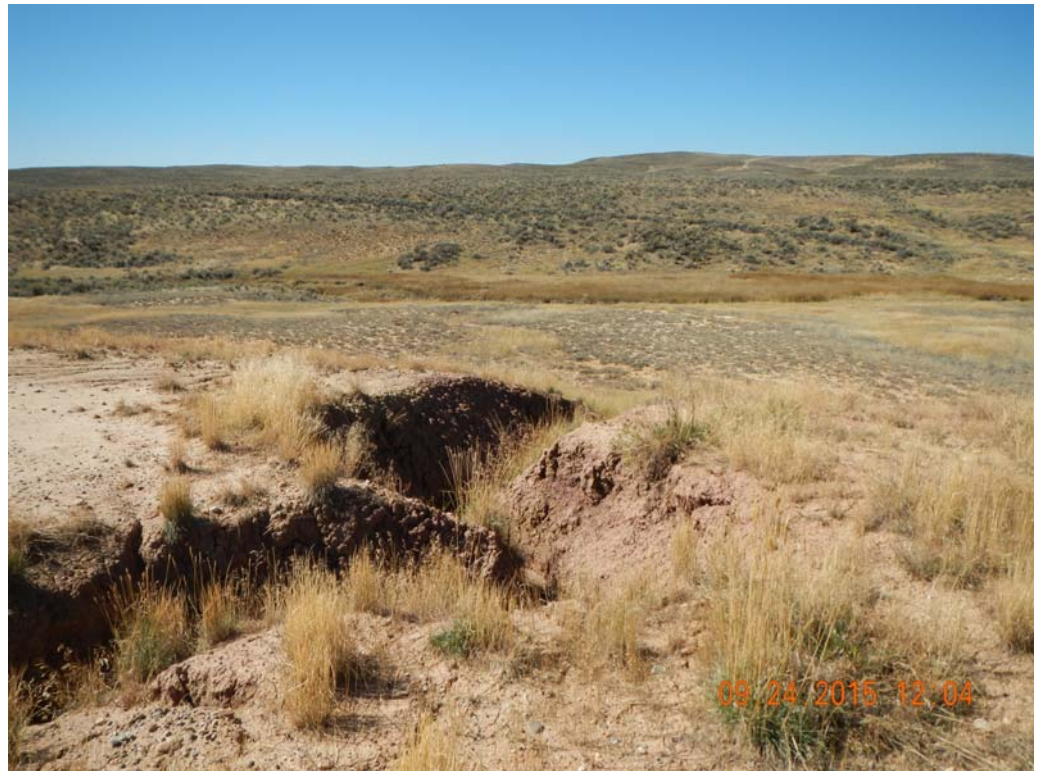
Inspection 673402474  
9/24/2015

Erosion gully on west side of location. Evidence of sediment migration all the way to drainage in background.

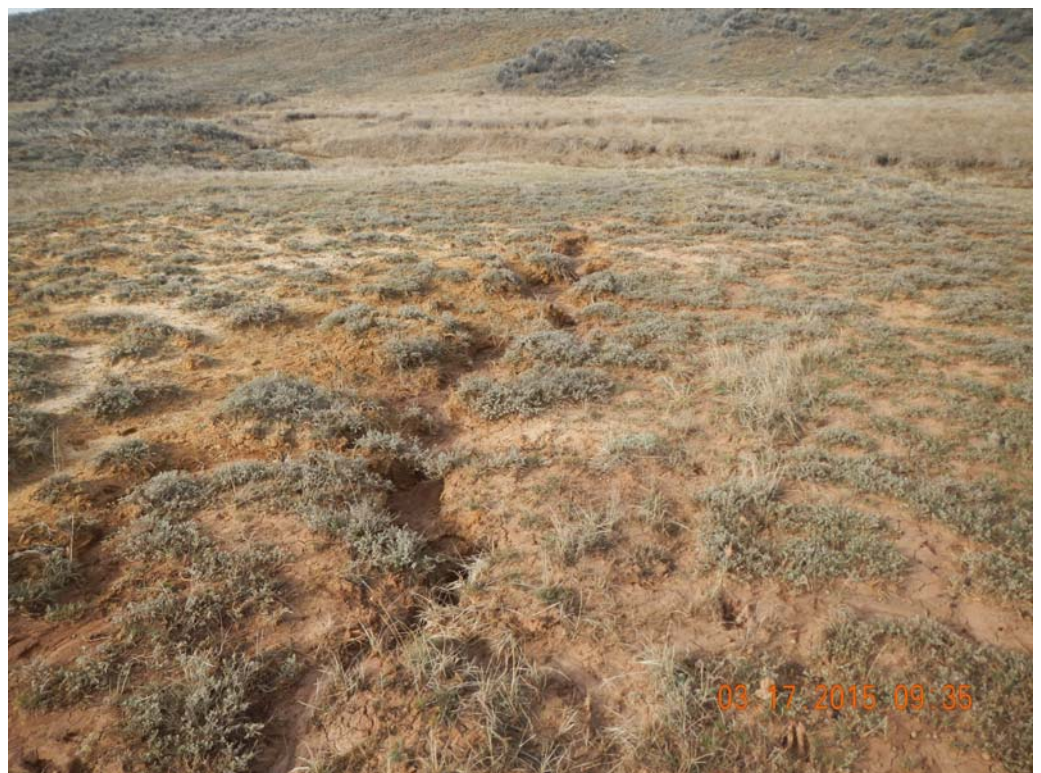
Inspection 673401912  
3/17/2015

Erosion gully on west side of location. Evidence of sediment migration all the way to drainage in background.

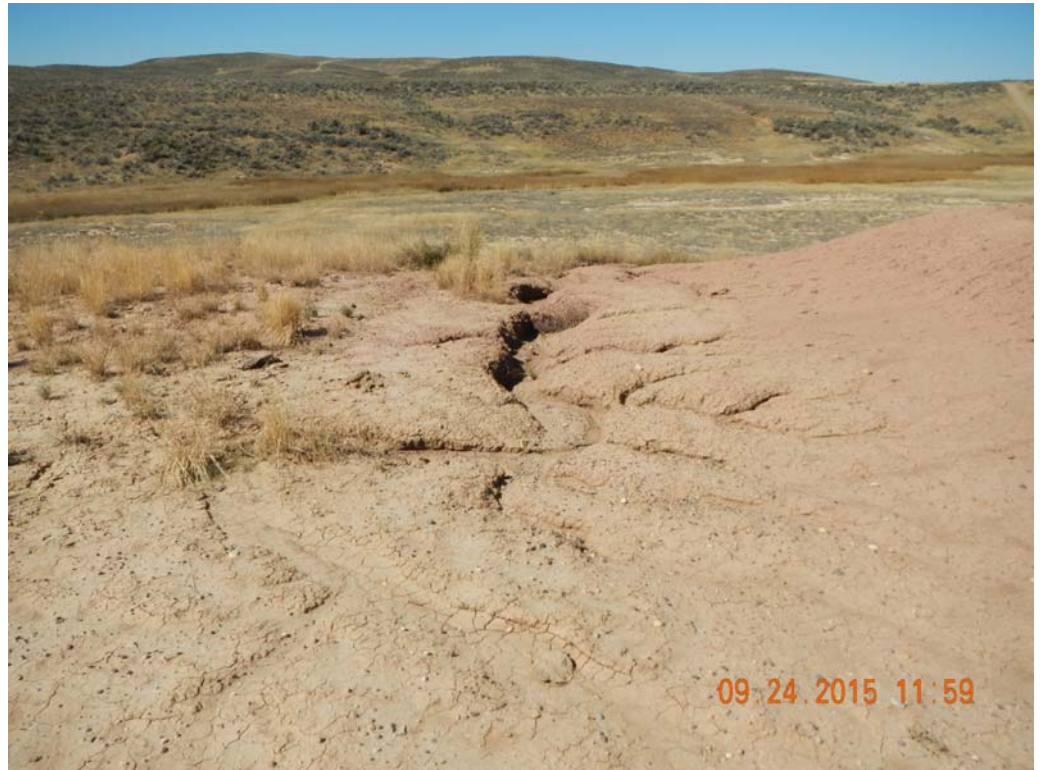
Inspection 673402474  
9/24/2015

Erosion gully on west side  
of location next to old  
tank battery berm.

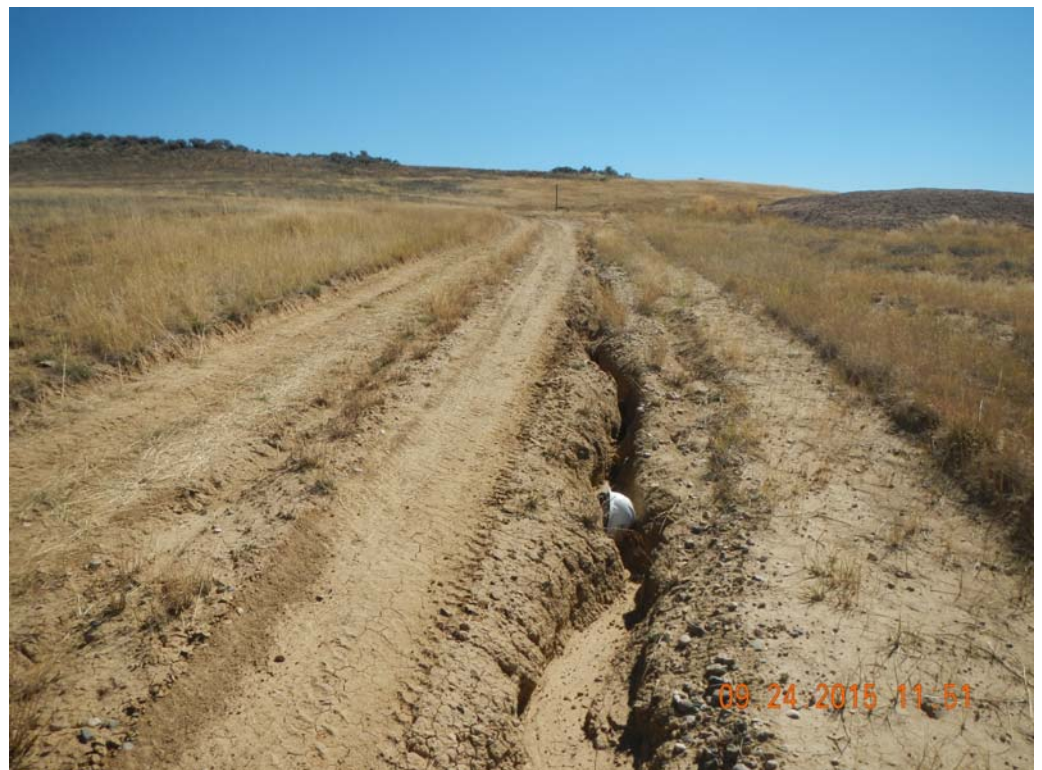
Inspection 673402474  
9/24/2015

Erosion rill on access road.

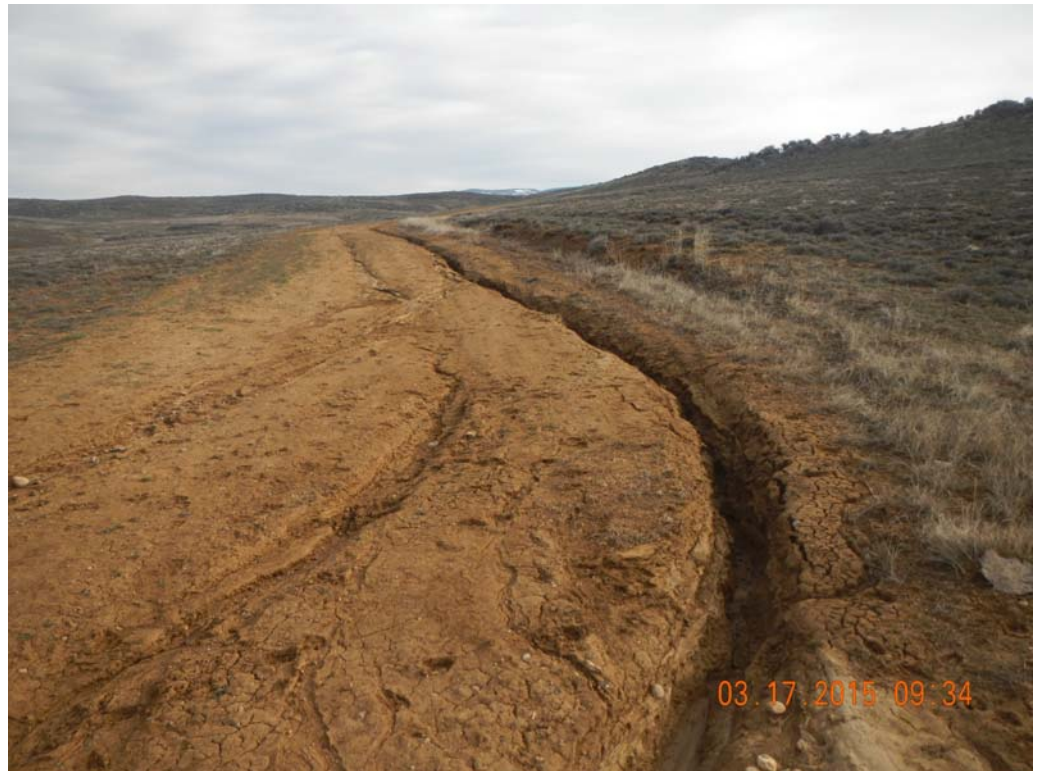
Inspection 673401912  
3/17/2015

Erosion rill on access  
road.
